# Glulam beams and columns after 5 years exposure to outdoor climate

**Anna POUSETTE**  
Researcher  
SP Technical Research  
Institute of Sweden/  
Wood Technology  
Skellefteå, Sweden  
anna.pousette@sp.se

**Karin SANDBERG**  
Researcher  
SP Technical Research  
Institute of Sweden/  
Wood Technology  
Skellefteå, Sweden  
karin.sandberg@sp.se

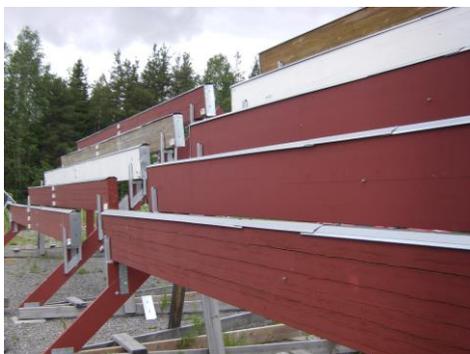
Fig. 1 Beams, nine meters long, in Bygdsiljum

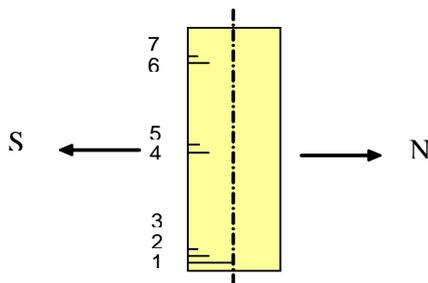
Fig. 3 Moisture contents in beams, pins at depths 10 mm, 35 mm and 70 mm

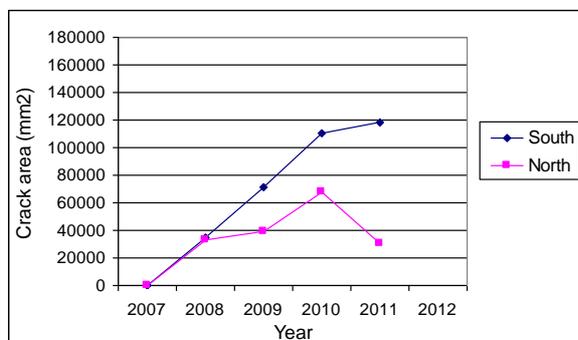
Total crack areas during 2007-2012 for each beam type are presented in fig. 5-8, for south and north side. The figures show the average of measured cracks on the five beams of each type. But some beams were not measured every year so the average is sometimes from fewer beams. Beam types B1 and B4 had most cracks and maximum amount on the south side especially beam type B4. Also the other red painted beam type, B3, had many cracks on the south side, but fewer on the north side. The white painted beam type, B2, had little crack area both on the south and north side.

Fig. 5 Crack area (mm<sup>2</sup>) in beam type B1, on south and north side, average of five beams (year 2011 only one beam measured)

After 5 years the crack area in beam type B1 (impregnated, oiled) was about 25 times larger than in B2 (impregnated, white painted) on the south side and about 15 times larger on the north side. Beam type 4 (impregnated, red painted) had crack area in the same order as in type B1. This indicates that the surface treatment made a difference, especially the colour. In the sunshine a light colour will not get as hot as a darker colour, and thus for the white beams the difference in the moisture contents between the surface and the inner of the beams is little.

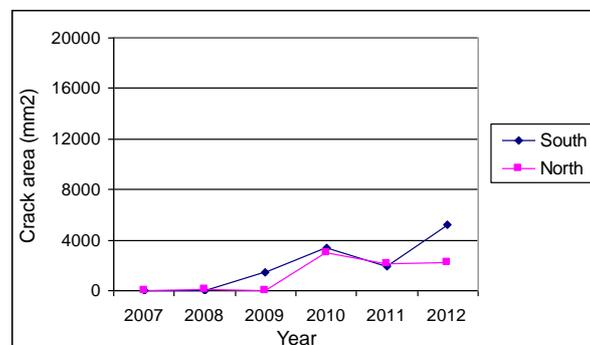
Fig. 6 Crack area (mm<sup>2</sup>) in beam type B2, on south and north side, average of five beams

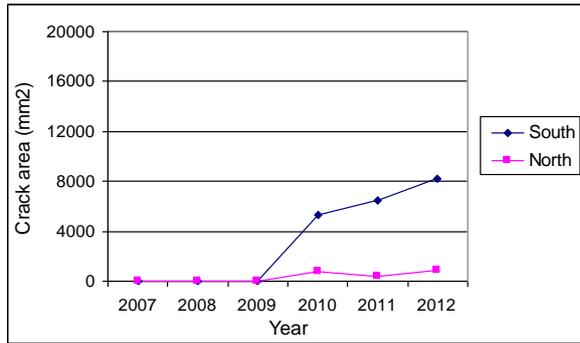
Fig. 7 Crack area ( $\text{mm}^2$ ) in beam type B3, on south and north side, average of five beams

Beam type B4 (impregnated, red painted) had about 20 times more cracks on the surface than beam type B3 (spruce, painted red) after 5 years. This shows that the wood material is also important and not just the colour. It is the sapwood in pine that is impregnated. Impregnated pine wood that cracked very much probably had more sapwood than spruce. The amount of sapwood and heartwood depends on how the laminations are sawn from the log. This will also influence the

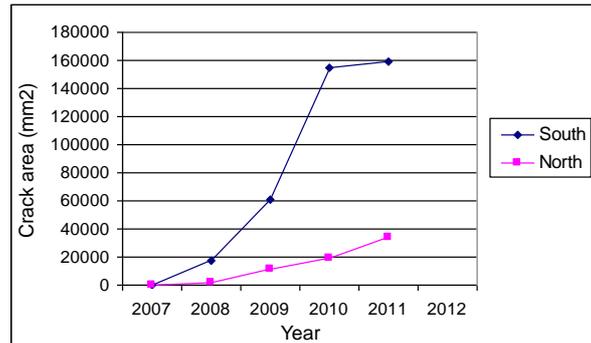
Fig. 8 Crack area ( $\text{mm}^2$ ) in beam type B4, on south and north side, average of five beams

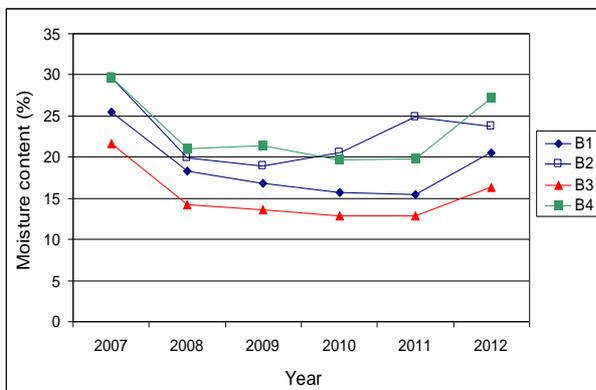
Fig. 9 shows the average moisture contents in beam types B1-B4 during 2007-2012. The values for 2011 are sometimes from fewer beams because several beams had no measurements for 2011. The average values were calculated from the values of all pins 1-7 in the middle of the beams. At the start in 2007 there were some high moisture contents at some pins and variations in moisture were large in all beams. The summers in 2010 and 2011 were dry, but the summer in 2012 was rainier. The beam type B3 (red spruce) had the lowest moisture contents all years.

Fig. 9 Moisture contents in beam types B1-B4, average of all pins 1-7 in middle of beam.

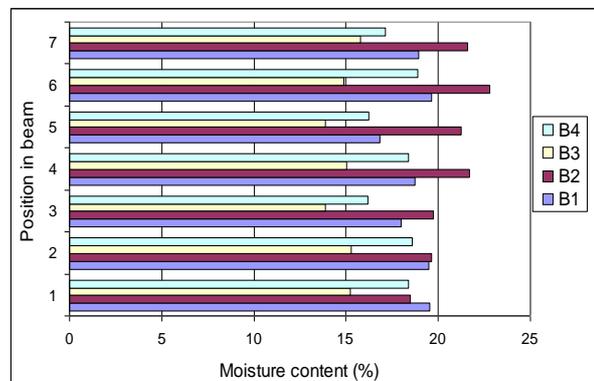
In Fig. 10 the moisture contents are shown for each pin 1-7 in the middle of beams. These are average values for all years. The pins 3, 5, and 7 had in general the lowest moisture contents, which means the surface was dryer than the inner of the beams. There was little difference between the moisture contents at pins 1 and 2, which means the moisture contents at 35 mm depth and at 70 mm depth were almost the same. The moisture contents were quite similar at top and bottom of the beams.

Fig. 10 Average moisture contents at pins 1-7 in middle of beams, in beam types B1-B4.

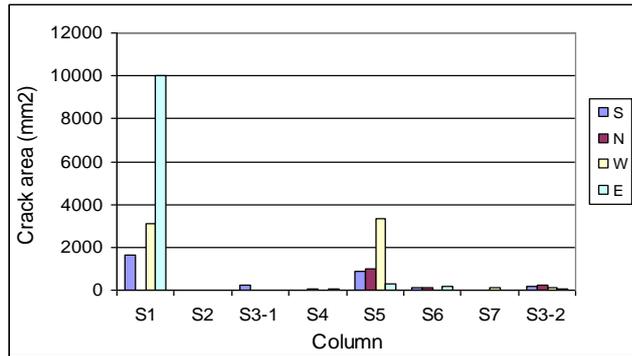
Fig. 11 displays the average amount of crack area for the different sides of the columns. The crack area was calculated in the same way as for the beams. Cracks in columns were not measured every year. Fig. 11 shows the maximum measured crack area for each column type, which can be for different years 2009, 2010 or 2012 (no measurements in 2011). The oiled glulam columns had most cracks, except on the north side. Also the Comwood columns had quite a lot of cracks. All the other columns had very little cracks.

Fig. 11 Crack area (mm<sup>2</sup>) for the different sides south (S), north (N), west (W) and East (E)

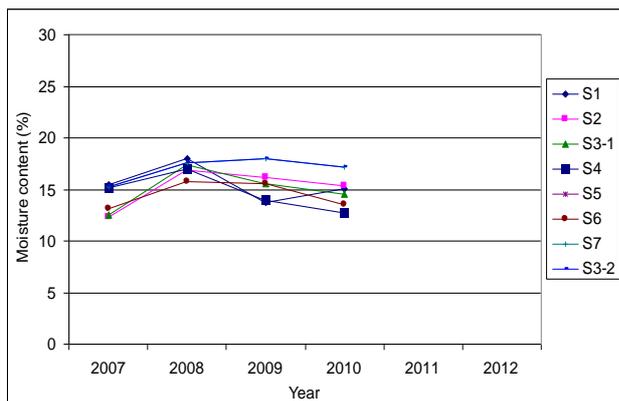
The columns were quite dry when they were placed in the test field, about 12-15 %, see Fig. 12. The moisture contents of the Comwood columns (S5) were not measured. No measurements were made during 2011 and 2012, and until 2010 the moisture contents had not changed very much.

Fig. 12 Moisture contents in the different types of columns

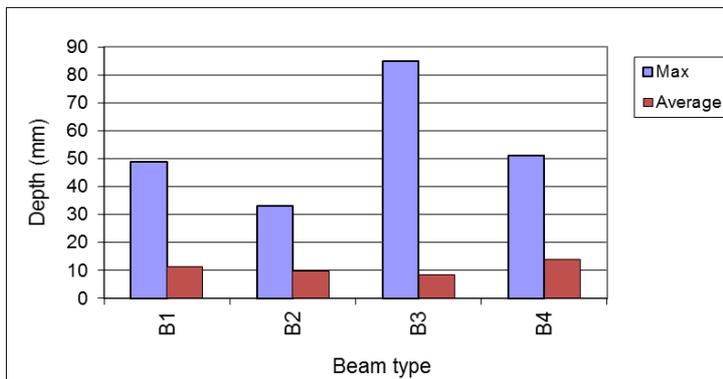
Beams with most cracks had a crack area of about 3-4 % of the total area of the beam surface. After 5 years these relatively small cracks should not significantly reduce the strength of the beams. The maximum measured crack depth was 85 mm in one beam B3, but most cracks of all beams were not deeper than 50 mm, see Fig. 13. The average depths were about 8-12 mm, see Fig. 13. The maximum measured width was 12 mm, but most cracks in all beams were not wider than 2 mm. It should also be taken into account that the depths and widths were only documented with the maximum values, which means all crack areas were overestimated.

Fig. 13 Maximum and average crack depths (mm) for beam types.
