Evaluation of Rumble Stripes on Low-Volume Rural Roads in Iowa—Phase I

**Final Report
July 2009**

EVALUATION OF RUMBLE STRIPES ON LOW-VOLUME RURAL ROADS IN IOWA—PHASE I

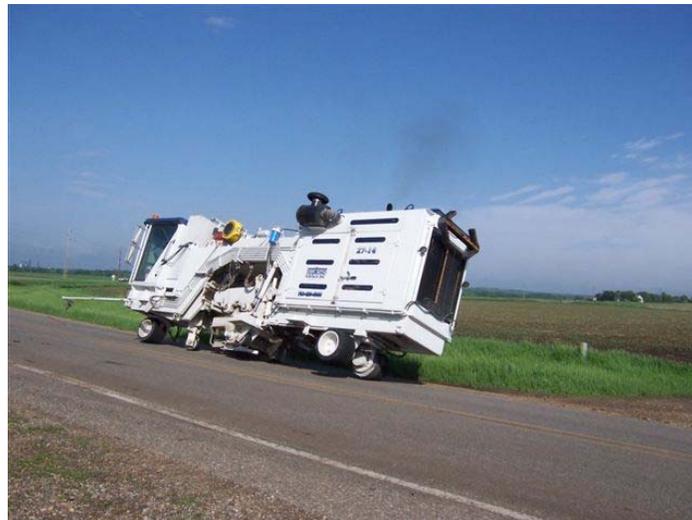
Figure 3-11. Machine tipping on inside curve

First, as described earlier in this report, some installation problems were encountered during milling operations. If rumble stripe installation is to be adopted as a recommended tool for mitigating roadway departure on lower-volume rural roadways, milling machine design will need to be modified to allow placement of these narrow width rumble strips along the pavement edge, regardless of shoulder quality along that edge. The modified machine developed by Iowa Plains Signing performed much better than the higher center of gravity machine owned by Diamond Surfaces, but the design should still be improved further to provide adequate and predictable alignment and milling depth in a variety of alignment situations and pavement types, especially on PCC pavement, where a heavier machine is necessary to consistently achieve desired milling depth.

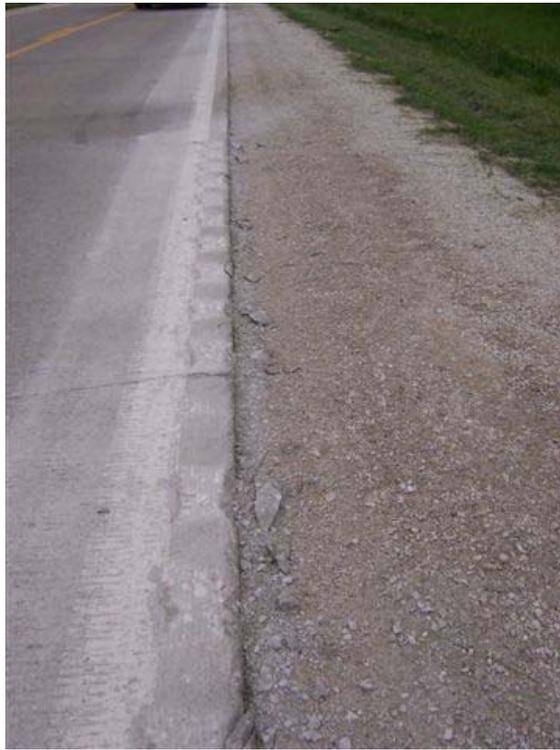
Milling in the rumble strips also resulted in some breakup of the pavement surface, as shown in Figure 3-12. In one county, milling was suspended around mailboxes to avoid damage, as shown in Figure 3-13.

Figure 3-12. Edge spalling along edge of PPC pavement

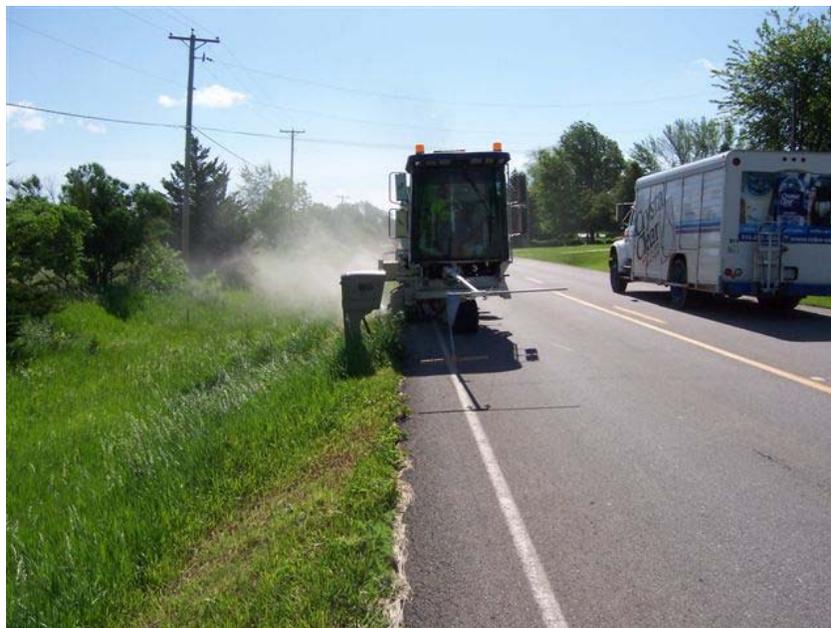
Figure 3-13. Milling operation omitting short areas around mailboxes in Polk County

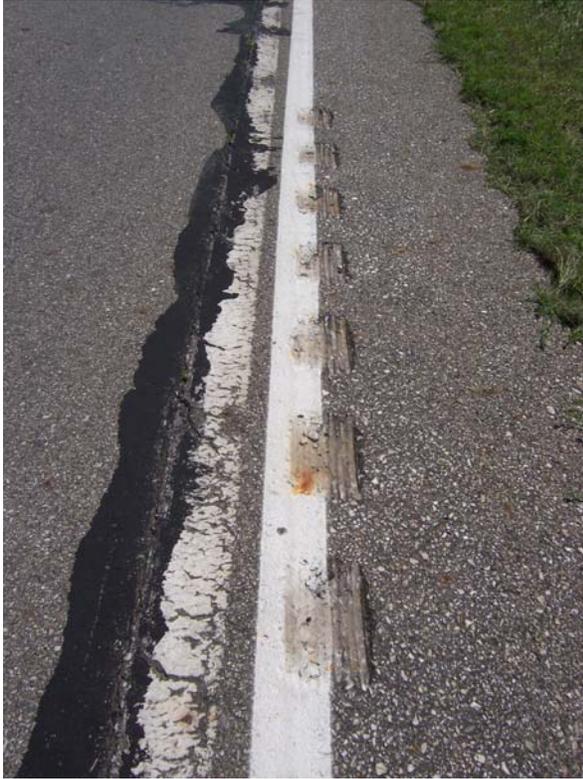
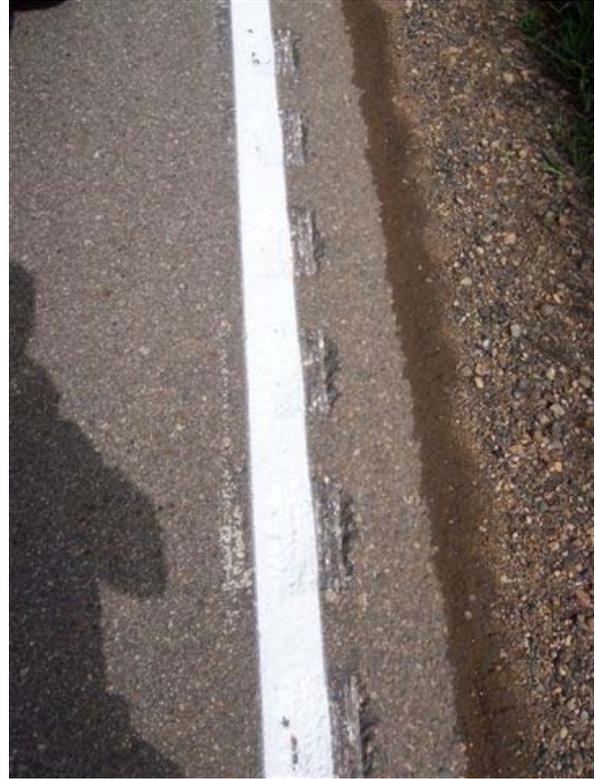
Figure 3-14 shows the difficulty in aligning the painted edge line with the milled rumble strip.

Figure 3-14. Photos showing difficulty in maintaining painted edge line alignment within rumble stripe installation

- There were problems maintaining horizontal consistency with distance from edge; as a result, the guidance system in the milling machine needs refinement.
- Inadequate removal of millings resulted; a compressor was added to the installation process to remove material.
- The milling machine had problems with stability around the low side of horizontal curves; those areas had to be omitted initially but were later cut with the modified Iowa Plains Signing machine.
- Breakup of edges on PCC pavement occurred when the milling operation was attempted too close to the edge.
- It was difficult to achieve the desired 5/8 inch milling depth in PCC pavement (most measured approximately 1/2 inch in depth) due to insufficient downward pressure on

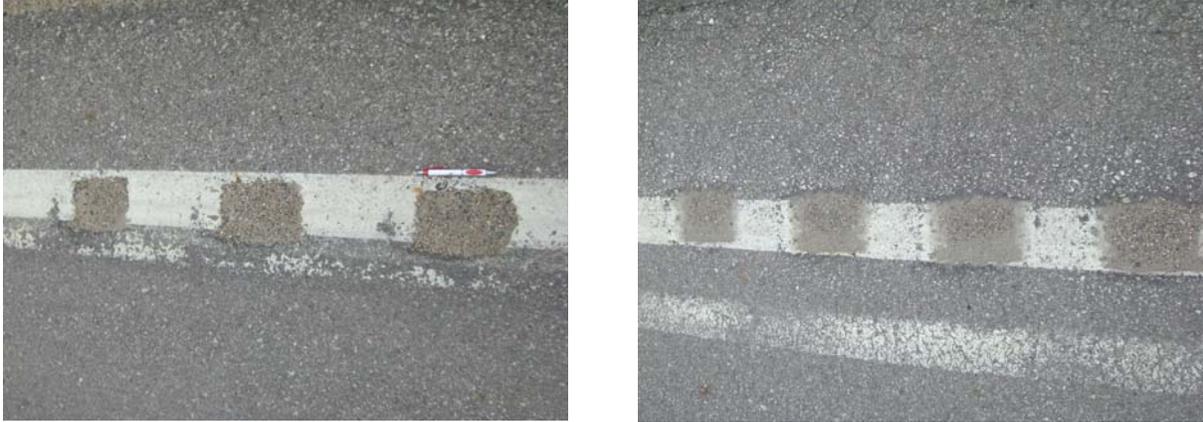
Although the appearance of the stripes seemed the same for the initial and most of the fall collections, county maintenance crews had pulled up the gravel shoulders on the Poweshiek project, filling the stripes with loose granular material. This rendered them ineffective until the paint contractor blew out the material with compressed air. Also, the spring collection period revealed that the many of the stripes had been filled or partially filled with loose gravel material,

even on the Polk County roads with paved shoulders. See Figure 5-2. This may be attributed to winter maintenance using sand (sometimes mixed with salt) on slick roads. The amount of filling seemed to be much heavier on the asphalt pavements than on the PCC pavements.

Figure 5-2. Rumble stripes filled with sand

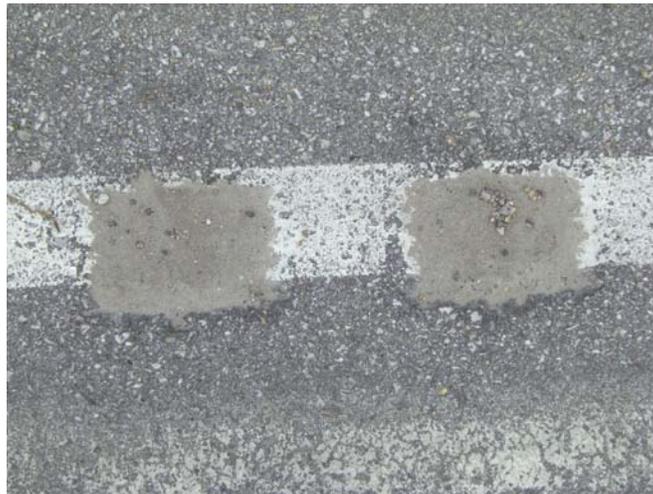
Some of the stripes, especially at the tops of hills, on straight road segments seemed to accumulate only a small amount of caked fines in the bottom of the stripe. See Figure 5-3.

Figure 5-3. Rumble stripe with caked fines in bottom

Stripes that were caked and only partially filled showed better retroreflectivity readings than those that were completely filled. Although the authors did not wish to introduce a possible maintenance activity for using these stripes, they did consider that the performance might be better if the loose (or caked) material was broomed from the stripe. See Figure 5-4. Therefore, they did broom (by hand) several stripes of each type and shot them for performance. In all cases, the retroreflectivity of the swept stripes measured lower than the untouched ones. The authors believe that this may have occurred due to dust created by the brooming covering most of the reflective beads and/or due to the brooming action itself removing much of the beading from the paint surface. Using a stiff or soft bristle hand broom seemed to make no difference.

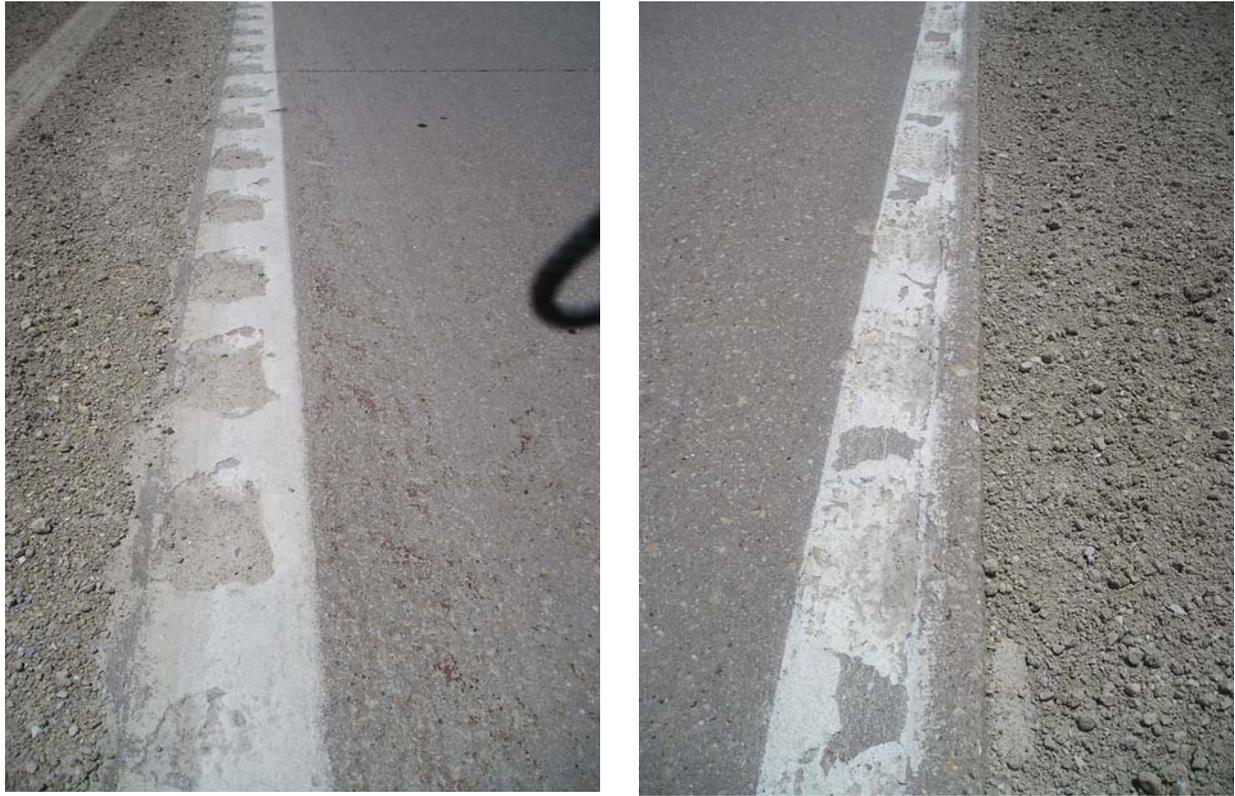
Wear on pavement markings was also compared by visual inspection. Figure 5-13 shows a section of the rumble stripes in Buchanan County taken in May 2009. Notice how, in general, the markings have worn considerably, but the area within the groove appears to have experienced even greater wearing. The pavement in this section is PCC.

Figure 5-13. W-13 pavement markings in spring and after wear over winter, showing more wear in the groove than in the flat section

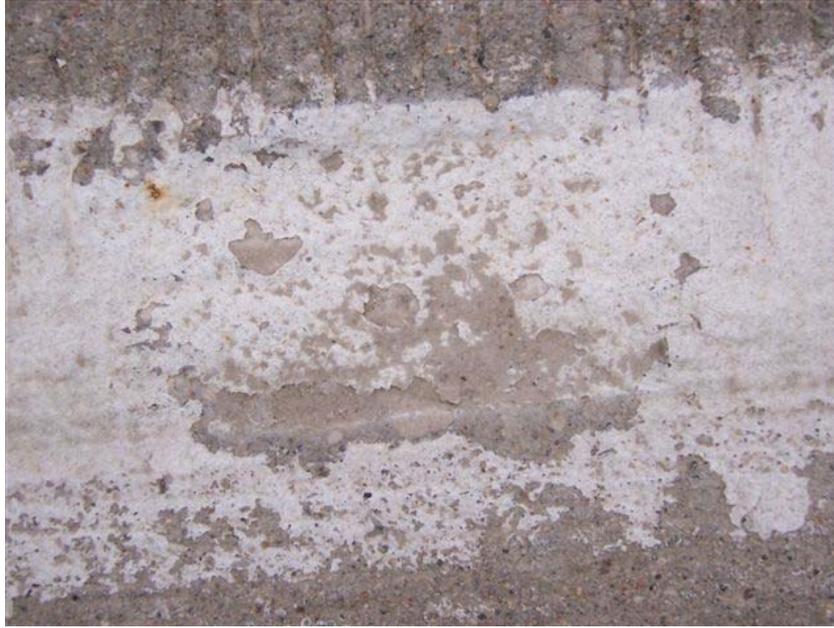
Some of the paint that was applied late in the fall (inside curve segments in Dallas/Madison, Polk, Buchanan, and Poweshiek Counties) did not seem to adhere well in the stripe area, especially on the PCC surfaces. Much of the paint was loose and had chipped away by the spring evaluation. Brooming seemed to remove most of the loosened pieces. See Figure 5-14.

Figure 5-14. Peeling paint chips on flat area

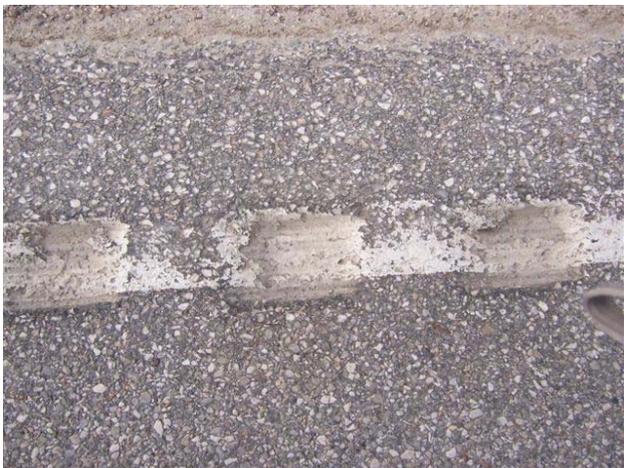
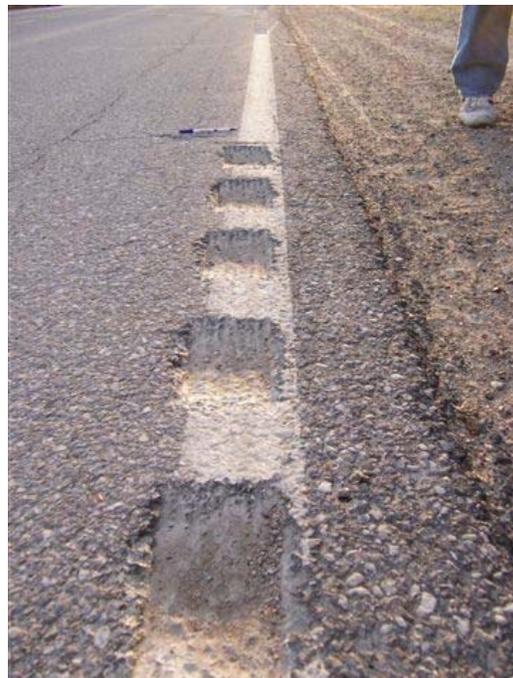
In other areas, the paint in the rumble stripe appeared to weather better and show less wear than the pavement markings on the flat portion of the roadway. Figure 5-17 shows a portion of F-29 that shows less wear in the groove than in the flat areas. Figure 5-18 shows a similar scenario for P-53.

Figure 5-17. Another portion of F-29 showing less wear in the rumble stripe than in the flat area (taken spring 2009)

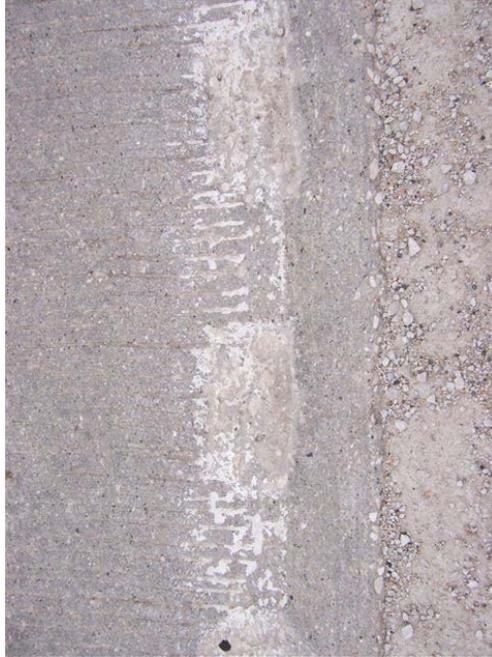
Figure 5-18. Another portion of P-53 showing less wear in the rumble stripe than in the flat area (taken spring 2009)

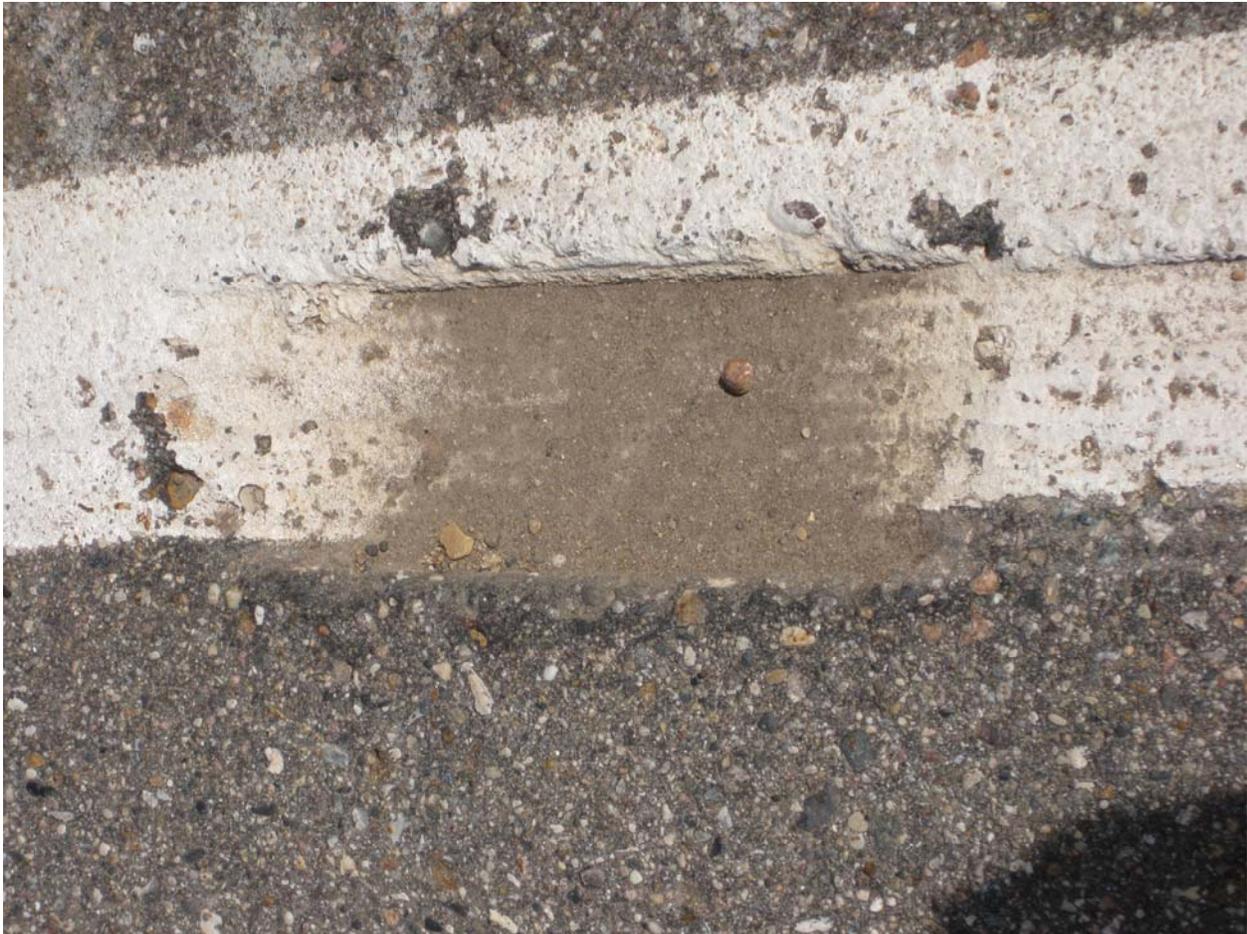
Some of the rumble strips collected an unusual amount of debris. See Figure 6-1. It was commonly believed that wind from vehicle tires would force dirt and other material from the rumble strips, leaving the area fairly clean. This was not the case on F-70 and in several other locations. This problem persisted over several seasons and was not an isolated occurrence. It is not known why this problem occurred in a few areas but not others.

Figure 6-1. Rumble stripes on B-30 filled with debris
