# Evaluating Roadway Subsurface Drainage Practices – Phase II

**Final Report**  
**April 2015**

**IOWA STATE UNIVERSITY**  
**Institute for Transportation**

**Sponsored by**  
Iowa Highway Research Board  
(IHRB Project TR-662)  
Iowa Department of Transportation  
(InTrans Project 13-473)

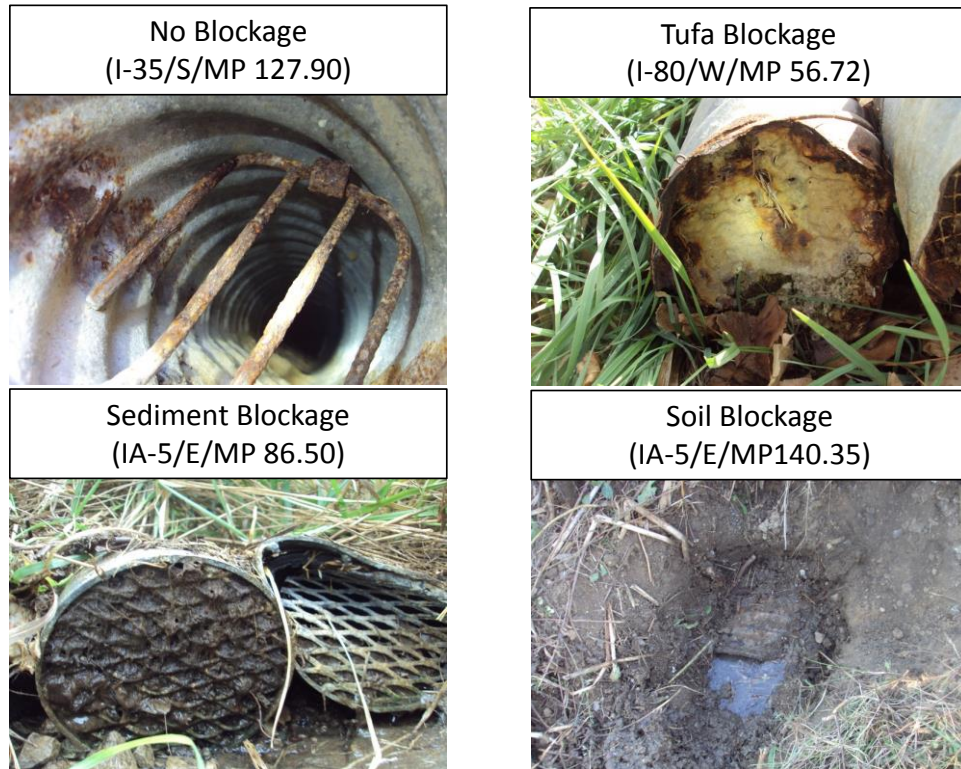
**Figure 6. Drainage outlet conditions categorized by blockage**

Among these items, similar to the Phase I study, the inspected drainage outlet conditions were rated according to four categories, as seen in Figure 6:

- No blockage (open): when the inside of the outlet pipe was in clean condition
- Tufa blockage: when there was build-up of calcium carbonate observed either inside the outlet pipe or nearby rodent guard screens
- Sediment blockage: when dirt or debris materials were deposited inside the outlet pipe or nearby rodent guard screens
- Soil/aggregate blockage: when the outlet was not exposed outside but covered by soil or aggregate

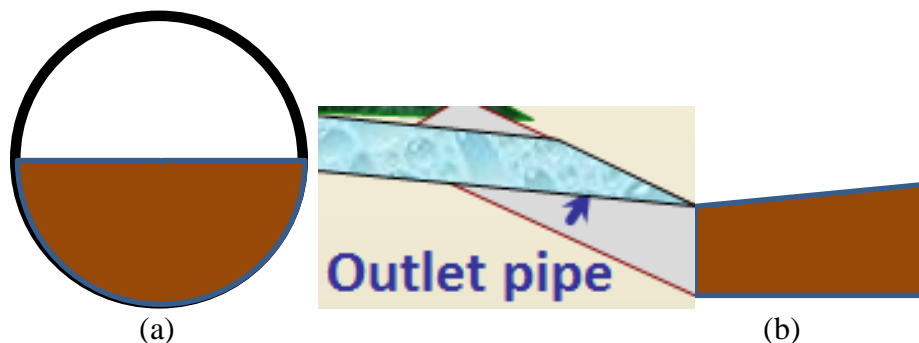
The functional condition of the outlet opening was rated in terms of percentage of blockage caused by coarse/fine materials accumulation. The slope condition of the surface at the outlet end was rated as “up-hill,” “down-hill,” and “parallel.” For instance, Figure 7(a) illustrates a 50 percent outlet blockage rating and Figure 7 (b) illustrates an “up-hill” slope condition. Any pavement distresses observed near the inspected drainage outlet location were also recorded (images and videos).

**Figure 7. Subdrain outlet functional rating based on visual observation: (a) 50 percent blockage, and (b) up-hill condition of surface at the outlet end**

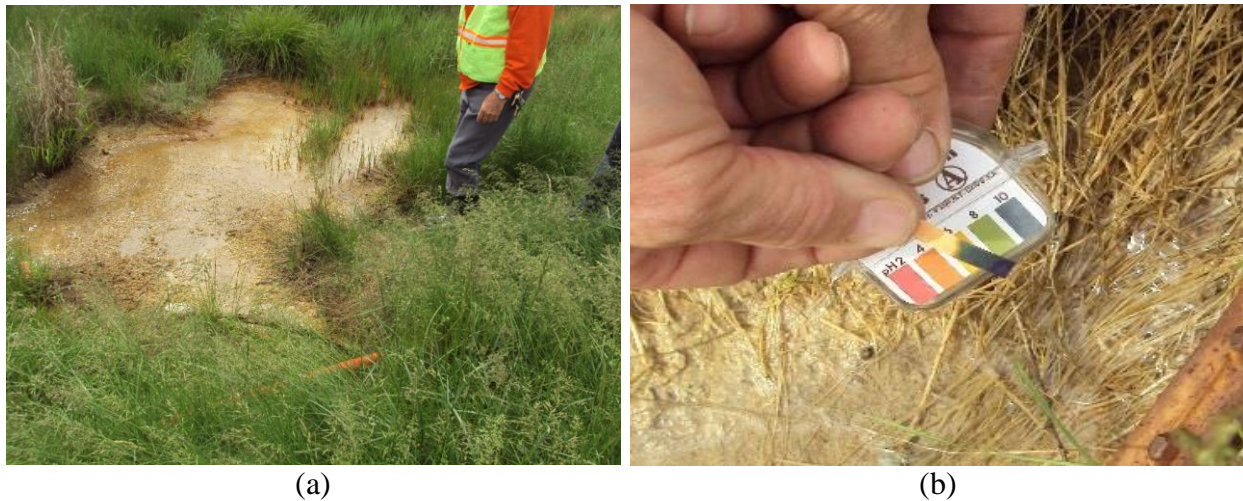
As seen in Figure 11(a), vegetation kills, referred to as “dead zones,” were observed in the vicinity of the drain outlet that carried tufa materials. The high-pH and high-alkalinity characteristics of tufa (see Figure 11(b)) could have possibly contributed to the observed vegetation kills. However, environmental assessment studies focusing on the impact of tufa on roadside vegetation are very limited, and none of them have reported it to be an environmental hazard (Snyder and Bruinsma 1996).

**Figure 11. Vegetation condition in the vicinity of drain outlets carrying tufa materials (I-35/N/MP141.30): (a) vegetation kill (dead zone), (b) water from the drainage outlet pipe showing a pH value of 10**

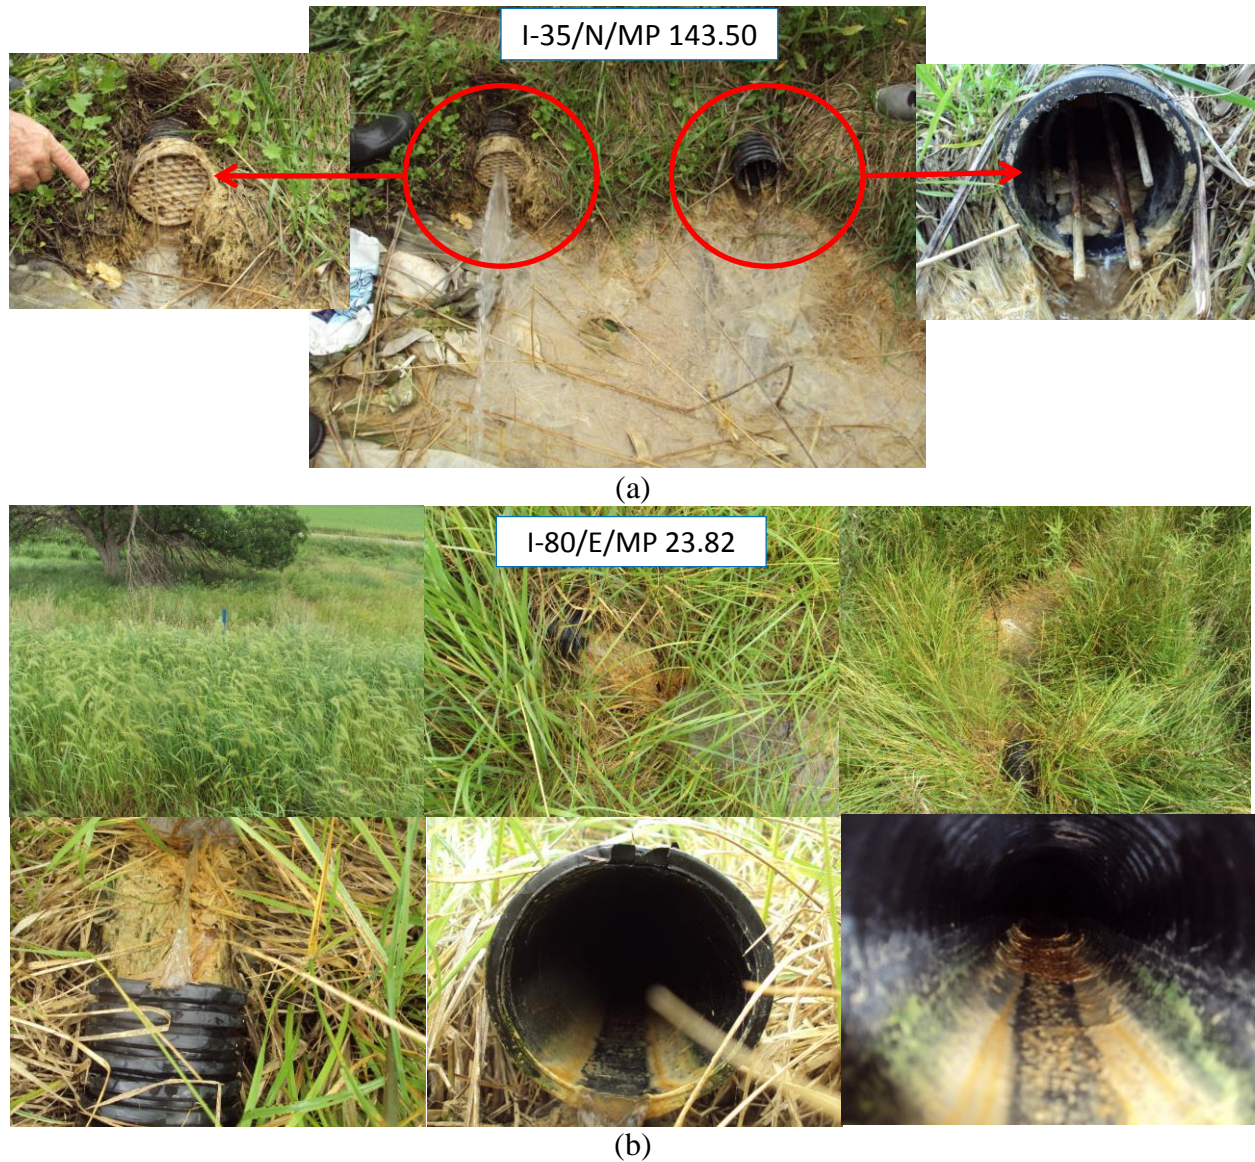
As seen in Figure 14(a), the mesh screen-type rodent guard (even in plastic outlet pipe) exacerbates the clogging of the outlet by blocking the free flow of draining water. Although tufa is still observed in the plastic outlet pipe with fork-shaped rodent guards, the amount of tufa inside the pipe is not enough to be able to cause clogging. Removal of the rodent guards in plastic outlet pipe, as shown in Figure 14(b), often seems to prevent the tufa blockage problem.

**Figure 14. Smaller amount of tufa blockage issues observed with the use of plastic outlet pipe in newly constructed JPCP sites containing RPCC base materials: (a) I-35/N/MP143.50 and (b) I-80/E/MP23.8**

- The use of a gate/mesh screen-type rodent guard has the potential to cause outlet blockage. Considering that very little rodent evidence was observed in Iowa subdrainage outlets during field investigations, it is highly recommended that these rodent guards not be used to cover drainage outlets in Iowa.

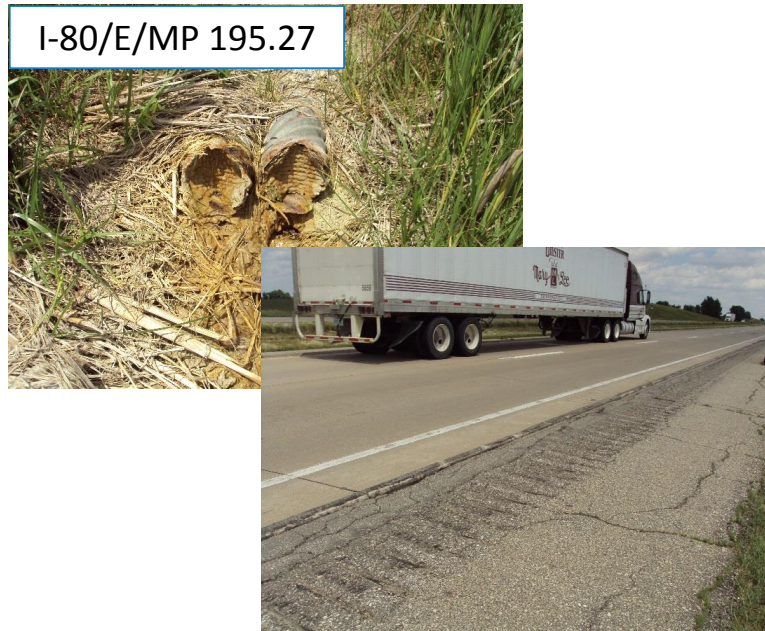
More instances of shoulder distresses (shoulder drop or cracking), as shown in Figure 16(a), were observed near blocked drainage outlet locations than near non-blocked locations at JPCP sites during both fall 2012 and summer 2013 (see Figure 16(b)). Especially note that shoulder distresses were observed near a majority (above 70 percent) of blocked drainage outlet locations during summer 2013. These results indicate that the blocked drainage outlet conditions in JPCPs have a significant impact on pavement shoulder distress development.

**Figure 16. Outlet locations with shoulder drop/cracking in newly constructed JPCP sites: (a) an example on I-80/E/MP195.27 and (b) shoulder distress conditions with respect to subsurface drainage outlet condition**

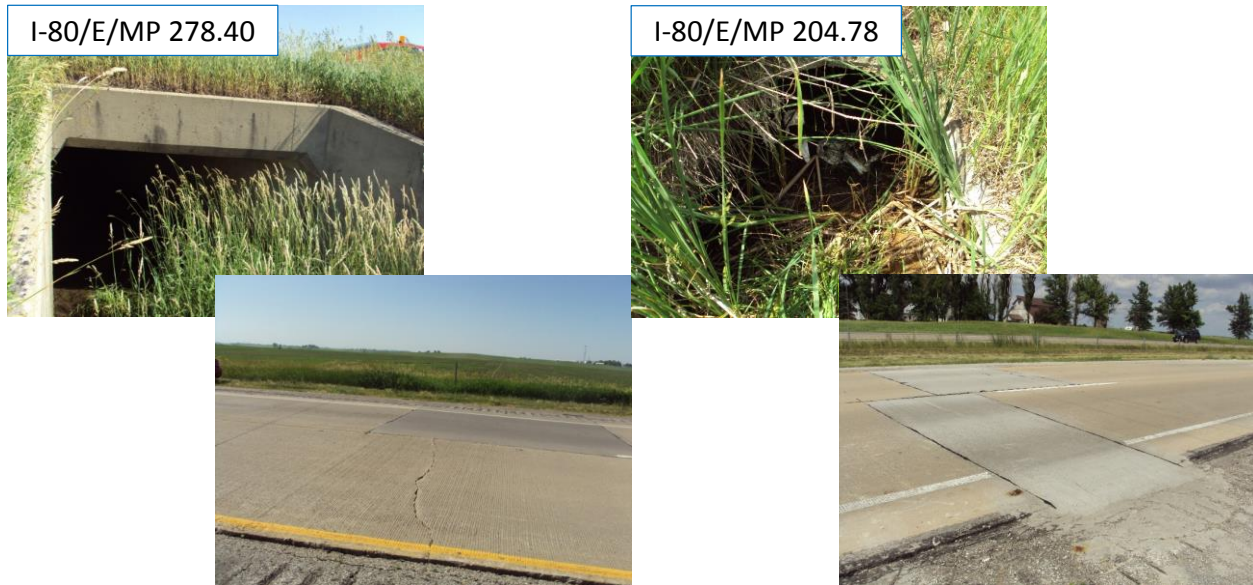
As described previously, pavement surface locations having a high severity of moisture-related distress or patching were also inspected in Phase II forensic testing to see if these are related to drainage problems. Transverse cracking or patching was more often observed where culverts only or culverts with drainage outlets (see Figure 17) were placed rather than just the drainage outlets. These observations indicate that these pavement surface failures are possibly caused by the culvert rather than the subdrain system.

**Figure 17. Cracking/patching observed near culvert-only/culvert with drainage outlet locations in newly constructed JPCP sites**

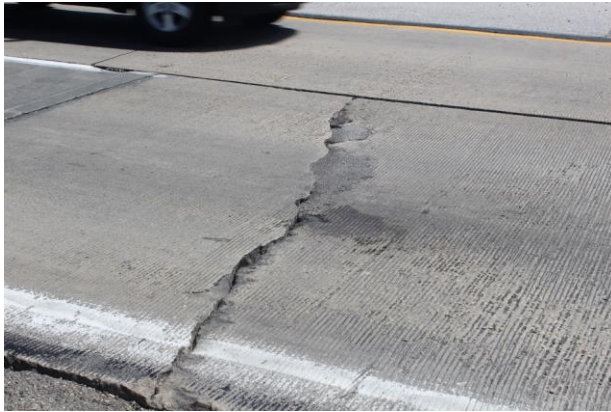
- Pavement type: JPCP (11.5 in PCC/10.0 in subbase)
- Subbase aggregate type: RPCC
- Construction year: 2005
- AADTT: 8,093
- Transverse cracking with water coming out

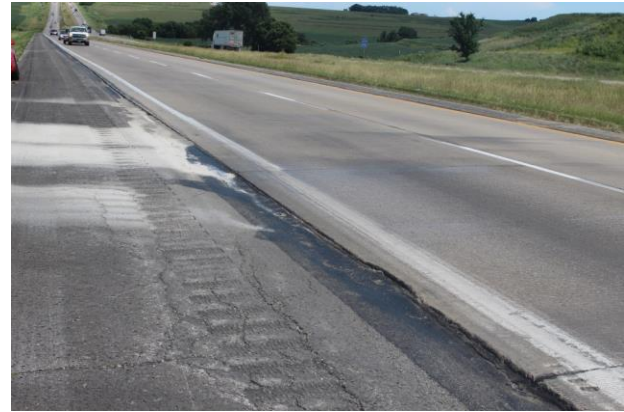
#### **I-80/W/MP 34.70/Pottawattamie County**

- Pavement type: JPCP (11.0 in PCC/8.0 in subbase)
- Subbase aggregate type: Virgin
- Construction year: 1986
- AADTT: 8,093
- Faulting with water coming out

**Figure 18. Moisture-related damage observed on JPCP sites where no drainage outlet was found**

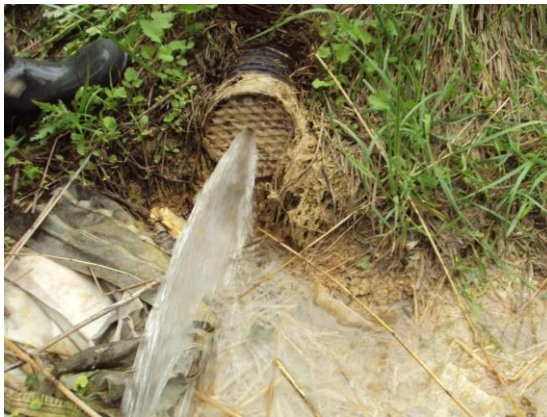
- Number of outlet pipe: 2
- Type of outlet pipe: Corrugated plastic
- Size of outlet pipe: 4 inch
- Condition of outlet pipe: 100% blockage (tufa blockage)
- Water present inside outlet pipe: Yes (standing)
- Type of rodent guard: Gate
- Tufa/Dead zone (due to tufa) present: Yes
- Embankment slop condition: Less than 30 degree

Water backup in pipe

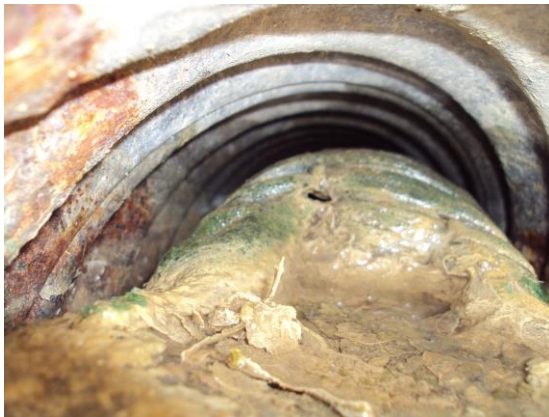
Tufa blockage extends back into the pipe

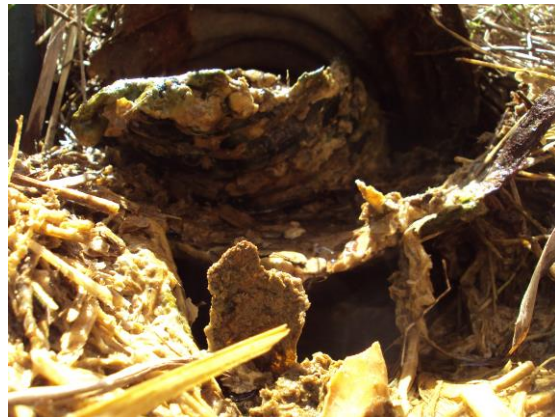
Damaged and tufa formation at outlet

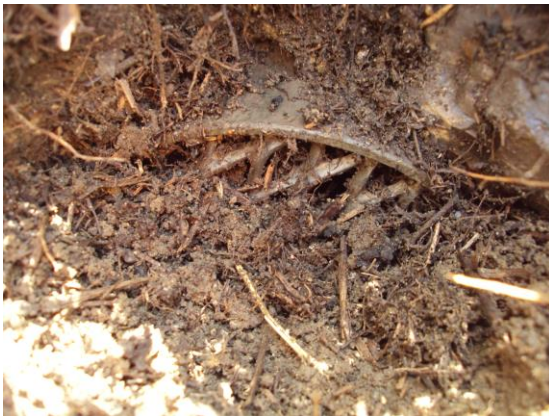
- Number of outlet pipe: 1
- Type of outlet pipe: Corrugated plastic
- Size of outlet pipe: 4 inch
- Condition of outlet pipe: 100% blockage (soil blockage)
- Water present inside outlet pipe: No
- Type of rodent guard: Gate screen
- Tufa/Dead zone (due to tufa) present: No
- Embankment slop condition: More than 30 degree

Had to dig to find drain

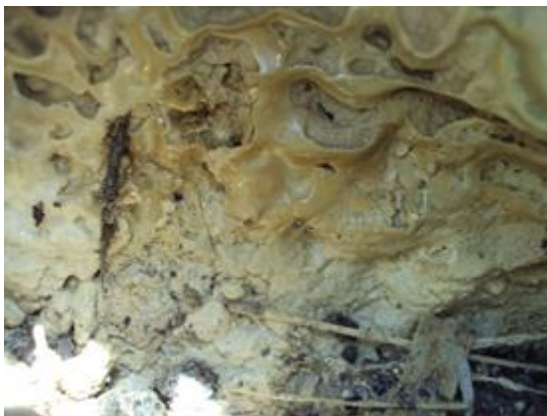
Tufa blockage

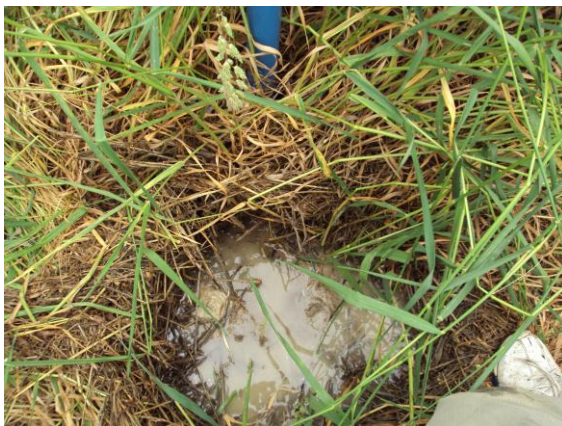
Soil blockage with standing water

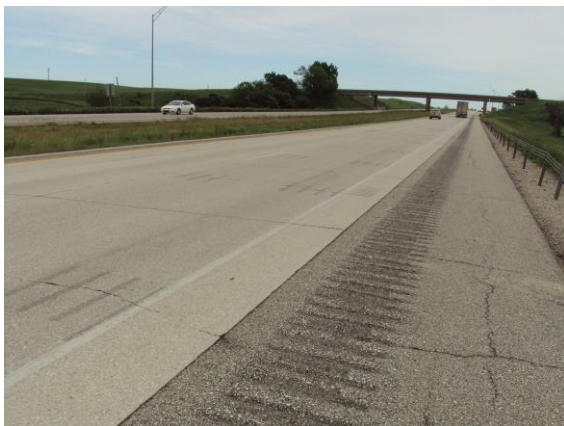
- Cracking due to culvert

Transverse cracking due to culvert

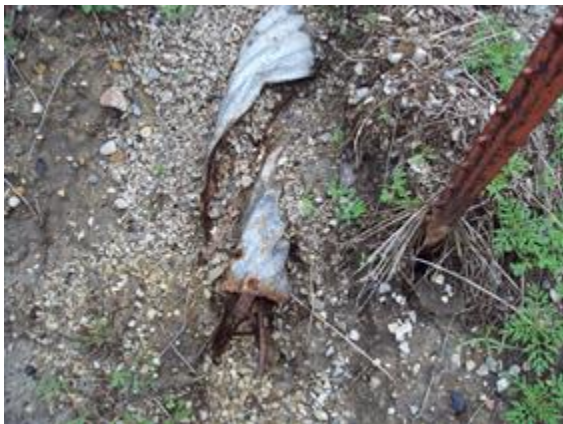
Broken pipe

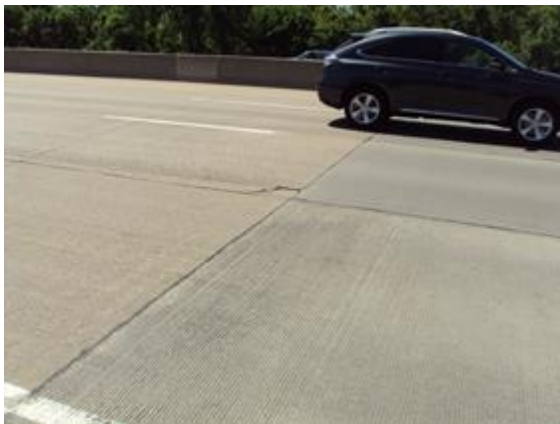
Small corner crack

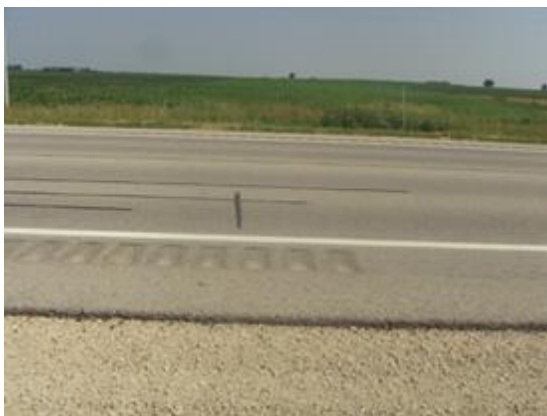
Longitudinal and transverse cracking patching

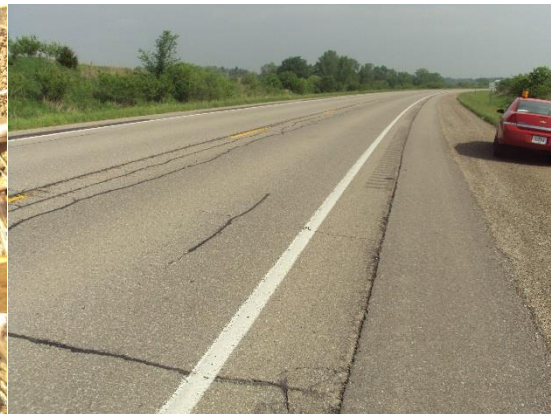
Longitudinal and transverse cracking patching

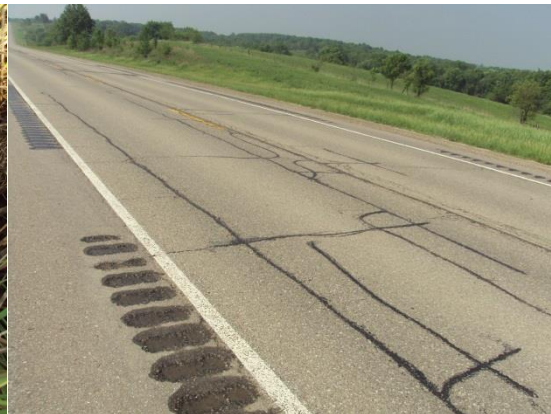
Longitudinal and transverse cracking patching

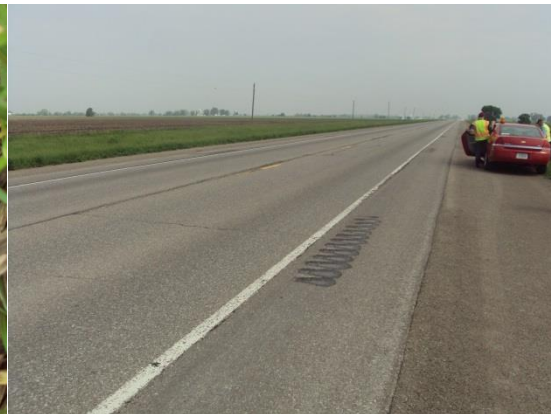
Transverse cracking

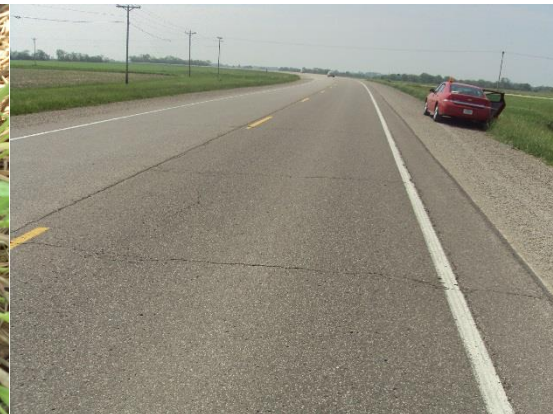
Reflection cracking

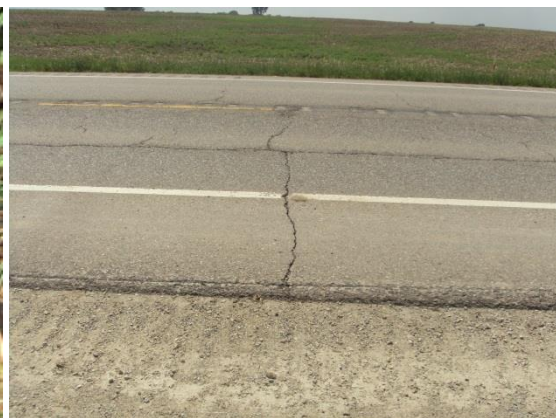
Longitudinal and transverse cracking

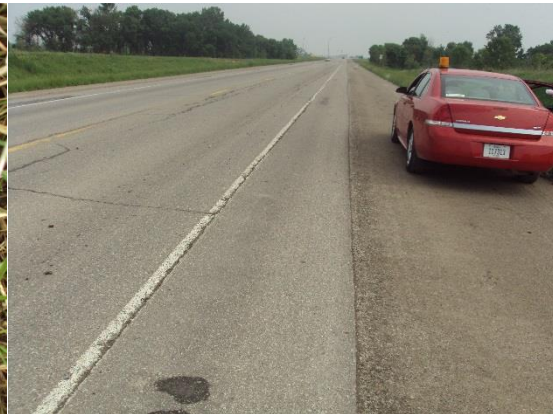
Longitudinal and reflection cracking

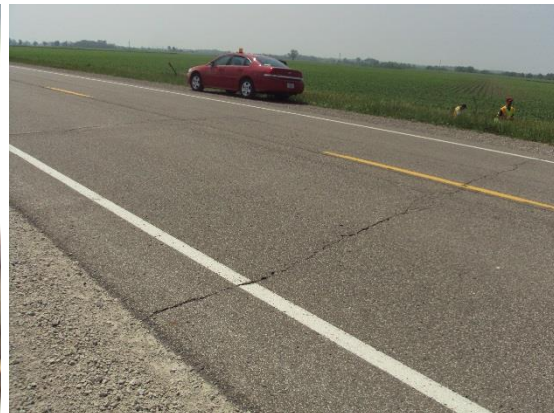
Reflection cracking

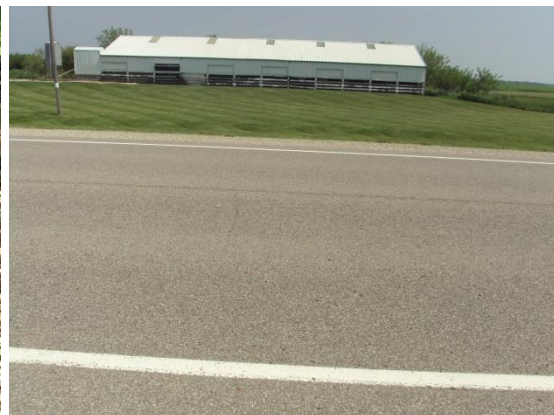
Transverse cracking

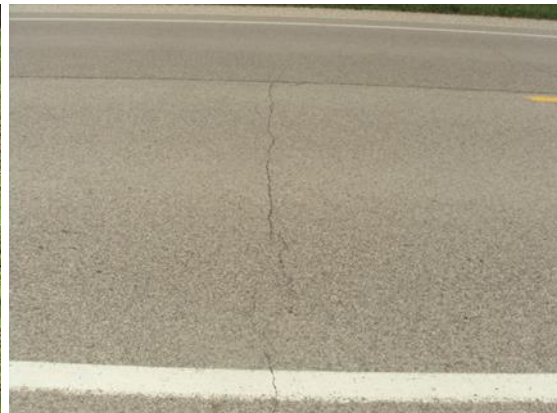
Transverse cracking

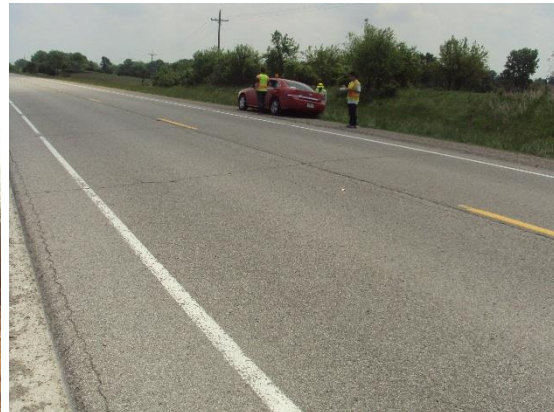
Reflection cracking

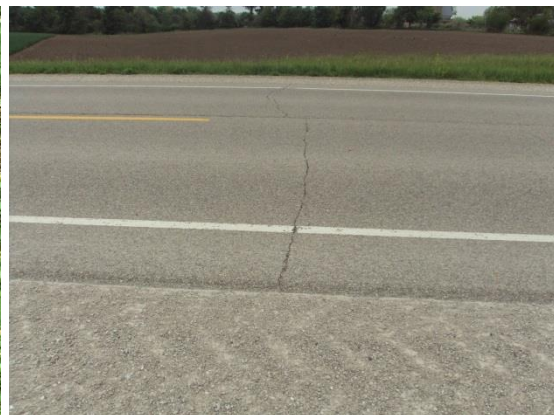
Transverse cracking

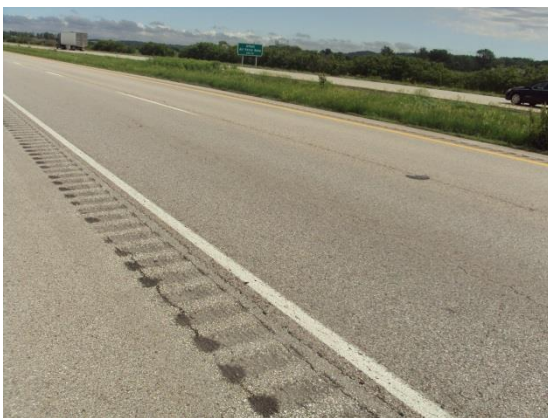
Longitudinal cracking

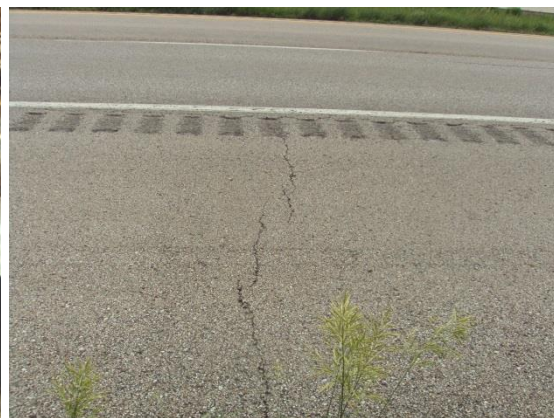
Transverse cracking

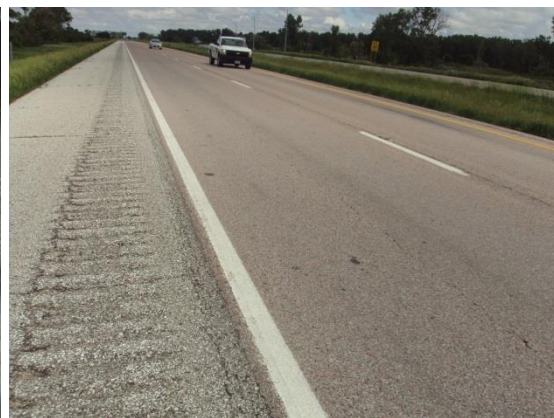
Longitudinal cracking

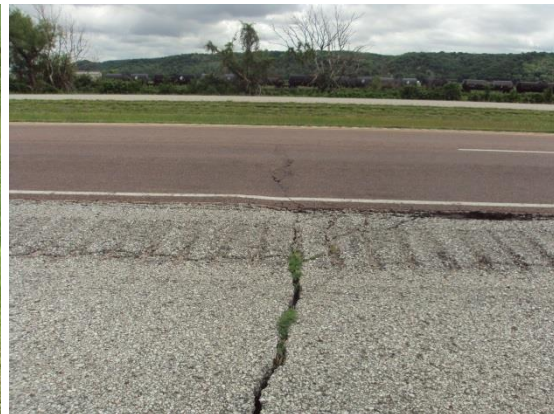
Transverse cracking/rutting

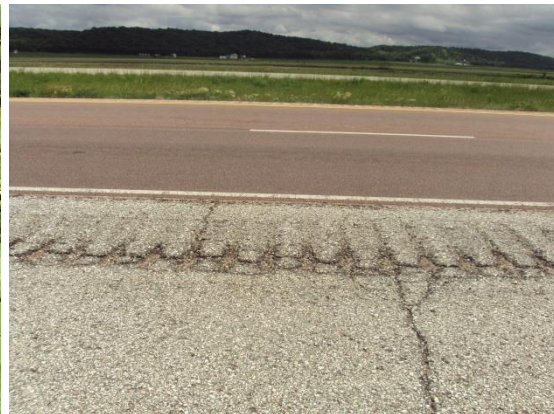
Transverse cracking

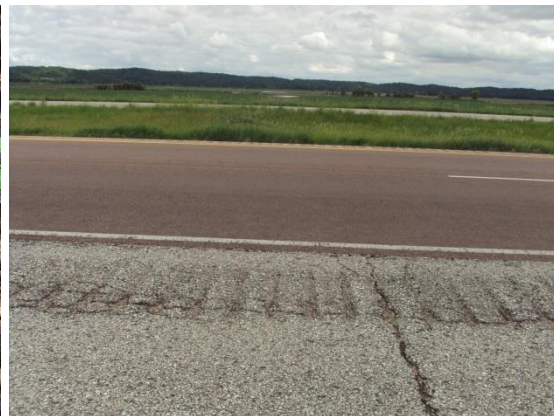
Rutting/transverse cracking

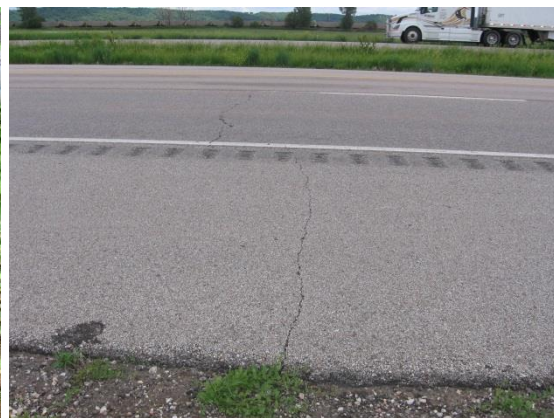
Transverse cracking

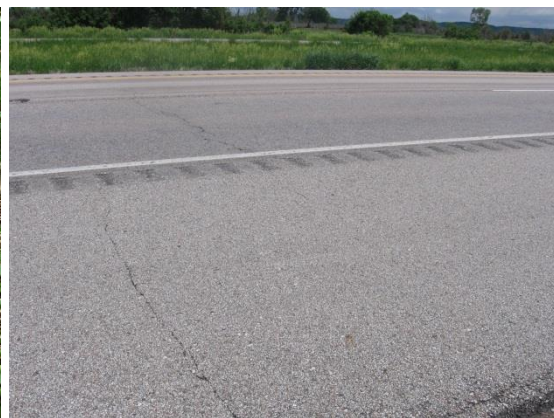
Transverse cracking

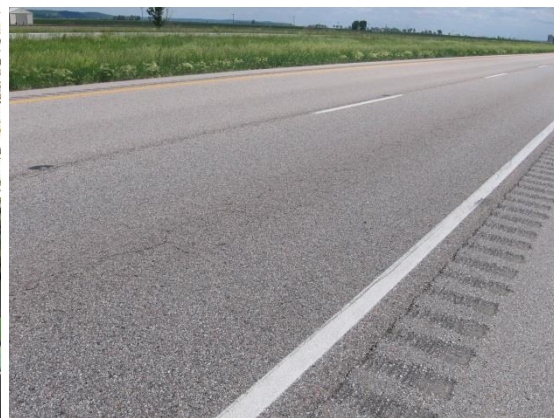
Longitudinal cracking

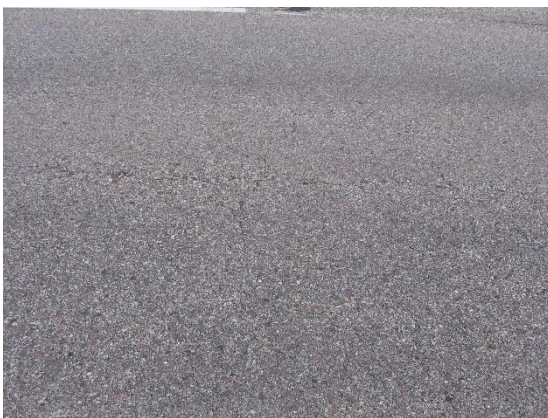
Alligator cracking

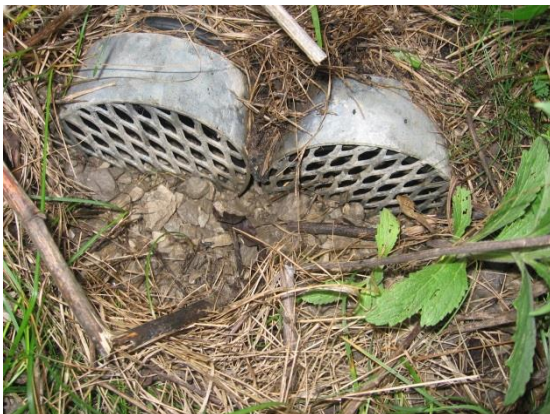
Soil blockage

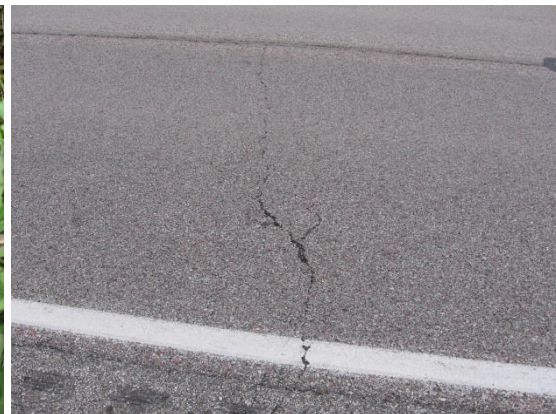
Transverse cracking

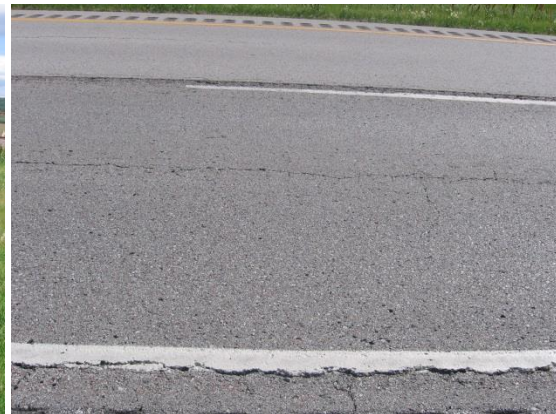
Alligator and transverse cracking

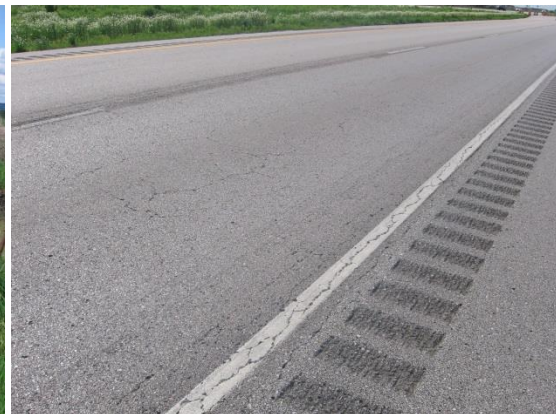
Alligator cracking/corner erosion damage

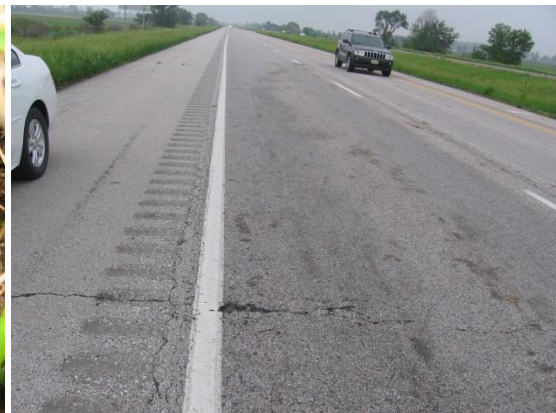
Longitudinal and transverse cracking/rutting

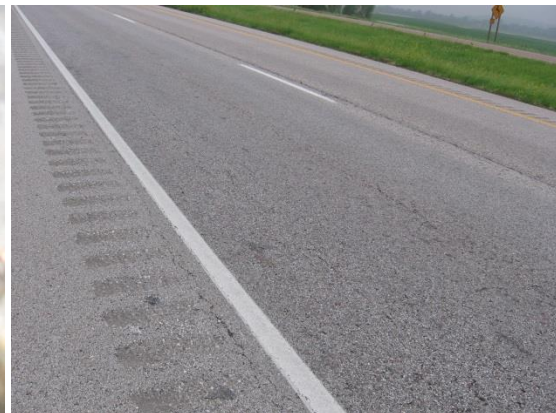
Alligator cracking

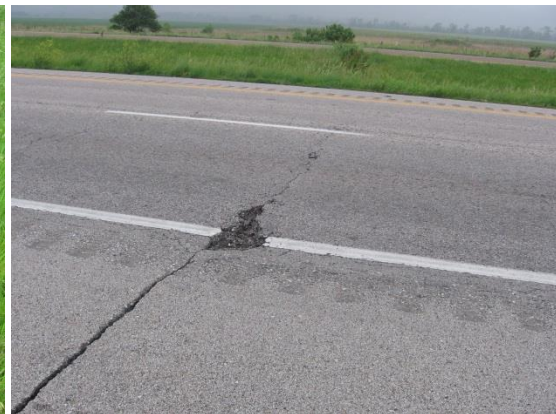
Transverse and alligator cracking

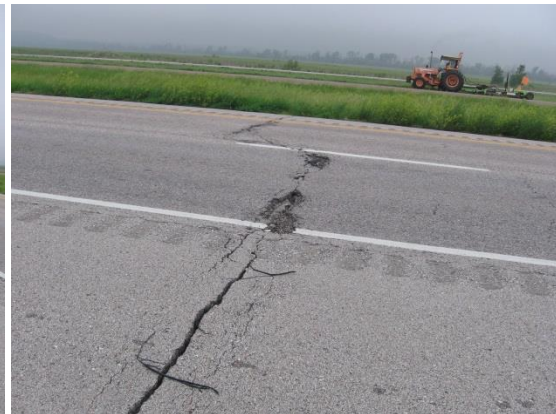
Transverse and alligator cracking

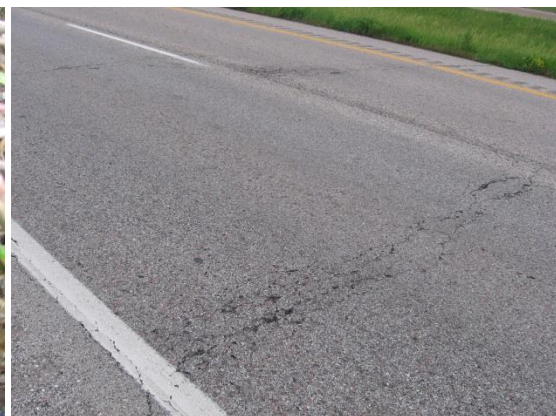
Transverse and alligator cracking/rutting

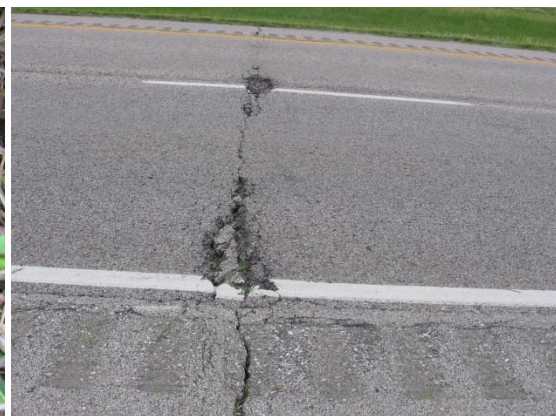
Transverse and alligator cracking

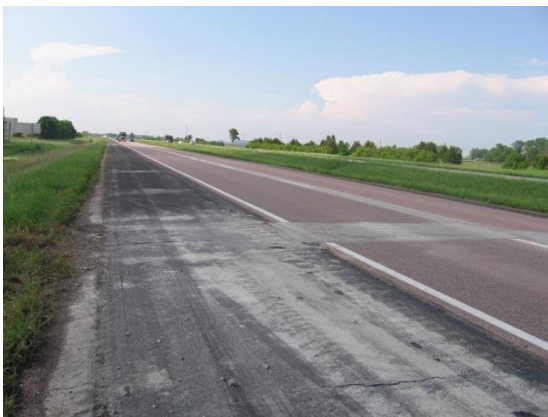
Reflection cracking/concrete patching
