**United States  
Department of  
Agriculture**

**Forest Service**

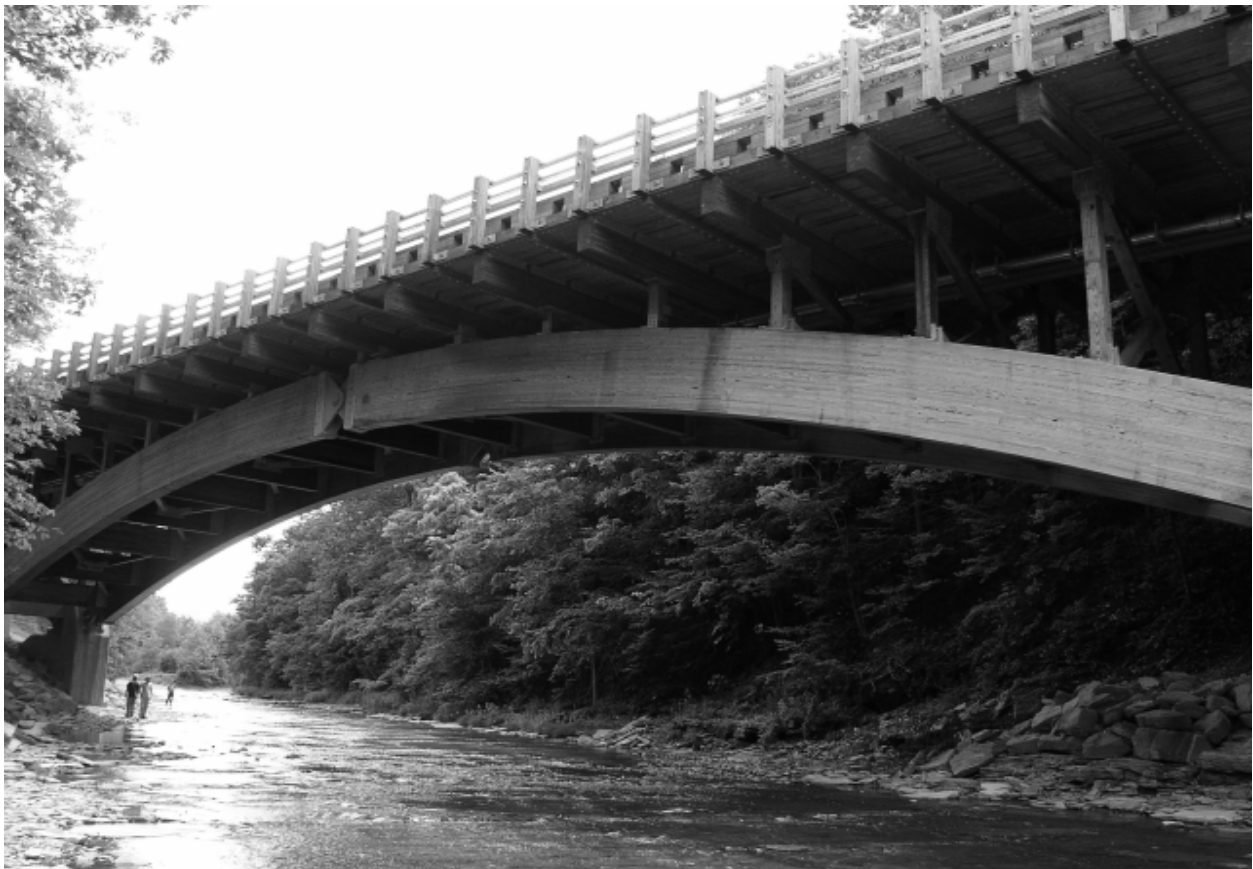
Doug Wood  
Michael Ritter

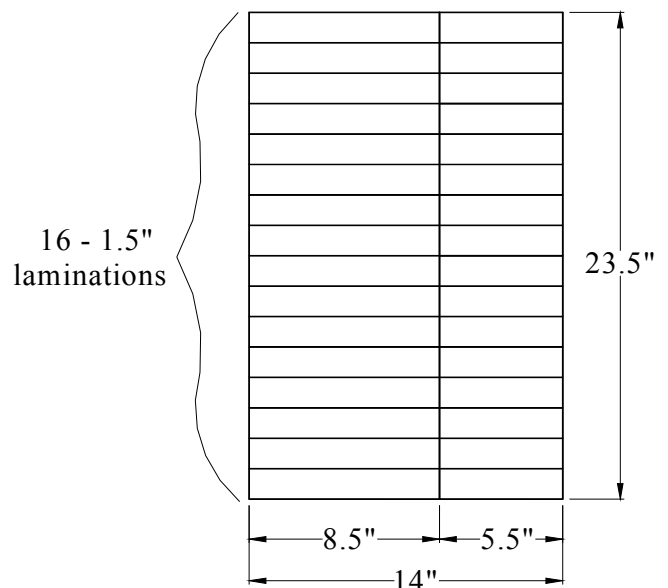
**Figure 1. Erfurth Bridge girder cross-section.**

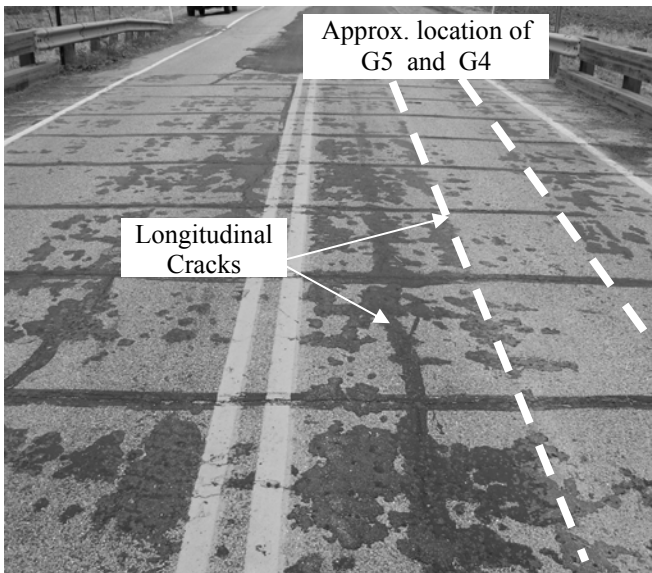
**Figure 2. Erfurth Bridge wearing surface in 2003.**

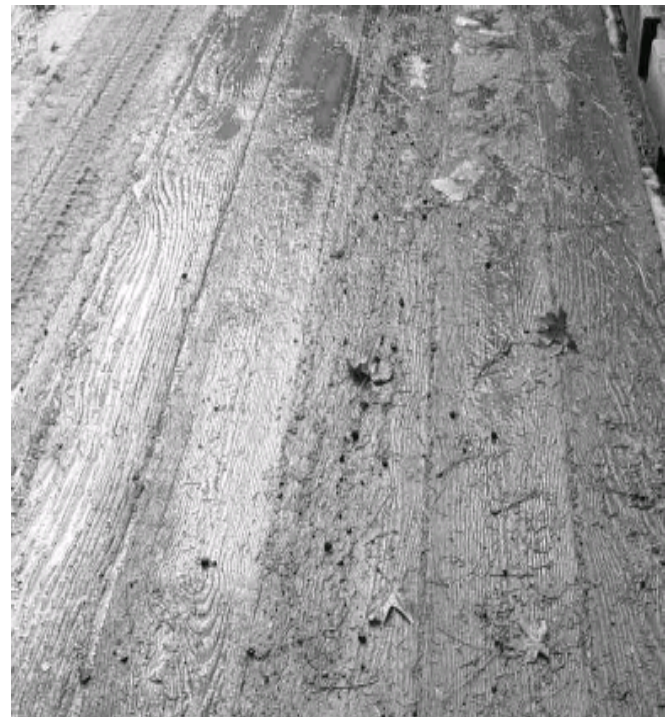
**Figure 3. Badger Creek Bridge wearing surface in 2002.**

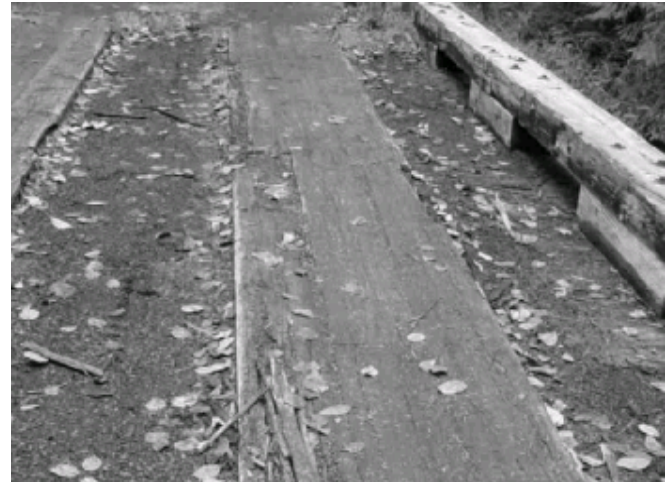
**a. Longitudinal planks on wheel lines.**

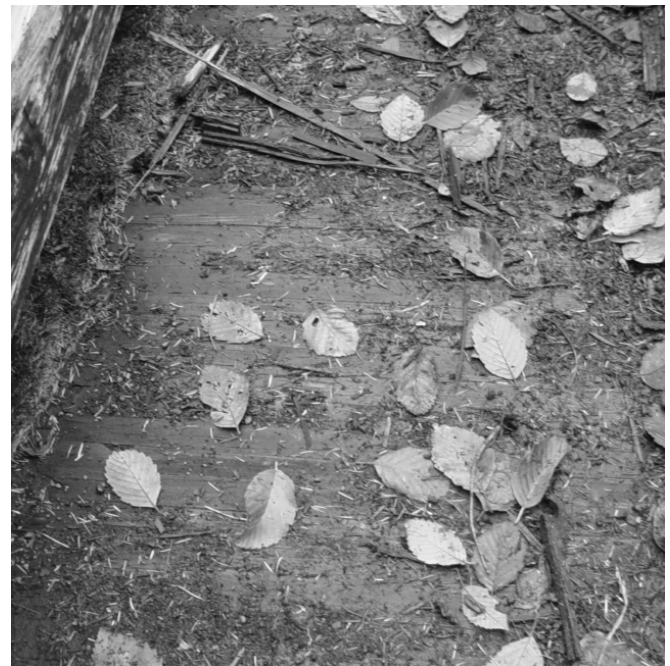
**b. Exposed deck panels due to asphalt deterioration.**  
**Figure 4. Camp Creek Bridge wearing surface in 2002.**

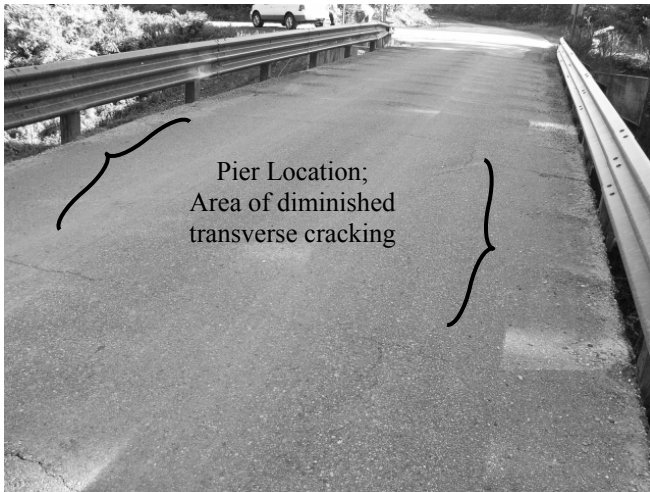
**Figure 5. Wittson Bridge wearing surface in 2003.**

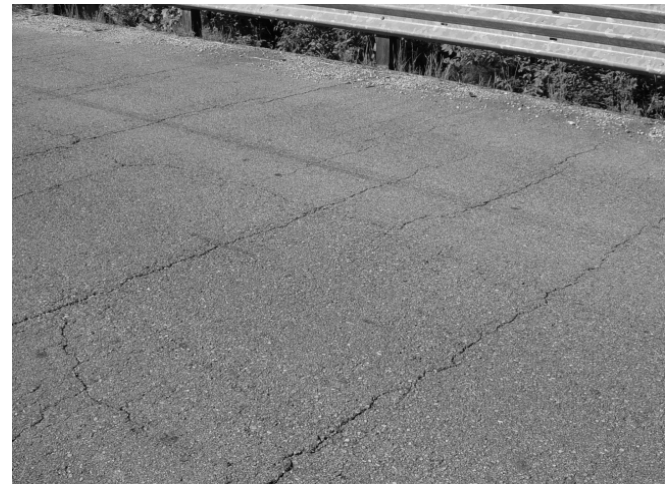
**Figure 6. Russellville Bridge wearing surface in 2003.**

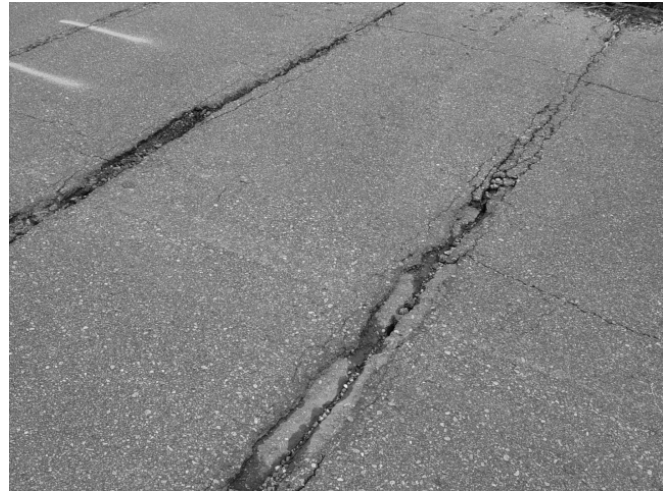
**Figure 7. Butler County Bridge wearing surface deterioration.**

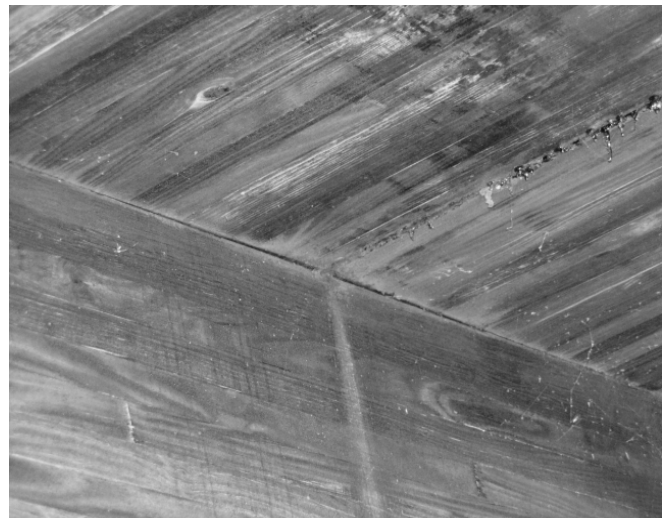
**Figure 8. Cupping of deck panels on the Butler Co. Bridge.**

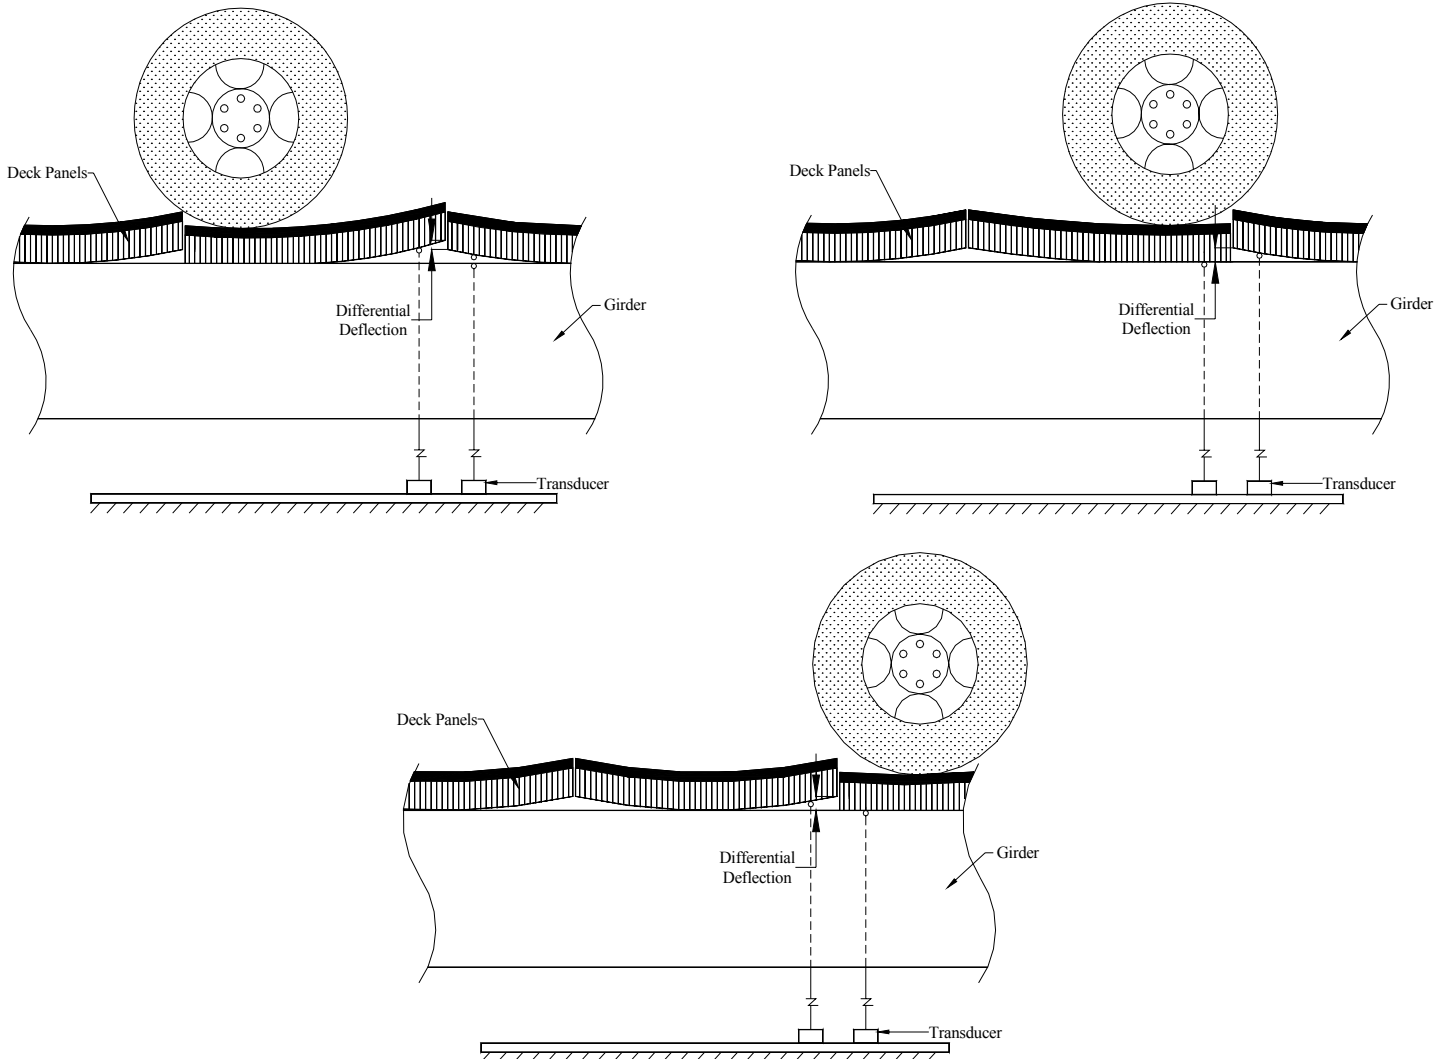
**Figure 9. Illustration of differential panel deflection.**

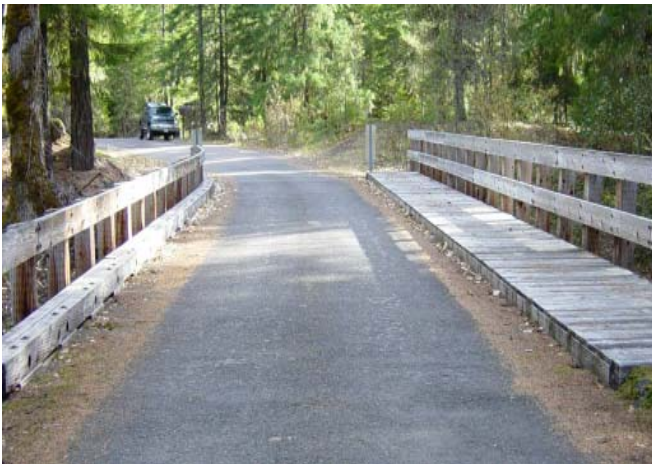
**Figure 10. Lost Creek Bridge wearing surface in 2002.**

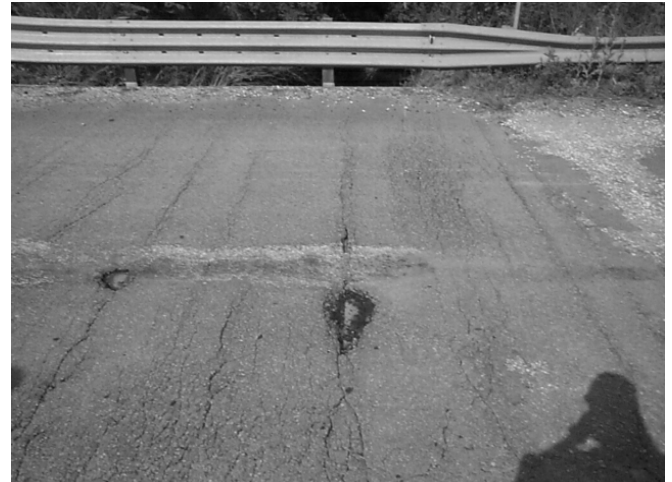
**Figure 11. Chambers Co. Bridge wearing surface in 2003.**

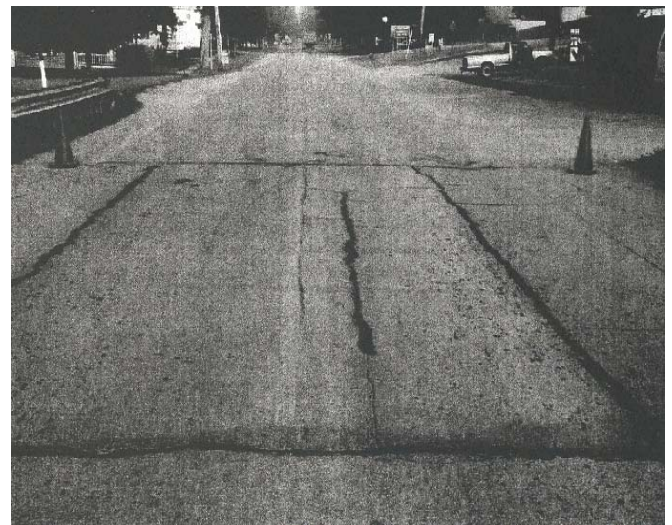
**Figure 12. East Main St. Bridge wearing surface in 2000.**

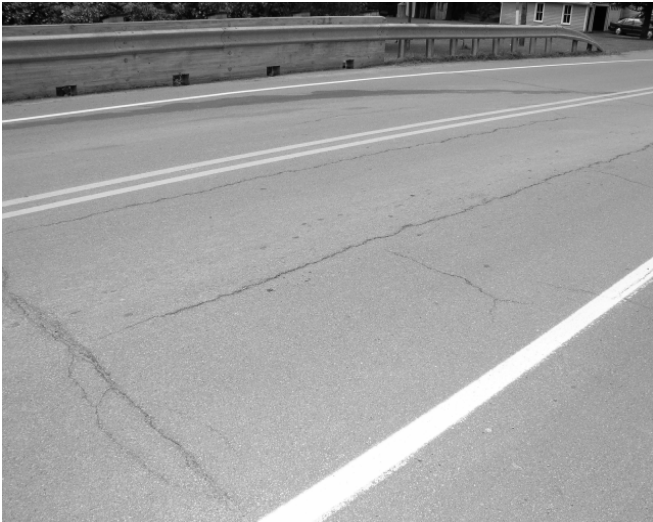
**Figure 13. East Main St. Bridge wearing surface in 2003.**

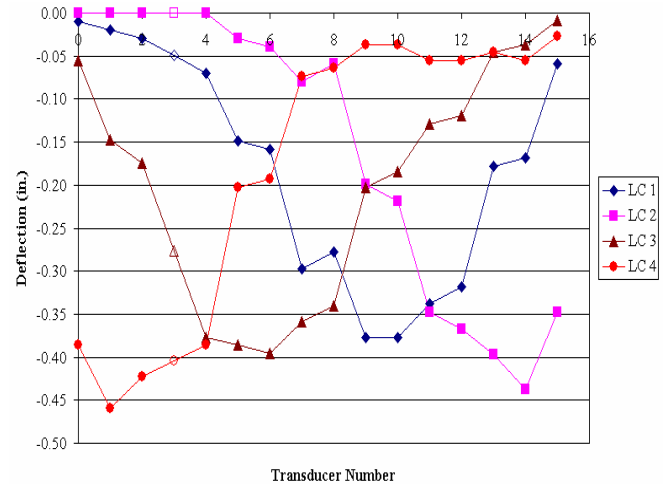
**Figure 14. Maximum midspan panel deflections, East Main St. Bridge.**

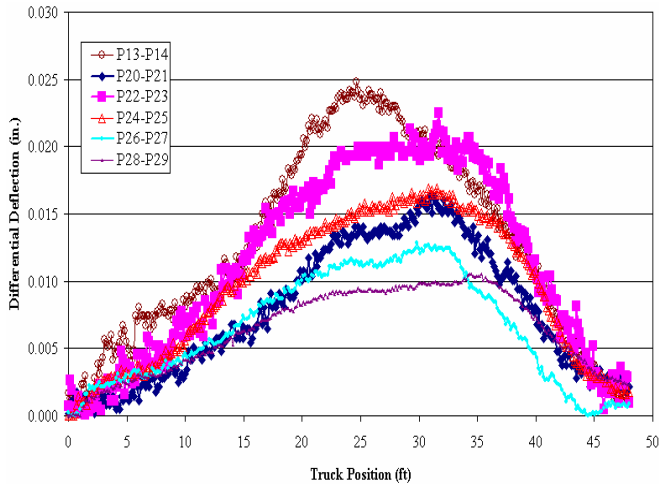
**Figure 15. Differential panel deflections along joint J7, East Main St. Bridge.**

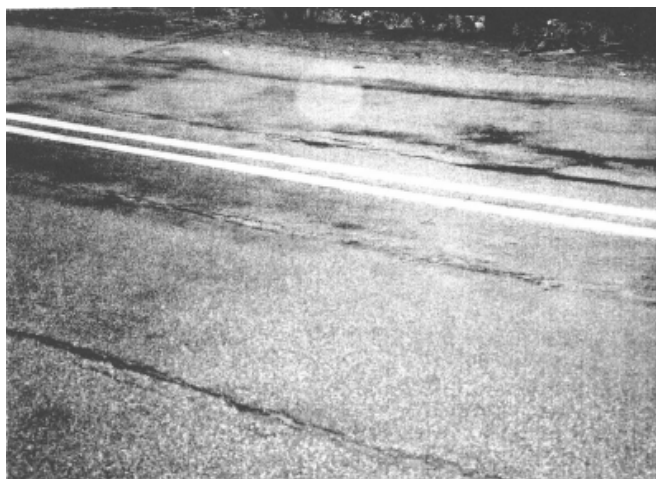
**Figure 16. Angelica Creek Bridge wearing surface in 1998.**

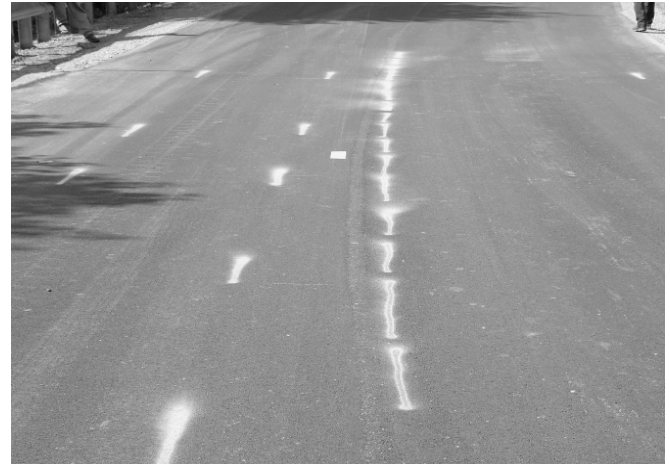
**Figure 17. Angelica Creek wearing surface in 2003.**

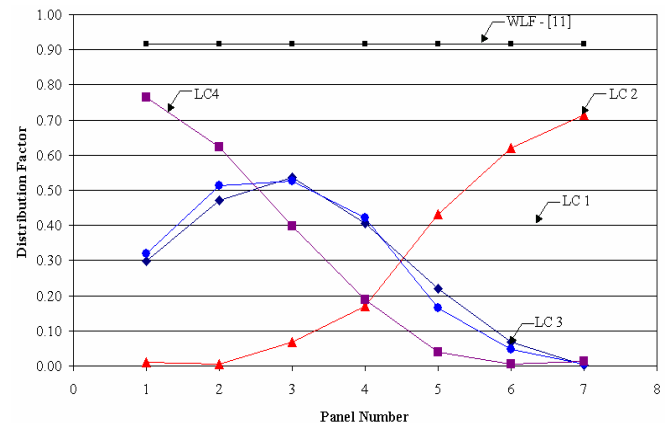
**Figure 18. Experimental and codified distribution factors, Angelica Creek Bridge.**

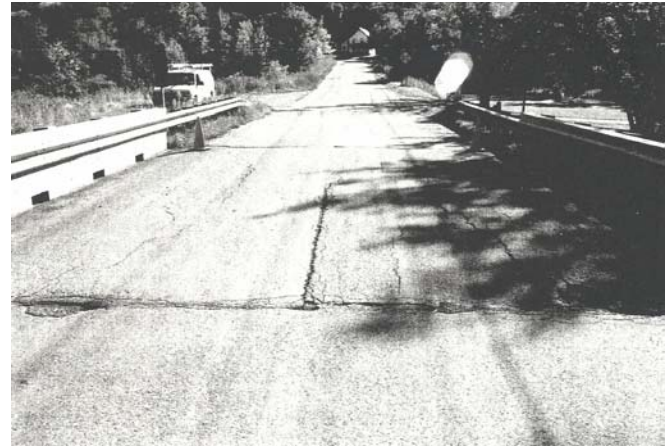
**Figure 19. Bolivar Bridge wearing surface in 2000.**

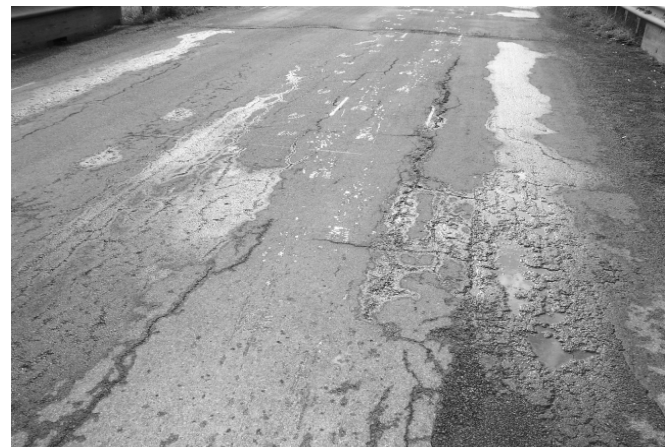
**Figure 20. Bolivar Bridge wearing surface in 2003.**

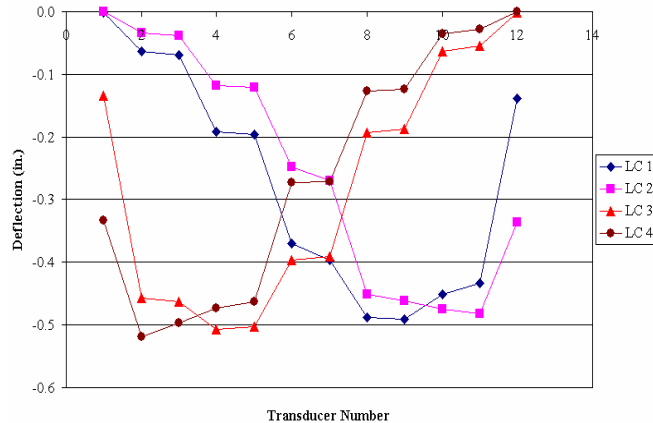
**Figure 21. Maximum midspan panel deflections in 2003, Bolivar Bridge.**

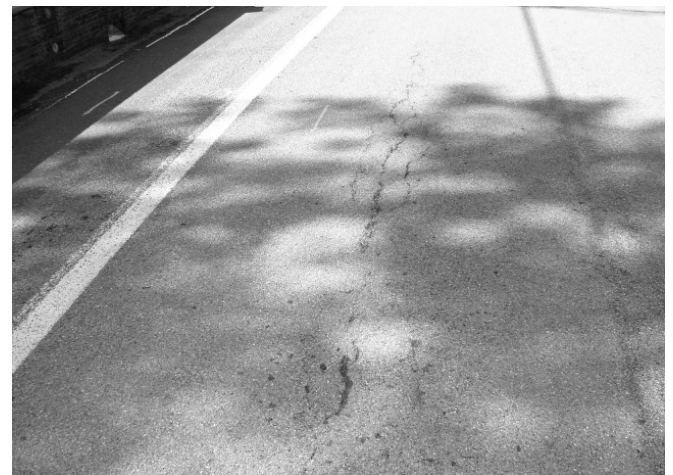
**Figure 22. Scio Bridge wearing surface in 2003.**

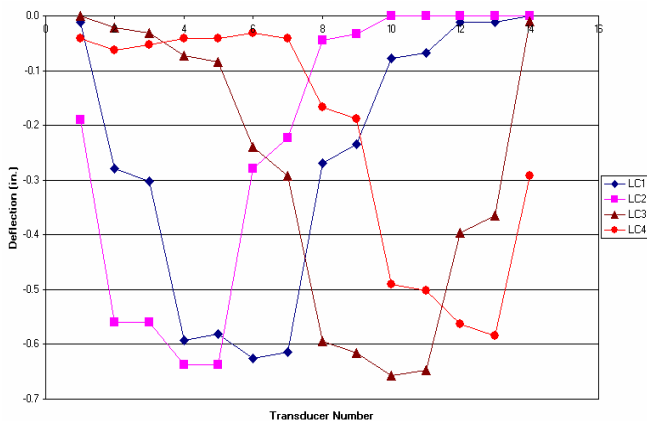
**Figure 23. Maximum midspan panel deflections, Scio Bridge.**

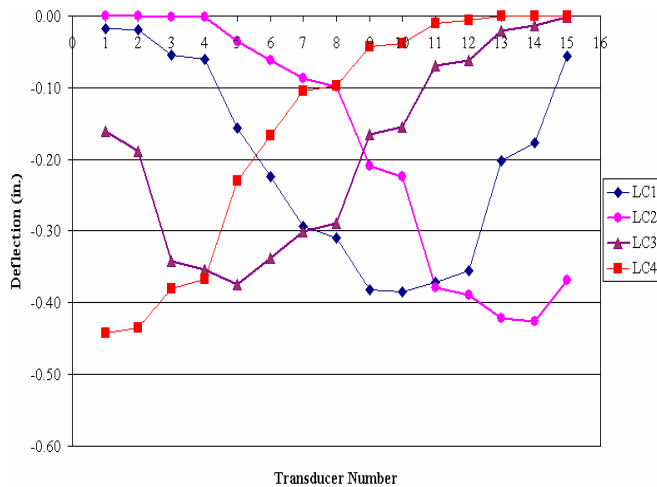
**Figure 24. Maximum midspan deflection, East Main St. Bridge.**

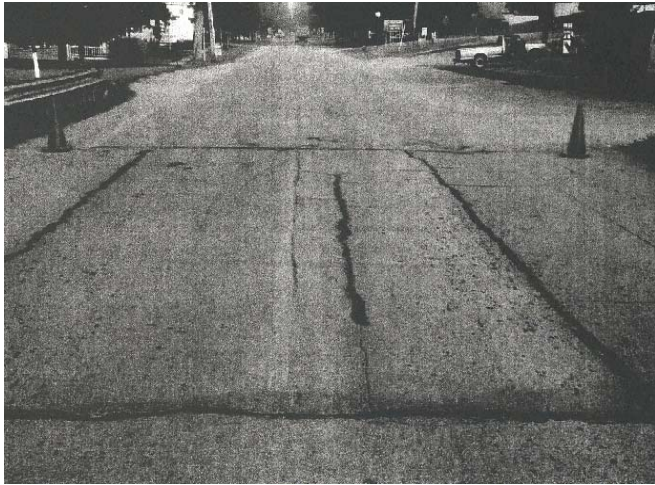
Figure 26. East Main Street Bridge wearing surface in 2000.

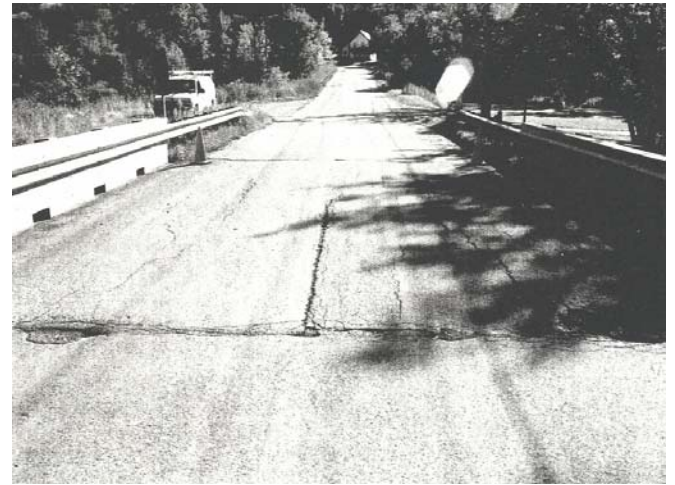
Figure 27. Bolivar Bridge wearing surface in 2000.

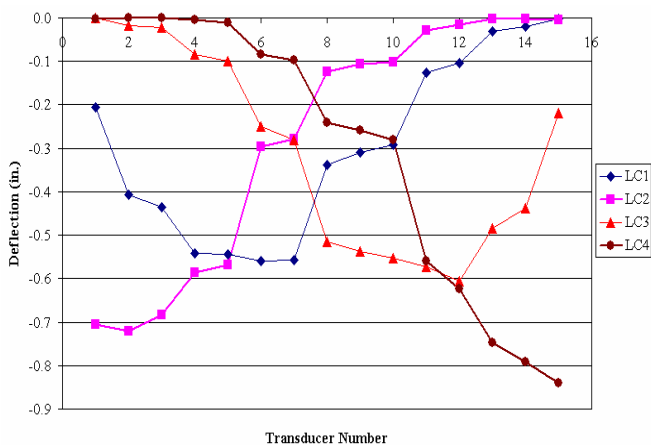
Figure 28. Maximum midspan deflection, Angelica Creek Bridge.

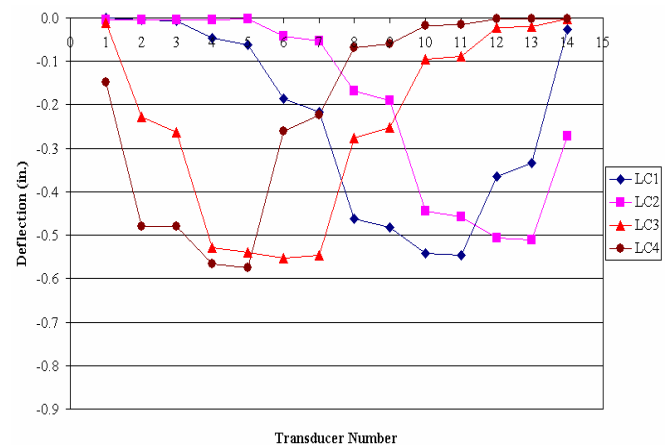
Figure 29. Maximum midspan deflection, Scio Bridge.
