Research  
Note  
FPL-RN-0289

# Creosote Retention Levels of Timber Highway Bridge Superstructures in Michigan's Lower Peninsula

August 2003

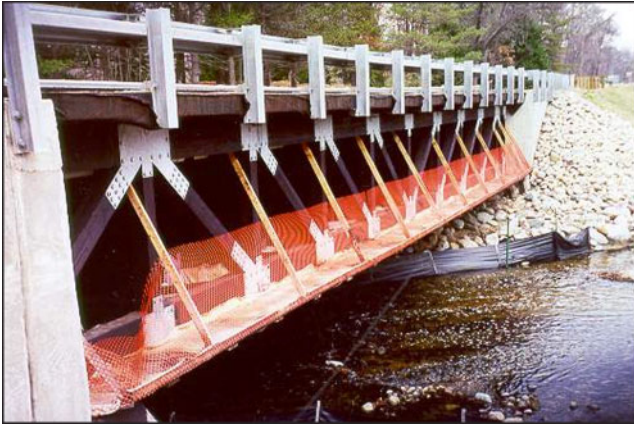
Figure 3—La Chance bridge in Missaukee County.

The bridge site with the most visibly active creosote bleeding was La Chance bridge superstructure in Missaukee County (Fig. 3). The La Chance bridge deck members (red pine glulam) seemed to be the primary source of creosote preservative bleeding, with additional residue from the asphalt paving membrane also present. The underlying truss members at La Chance did not seem to be actively bleeding but were extensively coated on the top sides with creosote “crud” from the deck above.

Comments: Active bleeding from the deck members was visible, and the preservative had migrated upward through the asphalt layer causing slippery conditions for motorists.

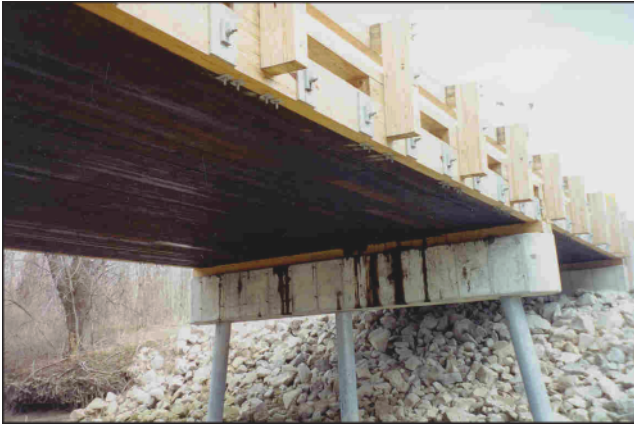
Figure 6—Houlihan bridge in Shiawassee National Wildlife Refuge.

Comments: Bleeding of creosote at several glulam deck beams (at the middle span only) into the sensitive waterways of the national wildlife refuge was of concern because of stagnant water conditions under the bridge.

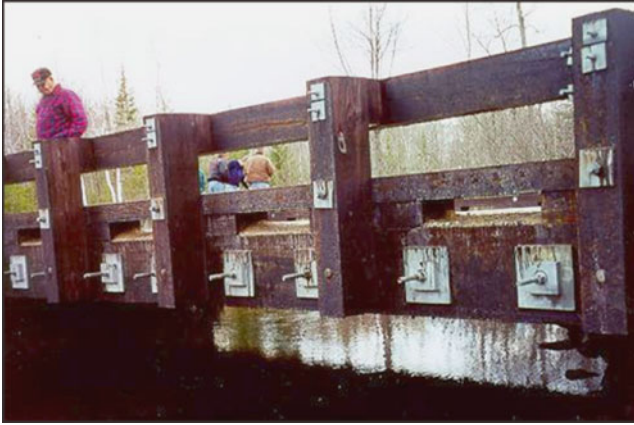
Figure 4—Cruzen bridge in Alcona County.

Creosote bleeding was extensive on the deck underside and along the edge beams at the Cruzen bridge superstructure in Alcona County (Fig. 4). The glulam (web) beams were actively bleeding at the bridge underside and along the edge beams at the Cameron bridge superstructure in Crawford County (Fig. 5). Several of the glulam beams in the middle span appeared to have an oily residue on the deck underside of the Houlihan bridge superstructure within the Shiawassee National Wildlife Refuge (Fig. 6). The control bridges, Barlow in Alcona County (Fig. 7) and Old Vanderbilt in Otsego County (Fig. 8), had minimal amounts of creosote crud on the exposed wood members and were not visibly bleeding.

Comments: Active bleeding was visible on the (southern pine) glulam webs but not so apparent at the sawn lumber flanges (pin oak). Also preservative migration was observed from web members into the overlying asphalt layer and was visible topside.

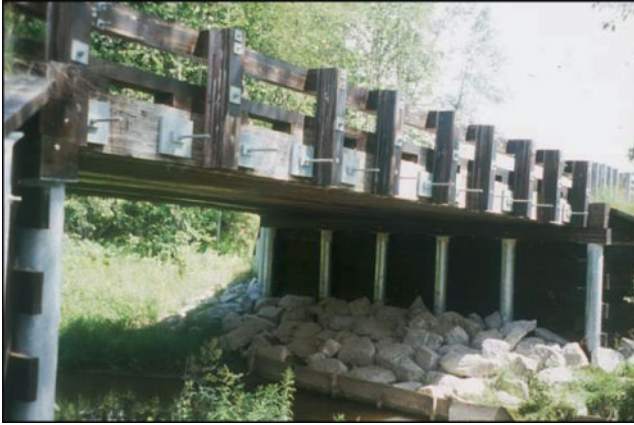
Figure 7—Barlow bridge in Alcona County.

Comments: No active bleeding observed at this site. Only minor staining visible on the riprap near the abutments.

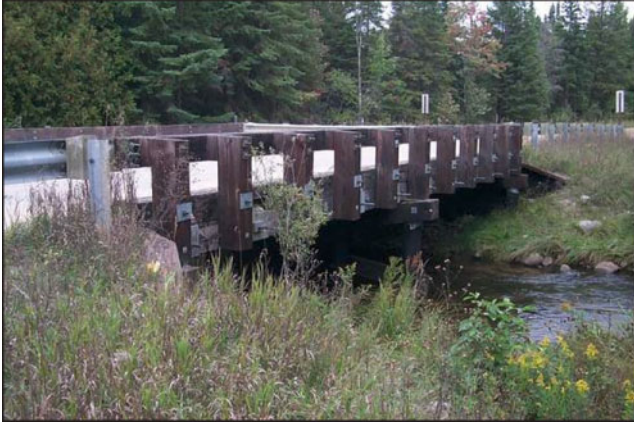
Figure 8—Old Vanderbilt bridge in Otsego County.

Comments: Wood members appeared dry with no surface residues.

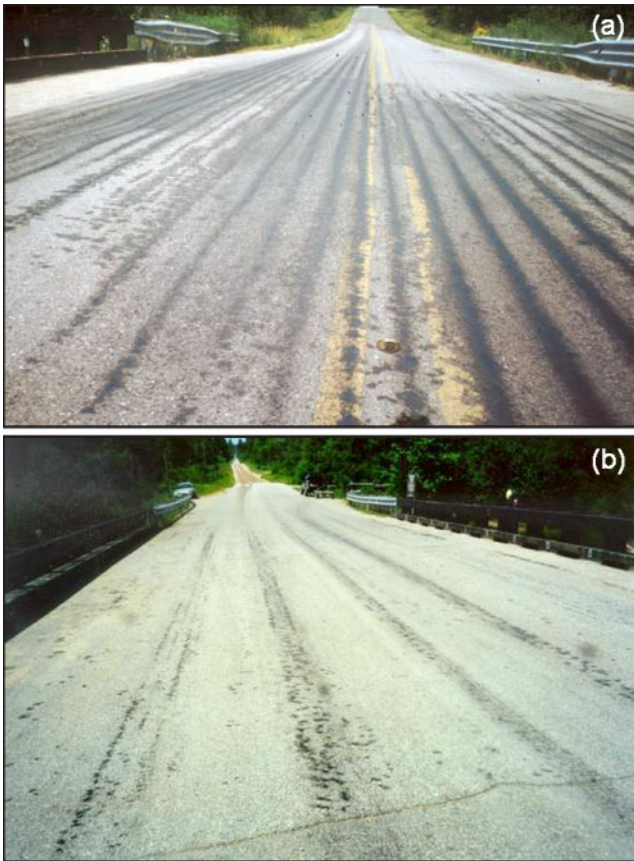
At the Cruzen and Cameron sites, the creosote wood preservative appeared to have migrated upward through the asphalt wearing surface (Fig. 9). At the Cameron bridge, the creosote wood preservative migrated into the asphalt wearing surface only at the glulam web locations. This is especially apparent in the summer months and has caused concerns about vehicle traction. At the La Chance bridge, there were no visible signs of preservative migration (Fig. 10). However, a waterproof paving membrane had been used that was not compatible with the creosote wood preservative or the asphalt mixture, causing the membrane to liquefy when the hot-mix asphalt was applied. The resulting pavement membrane residue was observed leaking through the transverse deck at the panel butt-joints. Similar problems with creosote wood preservatives and pavement membranes have also been reported (Eriksson 2002, Eriksson and others 2003). Future studies should examine this interaction between creosote preservatives, paving membranes, and the asphalt pavement layer.

**Figure 9—Creosote preservative visibly migrating upward through the asphalt wearing surface at the (a) Cruzen and (b) Cameron bridges.**

The interaction between creosote preservatives, paving membranes, and asphalt wearing surfaces needs further study to determine causes of membrane disintegration and creosote preservative migration upward through the asphalt pavement layer.

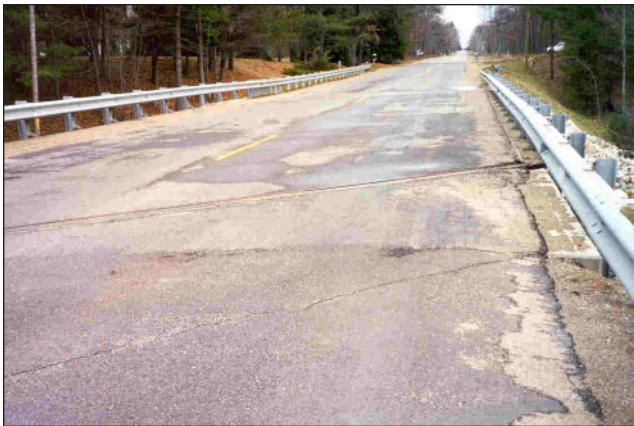
**Figure 10—The La Chance bridge showing the asphalt wearing surface condition.**
