Research
Paper
FPL-RP-563

Field Performance of Timber Bridges

13. Mohawk Canal Stress-Laminated Bridge

Paula D. Hilbrich Lee
Xanthi Lauderdale

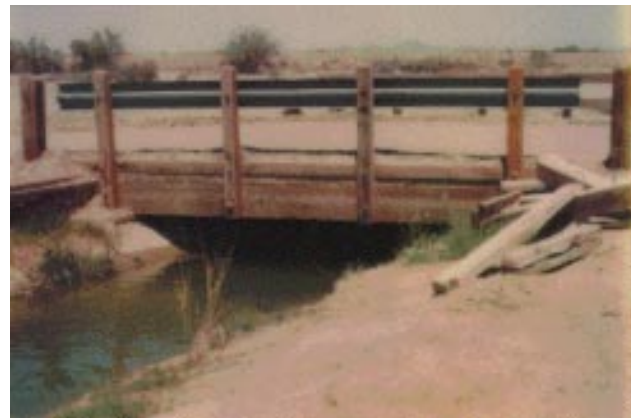
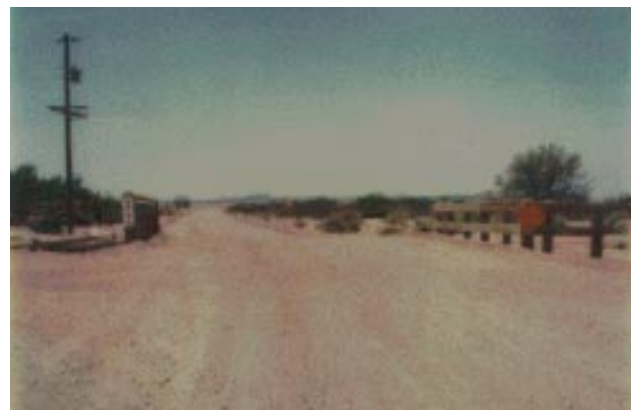
The existing structure, constructed in 1955, was a timber stringer bridge with a timber plank deck, supported by concrete abutments (Fig. 2). The original bridge was approximately 4.6 m (15 ft) long and 6.7 m (22 ft) wide. Inspection of the bridge in 1988 indicated that the deck was in poor condition. Several planks were broken or deteriorated, and the bridge was restricted to a load limit of 89 kN (10 tons). In addition, the railing system on the south side was broken. It was apparent that major rehabilitation or replacement of the structure would be required. After evaluating the structural deficiencies, a decision was made by Yuma County officials to replace the bridge.

Figure 2—Original Mohawk Canal bridge: side view (top), end view (bottom).

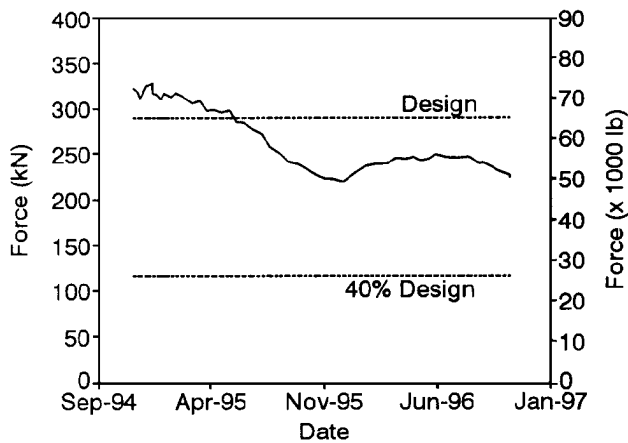
The average bar force for the Mohawk Canal bridge is shown in Figure 15. It also indicates the design force and the force level required to maintain the minimum recommended interlaminar compression level of 275.8 kPa (40 lb/in²) (Ritter 1990). Following the third bar tensioning on November 28, 1994, the average bar force was approximately 321.2 kN (72,200 lb), or 111% of the design force. For the next 13 months, the bar force declined at an approximately linear rate. In January 1996, the bar force had decreased to approximately 219.3 kN (49,300 lb), which corresponds to an interlaminar compression level of 536 kPa (78 lb/in²). At this time, the average bar force began to increase for an approximate half year, then resumed its overall decline. This slight increase may be attributed to fluctuations in the moisture content of the wood deck. However, as a result of the frequency of the moisture content readings, this cannot be

Figure 15—Average bar force.

determined with certainty. The top surface of the deck may absorb moisture from rainfall because there is no waterproof membrane beneath the asphalt and the bottom surface may absorb moisture from evaporation of the canal. At the conclusion of the monitoring period, the average bar force was approximately 224.2 kN (50,400 lb), or 78% of the design force, which corresponds to an average interlaminar compression of approximately 547 kPa (79 lb/in²).

- During the monitoring period, the average bar force for the Mohawk Canal bridge decreased from 321.2 to 224.2 kN (72,200 to 50,400 lb), which corresponds to a decrease in interlaminar compression from 785 to 547 kPa (114 to 79 lb/in²). Overall, the bars are maintaining a high level of interlaminar compression. Slight changes in bar force may be attributed to local changes in moisture content caused by rainfall or evaporation of the canal.

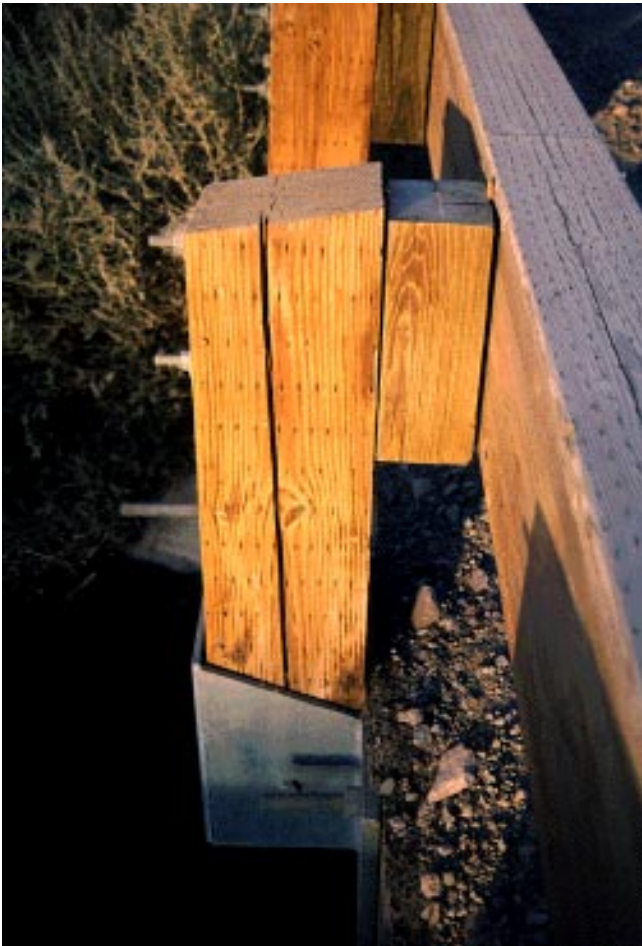
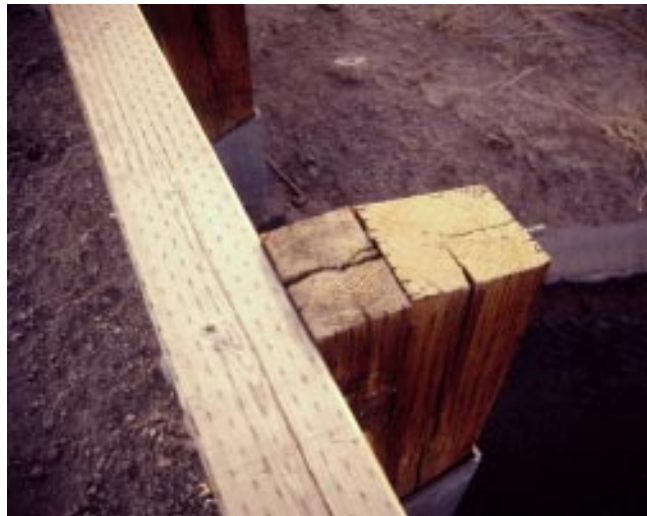
The glulam rail was in excellent condition, exhibiting no checks or delaminations. Severe checks and splits were observed in the railposts and spacer blocks (Fig. 23). A review of photographs taken during construction revealed that the posts were severely checked when installed. Such a condition is not advisable because the splits penetrate the preservative envelope and provide avenues for moisture penetration, accumulation, and potential decay as well as reduce the strength characteristics of the member. At this time, the posts and spacer blocks exhibit no visible signs of decay. Such deterioration is not anticipated in the near future because of the dry local environment; however, these areas should be closely monitored in future inspections of the bridge.

- Visual inspections of the bridge indicate that the performance of most wood components is satisfactory, although severe checks and splits were evident in the railposts and spacer blocks. Photographs taken during construction indicate that the railposts were severely split when installed. Members exhibiting such severe conditions should not be used in railing construction.

Figure 23—Severe checks and splits in railposts and spacer blocks noted during condition assessment.

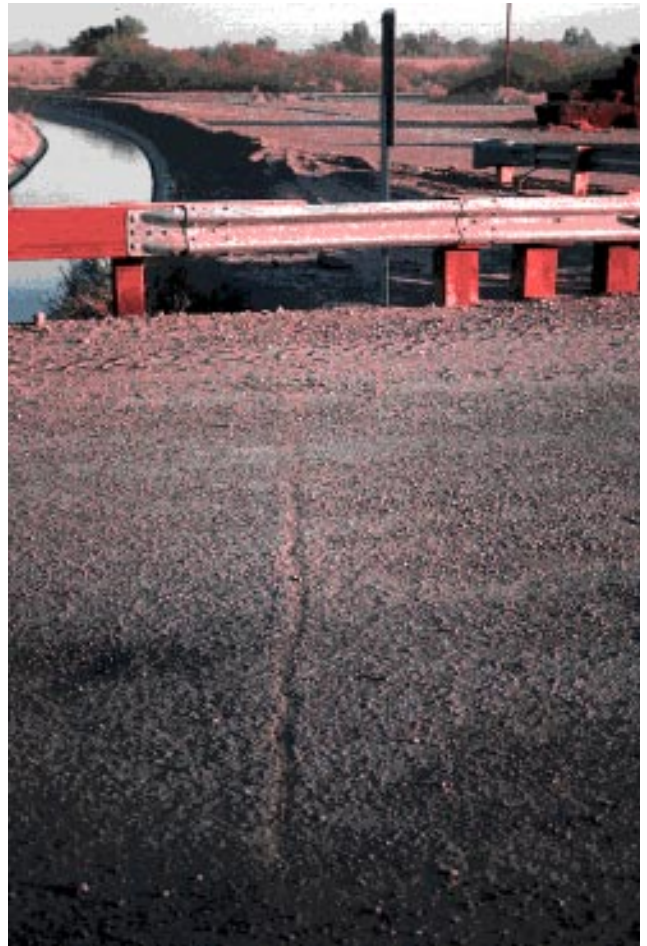
Inspection of the wearing surface at the conclusion of monitoring revealed a slight deterioration of the asphalt. The top surface had experienced some erosion, causing the wearing surface to appear to be constructed of compacted gravel. In addition, cracks were noted in the wearing surface at the end of the bridge and approach road interface (Fig. 24). Both the erosion and interface cracks are attributed to a deficiency in the asphalt mix or application procedures. Aside from this erosion, the surface of the bridge appeared to be in good condition and exhibited no additional signs of cracking, rutting, or other deterioration.

- The asphalt wearing surface exhibited deterioration, resulting in a gravel-like appearance. Cracks were visible at the end of the bridge and approach road interface. These conditions are attributed to a deficiency in the asphalt mix or application procedures.

Figure 24—Crack in asphalt at end of bridge and approach road interface observed during condition assessment.
