# Performance of Red Oak and Red Maple Glued-Laminated Bridges

Harvey B. Manbeck, Paul R. Blankenhorn, John J. Janowiak, Ray W. Witmer, Jr. and Peter Labosky, Jr., College of Agricultural Sciences, Pennsylvania State University

In: Ritter, M.A.; Duwadi, S.R.; Lee, P.D.H., ed(s). National conference on wood transportation structures; 1996 October 23-25; Madison, WI. Gen. Tech. Rep. FPL- GTR-94. Madison, WI: U.S. Department of Agriculture, Forest Service, Forest Products Laboratory.

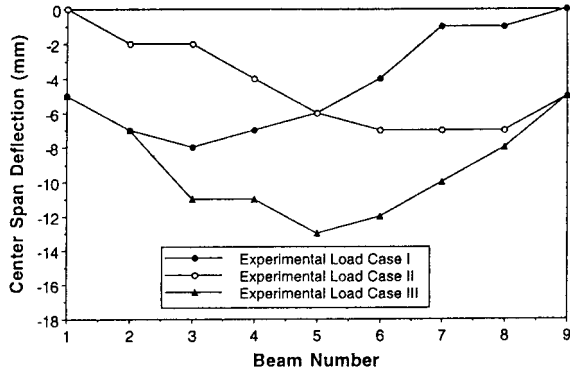
Figure 5--Centerline live load deflections for the red oak bridge.

The centerline live load deflection for load cases I and II are nearly symmetric with respective lane deflections agreeing to within 1 mm for all beams. The measured centerline live load deflection for load case III was nearly symmetric about the bridge centerline. The deflections of beams 4 and 6 differed by 1 mm (Approximately 8% of total deflection) and beams 3 and 7 differed by 1 mm (Approximately 9% of total deflection). The maximum measured centerline live load deflection for load case III (Beam 5) was 13 mm (0.52 in.). The sum of the respective beam deflections for load cases I and II agreed with the measured deflections for load case III to within 1 to 2 mm. (0.08 to 0.16 in.) The deflection profiles of beams 5 and 8 (Figures 6 and 7) show the maximum live load deflection occurring at midspan for each of load cases I, II and III. The symmetry of the live load deflections and the agreement of the superimposed case I and II deflections with load case III deflections are clear indicators of satisfactory live load distribution across the bridge by the glulam deck, the lag bolt connections and the glulam diaphragms.

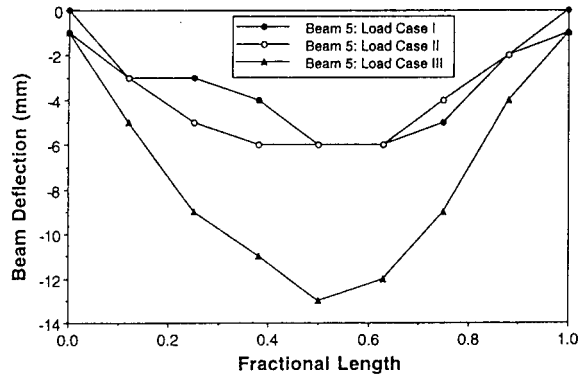
Figure 6--Live load deflection profile for beam 5 of the red oak bridge.

The predicted centerline live load deflection of beam 5, assuming no composite behavior between the deck and girder, girder E-value of 11.0 GPa ( $1.6 \times 10^6$  psi), and an HS25 or ML80 load, was 22 mm (0.85 in.). The observed maximum live load deflection for beam 5 was 14 mm (0.55 in.). Lower actual vs. predicted deflection is probably due to: 1) The conservative design value of E [Shaffer, et al. (1991) reported E-values of 13.1 GPa ( $1.90 \times 10^6$  psi) for northern red oak beams] used in the calculations; 2) Neglect of composite action between the deck and girders, and 3) The average E-value determined by static loading of each board used in the bridge girders being 15.5 GPa ( $2.2 \times 10^6$  psi). Predicted live load deflection using an

E-value of 15.5 GPa ( $2.2 \times 10^6$  psi) equals 16 mm (0.62 in.). Witmer (1996) has reported that composite action between lag bolt connected transverse hardwood glulam decks and beams increase girder stiffness by 8 to 12%. Applying this increase to the northern red oak girder stiffness yields a predicted live load deflection of 14.3 mm (0.56 in.) which compares favorably with the observed deflection.

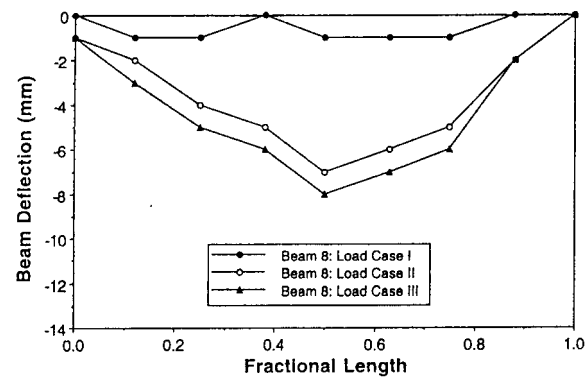
Figure 7. Live load deflection profile for beam 8 of the red oak bridge.

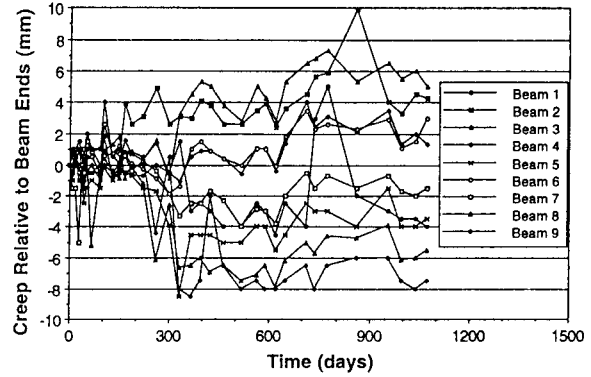
Figure 8--Creep deflection of girders 1 to 9 of the red oak glulam bridge.

Dead load deflections for the nine beams for 36 months duration are plotted in Figure 8. The long term dead load deflections vary considerably between beams. The bottom face of some beams experienced downward movement, whereas some experienced upward movement. Maximum upward movement of 10 mm (0.39 in.) was measured for beam 3; maximum downward movement of 8.5 mm (0.33 in.) was measured for beam 8. Dead load deflections of most of the beams remained relatively constant ( $\pm 2$  mm) for approximately 6 to 9 months, then experienced a shift of several mm. The deflection of the interior beams then stabilized. Over the last 24 months of the monitoring, the dead load deflections of the interior (2 through 8) beams did not increase nor decrease by more than 1 mm or 2 mm (0.08 in. or 0.16 in.). The trend suggests that one cycle of annual weather change is necessary to condition, or to seat, the superstructure. The dead load deflection of the exterior beams (1 and 9) fluctuated by nearly 7 mm (0.27 in.) over the last 24 months of monitoring. These beams were exposed to radiation and convective heat loads, whereas the interior beams were not. There are no apparent trends between beam location and direction of movement. One possible explanation of the upward movement of four beams is differential moisture content of the beam from top to bottom. That is, the lower portion of the cross section, being more exposed to the drying action of ambient air, was at a lower moisture content than the upper portion of the beam. Such a situation would have the effect of inducing a slight reverse curvature of the beam.
