The Durability of Wood-Concrete Composite Bridges

Summary

In wood-concrete composite bridge decks glued-in bars are simple connectors to join the two materials. For the design of the bars a simple truss model is introduced. Durability of the wood-concrete connections was tested by two long-term test series. The purpose of the tests was to find out, if outdoor condition or ageing affects the behaviour of the connections. First of the tests series consisted of pull-out tests of glued-in bars. Prepared specimens were divided into two control groups. One group of specimens was newly tested and the other group after ten years outdoor storing. In the second test fatigue loading was applied to full-size composite beam in three time periods. The beam was first newly loaded, then after two years and finally after 10-years outdoor storing. Connections with compression bars turned out to be stable and non-sensitive to ageing. Remarks of the current condition of two wood-concrete composite bridges are given.

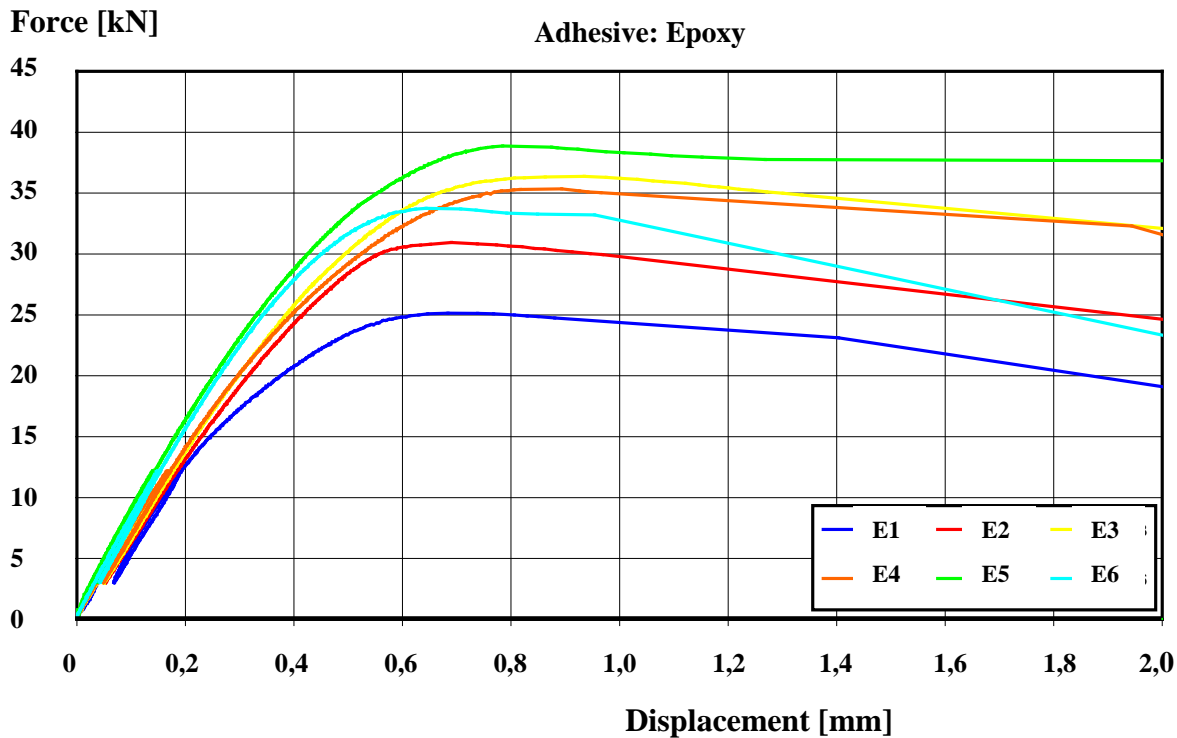
The force-displacement relations obtained in pull-out tests for 10 years old epoxy specimens are presented graphically in *Fig. 4*.

Fig. 4. Load-displacement curves of six E-specimens tested after ten years outdoor condition.

The glued-in connections were ductile as can be seen from the curves in *Fig. 4*. The ultimate load obtained varied usually between 30 – 38 kN, but for one E-specimen it was only 25 kN. By closer inspection it turned out that in this specimen 30 mm of the desired glue length was without adhesive, and that explains the obtained lower test values (blue curve in *Fig. 4*).

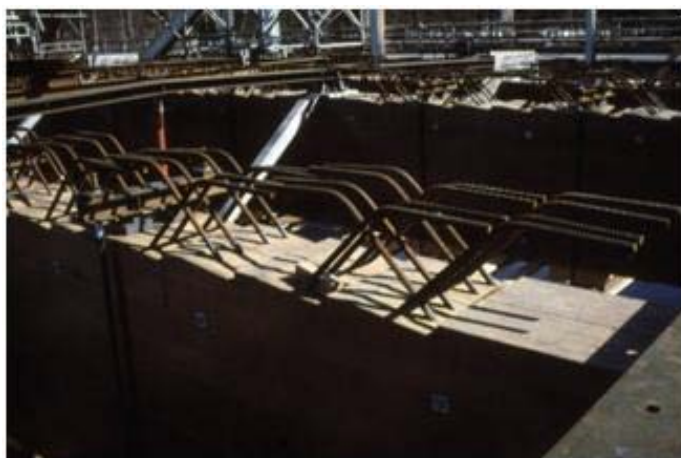
The deck of the *Vihantasalmi Bridge* is composed of glued-laminated timber girders and concrete slab. Reinforcing steel bars and notches are used as connectors (*Fig. 5*). Many laboratory tests were made during the design phase of the bridge. [5, 6]

Fig. 5. The connectors and notches of the timber girders in the deck of the Vihantasalmi Bridge.

The connectors are glued-in reinforcing bars in two inclined directions, similarly as shown in Fig. 5.

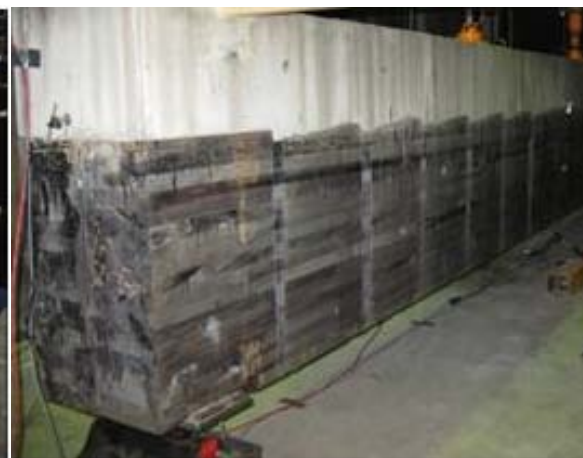
To investigate the fatigue behaviour and the influence of the long-term outdoor condition, two equal full-size beams were prepared (*Fig. 6*). The beams were tested for fatigue loading in three periods.

Fig. 6. Test arrangement and the wood-concrete composite test beam.

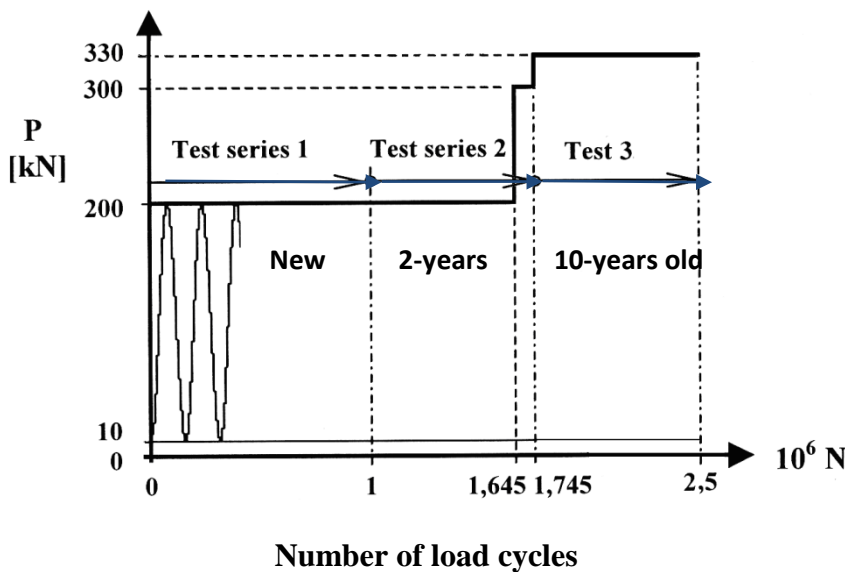
The third fatigue test was applied to the beam, which had been kept outdoors without shelter approximately 10 years. The maximum load P in the last fatigue test was increased up to 330 kN. Complete loading history of the three fatigue tests is shown in Fig. 8.

Fig. 8. The loading history of the three fatigue test series of the composite test beam.

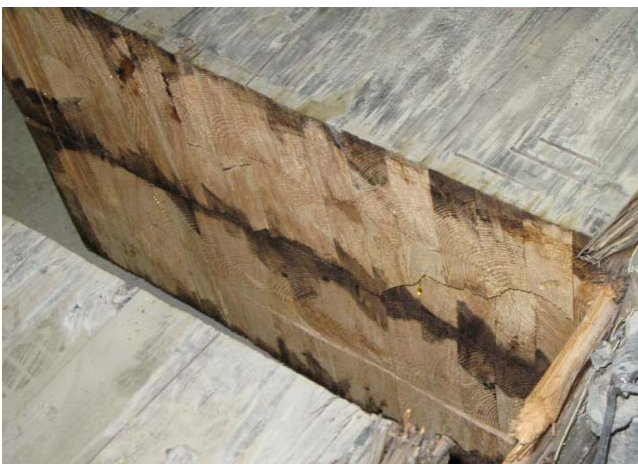
After the last fatigue test was finished, the wooden part of the test beam was cut and opened. Inner wood was inspected and found to be in perfect condition (*Fig. 10*).

Fig. 10. Cross-section of the test beam after ten years outdoor condition and fatigue tests.

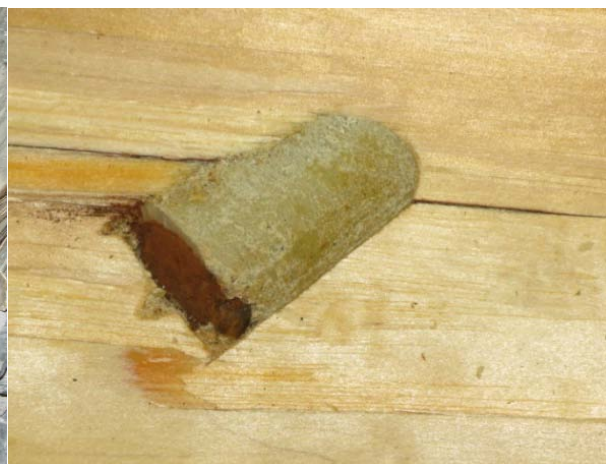
The bottom end of the glued-in bar in wood was also uncovered and examined. No damage due to fatigue loading could be observed and no signs of slip could be found. The surface of the glue was smooth (*Fig. 11*).

Fig. 11. The bottom end of the glued-in bar in wood after ten years outdoor condition and fatigue tests.

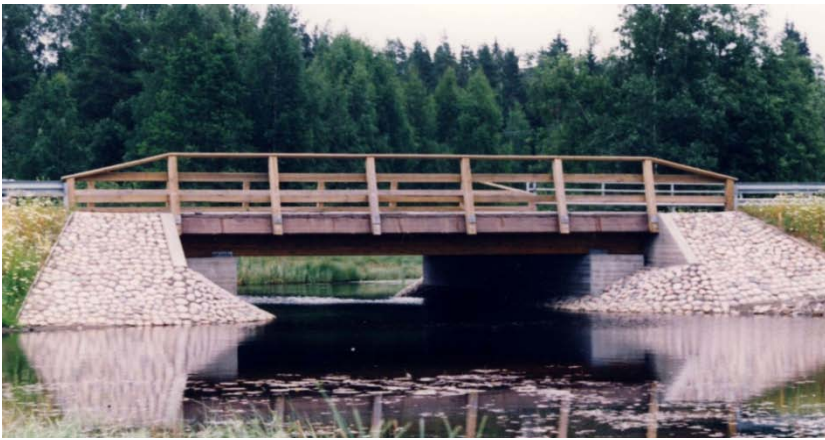
Kruununmylly Bridge is the oldest wood-concrete composite bridge built in the Nordic countries (Fig. 12). The beams of the deck are glued-laminated timber beams with salt impregnation.

The connectors are glued-in reinforcing bars in two inclined directions.

The span of the bridge is 8 m and the effective width is 12 m.

Fig. 12. Kruununmylly Bridge after completion in 1993.

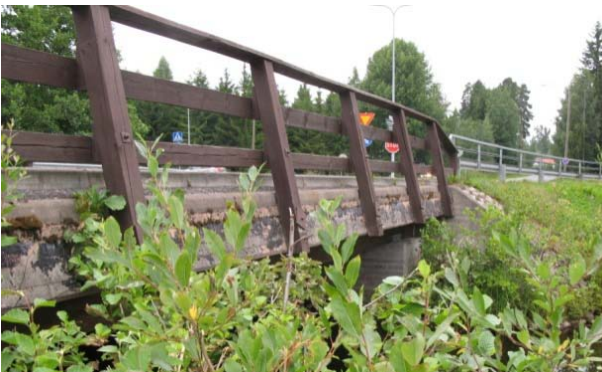
The current outlook of the bridge has somewhat suffered during years. Bushes have grown wildly hiding partly one side of the deck. Additionally, the surface of the concrete edge beams and the wooden railings need refurbishment (Fig. 13).

Fig. 13. Kruununmylly Bridge in 2013.

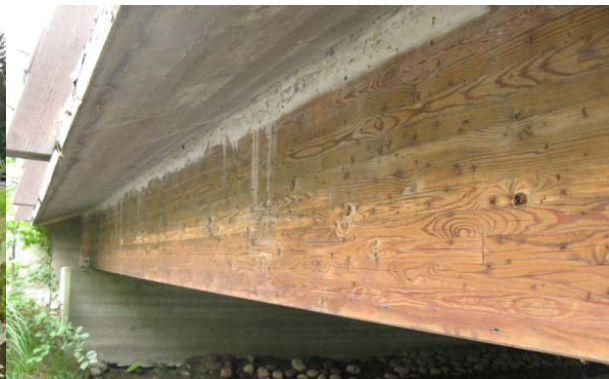
The glulam beams were inspected and found to be in perfect condition (Fig. 14). Cracks or other damages in the wooden beams were not discovered. The moisture content of several beams was measured and found to be on normal level in a range from 14,2 % to 18,2 %.

Fig. 14. Outer surface of the glulam beam.

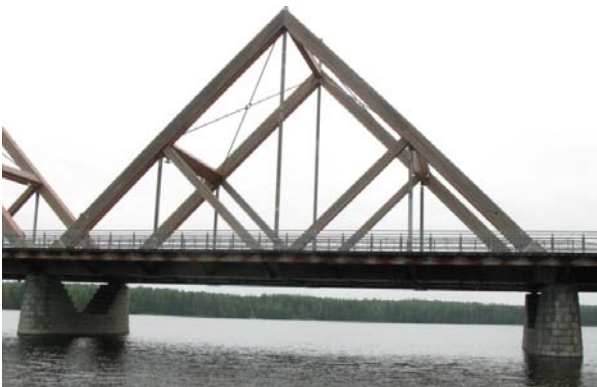
Fig. 15. One span of the Vihantasalmi Bridge in 2013.

The zinc coating of the railing poles has caused runs on the surface of the utmost beam causing visible harm to the aesthetics of the side view (Fig. 15).

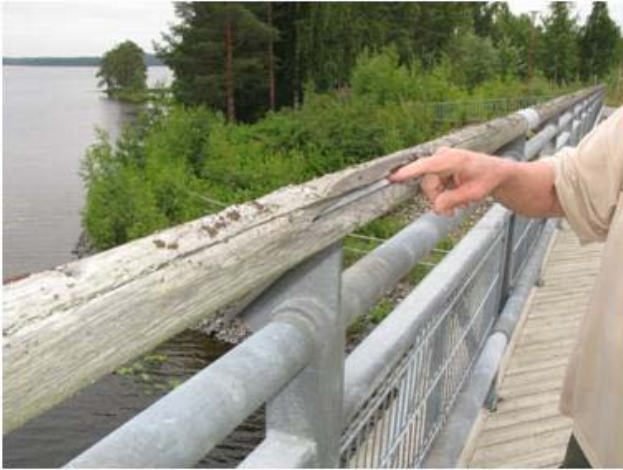
The wooden rail on the deck is worn out and needs to be replaced (Fig. 16).

The southern end of the bridge needs clearing of bushes (Fig. 16).

Fig. 16. Worn top guide of the railing. On the background wildy growing bushes are seen.

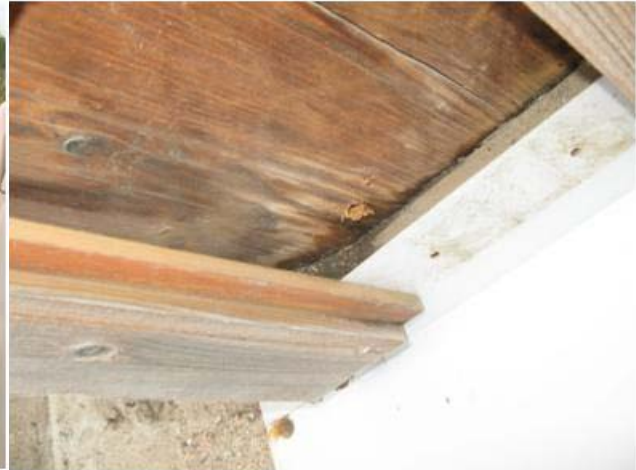
Fig. 17. Water pocket and crack at the end of the inclined load-carrying member.

Two inclined load-carrying members of the superstructure were inspected by removing the protecting wooden cover on the beams. Water pockets were found at the ends of the members and the beam ends were practically wet. A long crack in the direction of grains was noticed (*Fig. 17*).

High moisture contents were reported earlier at the same joint, but at the ends of the wooden beams under the concrete deck [1]. The problem of the connection is that the ends of wooden members are on all sides confined by steel walls. The situation is even worse at the top part of the connection, where concrete cover encloses the joint.

The problematic joints need to be inspected and repair actions planned.
