Evaluation of Corrosion Resistance of Different Steel Reinforcement Types

Final Report
May 2006

Sponsored by
the Iowa Department of Transportation
(CTRE Project 02-103)

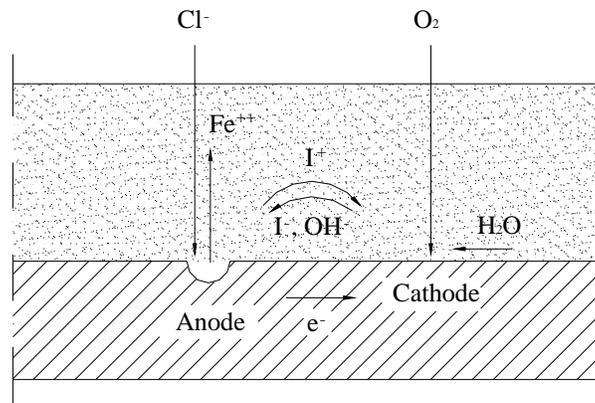
Figure 2.1. Schematic of the corrosion process

The surface of the iron, at which oxidation occurs, serves as an anode. The two free electrons, $2e^{-}$, created in the anodic reaction must be consumed elsewhere on the steel surface to preserve electrical neutrality in the system. In other words, it is not possible for a large amount of electrical charge to build up at one location. Another chemical reaction must consume the electrons. Oxidation and reduction are coupled together as electrons are transferred between them. This reaction consumes both water and oxygen.

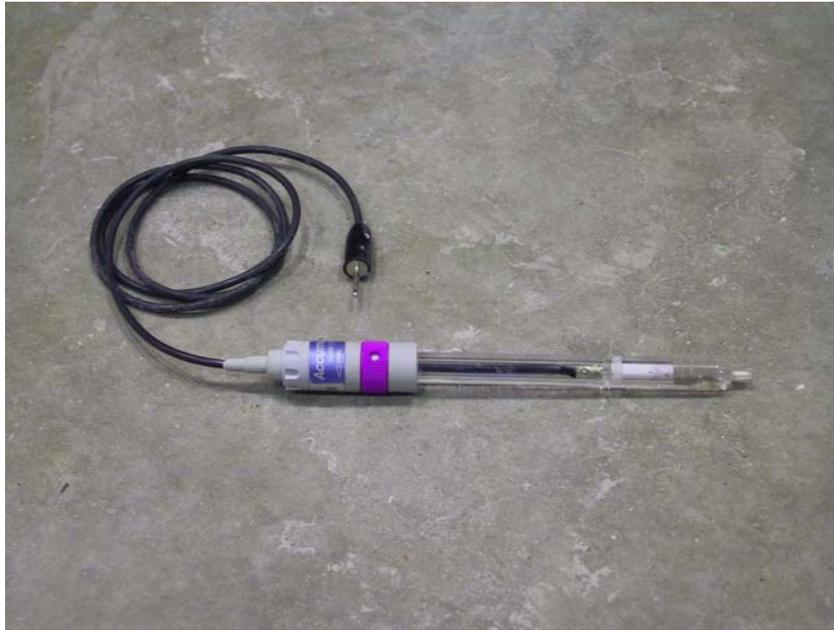
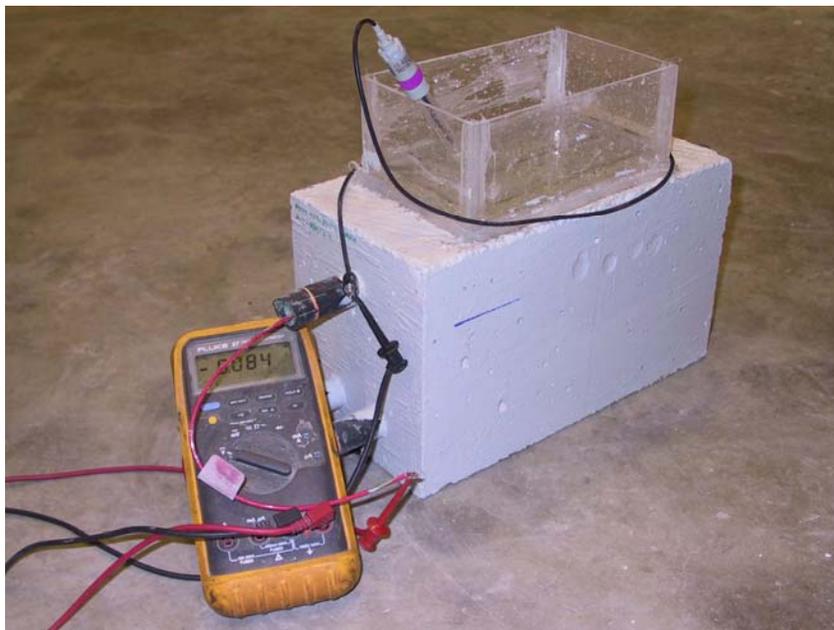
Figure 2.2. Half-cell corrosion potential monitoring method

(a) Saturated calomel reference electrode

(b) Measure of half-cell corrosion potential for the top layer of reinforcement

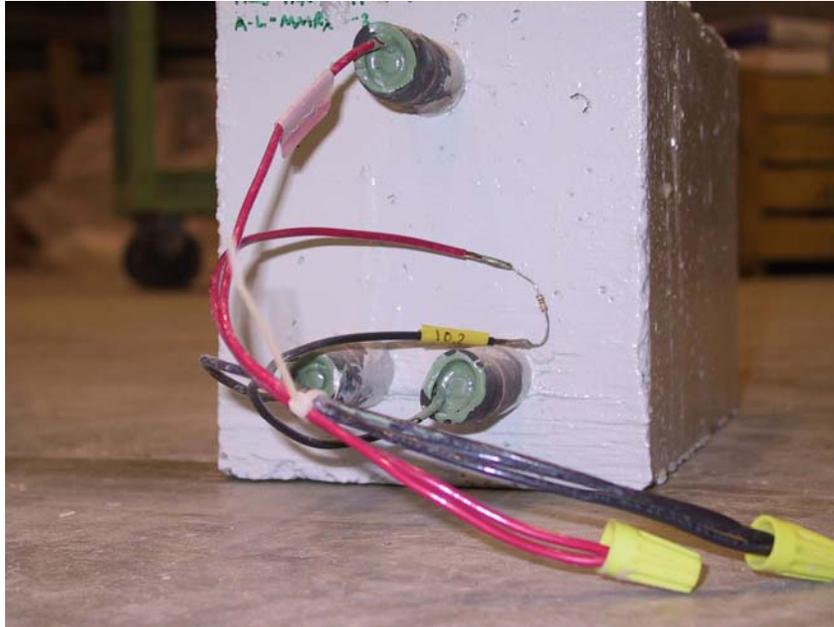
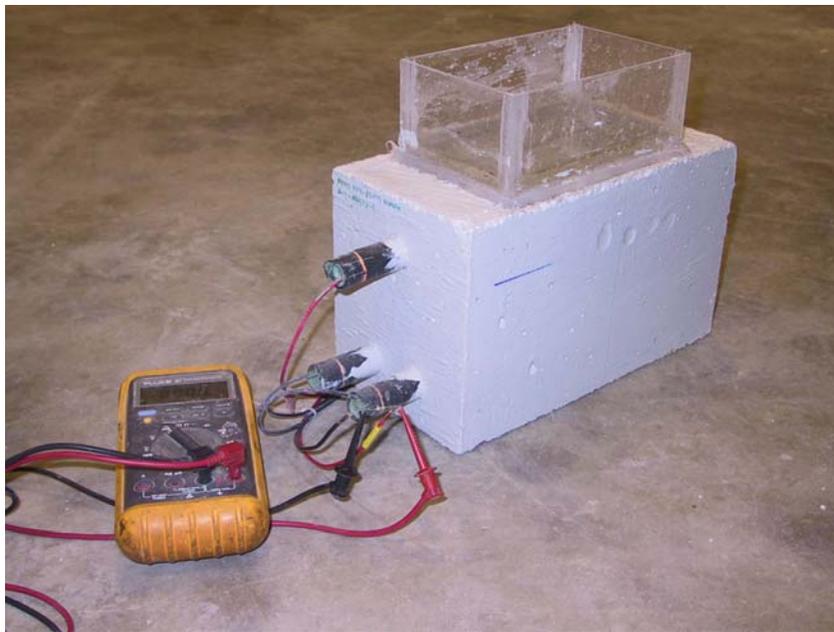
Figure 2.3. Macrocell corrosion monitoring method

(a) Top and bottom reinforcement layers connected via resistor

(b) Measurement of macrocell corrosion

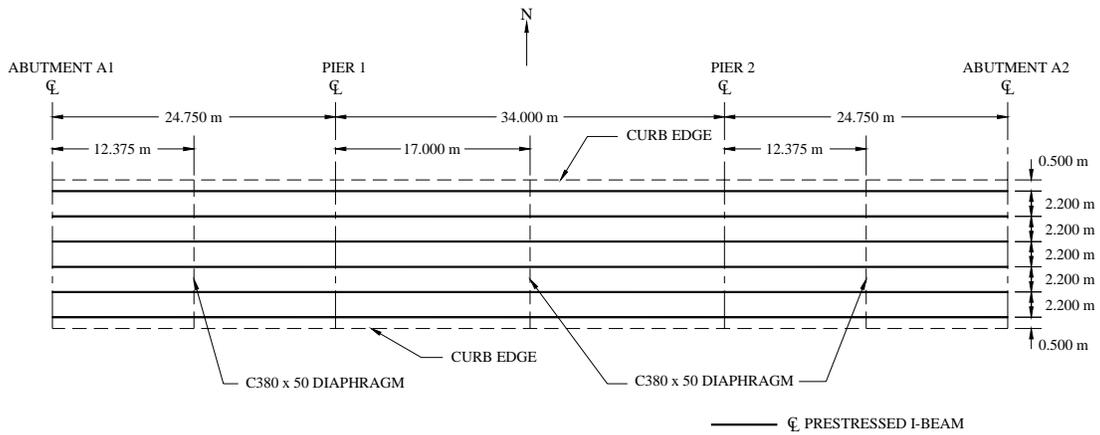
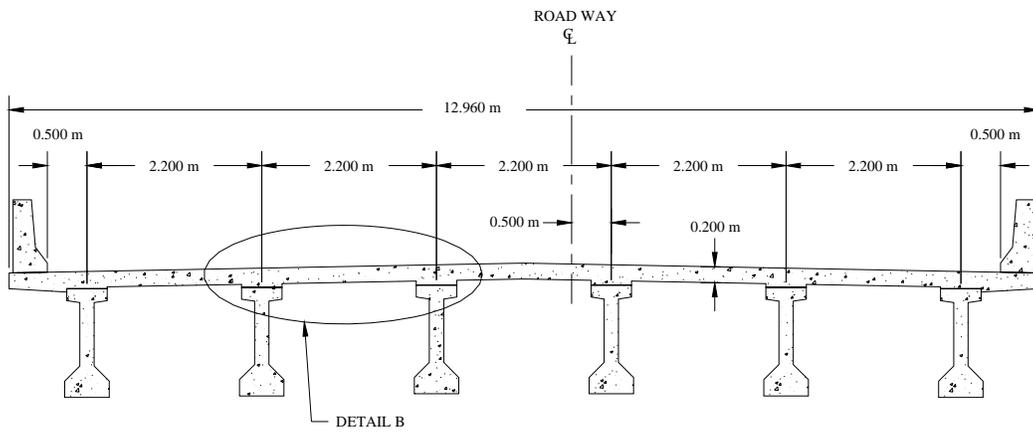
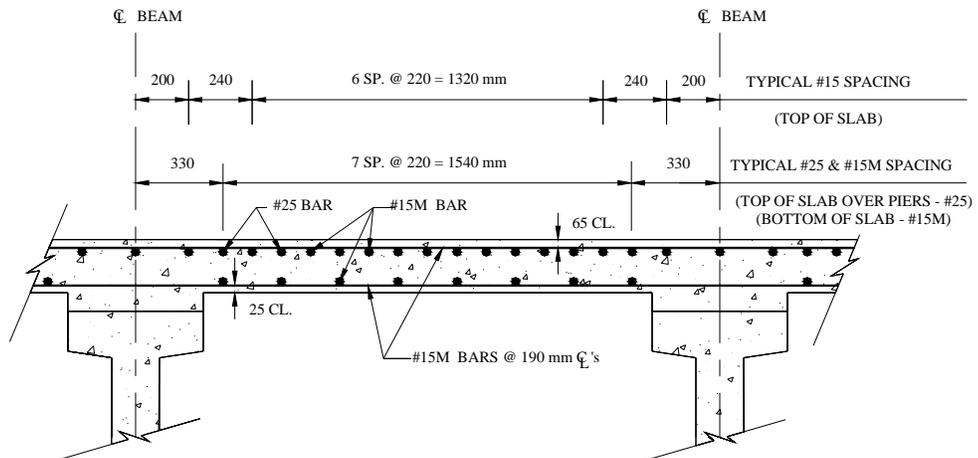
Figure 3.1. Bridge framing plan and typical cross-section

(a) General framing plan

(b) Typical cross-section

(c) Detail B

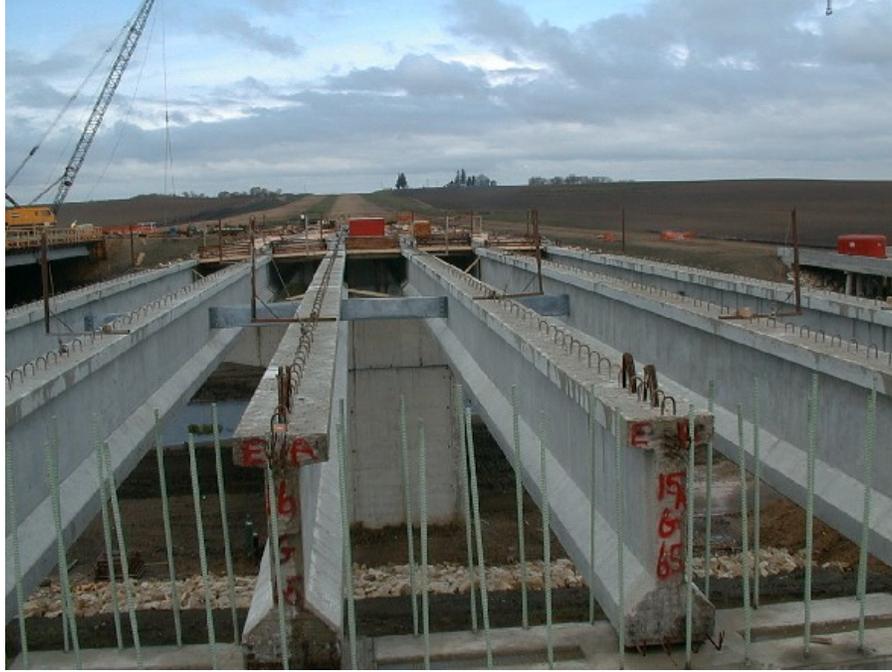
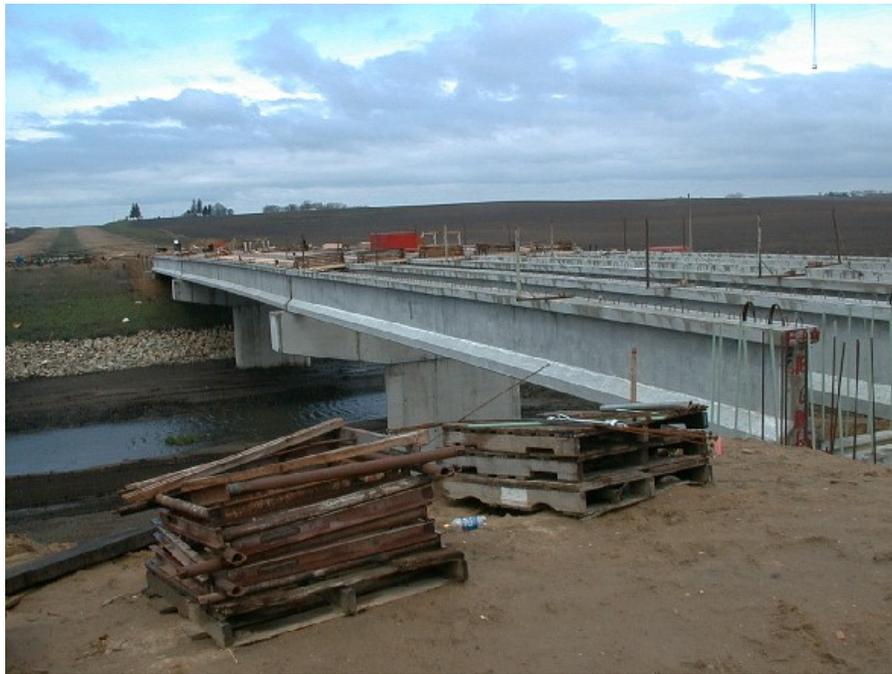
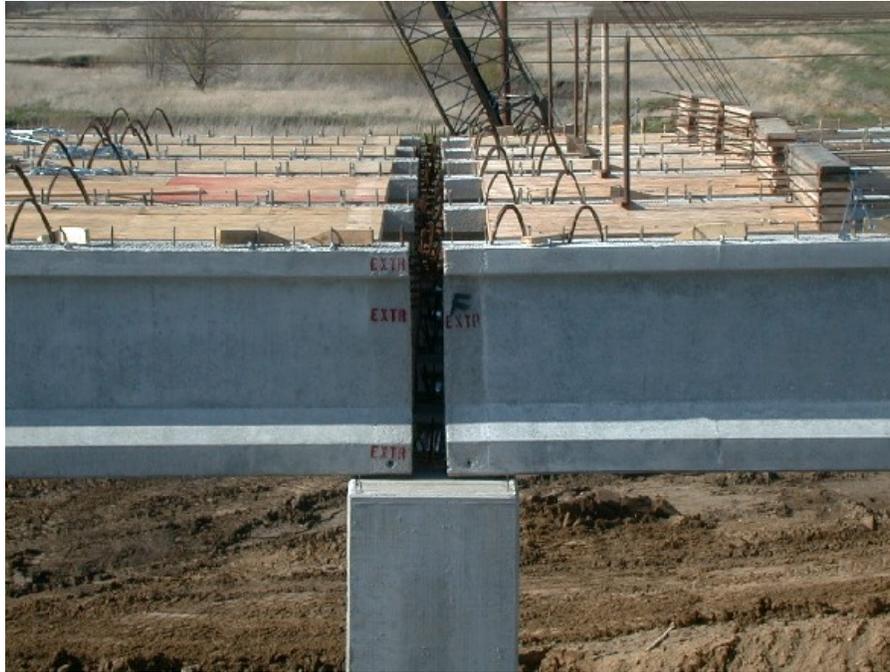
Figure 3.2. Typical prestressed I-beams

(a) Typical beam layout

(b) Side view

(c) Typical beam connection at pier

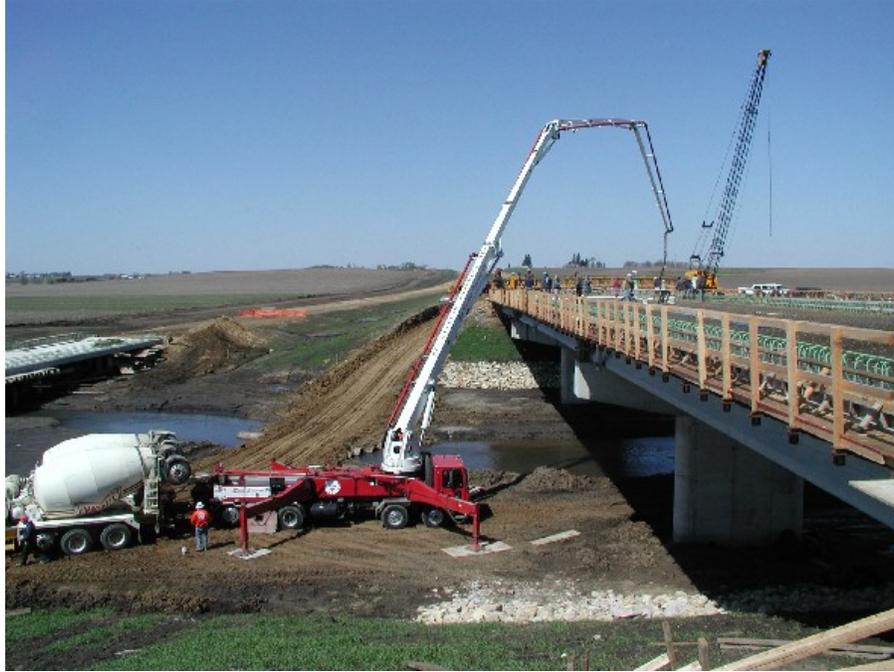
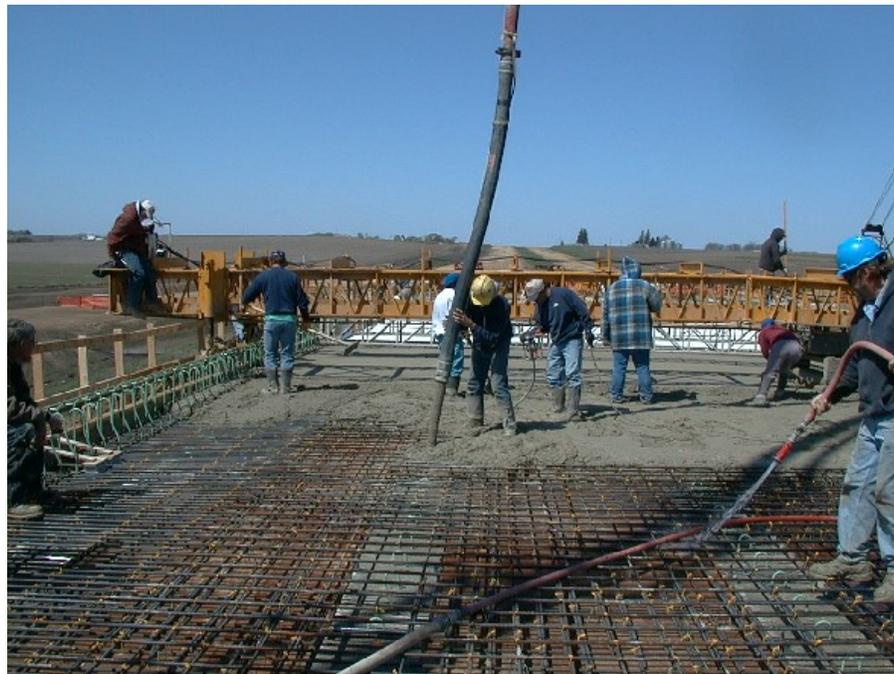
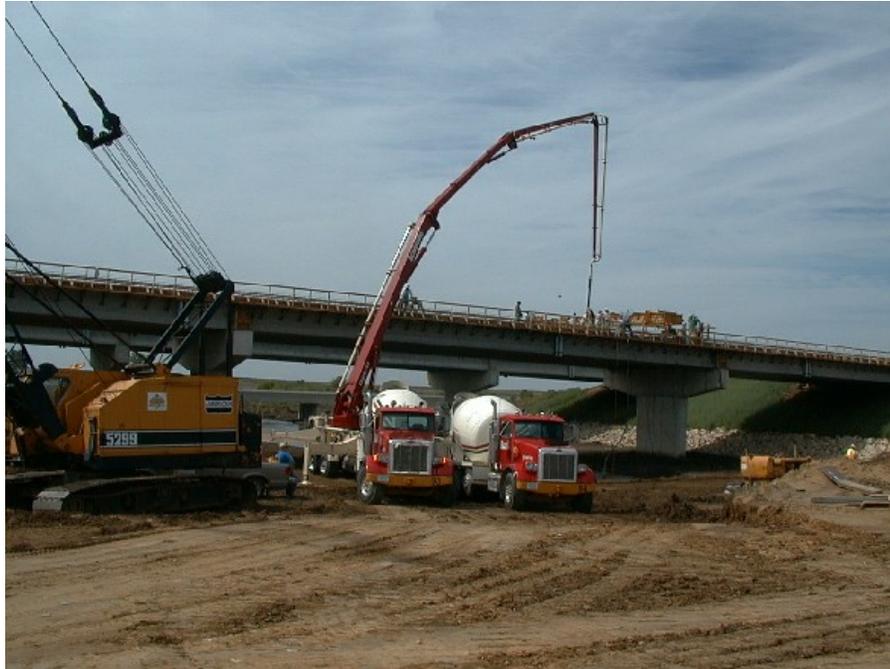
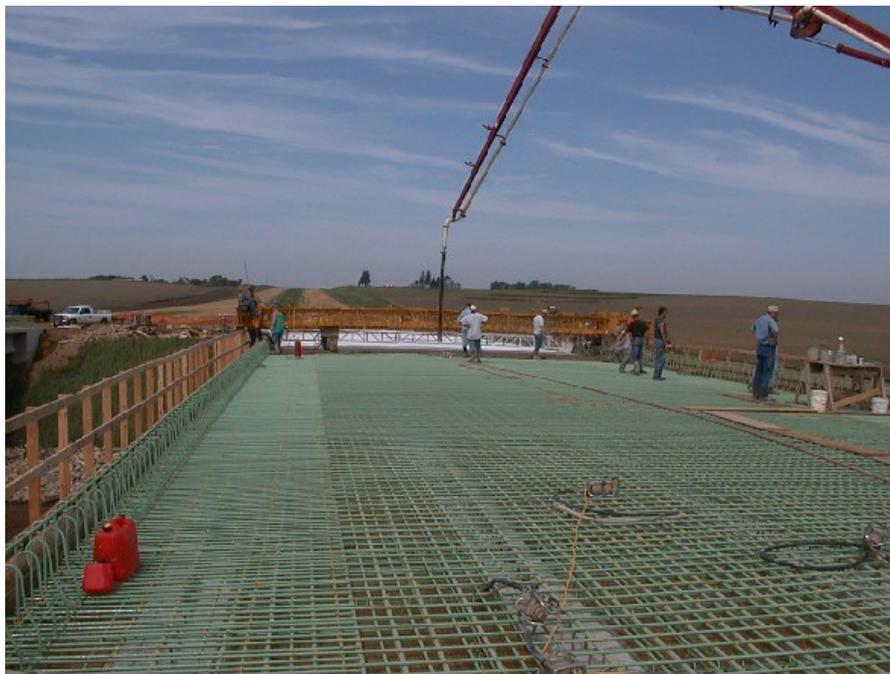
Figure 3.4. Bridge deck concrete placement

(a) MMFX bridge (looking northwest)

(b) MMFX bridge (looking west)

(c) Epoxy bridge (looking southwest)

(d) Epoxy bridge (looking west)

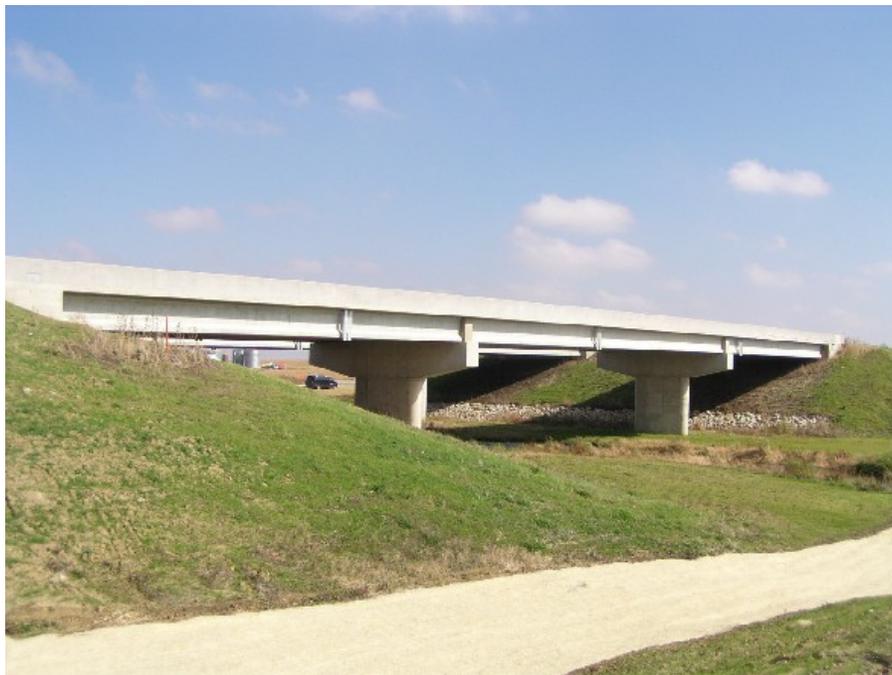
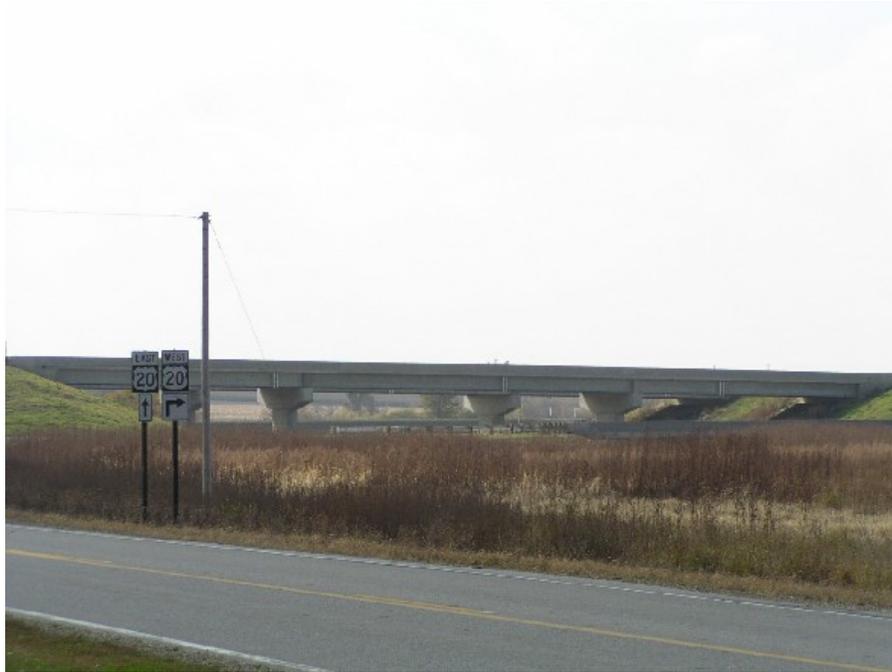
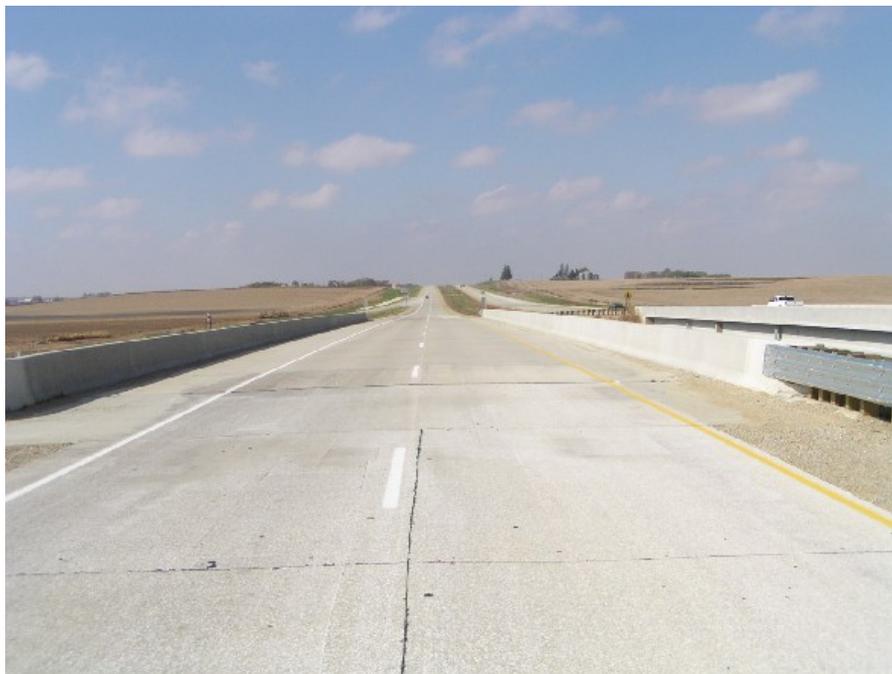
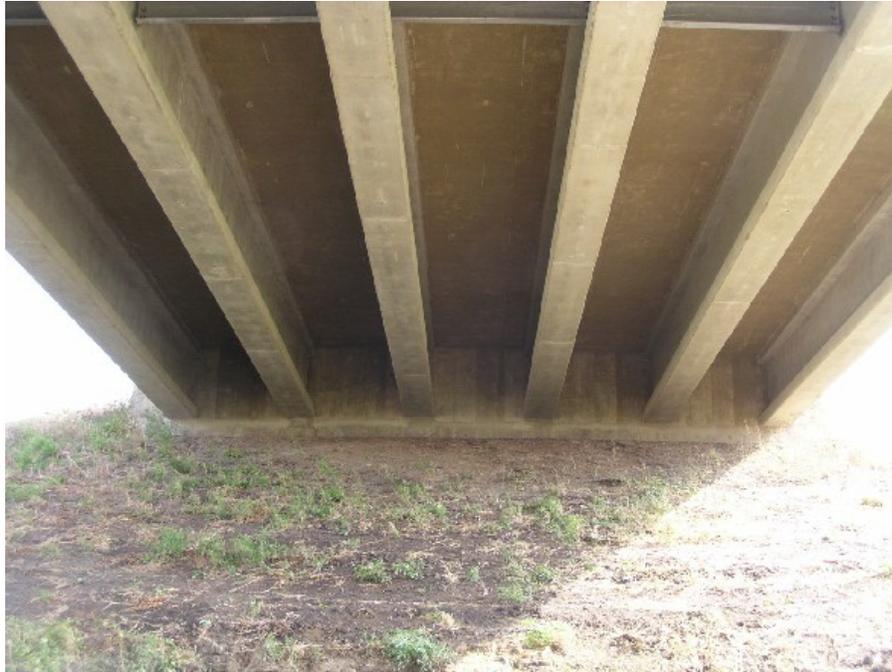
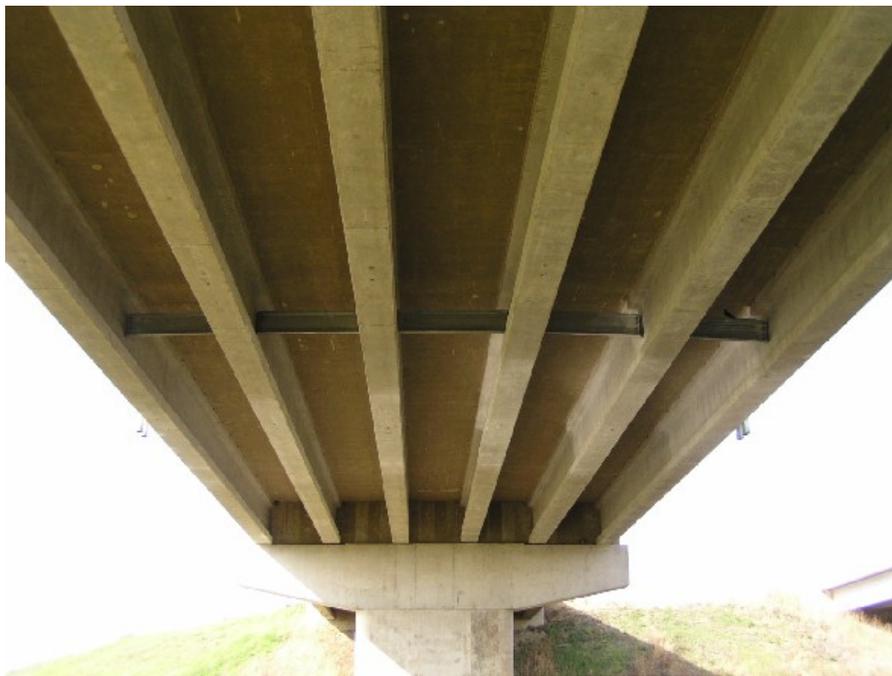
Figure 3.6. Completed bridge

(a) Side view (MMFX bridge)

(b) Side view (Epoxy bridge)

(c) End view

(d) Bottom view (abutment)

(e) Bottom view (center span and west pier)

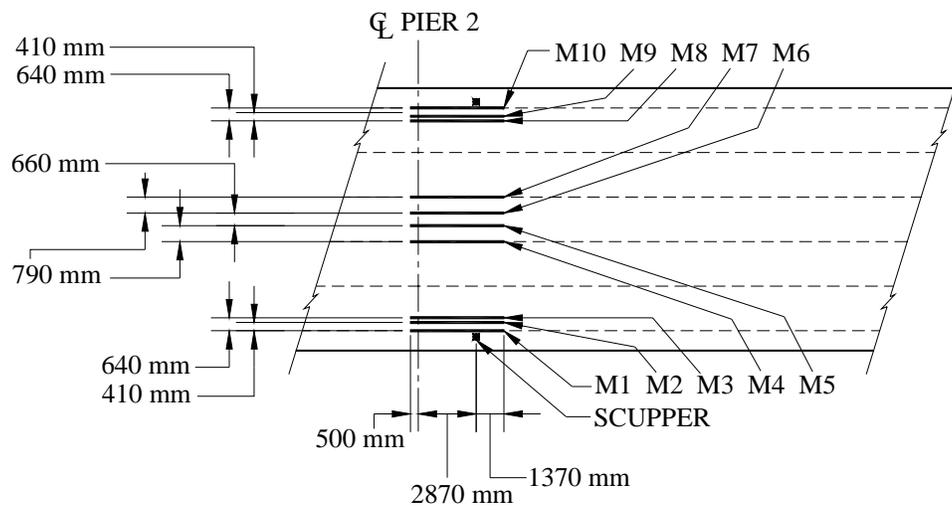
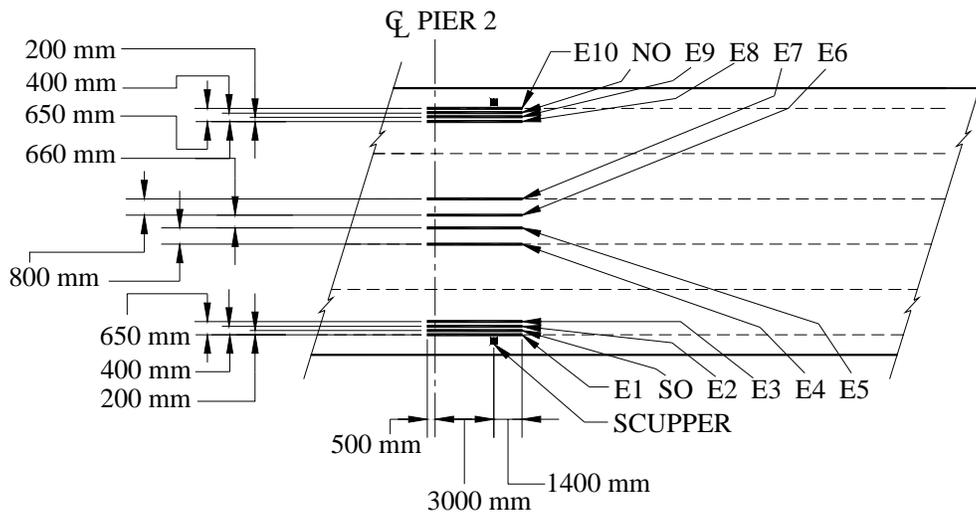
Figure 3.8. Detail C (general instrumentation of V2000 sensors)

(a) MMFX bridge

(b) Epoxy bridge

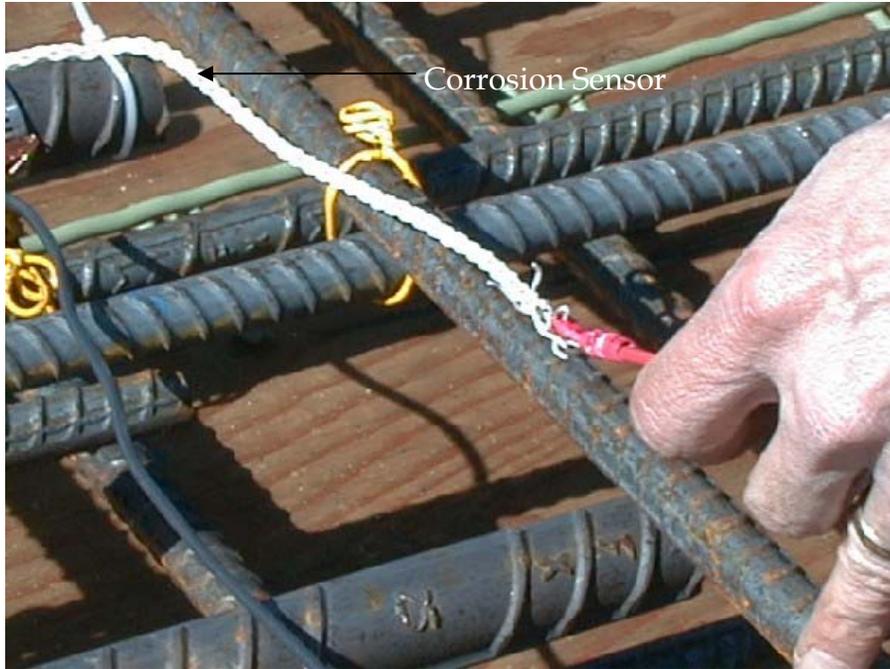
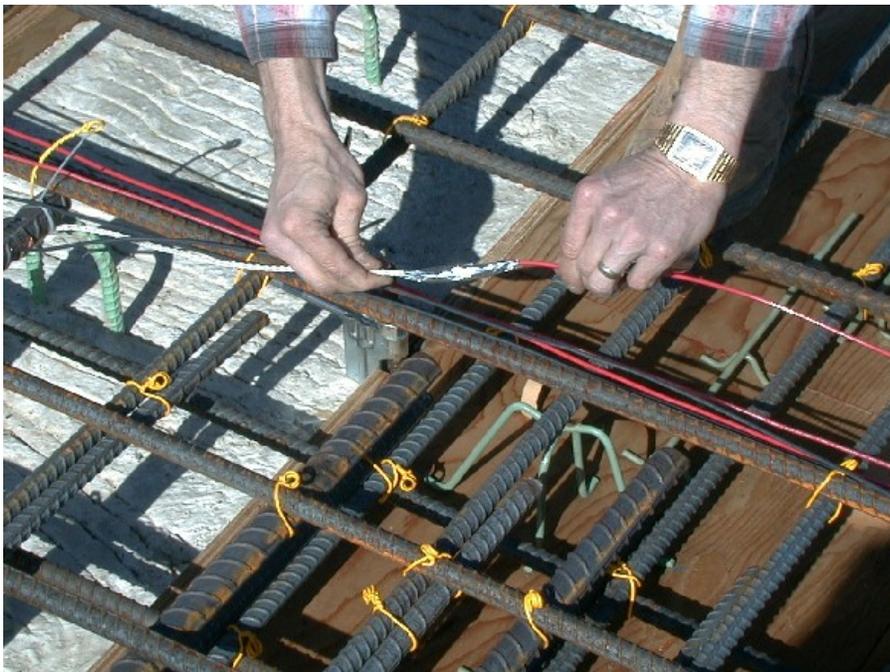
Figure 3.9. Connecting V2000 sensor with lead wire

(a) Butt splice of electrode corrosion sensor and lead wire

(b) Butt splice protected with butyl rubber underneath aluminum foil tape

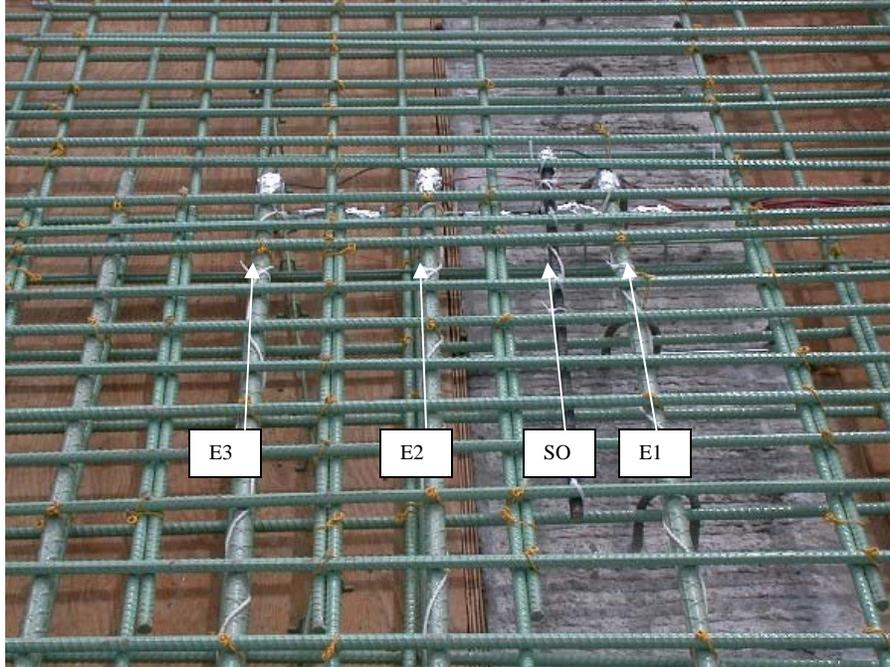
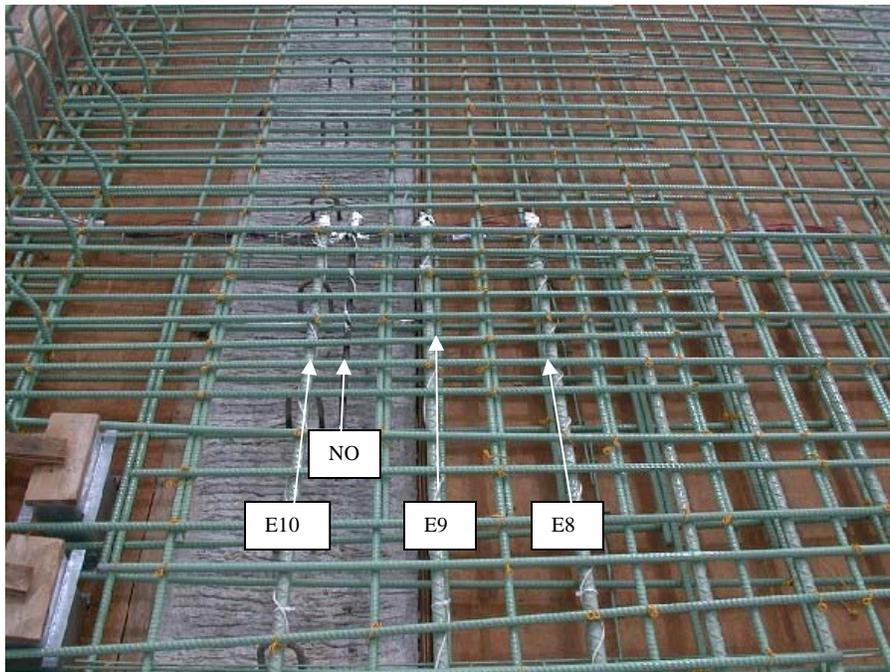
Figure 3.12. Typical photographs of the instrumentation layout on epoxy bridge

(a) “SO” MMFX bar and epoxy bars E1–E3 (looking east)

(b) “NO” MMFX bar and epoxy bars E8–E10 (looking east)

On the epoxy bridge, two additional short sections of MMFX bars were instrumented with electrodes and placed between other epoxy coated bars (i.e., one on the north side, referred to as “NO,” and one on the south side, referred to as “SO”) to compare the two types of bars in exactly the same environment. Figures 3.11 and 3.12 show typical photographs of the instrumentation layout.

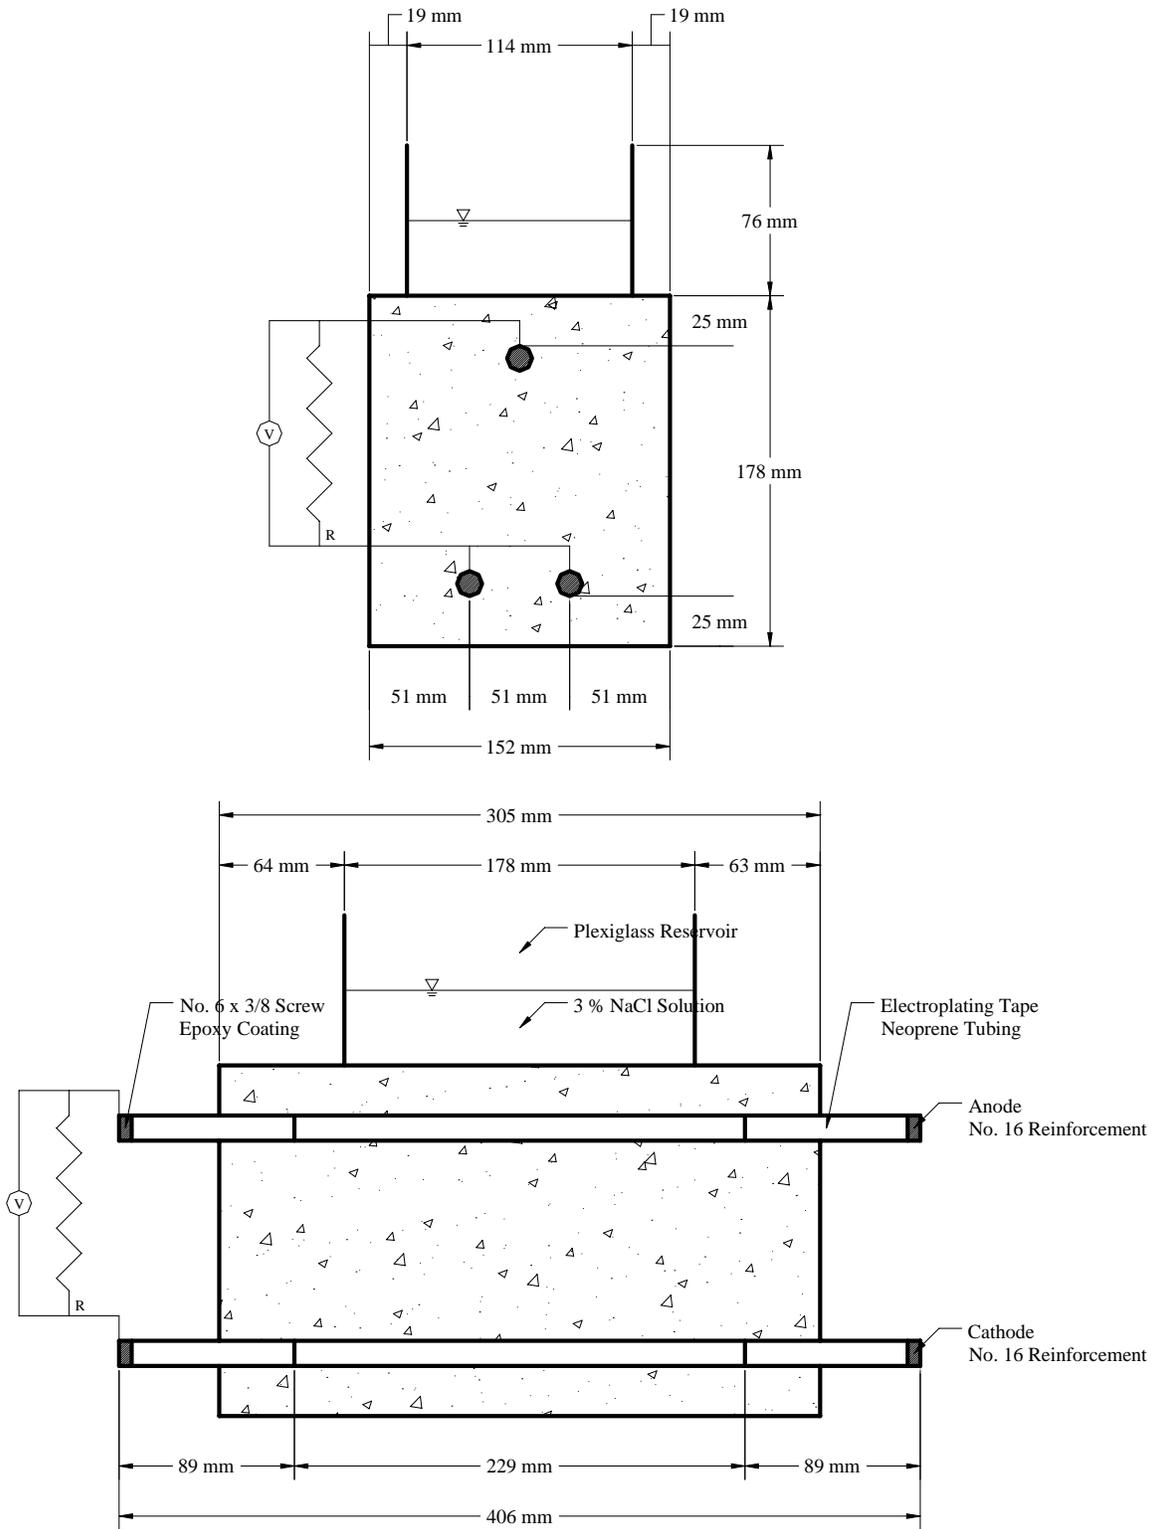
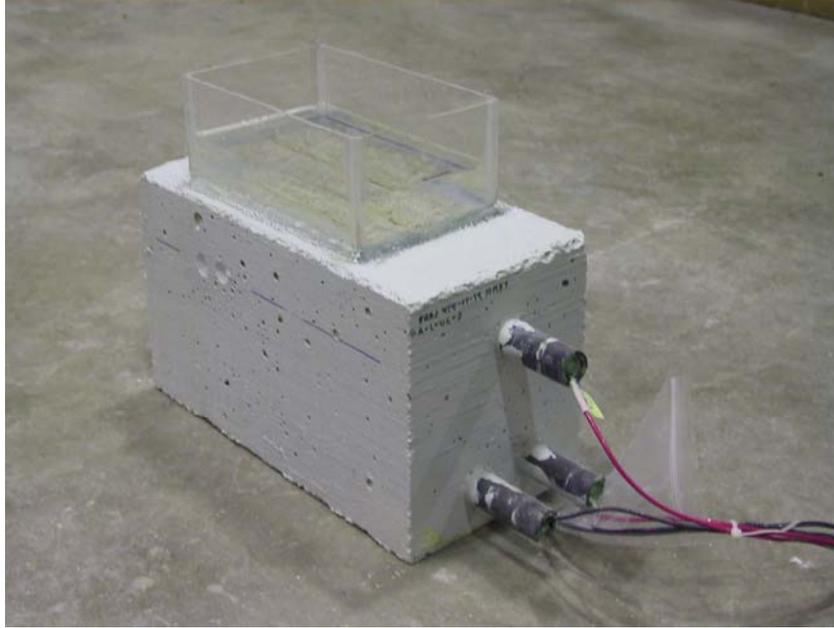
Figure 5.1. Accelerated corrosion test specimen

(a) Schematic of ASTM G 109 ACT

(b) Typical as-constructed ASTM G 109 ACT

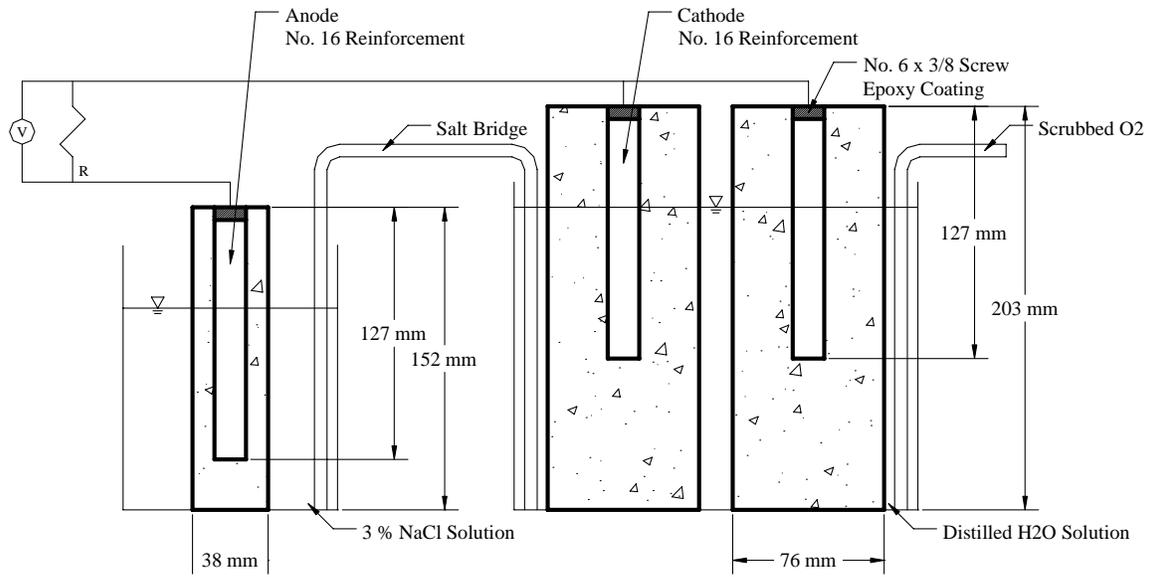
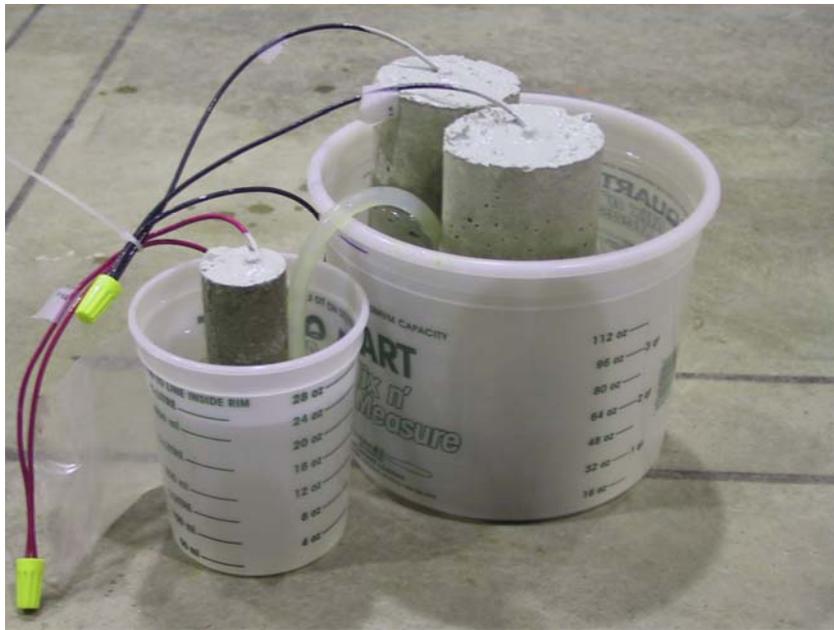
Figure 5.2. Schematic of Rapid Macrocell accelerated corrosion test specimen

(a) Schematic of Rapid Macrocell ACT

(b) Typical as-constructed Rapid Macrocell ACT

The Rapid Macrocell ACT salt bridge described previously serves as an ionic pathway between the containers holding the specimens. Each salt bridge is made using a 0.9 m (36 in.) long flexible Tygon tube with an inner diameter of 6.4 mm (1/4 in.) and an outside diameter of 9.5 mm (3/8 in.). The tube is filled with a salt gel made from 4.5 g (0.16 oz.) of agar, 30 g (1.06 oz.) of potassium chloride (KCl), and 100 g (3.52 oz.) of distilled water, a quantity of ingredients adequate to make three salt bridges.

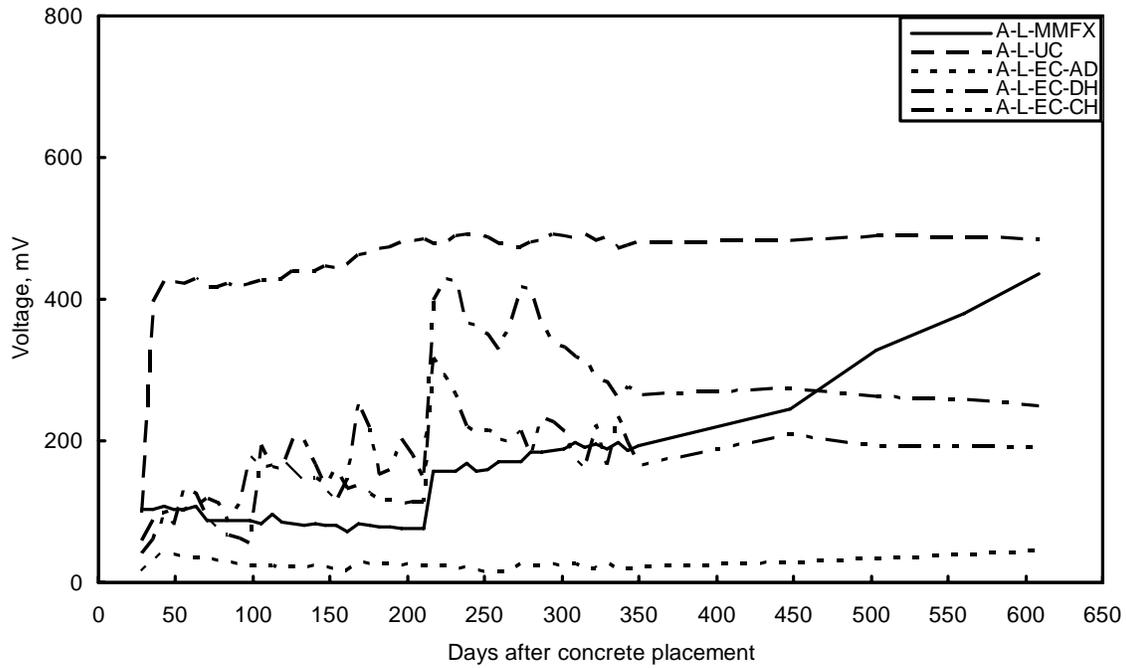
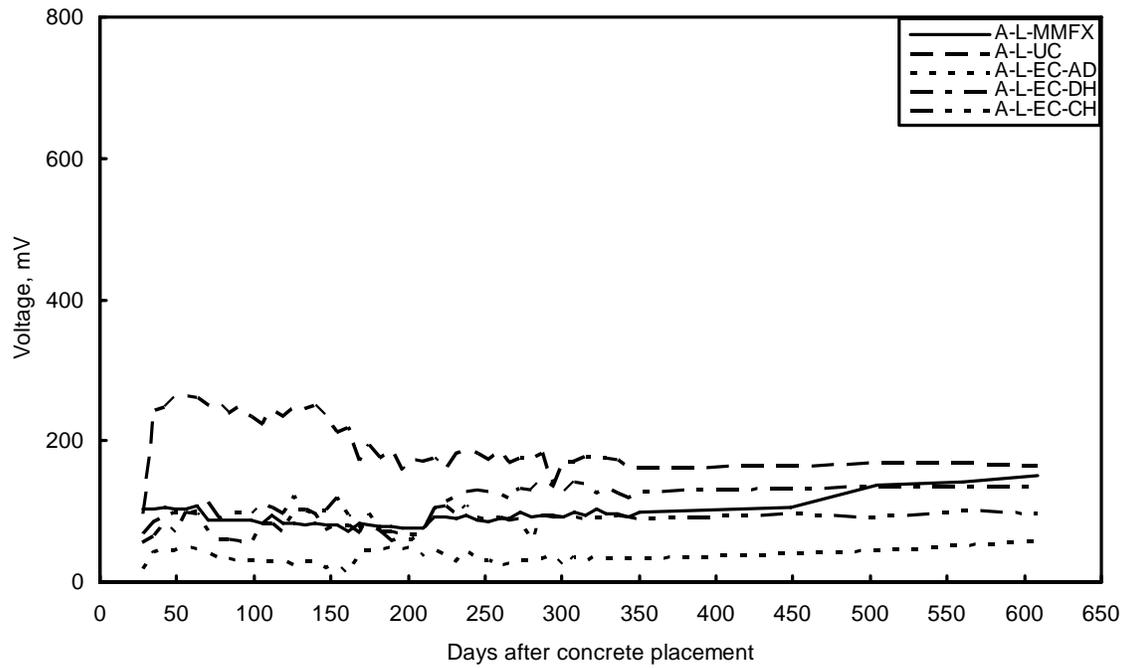
Figure 6.1. ASTM G 109 ACT subjected to 3% NaCl solution through longitudinal crack

(a) Corrosion risk of the top layer of steel reinforcement

(b) Corrosion risk of the bottom layer of steel reinforcement

Specimens with the as-delivered epoxy-coated reinforcement exhibited a relatively constant corrosion potential of around 25 mV through 609 days (87 weeks), indicating a low risk for corrosion.

The corrosion potential for the drilled holiday epoxy-coated reinforcement experienced spikes of 300 mV throughout days 105 to 217 (weeks 15 to 31), as the specimens began to corrode throughout the interval. The corrosion potential rose to a maximum of 430 mV at 224 days (32 weeks), but decreased to 219 mV through 609 days (87 weeks), indicating that the corrosion had ceased.

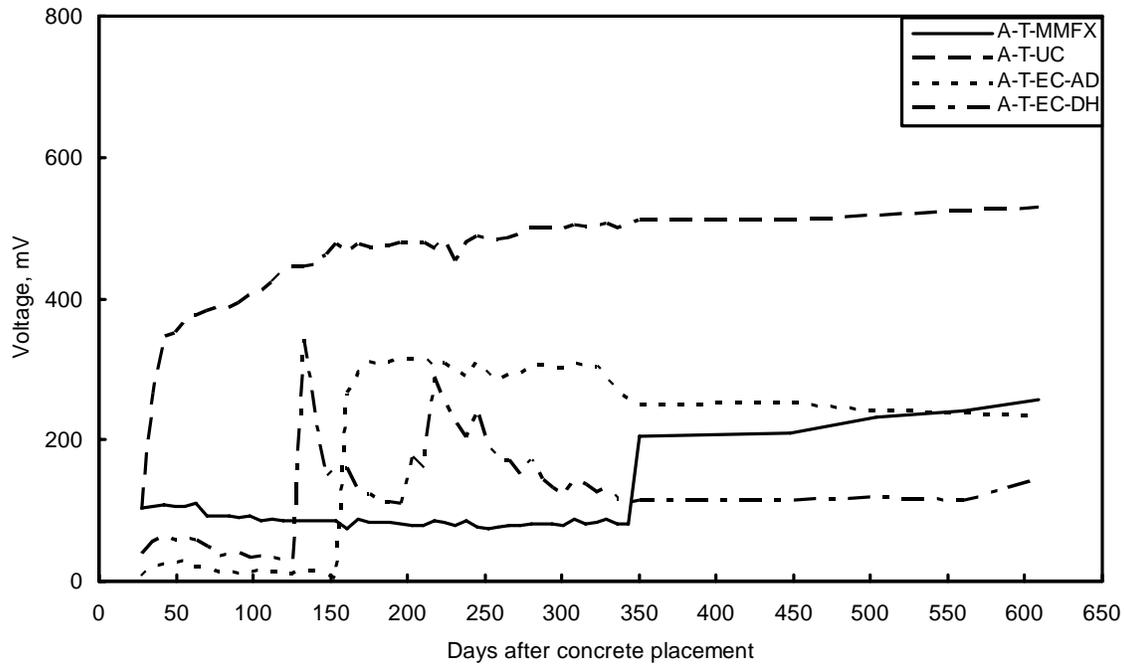
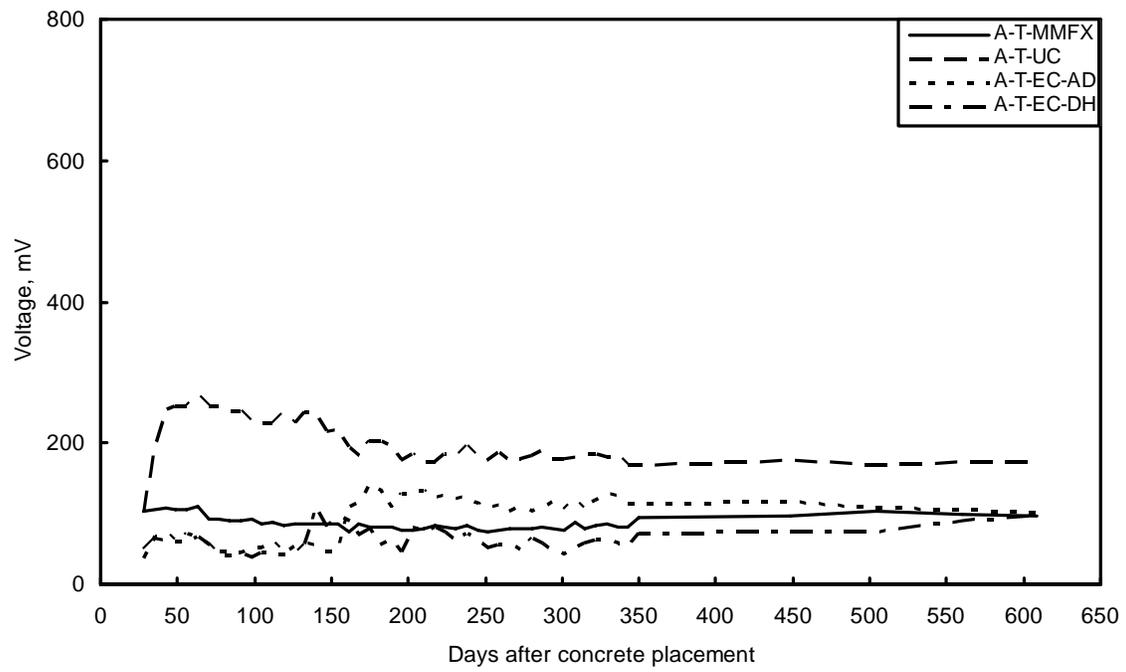
Figure 6.2. ASTM G 109 ACT subjected to 3% NaCl solution through transverse crack

(a) Corrosion risk of the top layer of steel reinforcement

(b) Corrosion risk of the bottom layer of steel reinforcement

Similar to the longitudinally cracked specimens, the drilled holiday epoxy-coated reinforcement with transverse cracks experienced spikes of 250 mV throughout days 105 to 217 (weeks 15 to 31) as the specimens began to corrode. However, due to continued decrease in corrosion potential, the 609-day (87-week) corrosion potential was 144 mV.

The corrosion potential for the bottom layer of reinforcement (cathode) for all reinforcement types remained below 276 mV, indicating that none had undergone active corrosion. Additionally, no corrosion products were observed on the concrete surface for any of the test specimens.
