Evaluation of Corrosion Resistance of Different Steel Reinforcement Types

Final Report
May 2006

Sponsored by
the Iowa Department of Transportation
(CTRE Project 02-103)

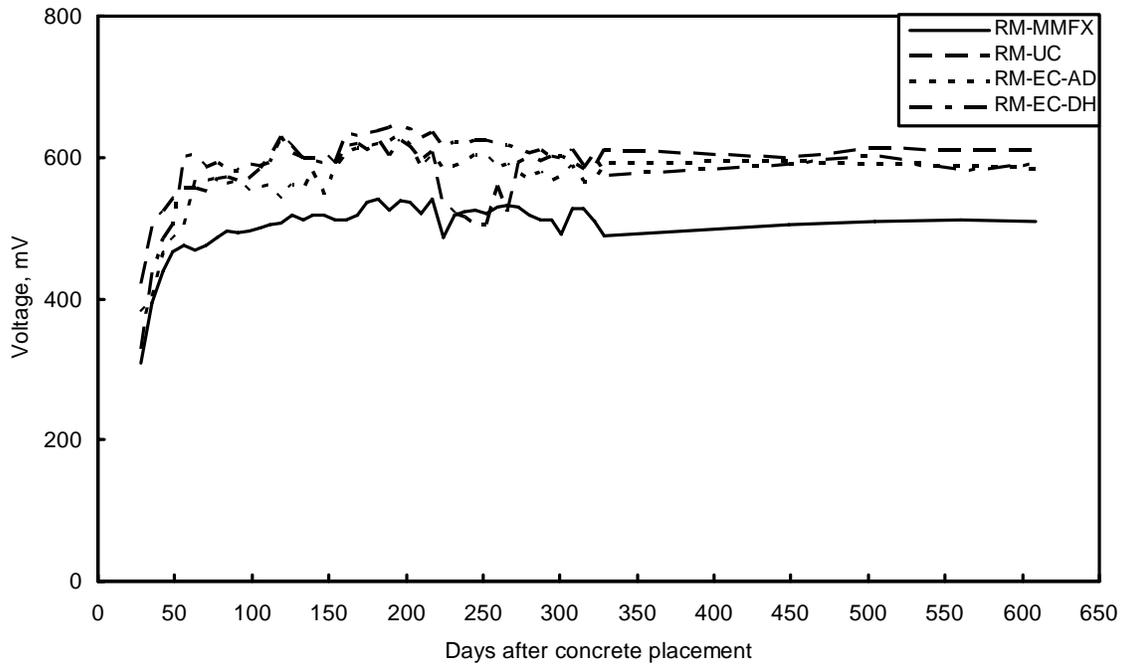
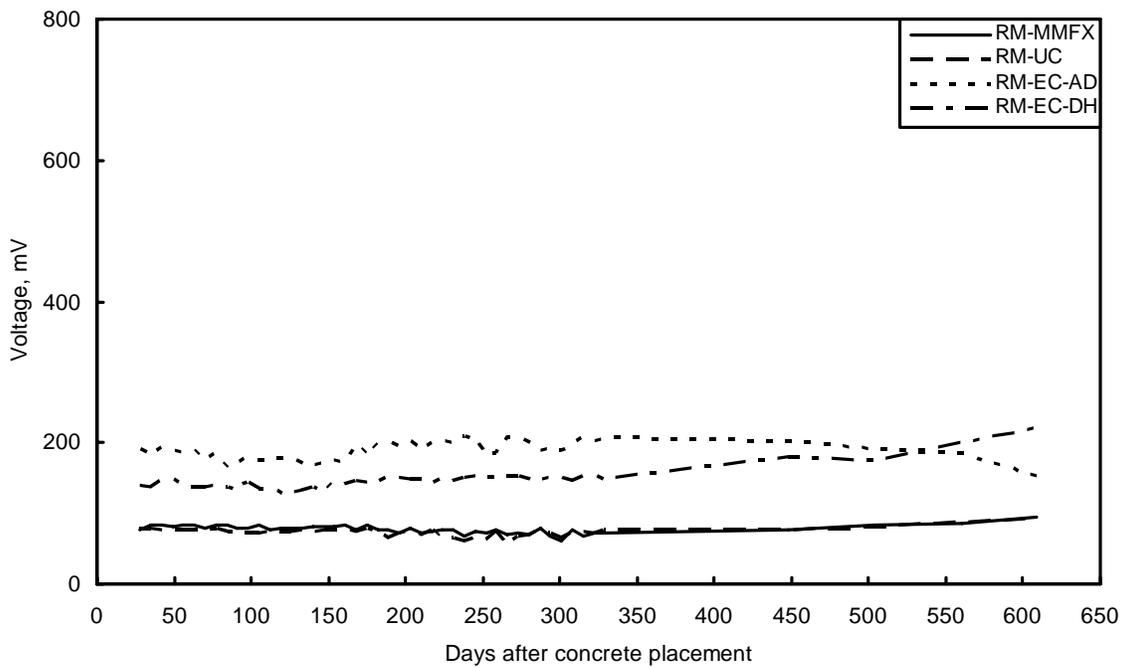
Figure 6.3. Rapid Macrocell ACT subjected to 3% NaCl solution

(a) Corrosion risk of the top layer of steel reinforcement

(b) Corrosion risk of the bottom layer of steel reinforcement
