Impact of Curling, Warping, and Other Early-Age Behavior on Concrete Pavement Smoothness: Early, Frequent, and Detailed (EFD) Study

National Concrete Pavement
Technology Center

Phase II Final Report
January 2007

Sponsored by
the Federal Highway Administration (Project 16)

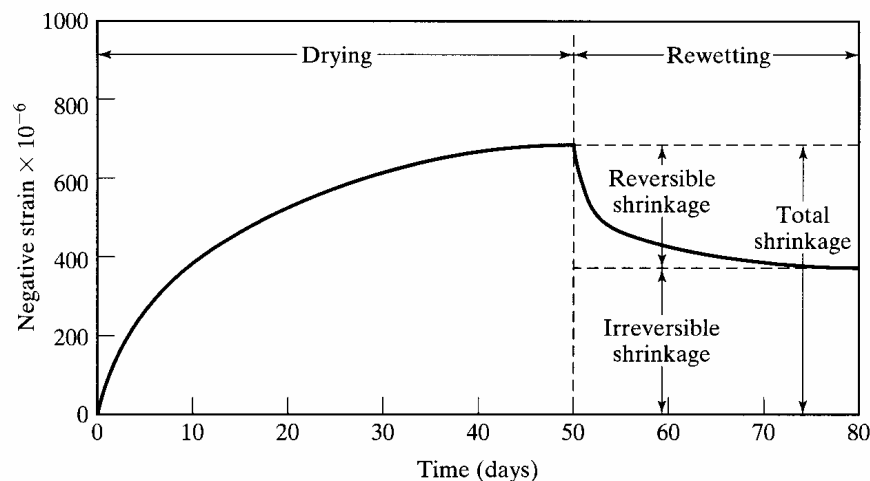
As shown in Figure 4, most of the shrinkage which is caused by the loss of water shows the significant irreversible deformation after rewetting. Mindess et al. (2003) suggested that the origin of this irreversibility could be related to the unstable amorphous nature of C-S-H which produces rearrangement of bond structure due to loss of moisture. This irreversibility of shrinkage could contribute to the permanent deformation at zero temperature gradient and zero moisture gradient (Yu et al. 2004; NCHRP 2004).

Figure 4. Typical behavior of PCC on drying and wetting

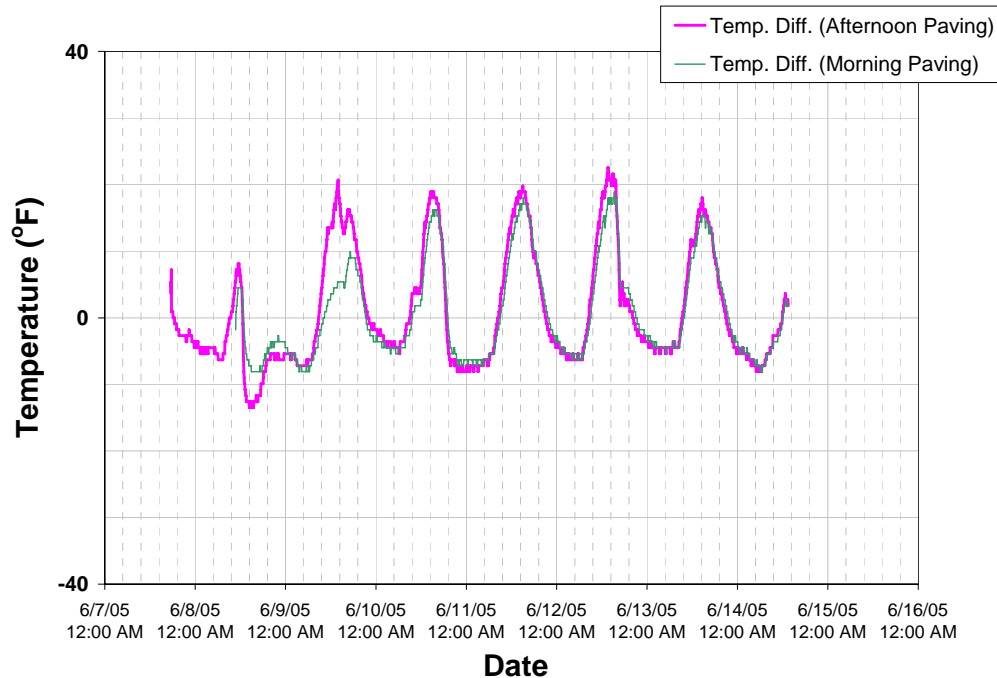
Since the variations in PCC slab curling were directly influenced by temperature difference between the top and the bottom of the slab surface, the variations in temperature differences with time are plotted in Figure 31. In general, temperature differences are positive during daytime and early nighttime and negative during late nighttime and early morning. However, both test sections show the negative gradient at afternoon of June 8, 2005, because top surface of slabs in test sections experienced rapid cooling down during this period due to thunderstorm.

Figure 31. Burlington site—pavement temperature difference between the top and the bottom of slab with time

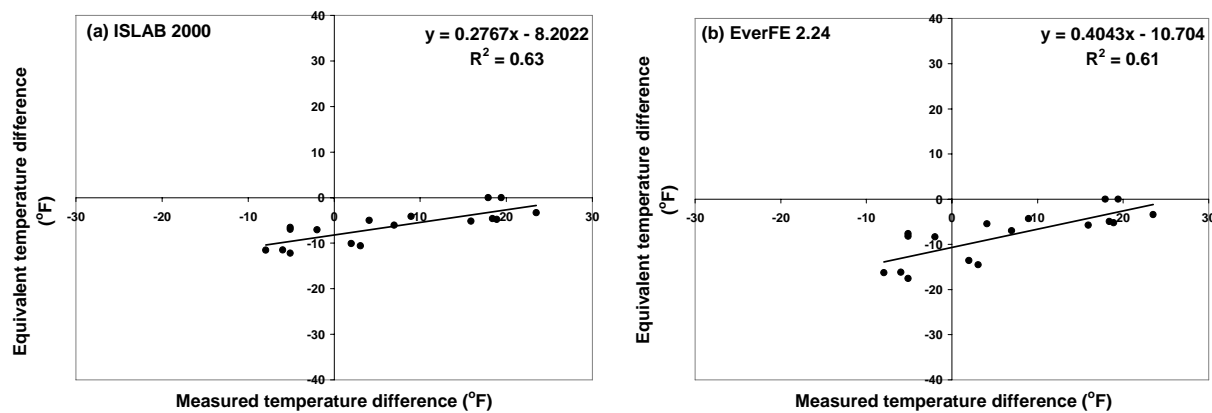
It is interesting to note that approximately -8°F (-4°C) for ISLAB 2000 and -11°F (-6°C) for EverFE 2.24 were obtained as intercepts for the linear regression equations in this study, which is similar to a value of -10°F (-5.6°C) defined as permanent curl/warp effective temperature difference in the MEPDG through national calibration results. Based on linear regression equations from Figure 34, equivalent temperature differences during pavement profile data collection were calculated and used as inputs for both FE programs.

Figure 34. Burlington site—equivalent temperature differences versus measured temperature differences

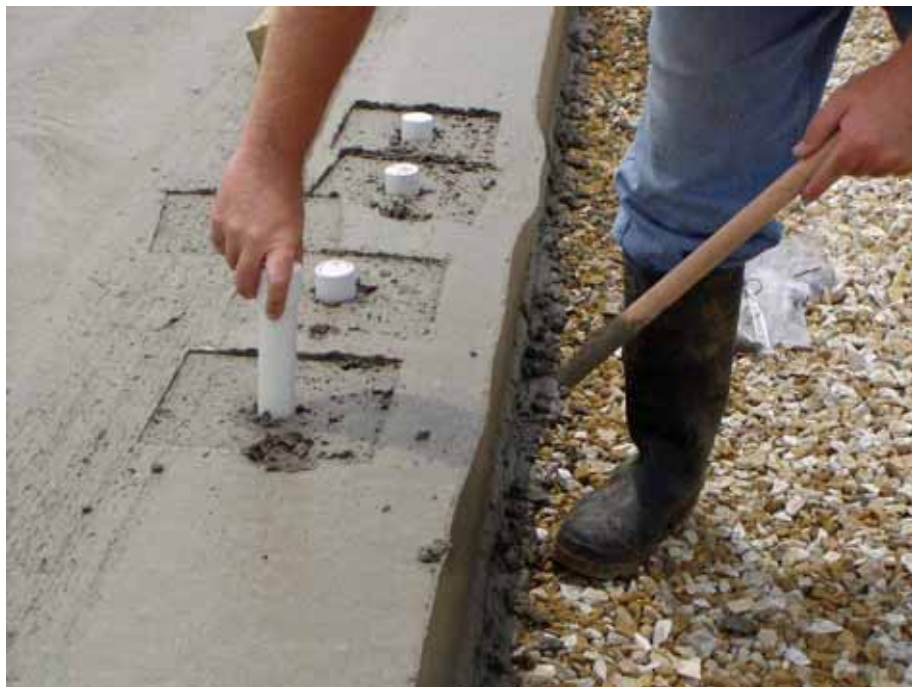
Figure D.10. Relative humidity instrumentation installation following AVA sampling

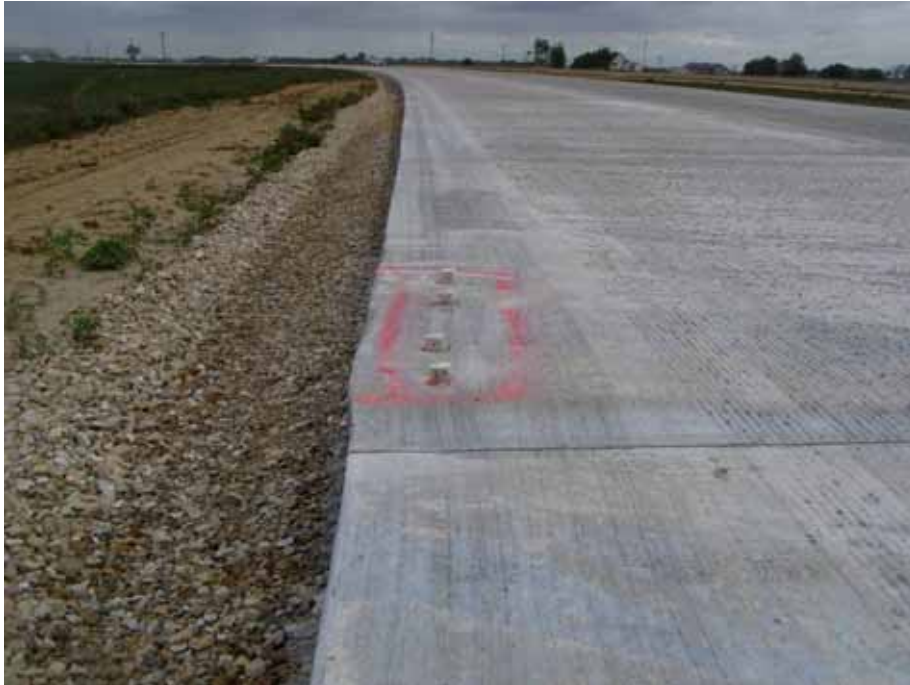
Figure D.11. Relative humidity instrumentation location

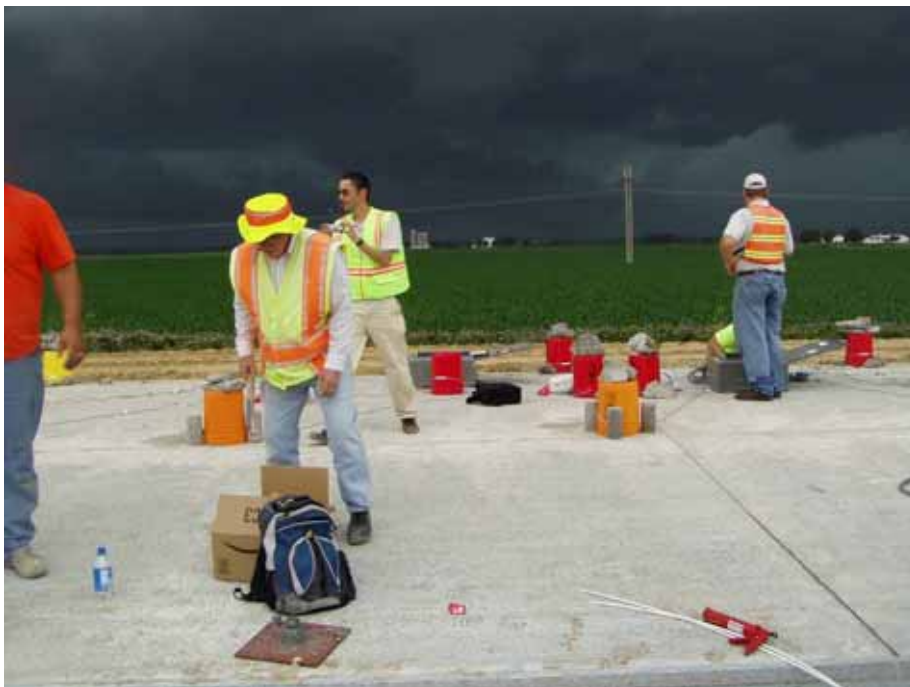
Figure D.12. LVDT installation before thunderstorm

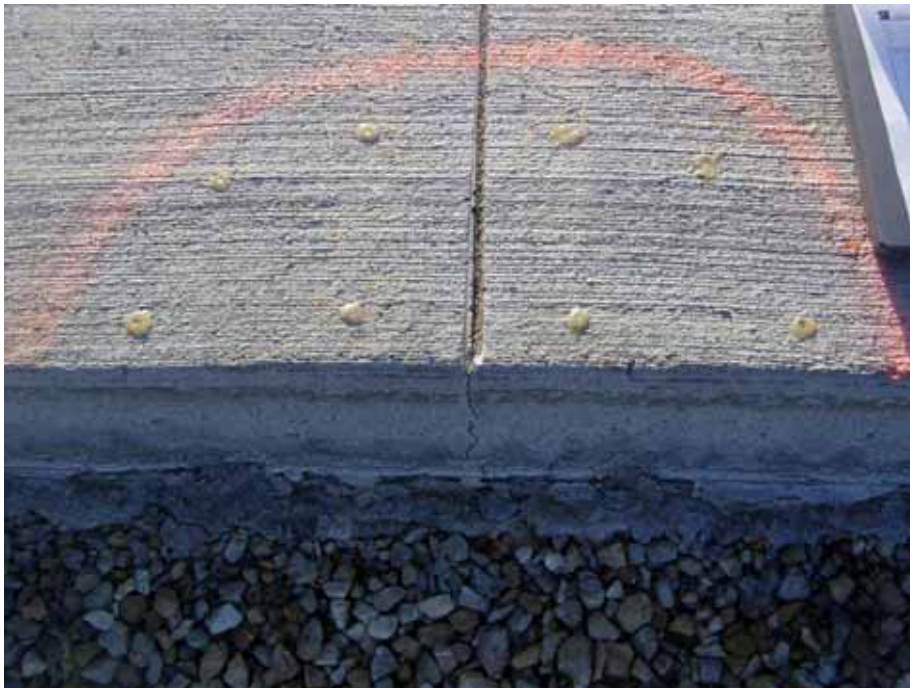
Figure D.14. Corner DEMEC location with crack at transverse joint

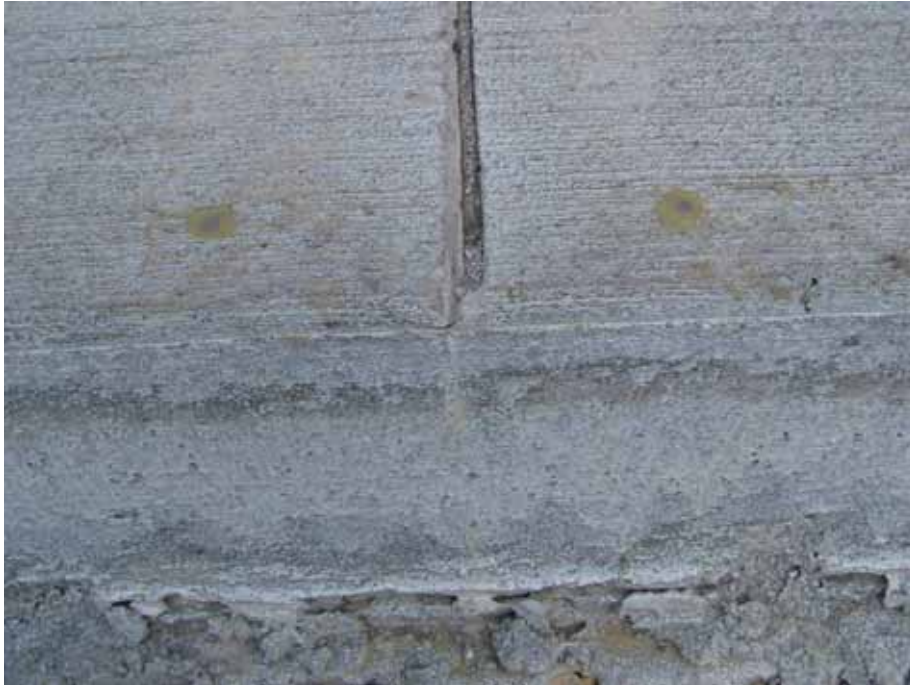
Figure D.15. Transverse joint DEMEC location in afternoon (no visible crack)

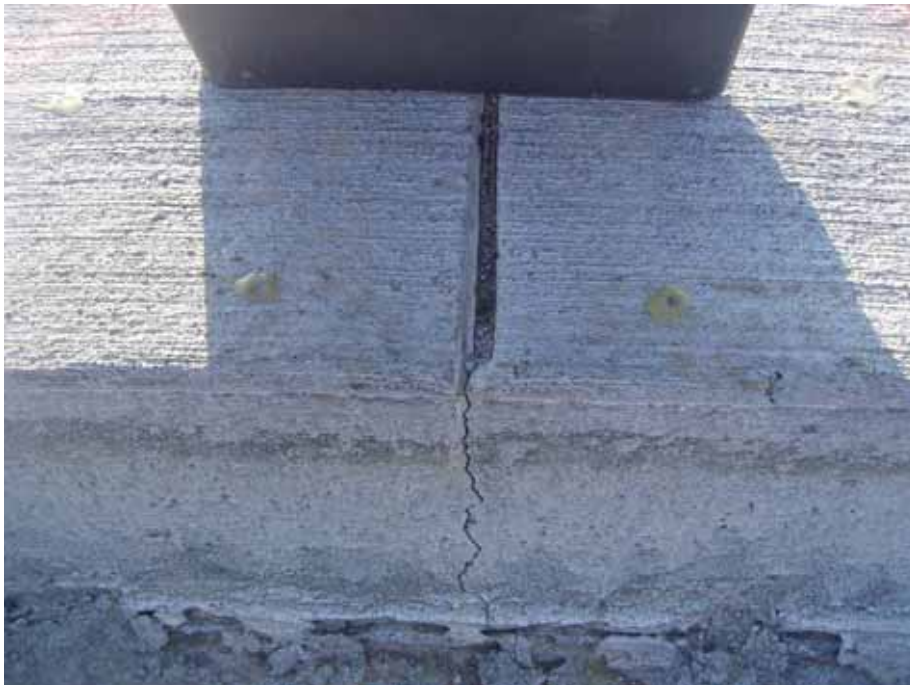
Figure D.16. Transverse joint DEMEC location in morning (visible crack)

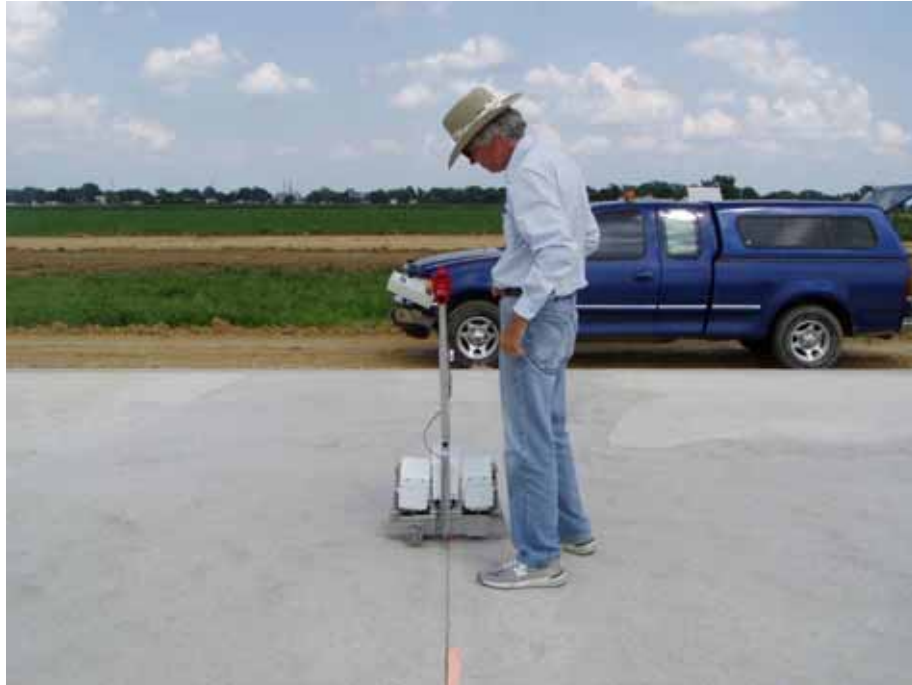
Figure D.17. Inclinometer profiler

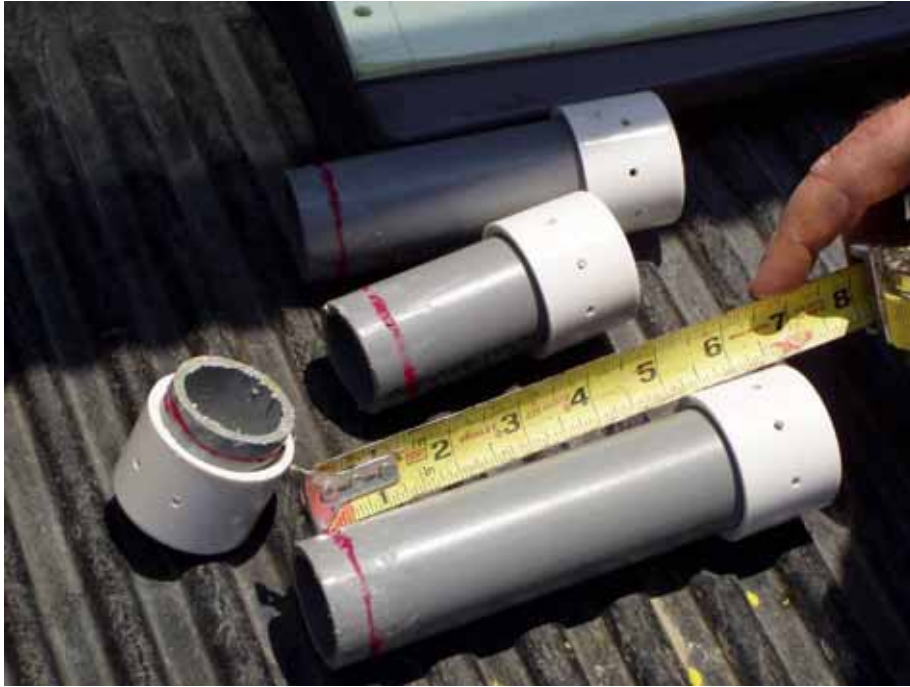
Figure G.9. Hygrochron relative humidity instrumentation casing

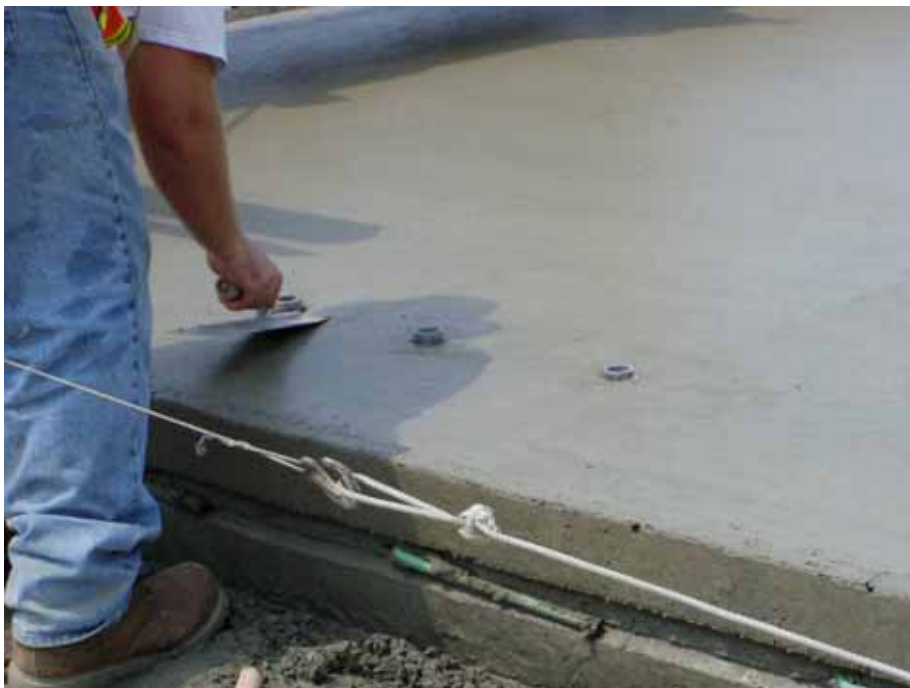
Figure G.10. Hygrochron instrumentation casing insertion

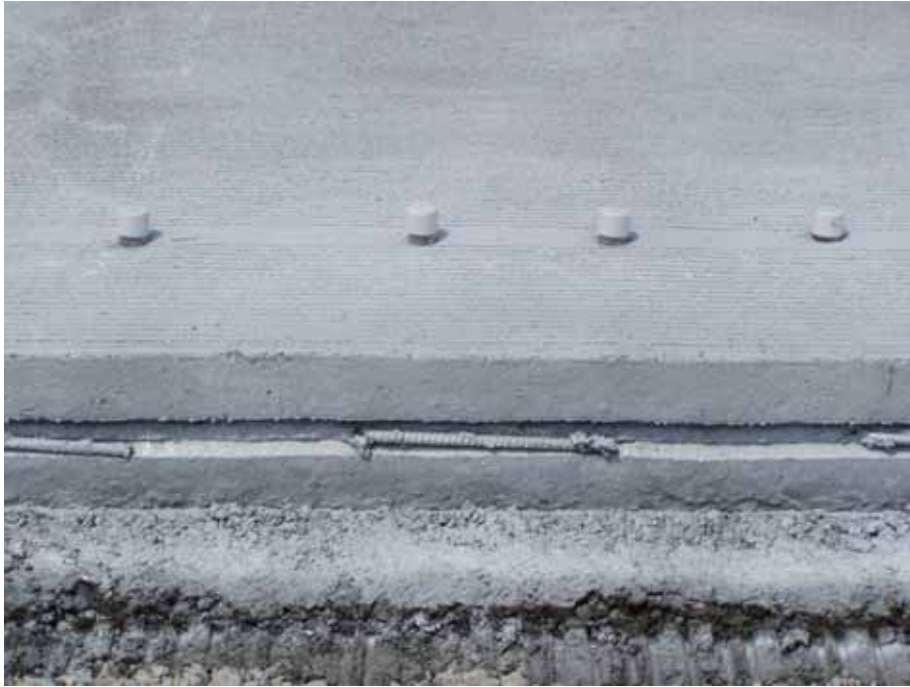
Figure G.11. Hygrochron relative humidity instrumentation

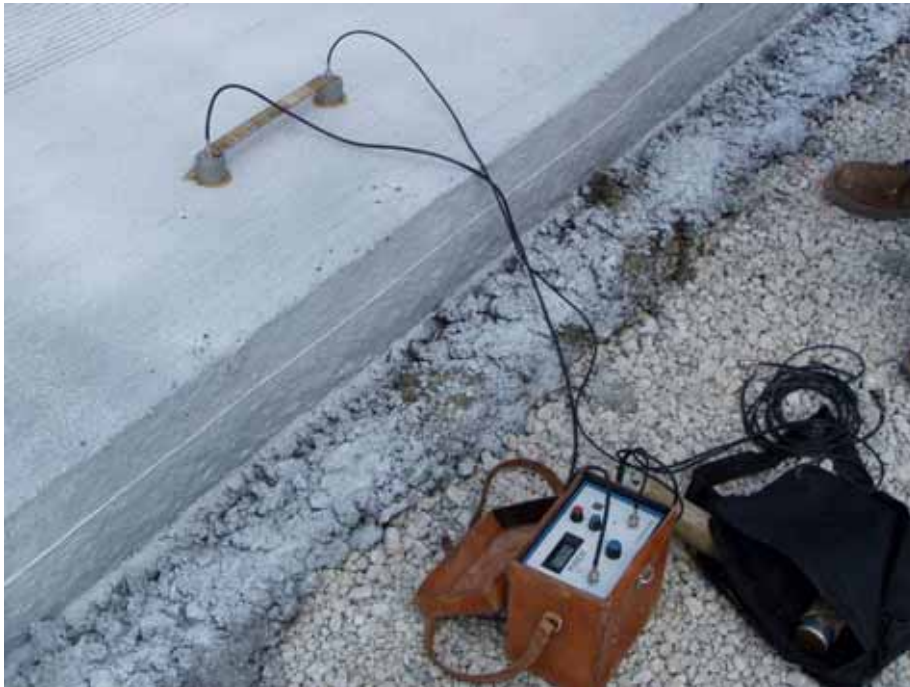
Figure G.12. Ultrasonic pulse velocity measurements
