Evaluation of Safety Edge Benefits in Iowa

Final Report
March 2011

Sponsored by
Iowa Department of Transportation
University Transportation Centers Program,
U.S. Department of Transportation
Federal Highway Administration
(MTC Project 09-358)

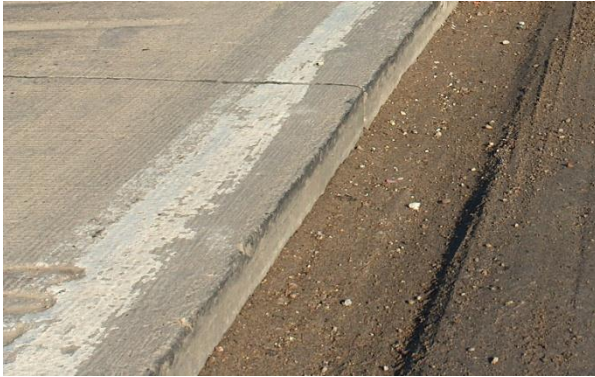
Typical vertical edge with Portland cement concrete pavement

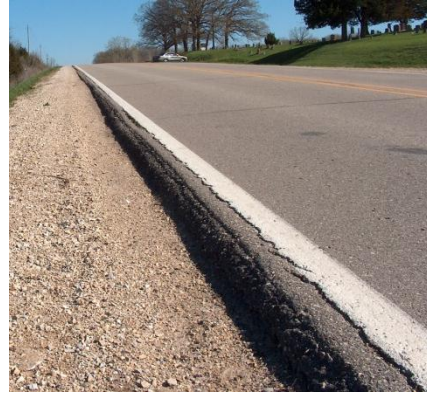
Typical rounded edge with hot-mix asphalt pavement

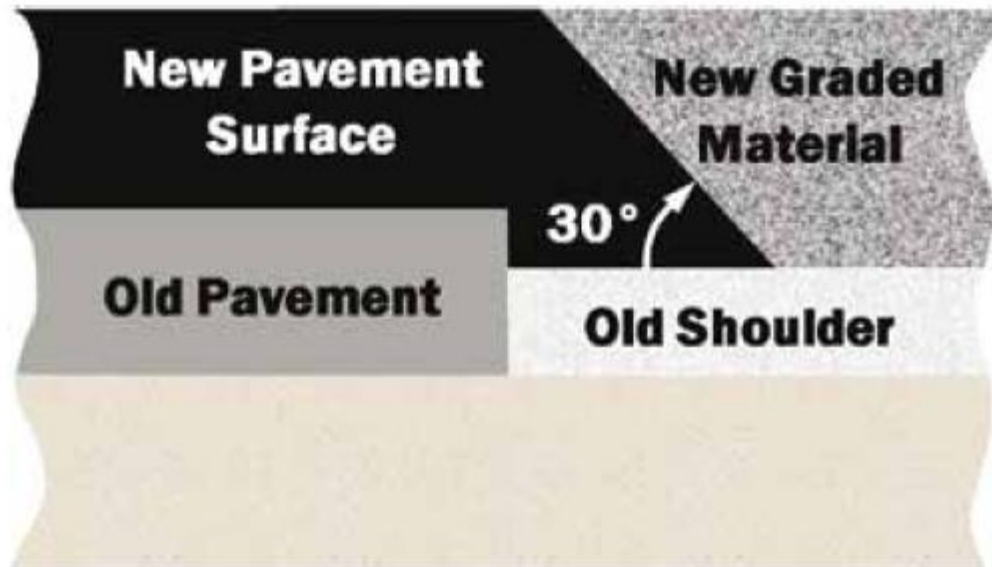
Figure 1.2. Safety Edge (FHWA, 2009)

The Safety Edge shape reduces the likelihood that scrubbing will occur and provides a gradual rather than abrupt transition back to the roadway as an errant vehicle remounts the pavement surface. The Safety Edge provides this benefit before shoulders have been pulled back up after resurfacing, as well as when the unpaved shoulder material migrates away from the pavement edge over time due to wear or erosion.

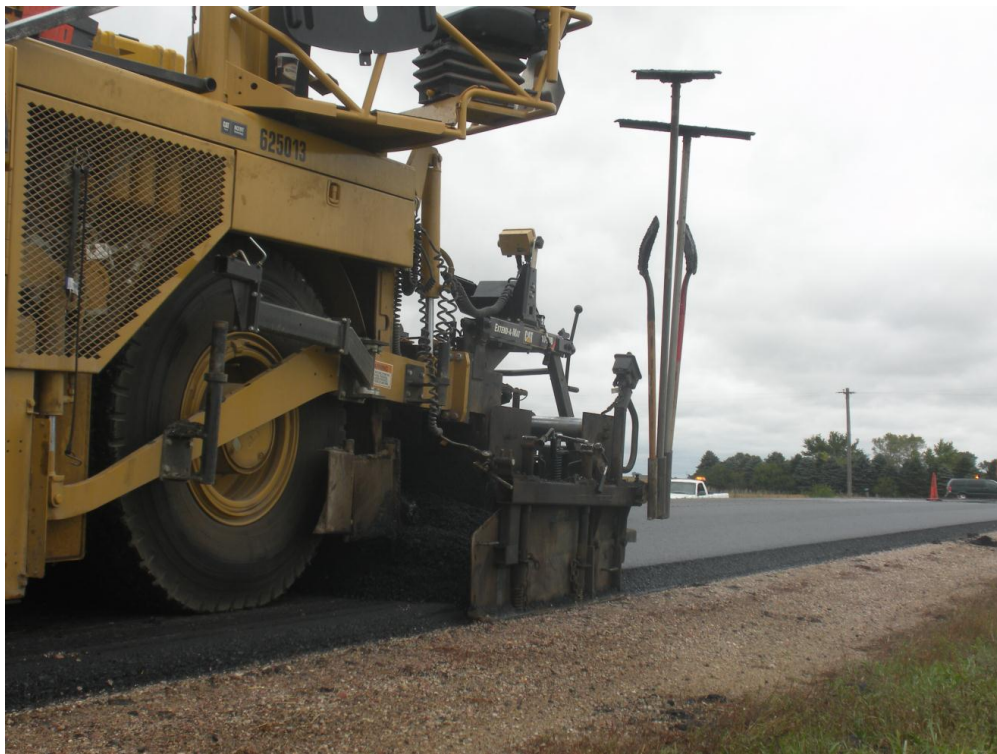
Figure 1.3. Application of the Safety Edge during paving

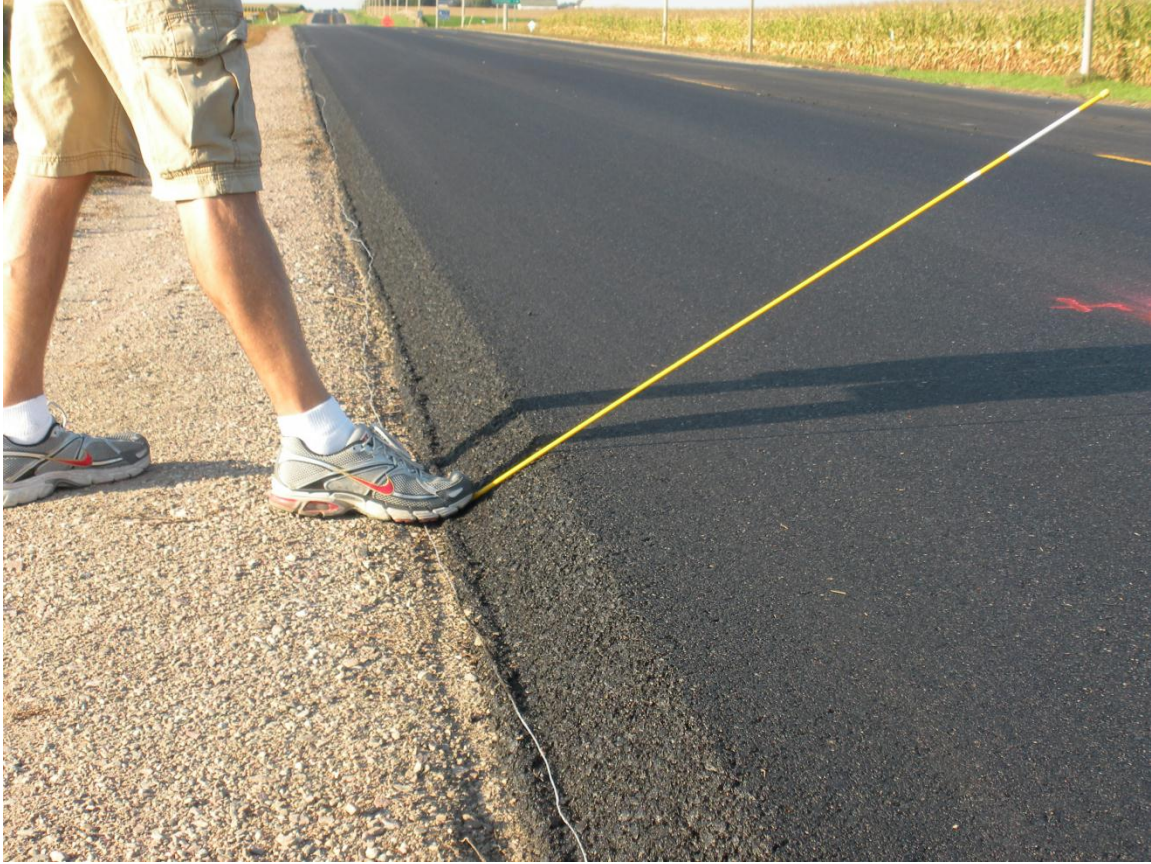
Figure 1.4. Pavement edge shape resulting from application of the Safety Edge

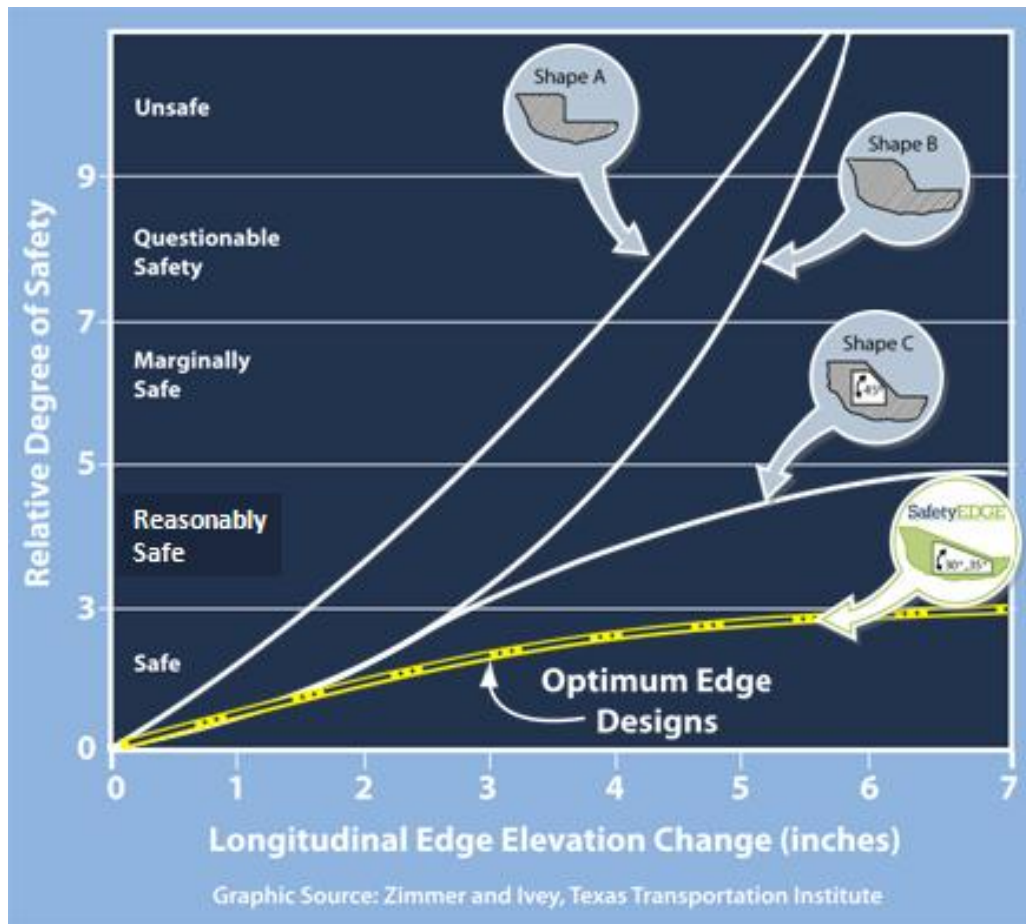
Figure 1.5. Relationship between pavement edge face and safety (Zimmer and Ivey, 1982)

Figure 1.5 shows the relationship between pavement edge shape, height, and relative degree of safety per Zimmer and Ivey with the Texas Transportation Institute (TTI) (1982).

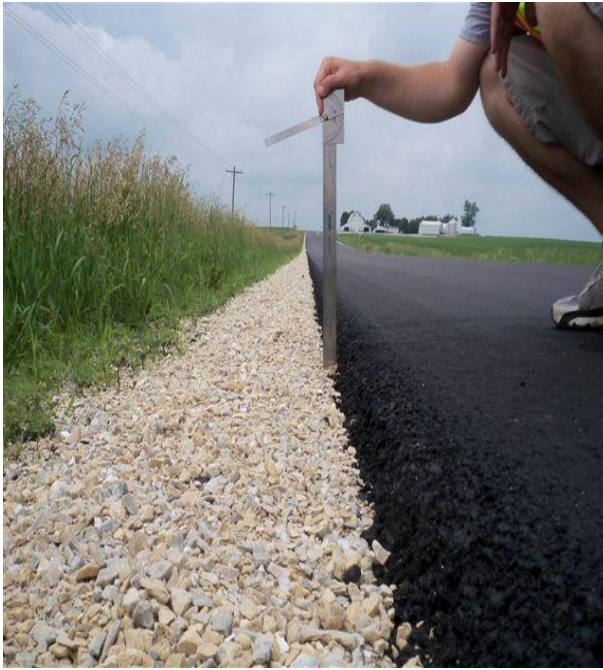
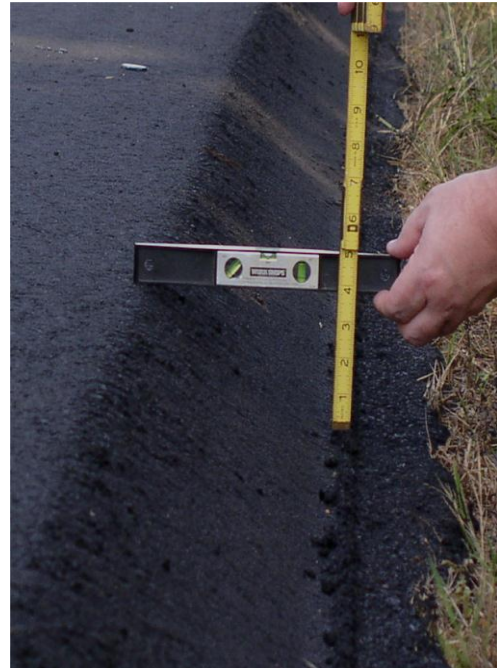
**Pavement edge after resurfacing without
Safety Edge**

**Pavement edge after resurfacing with
Safety Edge**

Figure 1.5. Edge of pavement immediately after HMA resurfacing (Roche, 2009)

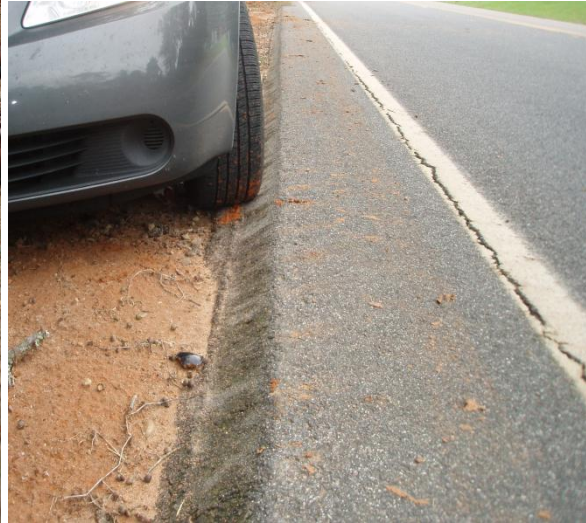
Figure 1.6. Edge of pavement six years after resurfacing (Roche, 2009)

**Pavement edge after resurfacing without
Safety Edge**

**Pavement edge after resurfacing with
Safety Edge**

Figure 1.6 shows a site in Georgia that was examined six years after installation and the Safety Edge appeared to be in similar condition as when it was constructed. Although the durability of the Safety Edge has apparently not been evaluated, it is anticipated that even if the Safety Edge eventually deteriorates or "breaks off," the resulting pavement edge face would present no worse safety condition than had the Safety Edge not been placed.

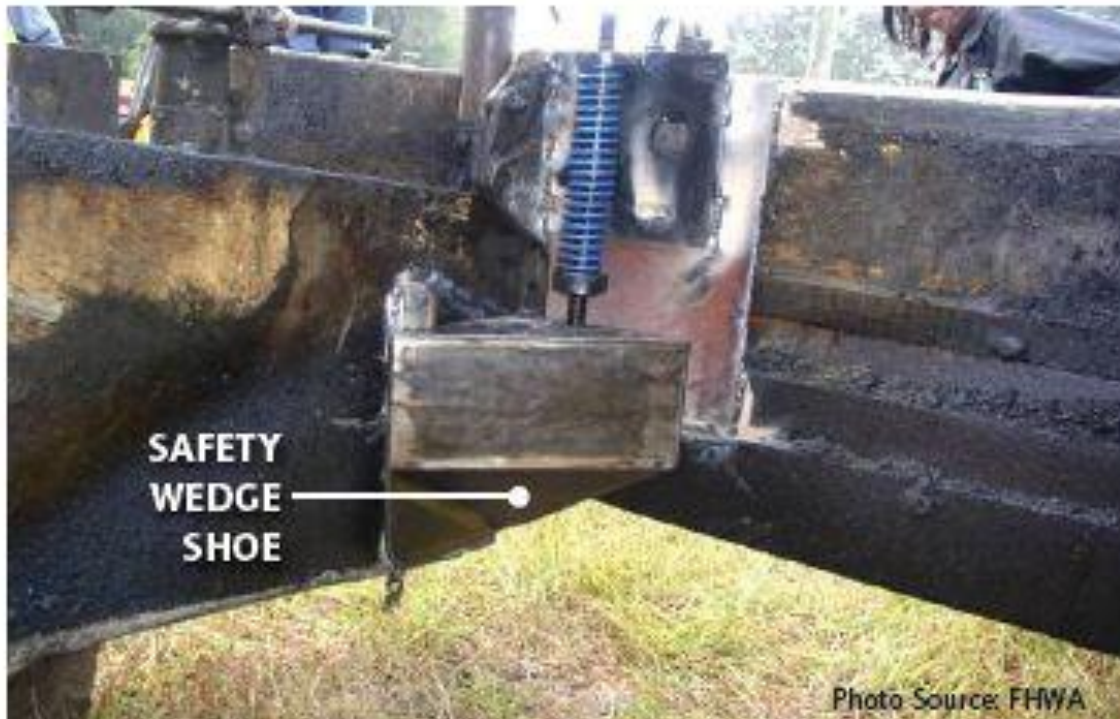
Figure 2.1. Trans Tech safety wedge shoe (FHWA, 2009a)

The component that makes the Safety Edge includes a curved runner that, in conjunction with the self-adjusting spring, helps the device to adapt to any obstacles it may encounter. The device has an angled surface that pre-compacts the asphaltic material as it enters the device and continues on to the wedge forming surface. The Trans Tech Safety Edge Shoes are side specific to the asphalt paver (left- and right-side shoes). The final angle is created when the roadway is compacted. Figures 2.1 and 2.2 show the Safety Edge device as developed by TransTech Systems.

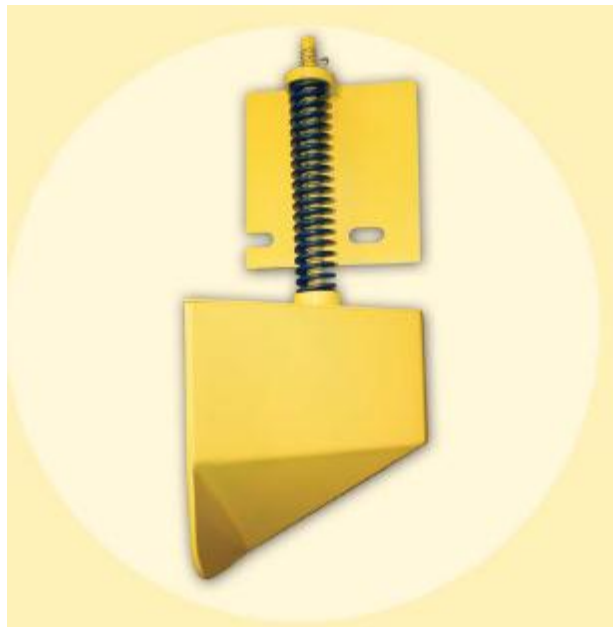
Figure 2.2. TransTech Shoulder Wedge Maker™ (TransTech Systems)

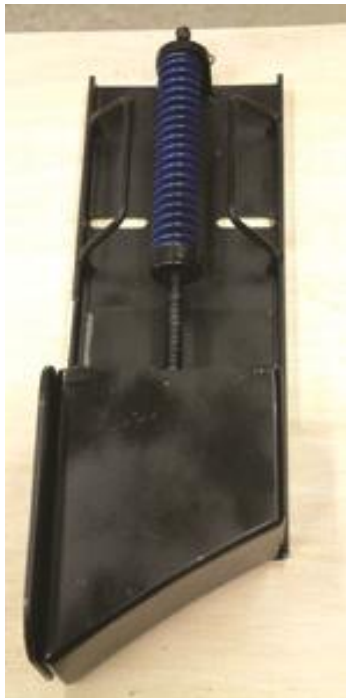
Figure 2.3 Advant-Edger device (Advant-Edge Paving Equipment)

The Advant-Edger is shown in Figure 2.3 and attached to the paver in Figure 2.4. This device is manufactured by Advant-Edge Paving Equipment, LLC, of Loudonville, New York. The company's product is made in the U.S. of high-quality steel and comes with a one-year guarantee. It is designed primarily to construct a consolidated, tapered mat edge with a final angle after rolling of the lane mat of approximately 30 degrees to the horizontal. The Advant-Edger Universal model can be used on both the right and left side of the paving machine. The purpose of providing both left and right operation in one device is to facilitate creating the lane edge wedge fillet, whether paving in the direction of traffic or paving against the traffic pattern. Therefore, only one unit is required to do both functions. While paving, the Advant-Edger is adjusted to keep the bottom edge of the device in contact with the road shoulder surface to prevent asphalt leakage under the wedge, producing a well-defined wedge fillet.

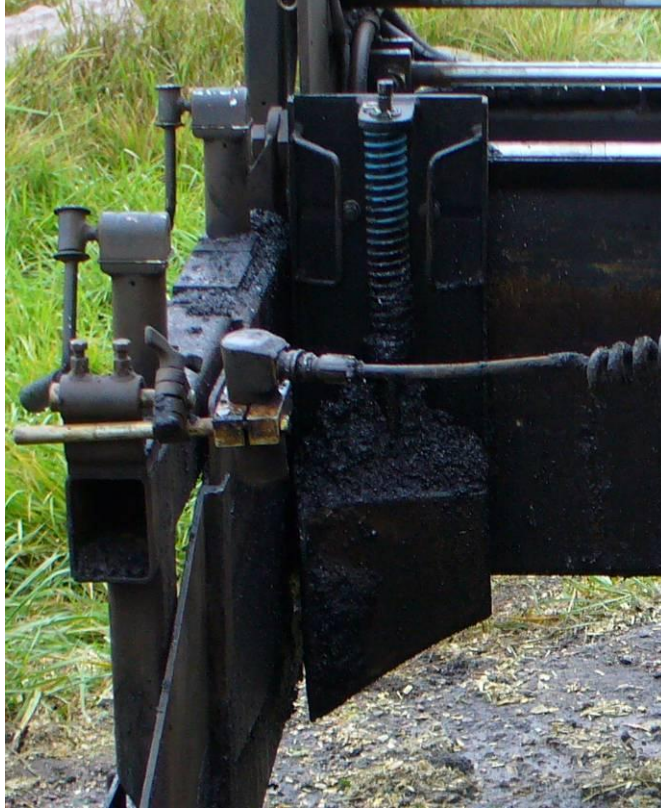
Figure 2.4. Advant-Edger device installed for use

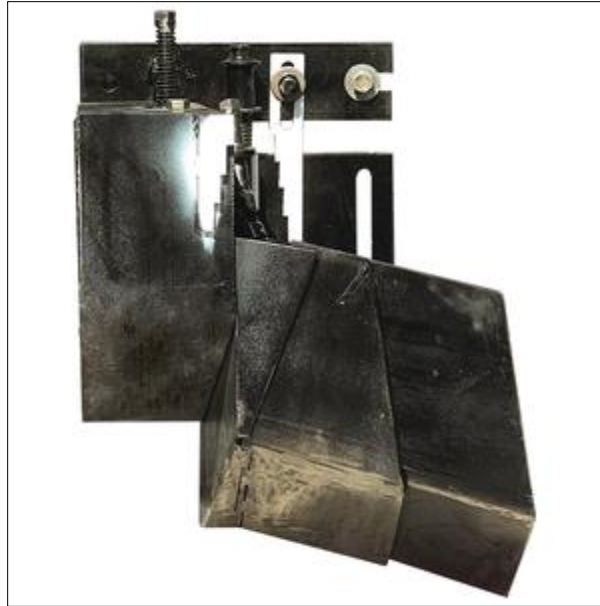
Figure 2.5 Notched Wedge Joint Maker (TransTech Systems)

The Notched Wedge Joint Maker was designed to create a denser joint between two lanes of asphalt paving. The equipment is not intended to create an exact 30 degree slope, instead being adjustable to any angle. It leaves a notch on the top surface of the asphalt. Figure 2.5 shows one model of the Notched Wedge Joint Maker made by TransTech Systems, Inc. This model has been available for a longer period of time and has been used by contractors (especially in other states) for several years in the construction of centerline joints on HMA projects. However, the flatter edge slopes that this model produces make it a very desirable alternative for areas of narrow shoulders and in subdivisions where additional shoulder material is not planned to be used.

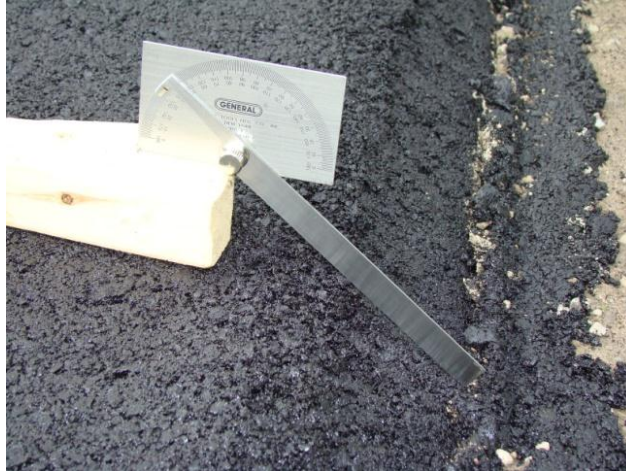
Figure 4.1. Slope-measuring tool developed by CTRE

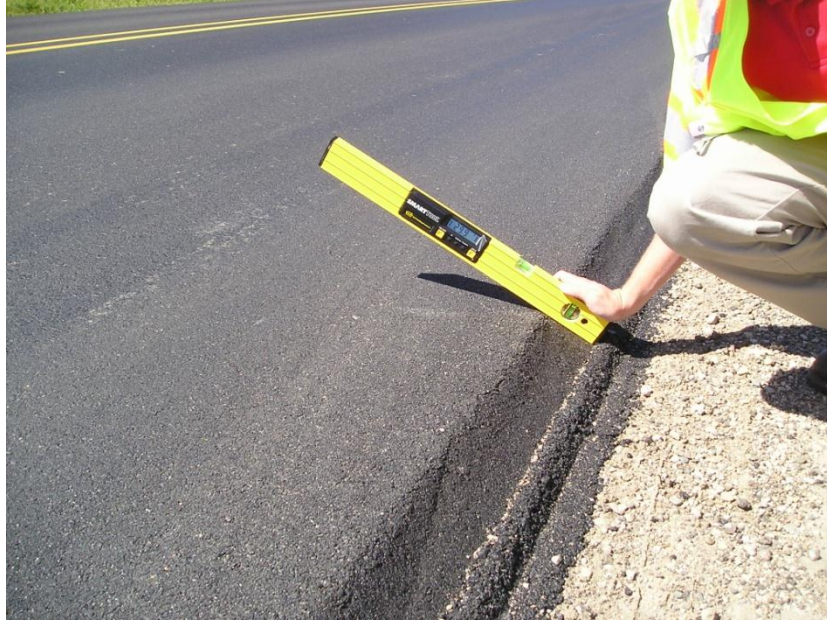
Figure 5.1. Measurement of Safety Edge slope with SmartTool

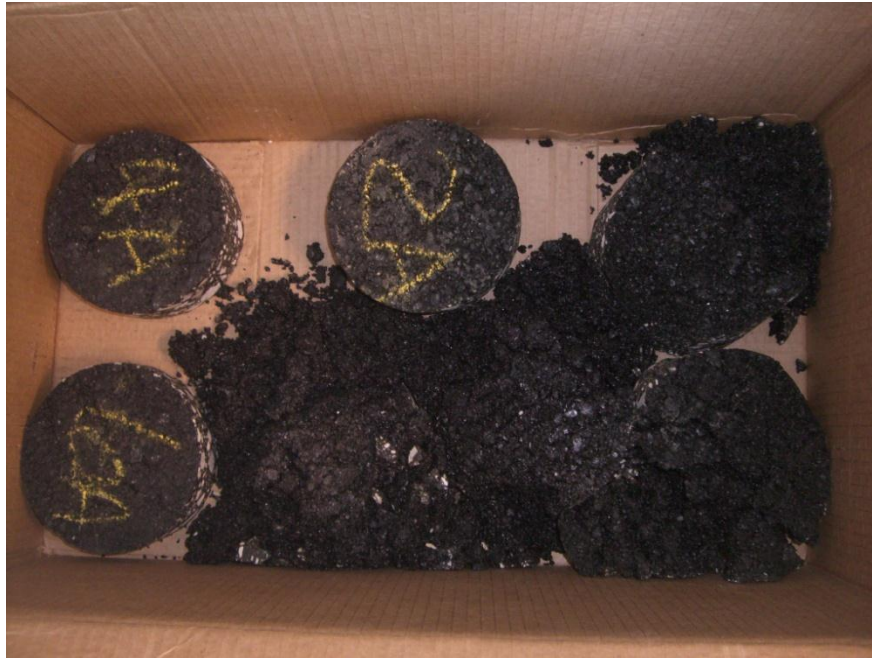
Figure 5.2. Deterioration of Safety Edge core samples from Jasper County

The cores samples are shown in Figure 5.2. Some of the cores deteriorated soon after density tests were performed. The use of modified safety shoes, which tended to “extrude” HMA material, visually appeared to produce the best results in producing a uniform finished look.

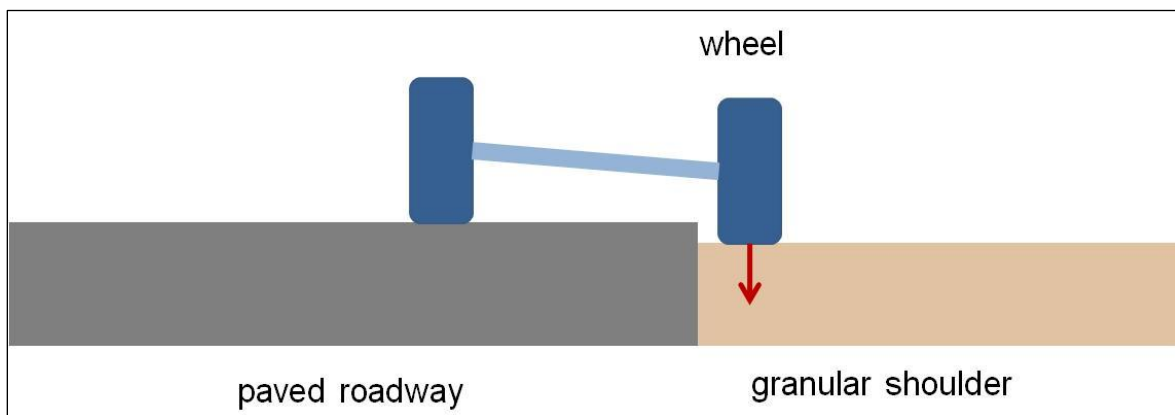
Figure 5.3. Wheel impacting granular shoulder with regular resurfacing pavement edge face

When a vehicle leaves the paved roadway surface and encounters a granular or earth shoulder, the force of the tire can dislodge the larger particles. With a normal vertical or rounded pavement face that commonly exists, the force of the tire is mostly vertical, which can cause a rut to form near the pavement edge as shown in Figure 5.3.

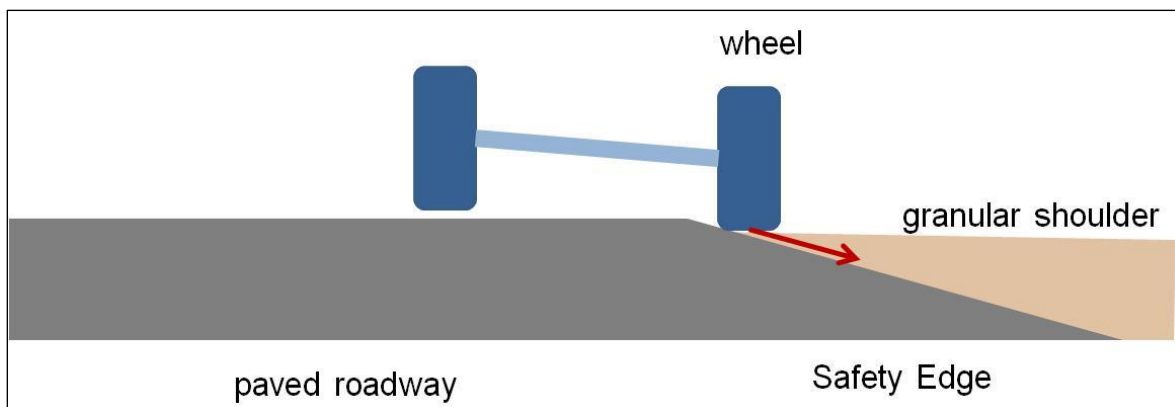
Figure 5.4. Wheel impacting granular shoulder with Safety Edge

With the Safety Edge, the tire may push the loose material down the sloped edge as illustrated in Figure 5.4. As a result, there may be a slightly greater tendency for pavement edge drop-off to form.

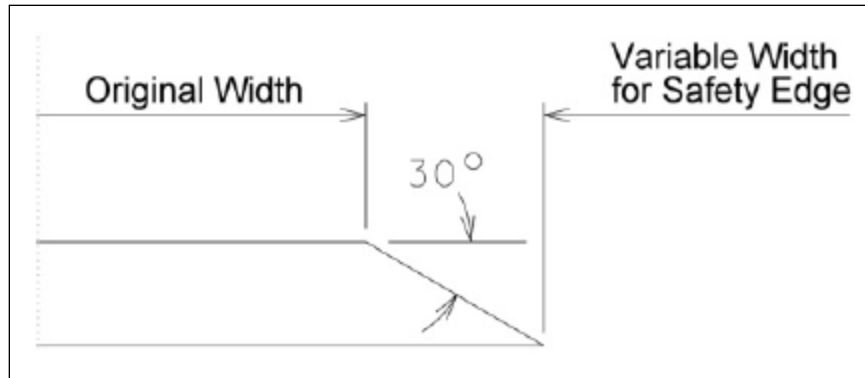
Figure 6.1. HMA Safety Edge dimensions from the Iowa DOT Design Manual

The Iowa DOT design standard for use of the Safety Edge in HMA paving and overlays is shown in Figure 6.1. The design prescribes a 30 degree Safety Edge beginning at the edge of the original pavement width extending the full-depth of the paving.

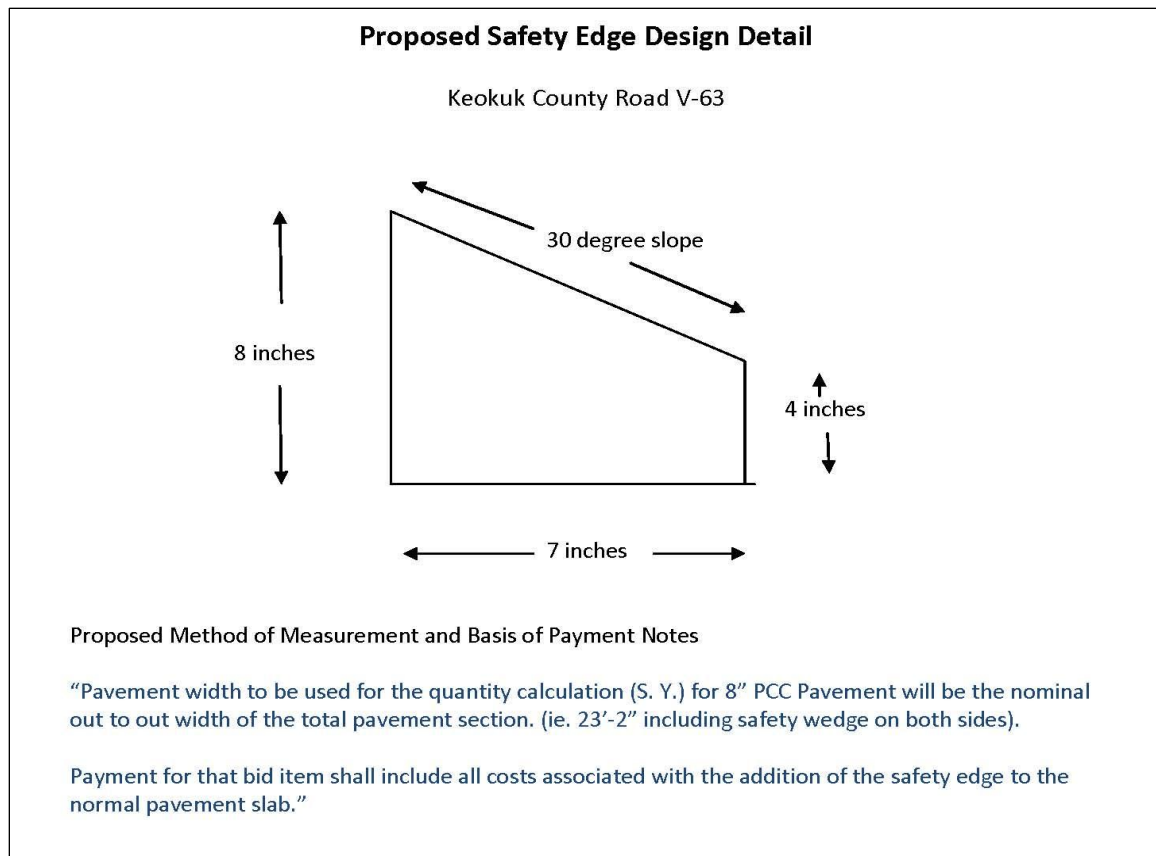
Figure 6.2. CTRE PCC Safety Edge design used in Keokuk County

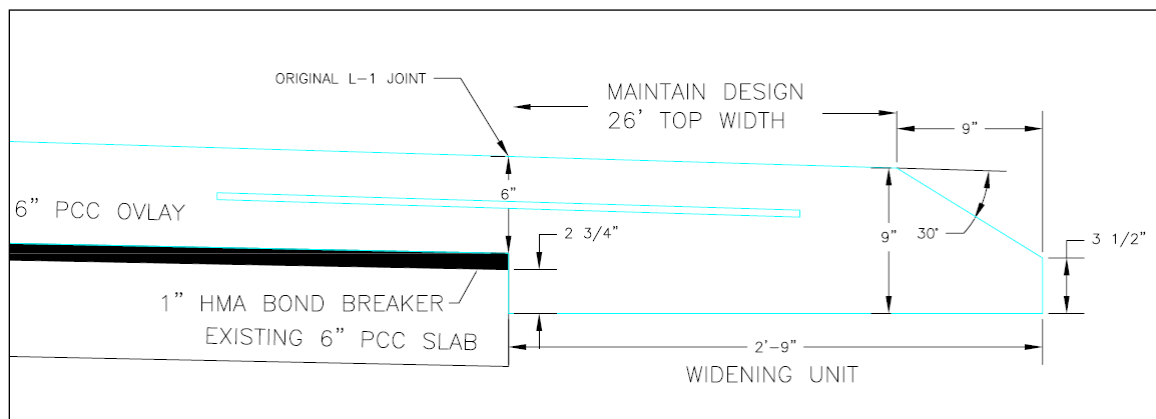
Figure 6.3. Jones County PCC Safety Edge design

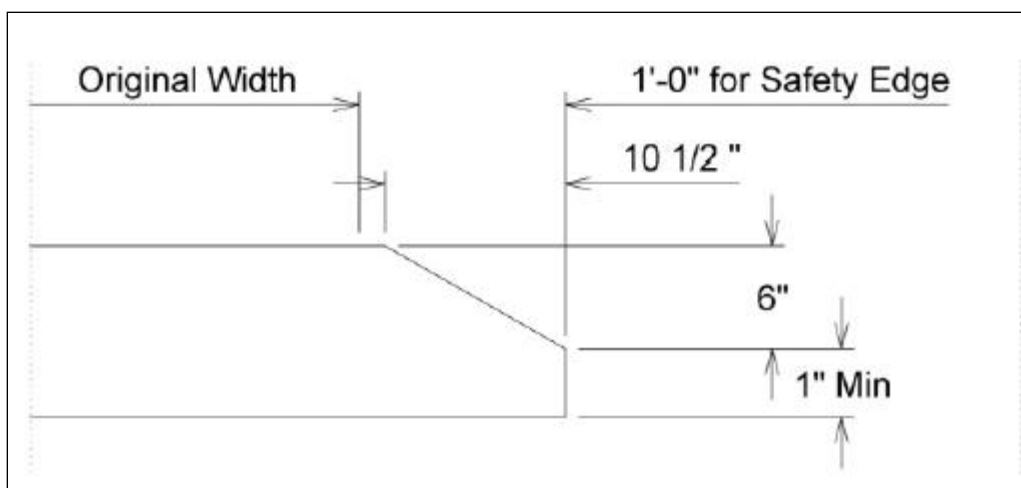
Figure 6.4. PCC Safety Edge dimensions from the Iowa DOT Design Manual

The Iowa DOT Design Manual (2010) for PCC paving and overlays prescribes a 1 foot widening to accommodate the Safety Edge. The specified depth for the Safety Edge is 6 inches with a minimum 1 inch vertical face as shown in Figure 6.4.

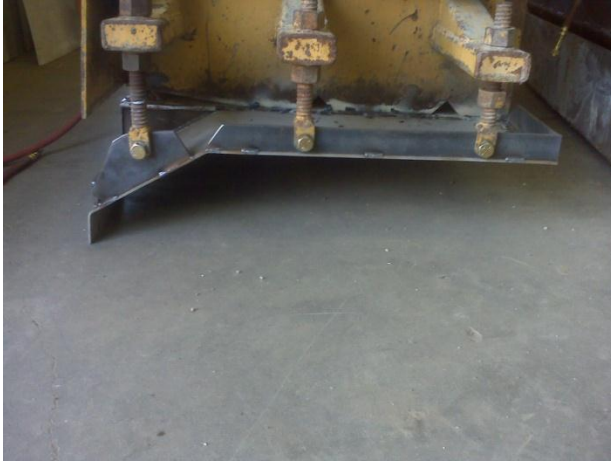
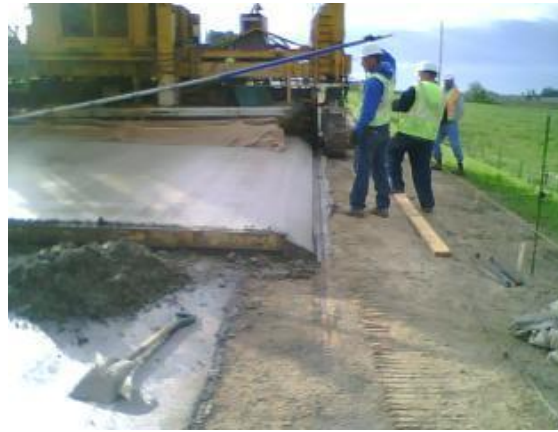
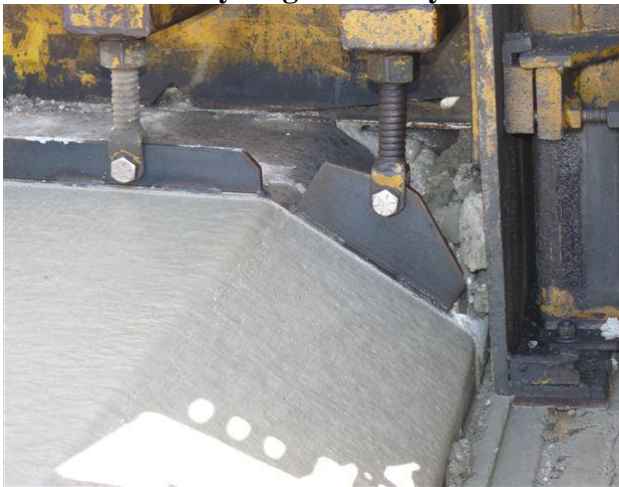
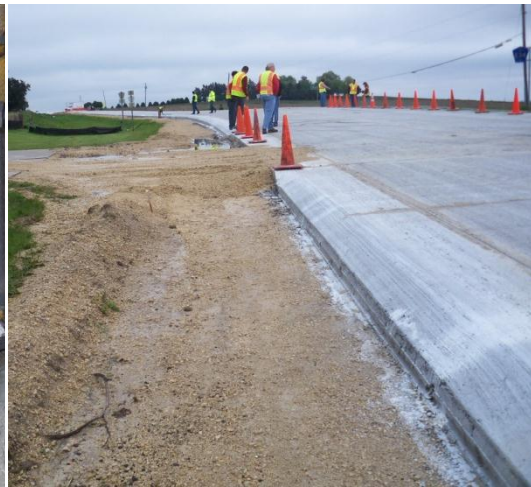
Safety Edge assembly

Start of construction

Extrusion of the Safety Edge

Finished section

The contractor indicated there may be additional benefit to use of the Safety Edge versus a conventional vertical face, expecting a more workable concrete mix can be used, which would facilitate improved concrete quality. Figure 6.5 shows the modified equipment and paving with the Safety Edge on the Jones/Linn County PCC project.

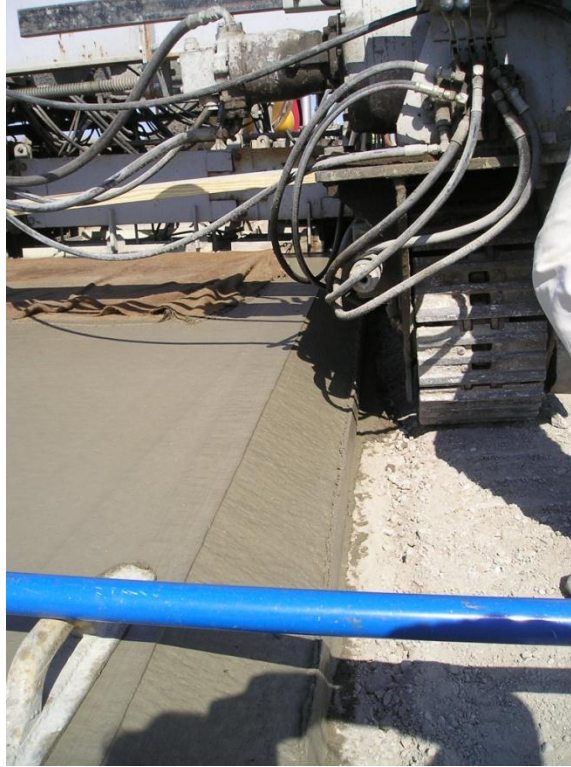
Figure 6.6. PCC paver modification for the Keokuk County Safety Edge

The contractor for Keokuk County, Wicks Construction of Decorah, Iowa also fabricated an extension to the paver pan to form the Safety Edge, working with Gomaco Corporation, the equipment manufacturer, to design and build the proper assembly shape to achieve the desired Safety Edge shape. Figure 6.6 shows the device that was fabricated for the Keokuk County project.

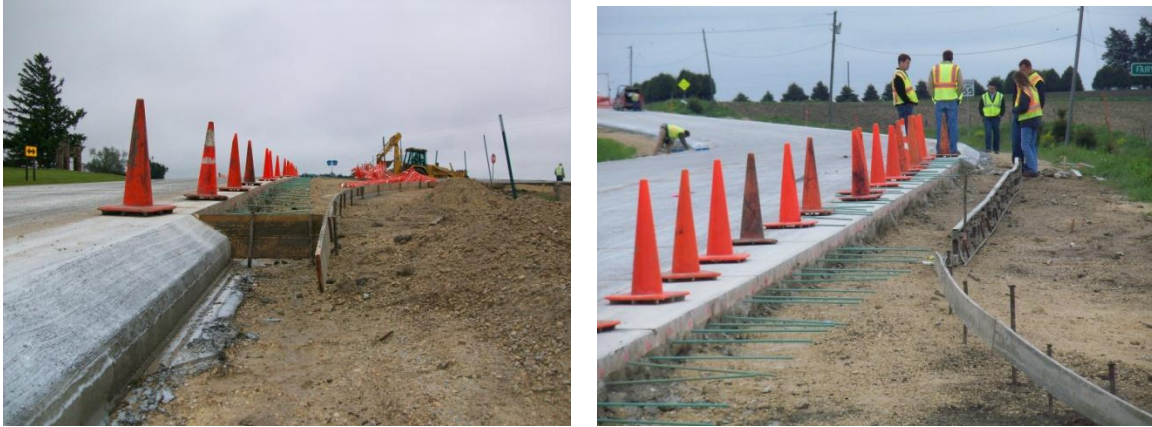
Figure 6.7. Safety Edge modifications at a paved road intersection

The sloped Safety Edge face of the mainline pavement poses a concern when constructing a durable interface joint at PCC paved road intersections. In Iowa, a reinforced joint is constructed to adequately tie the intersecting pavements together and this is accomplished with a vertical pavement edge, not sloped. To accomplish the desired connection effectively, it is necessary to remove or eliminate the Safety Edge through intersections with paved roads. The contractor would be required to either saw-cut and remove the Safety Edge, as shown in Figure 6.7, or construct a formed “box-out” to prevent placement of the sloped edge when the mainline was paved.

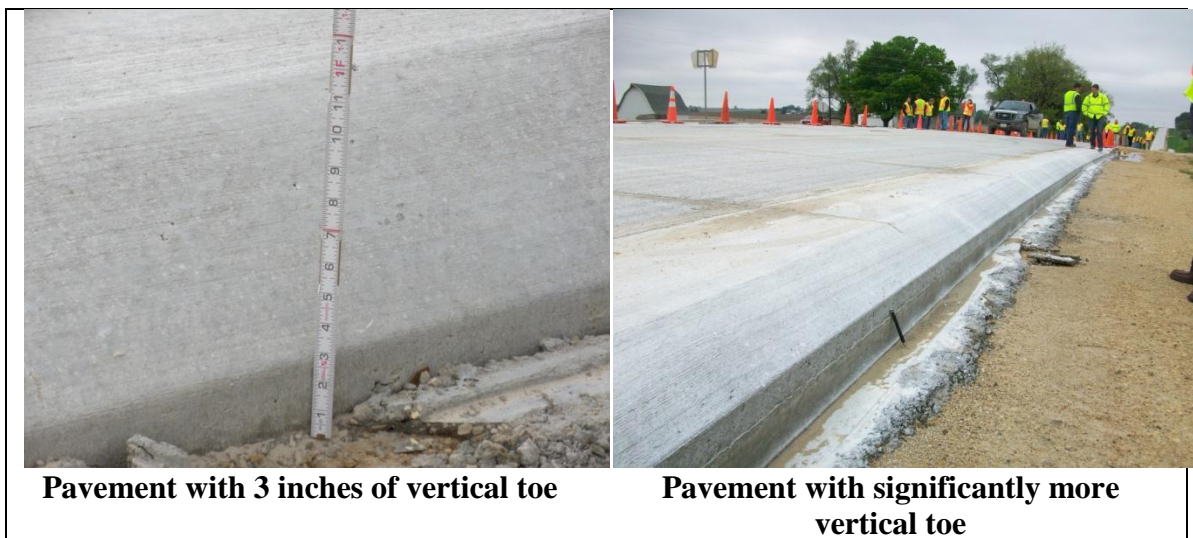
Figure 6.8. Placement with various dimensions of vertical toe

Depending on the design of the Safety Edge forming assembly and thickness of the pavement section, the shape of the pavement edge will vary significantly. As shown in Figure 6.8 and with the Iowa DOT design details previously shown, the vertical dimension of the Safety Edge might vary from 4 to 6 inches with any remaining edge exhibiting a typical vertical pavement face for the remaining slab thickness.

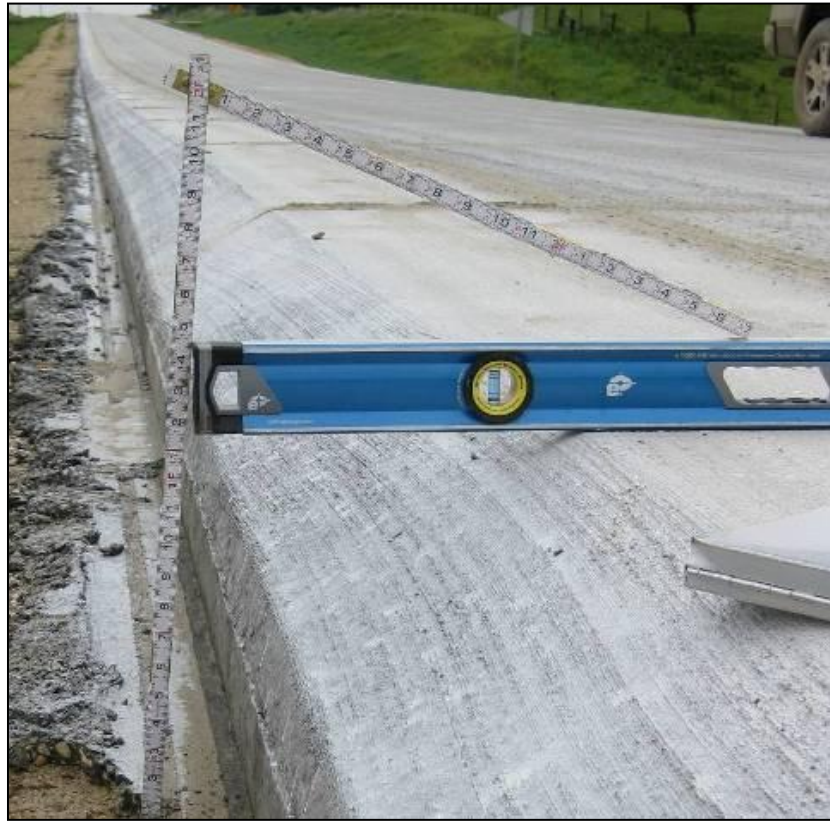
Figure 6.9. Edge of PCC Safety Edge showing ridge and bow (FHWA, 2011)

An assessment by the FHWA (2011) indicated the average slope for the Jones/Linn County Safety Edge applications was 31.5 degrees with a range of 28.5 to 34.0 degrees. The report also indicated the face of the Safety Edge was slightly concave or convex in some locations, which may have resulted from flex in the paving pan or from issues during finishing (as shown in Figure 6.9). Results of an air voids and modulus test indicate that the quality of the concrete was uniform for both the normal pavement section and the Safety Edge.

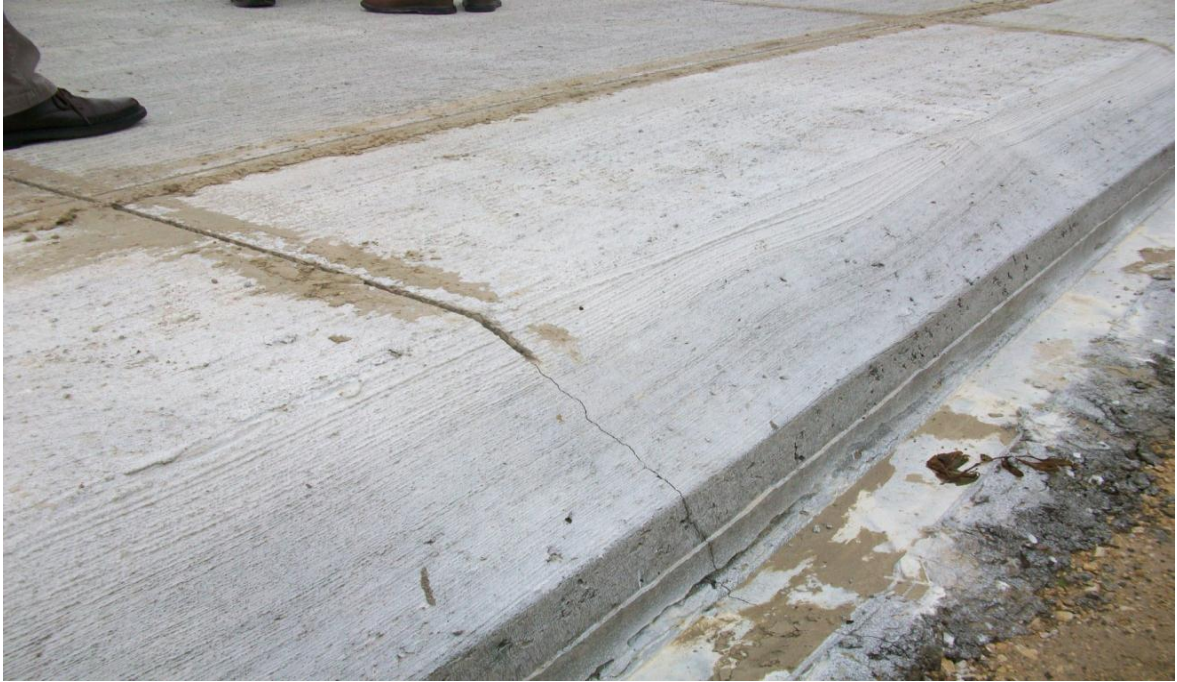
Figure 6.10. Saw cut transverse joint with the Safety Edge

To control random cracking in a newly-placed PCC pavement, full-width saw-cutting for transverse joints at approximate 20 foot intervals is required before hardening of the pavement material. To avoid challenges from operating a saw on a sloped surface, it was decided not to extend the saw cut down the Safety Edge slope. It was anticipated that a near vertical random crack would eventually occur from the saw cut through the remaining pavement thickness. As shown in Figure 6.10, the predicted random crack did occur, thus negating the necessity for extending the saw cut through the Safety Edge section.

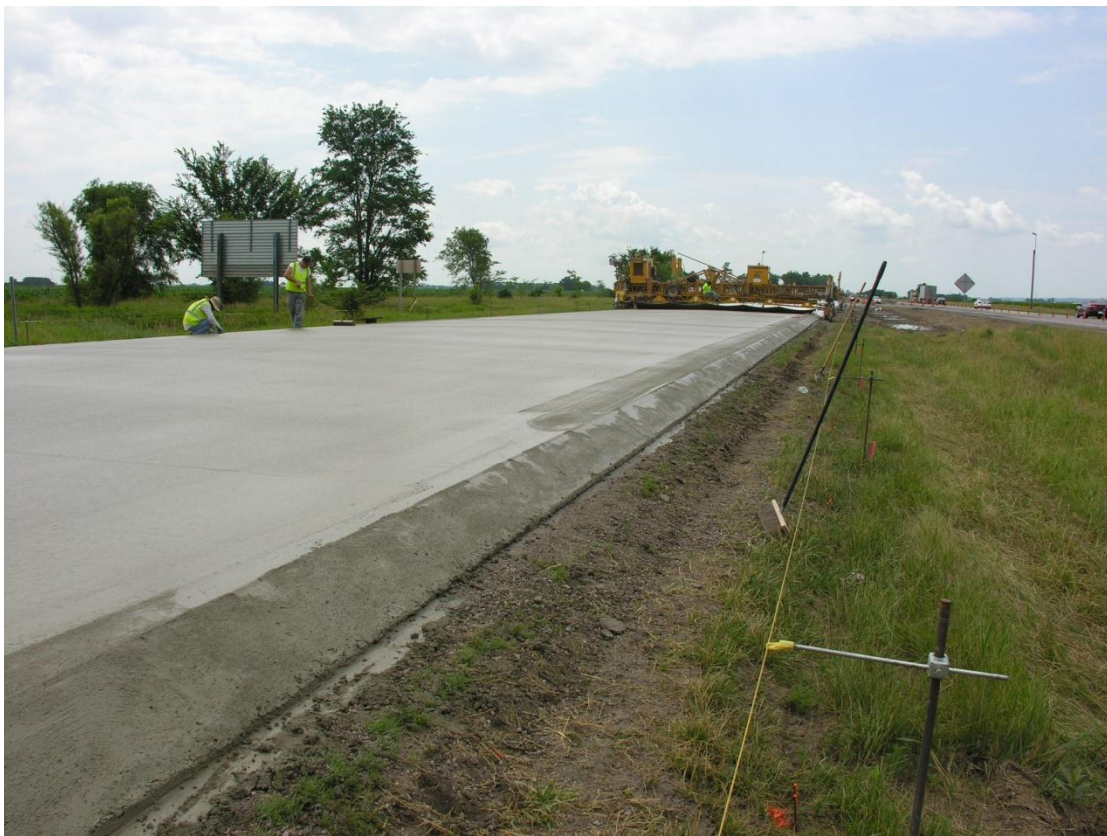
Figure 7.1. Sloped edge on I-29 in Woodbury County

The designed new pavement section consisted of 9 inches of PCC pavement with 7 inch thick paved shoulders (See Figures 7.1 and 7.2). The contractor was allowed the option of selecting the paving material for the shoulders and PCC was chosen as the preferred material. A sloped outer edge was part of the design to eliminate the need for additional shoulder material there. For various reasons, the desired shoulder top width was not attained with the sloped edge as designed. This experience pointed out the need for carefully-devised design standards and specifications to achieve the desired results.

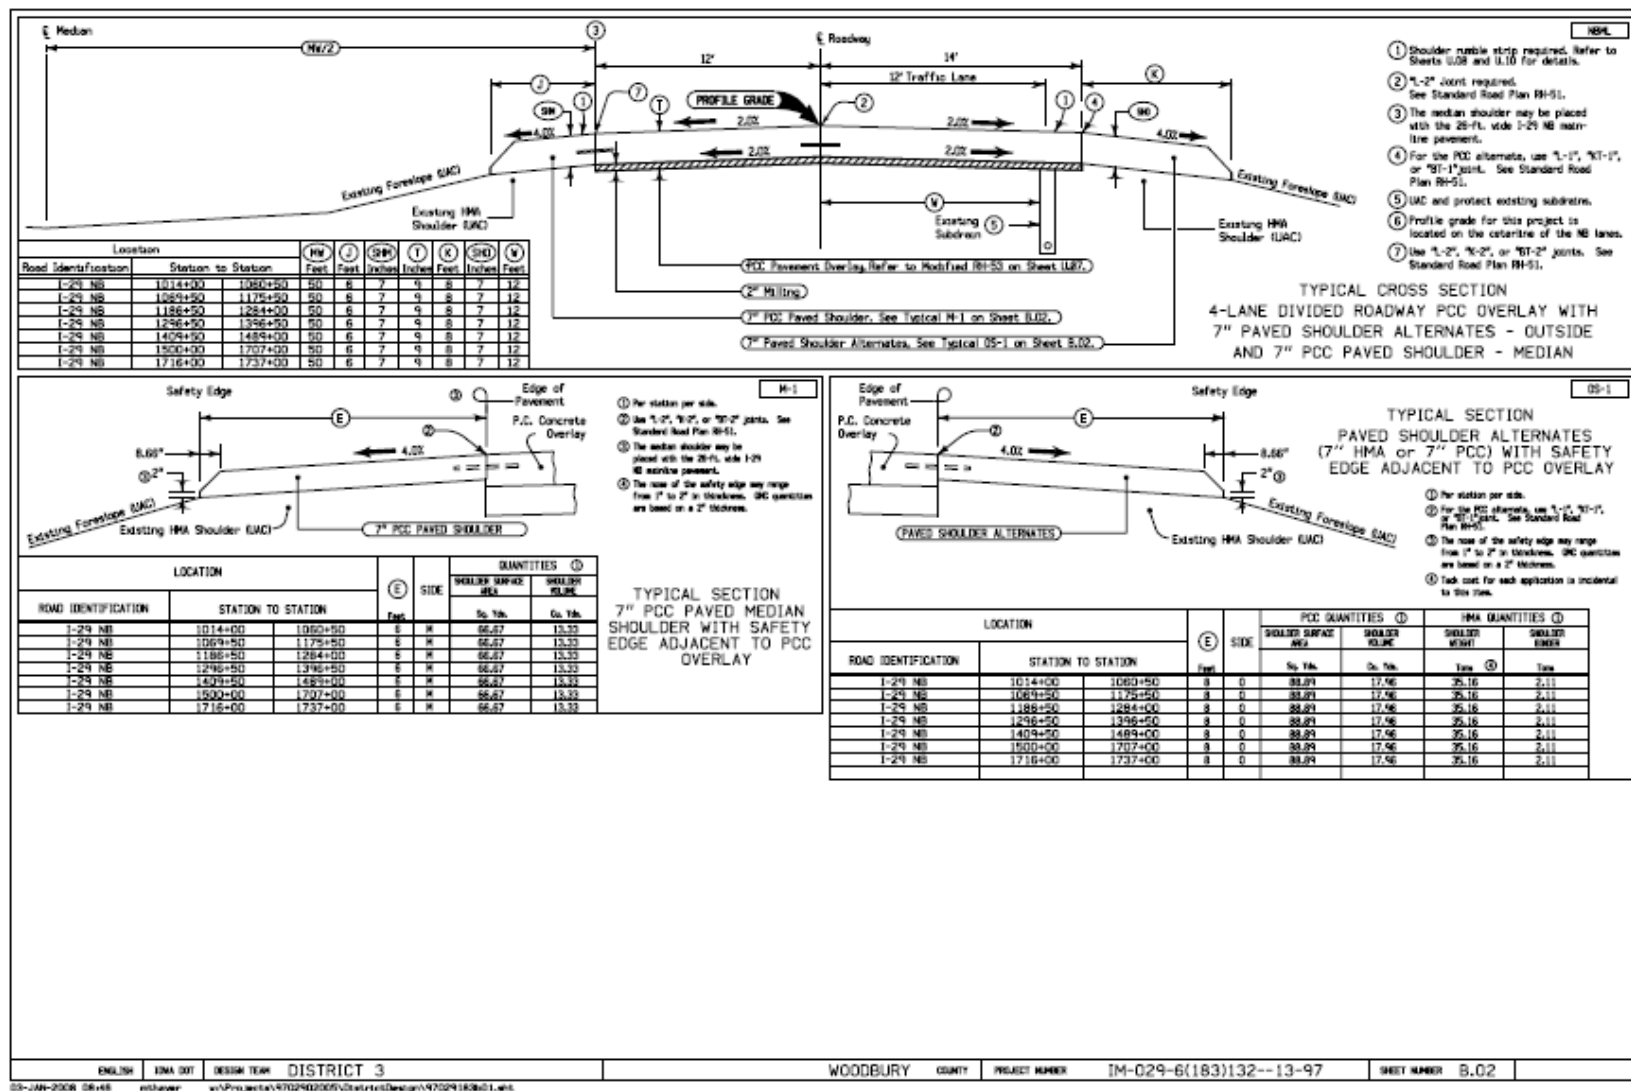
Figure 7.2. Woodbury County I-29 typical sections

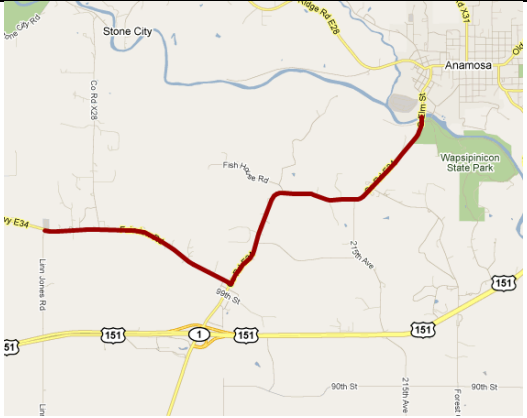
Project	E34, Jones/Linn Counties

Surface Material	Unbonded 6 inch PCC overlay over an existing 6 inch PCC pavement with a 1 inch HMA bond breaker	
Paved Width (not including Safety Edge)	26 feet	
Project Length	2.5 miles	
Letting Date	August 18, 2009	
Open House	May 11, 2010	
Construction Start/End	May 1 – July 20, 2010	
		Project Extents (Google image)

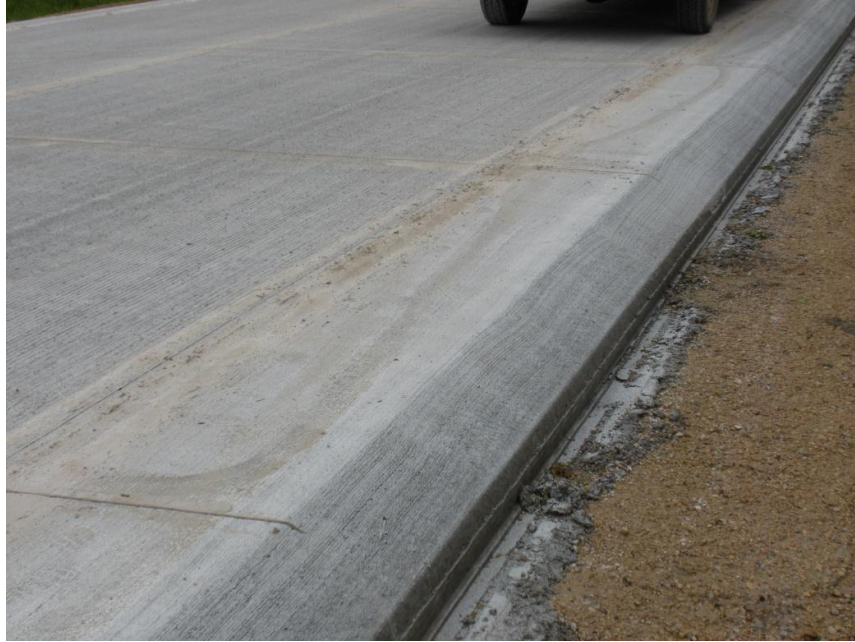
Figure 7.3. Finished PCC Safety Edge for CR E34 in Jones/Linn Counties

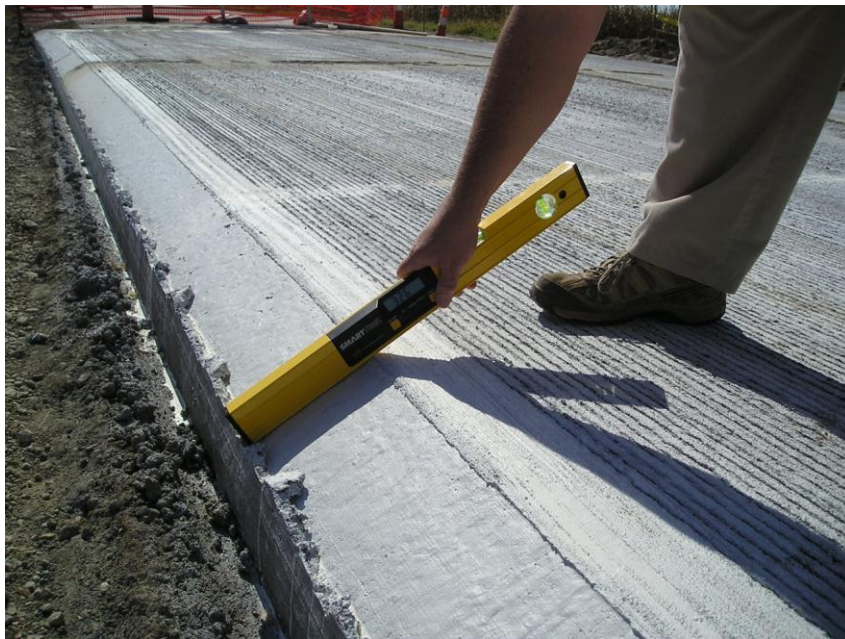
Figure 7.4. Safety Edge on Keokuk CR V63

Site visits were made during and following work completion to observe the work in progress and measure the Safety Edge slope, using a smart level (See Figure 7.4). The project inspector stated that the whole construction process went smoothly and seemed like any other PCC paving project. The county is also hoping that the Safety Edge will help with future edge rutting problems on the road.
