Evaluation of Safety Edge Benefits in Iowa

Final Report
March 2011

Sponsored by
Iowa Department of Transportation
University Transportation Centers Program,
U.S. Department of Transportation
Federal Highway Administration
(MTC Project 09-358)

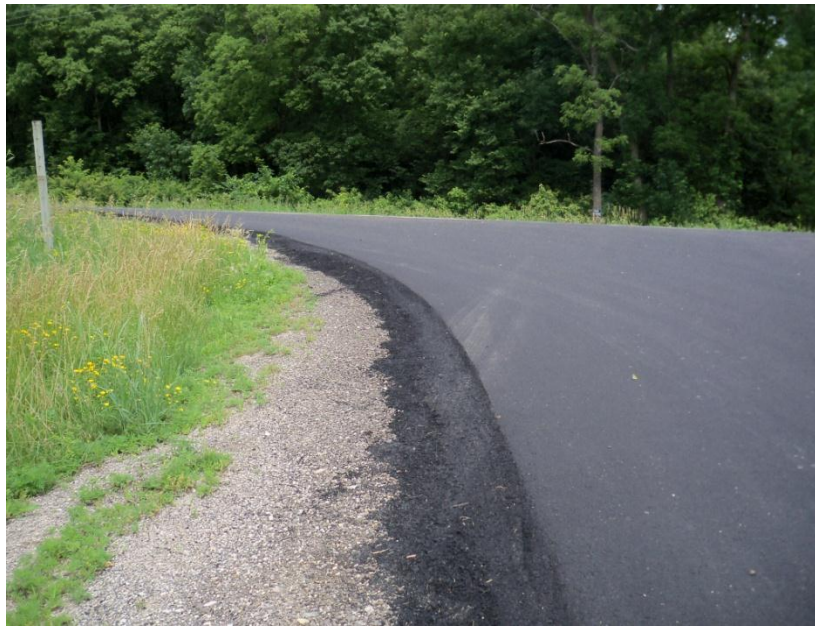
Figure 7.5. Safety Edge on Skyline Road in Blackhawk County

Measurements taken with the smart level indicated an average of 26 degrees. The Blackhawk County inspector, Chad Wurzer, stated that challenges in achieving the desired Safety Edge slope were encountered with varying lift thickness. The design of the Notch Wedge Maker includes two adjustment screws, but the fixed width of shoe results in steeper Safety Edge slopes with the thicker courses, while thinner lifts exhibit a safety edge with quite flat slopes. In addition, the resultant slope sometimes presents a coarse, possibly permeable surface texture because little downward pressure on the sloped edge is imparted as the mix is extruded.

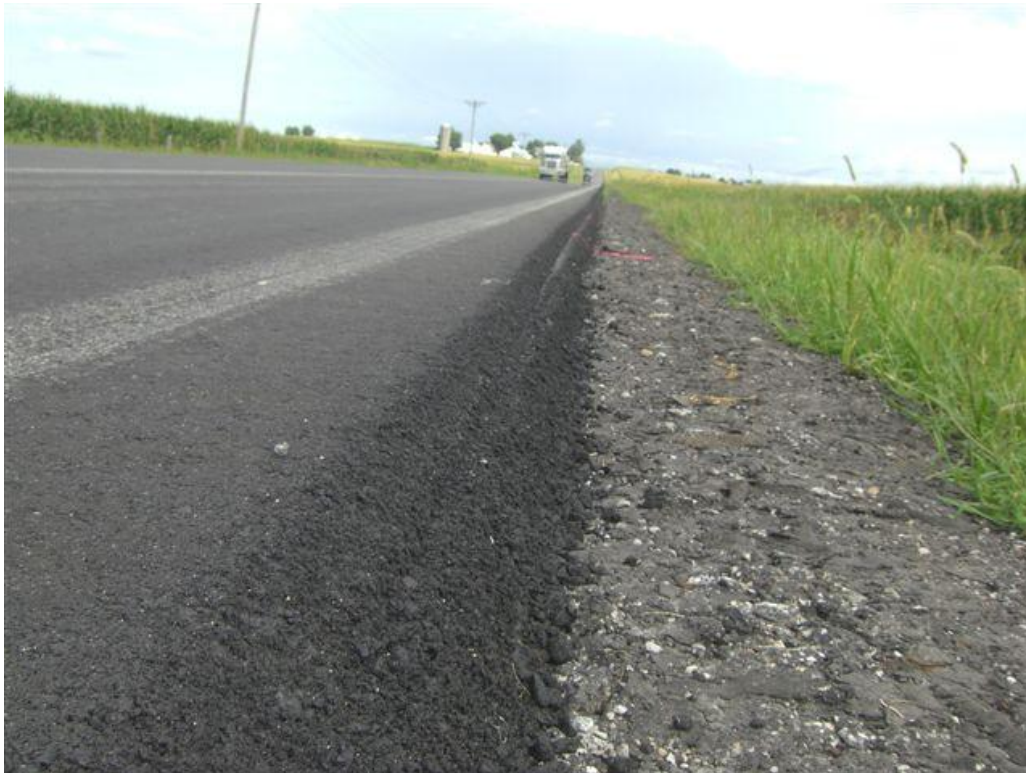
Figure 7.6. Safety Edge on CR F62 in Jasper County

The Safety Edge slope was measured throughout the project using the smart level and recorded to the nearest degree, with an average reading of 37 degrees. The contractor experienced some initial problems with rollover of the Safety Edge during compaction. The issue was addressed by delaying compaction of the pavement edge with the initial roller passes. Figure 7.6 shows the typical edge produced on this project.

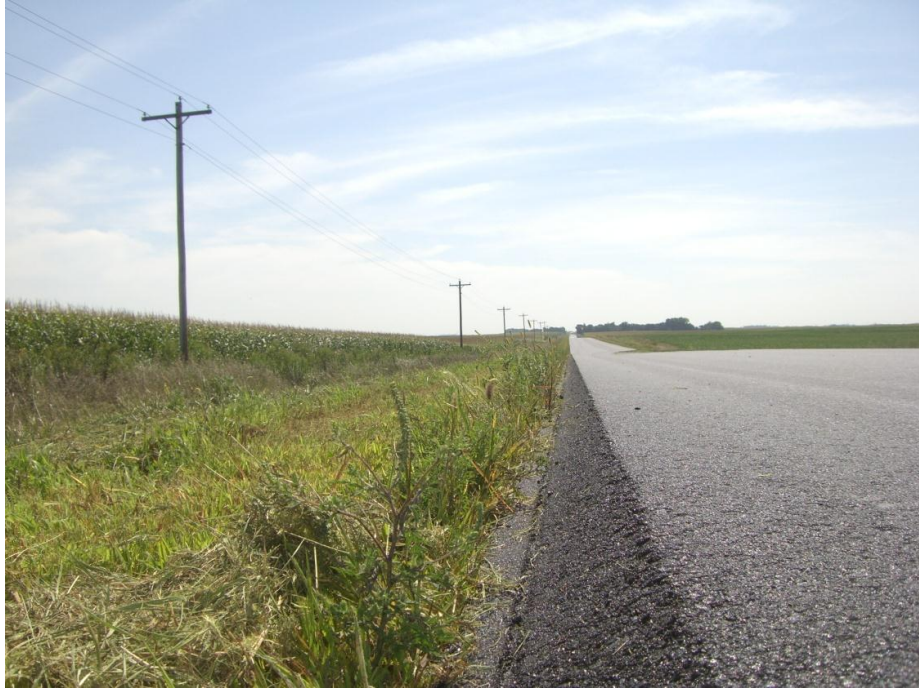
Figure 7.7. Safety Edge on CR P20 in Kossuth County

CTRE staff visited the projects following construction to view the completed work and obtain Safety Edge slope edge measurements. Some rollover of the Safety Edge was observed at the beginning of the CR P20 project, but this was corrected within 0.2 mile. Slope measurements taken every 0.2 mile along the sides of both projects with the smart level yielded average readings of 36 and 35 degrees for CR A21 and P20, respectively. No measurements were taken along CR B20 because the other two projects provided 13 miles of data and no difference in performance was anticipated. Figure 7.7 shows the completed Safety Edge construction achieved on CR P20.

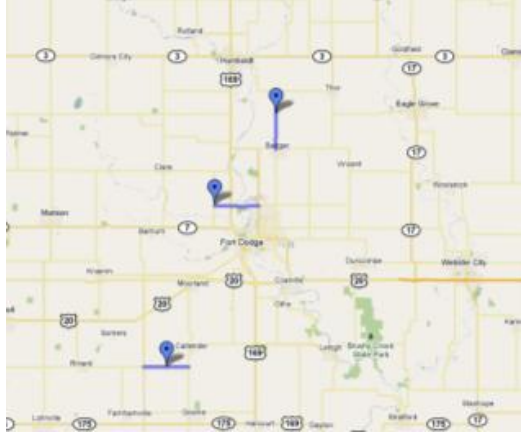
Project	D14, D46, P59 , Webster County

Surface Material	Rubblization and two 2 inch HMA overlay lifts on D14 and P59, two 1.5 inch overlay lifts on D46	
Paved Width (not including Safety Edge)	D14 – 32 feet D46 – 22 feet P59 – 22 feet	
Project length	2.4 miles, 4 miles, and 2 miles, respectively	
Letting Date	June 15, 2010	
Open House	August 3, 2010	
Construction Start/End	July 5 – August 2010

Project Extents (Google image)

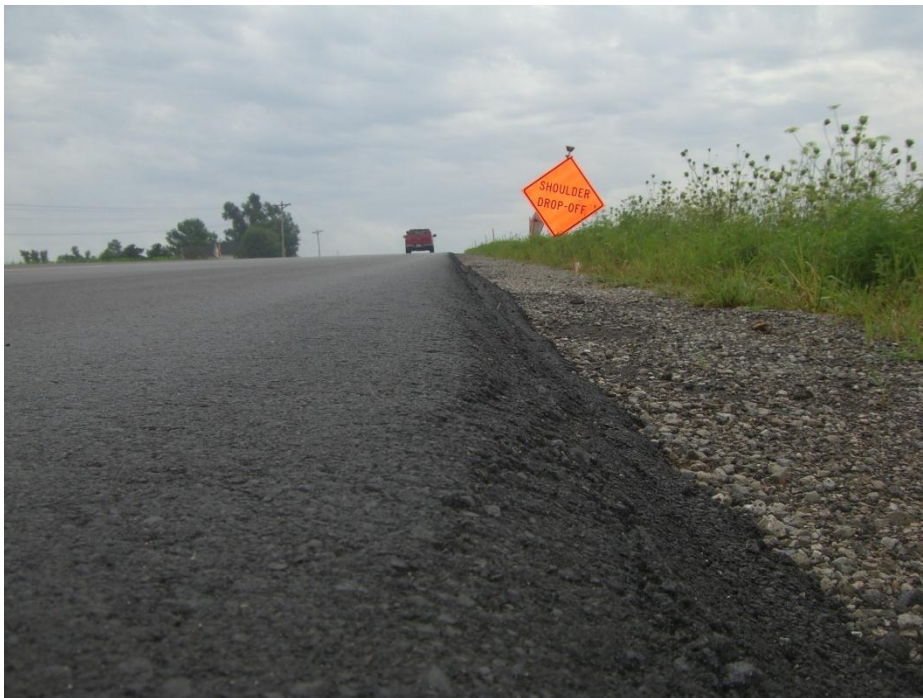
Figure 7.10. Completed Safety Edge on CR Y26 in Cedar County

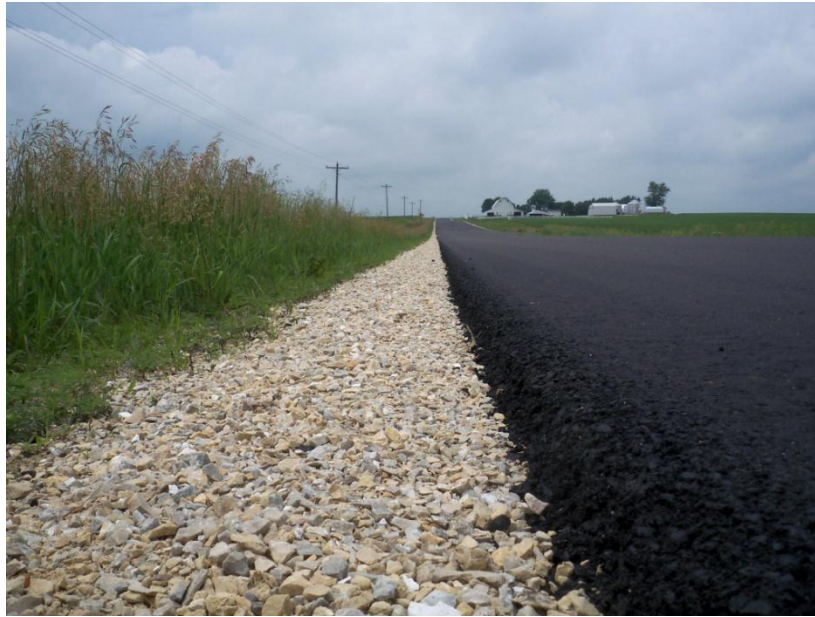
Figure 7.11. Typical Safety Edge on CR D34 in Delaware County

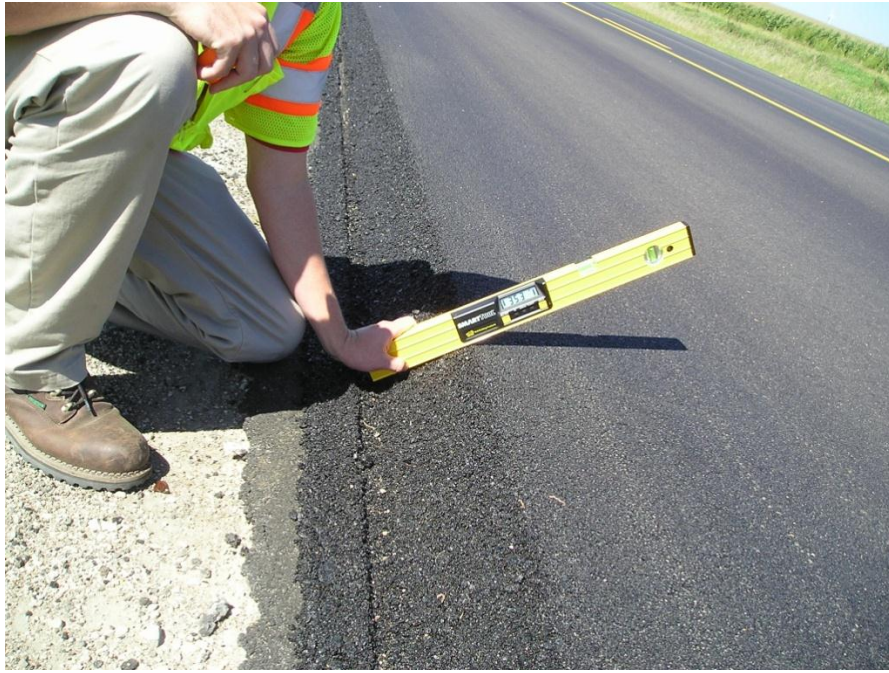
Figure 7.12. Typical Safety Edge Slope on US 20

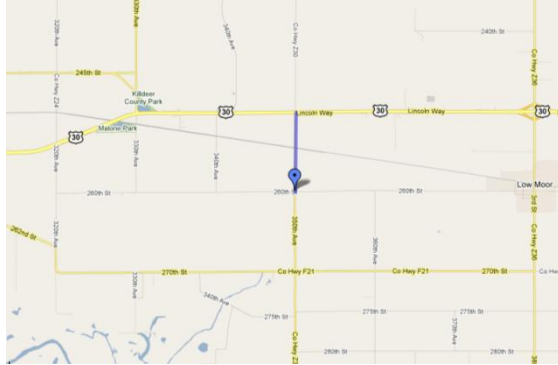
Project Extents (Google image)

Project	Z30, Clinton County
Surface Material	Full-Depth HMA
Paved Width (not including Safety Edge)	22 feet with 4 foot granular shoulders
Project Length	4.2 miles with 0.9 miles HMA
Letting Date	May 28, 2010
Open House	None
Construction Start/End	July 12 – September 15, 2010

Although this project was a total of 4.2 miles long, only about 0.9 miles were constructed using HMA. The contractor, Flynn Company, Inc. of Dubuque, Iowa paved the remainder with 7 inches. of PCC pavement. Use of the safety shoes by the HMA paving subcontractor, Determann Asphalt Paving, LLC of Comanche, Iowa allowed them to incorporate the Safety Edge into the HMA portion of the project.

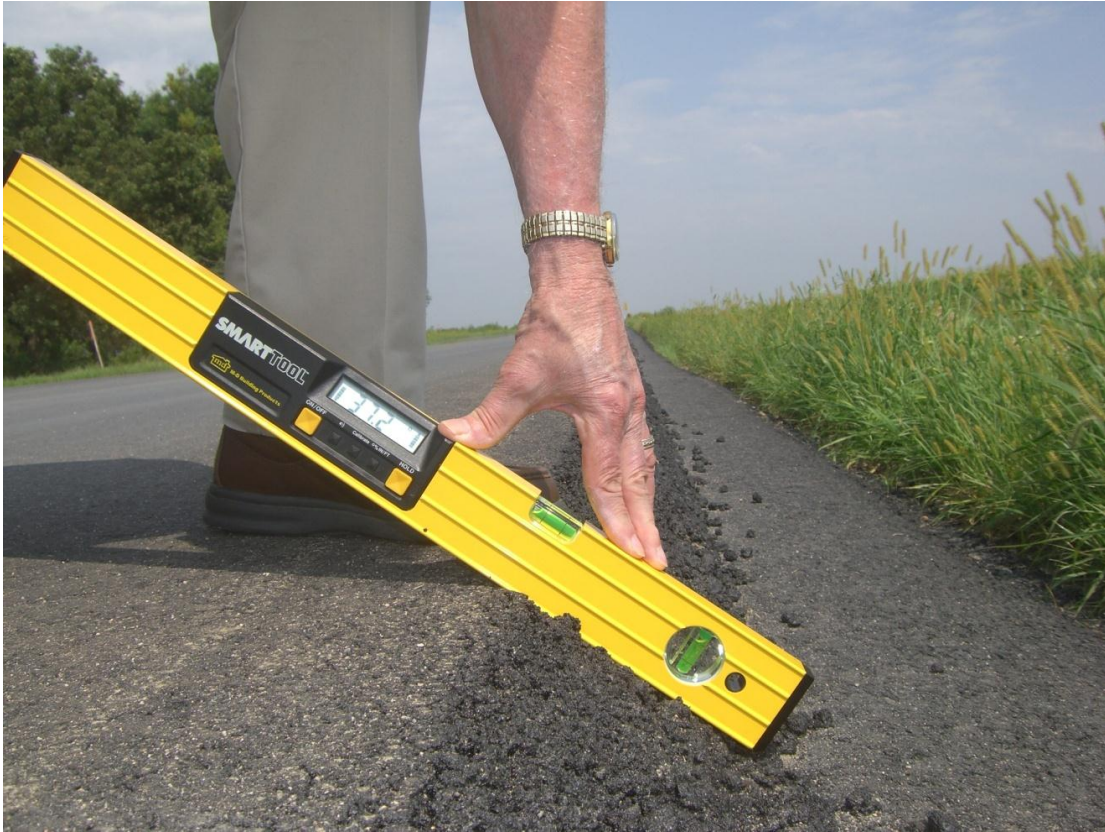
Figure 7.13. Safety Edge on CR Z30 in Clinton County

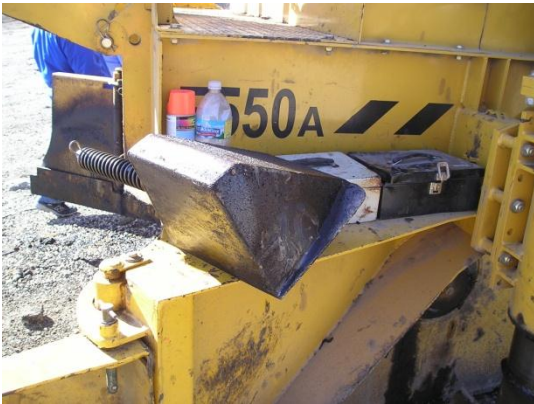
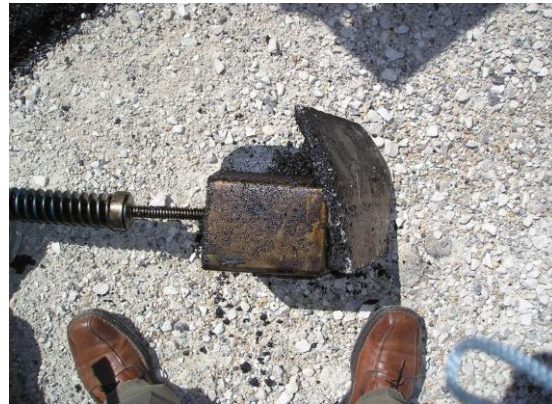
Modified shoe A

Fabricated shoe B

Agencies and contractors on some HMA projects indicated that rollover of the Safety Edge during the compaction process had occurred or the CTRE team noted the problem during site visits. Rollover occurred when the desired 30 degree slope of the Safety Edge was distorted during compaction of the asphalt material. In most cases, rollover resulted in a slope that was steeper than 30 degrees, although one contractor suggested that it could also cause flattening of the slope.

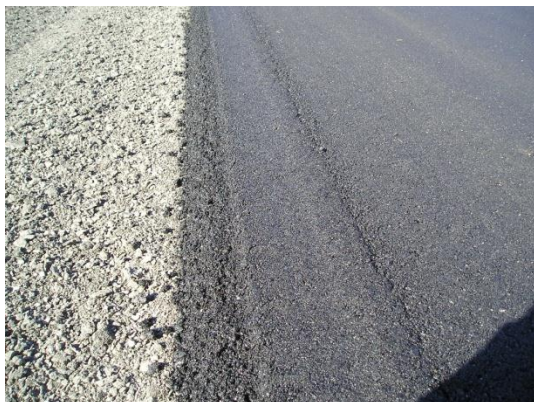
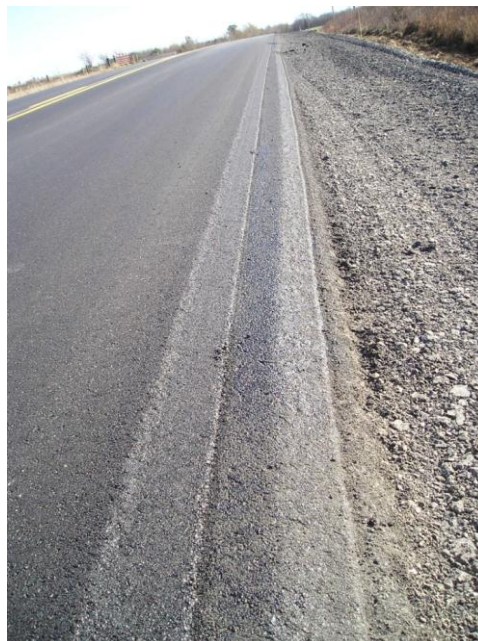
Figure 8.2. Improved safety edge resulting from modified shoes

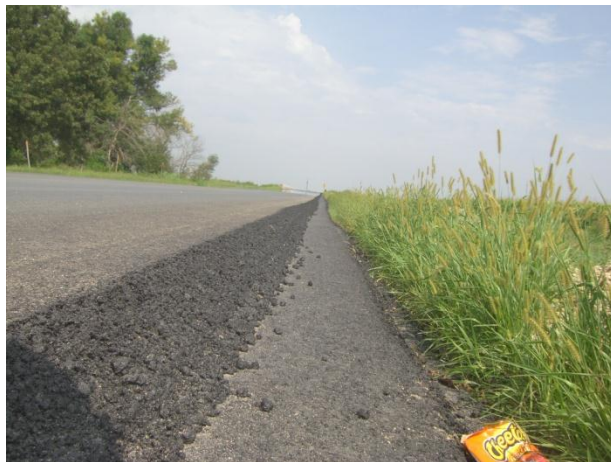
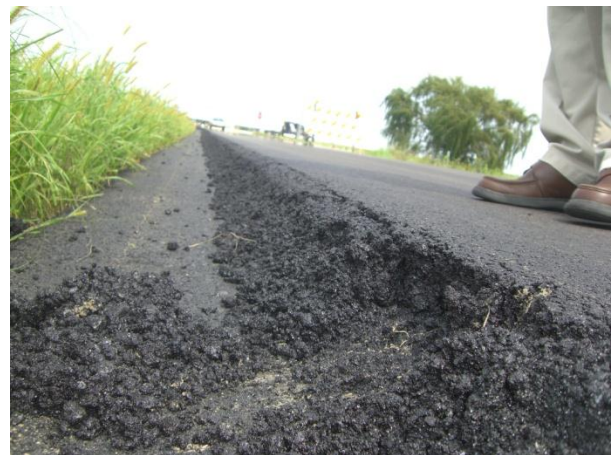
Excess width in base for second and third lifts

Excess base and insufficient second width for third lift

Figure 8.3. Illustrations of improperly matched lifts
