EVALUATION OF TECHNIQUES FOR EMBEDDING AND ATTACHING FIBER BRAGG GRATING SENSORS TO GLULAM BRIDGE MEMBERS¹

Ursula Deza, Brent Phares, Terry Wipf
Iowa State University

Deza, Ursula Mercedes, "Development, Evaluation and Implementation of Sensor Techniques for Bridges Critical to the National Transportation System" (2011). Graduate Theses and Dissertations. 12313. Iowa State University – Digital Repository. <http://lib.dr.iastate.edu/etd/12313>

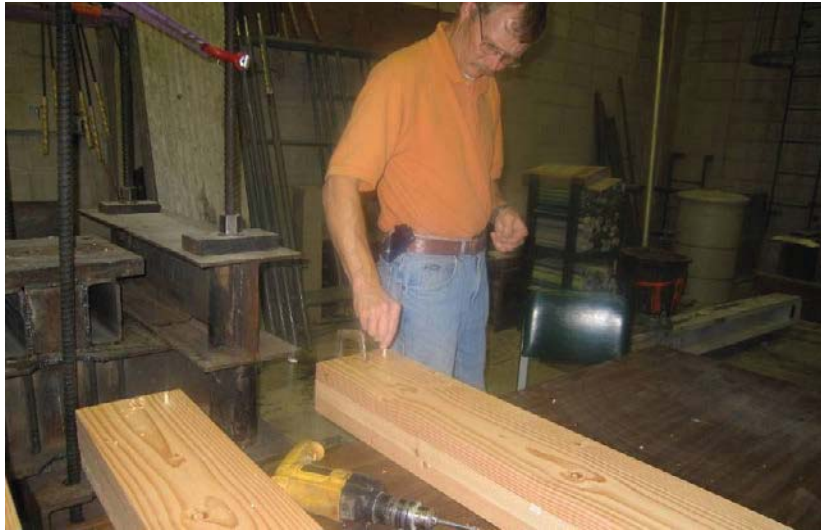
Figure 6.21. Assembly of the Glulam Specimens with Non-Structural Packages: Insertion of the Wooden Dowels

After curing the non-structural packages installations, the laminates were grouped to form Specimens 1 through 5. The laminates were bonded with the established wet-adhesive, Cascophen LT-5210 mixed with the Cascoset FM-6210 hardener, applying the same procedure as described in the previous Section 6.2.5.1 (Hexion, 2010). Wooden dowels were inserted into the predrilled holes to align the laminates (see Figure 6.21). The relative humidity and temperature in the laboratory were approximately 50% and 71°F, respectively.

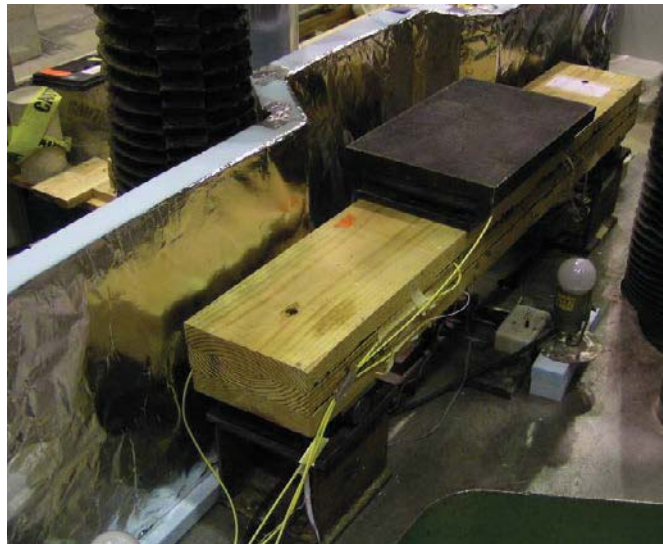
Figure 6.27. Heat and Sustained Loading Test: Assembling of the Heat Box

During the test of Specimen 1, Side 1, some overheating occurred after five hours. The FBG sensor reached 173°F on the tension side (RS-SS package bonded with 454-Loctite adhesive); which is near the maximum recommended operating temperature of the adhesive (180°F). At this point, the lids were partially opened to reduce the temperature. Although the temperature decreased, a sustained temperature of approximately 163°F was still present. To moderate the internal temperature, a small fan was installed to distribute the heat and the heat box lids were partially open to release the excess of heat (see Figure 6.28). This change in the methodology of testing provided sustained temperatures between 110°F and 120°F on average and was repeated as part of the test protocol for the remaining tests.
