Research
Paper
FPL-RP-549

Field Performance of Timber Bridges

6. Hoffman Run Stress-Laminated Deck Bridge

December 1996

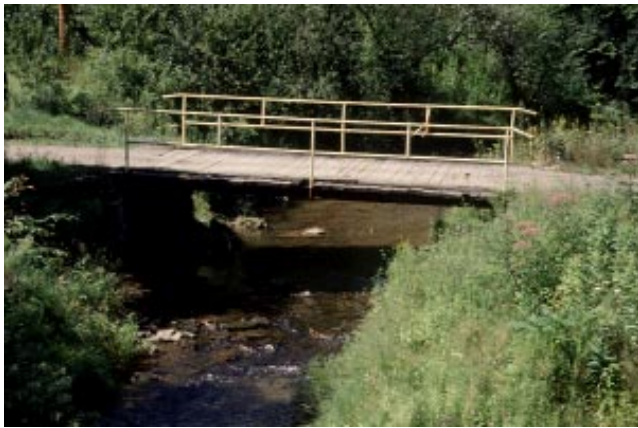
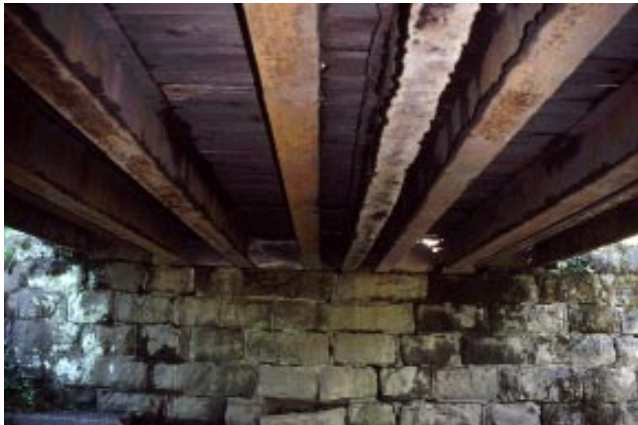
Figure 2—Original Hoffman Run bridge: (top) side view; (bottom) underside of bridge and abutment.

The original Hoffman Run bridge was constructed in the early 1930s and consisted of a timber plank deck supported by steel girders (Fig. 2). Inspection of the bridge in the 1980s indicated that the steel girders were in poor condition and insufficient to carry modern traffic loads. Because of these deficiencies, a decision was made by Jones Township to replace the bridge.

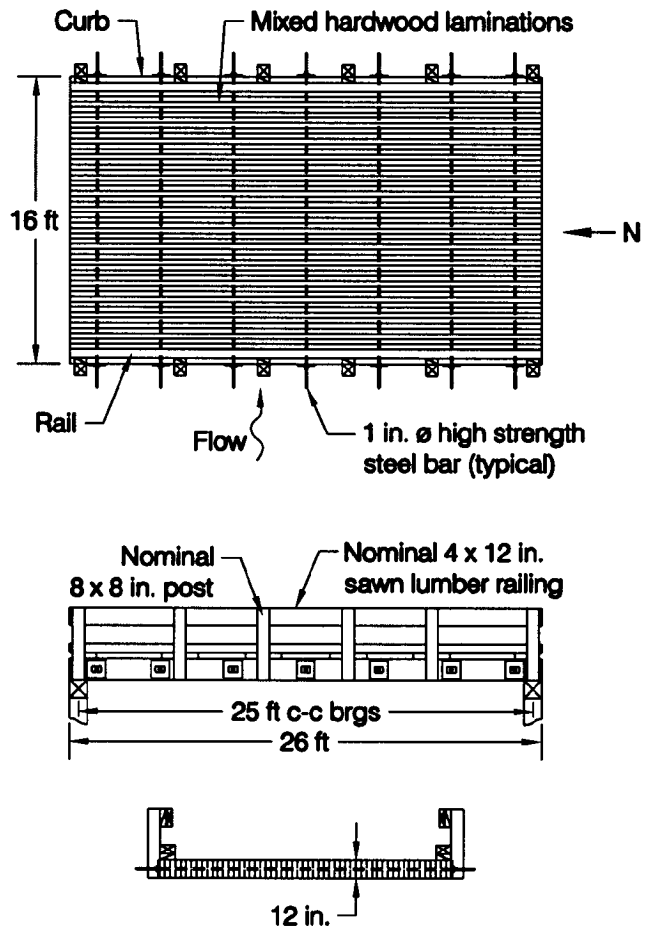
Figure 3—Design configuration of the Hoffman Run bridge.

The Hoffman Run bridge was designed for AASHTO HS 20-44 loading with a span length of 25 ft center-to-center of bearings, a width of 16 ft, and a nominal deck thickness of 12 in. (Fig. 3). Mixed hardwoods, mostly beech, visually graded No. 2 and better, were selected as the material for the bridge. The design of the deck was based on nominal 2- by 12-in. mixed hardwood laminations, pressure treated with creosote. The length of the laminations varied from 3 to 16 ft in length, and butt joints in the deck laminations were placed transverse to the bridge span in every fourth lamination, with a 4-ft longitudinal spacing between butt joints in adjacent laminations (Fig. 4). The stressing system was designed for seven 1-in.-diameter, high strength, threaded steel bars conforming to the requirements of ASTM A722 (ASTM 1988). Average bar spacing was 45 in. on-center, beginning 18 in. from the bridge ends. The design bar tension force was 65,000 lb, resulting in 120 lb/in² of inter-laminar compression, which is approximately 10 percent greater than that of the Little Salmon Creek bridge. A discrete plate bar anchorage system was used, consisting of two steel plates (Fig. 5). The bridge railing consisted of a sawn lumber curb, post, and rail. Because of the low traffic volume, no wearing surface was specified.

The as-built configuration of the Hoffman Run bridge varied slightly from the design configuration shown in Figure 3. After the final stressing, the width of the bridge measured 16.1 ft at the abutments and midspan.

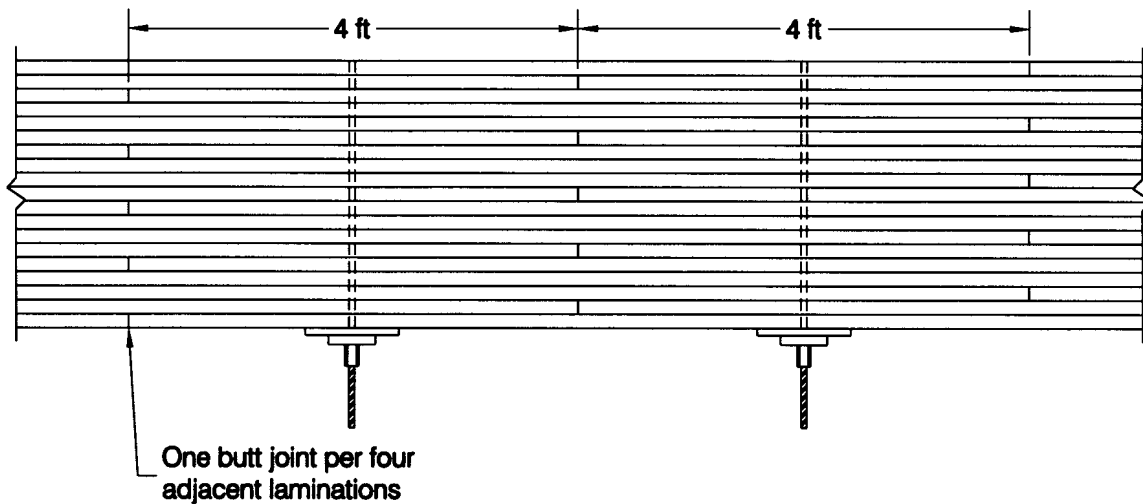
Figure 4—Butt joint configuration used for the Hoffman Run bridge. A butt joint was placed transverse to the bridge span in every fourth lamination. Longitudinally, butt joints in adjacent laminations were separated by 4 ft.

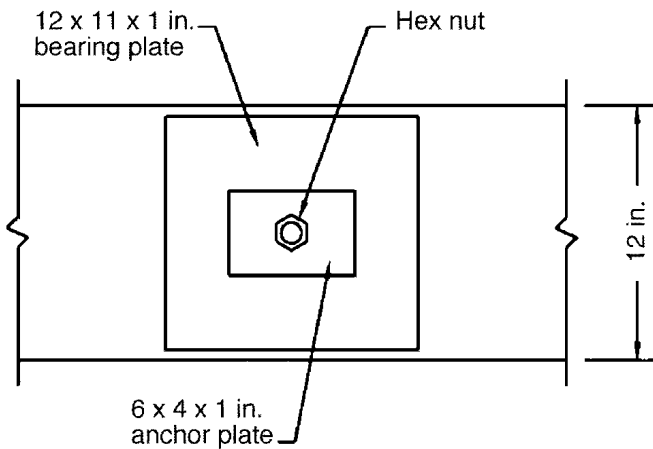
Figure 5—Details of the discrete plate bar anchorage configuration.

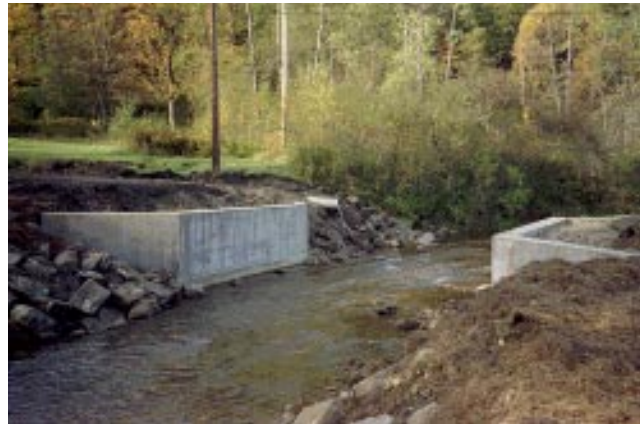
Figure 6—Completed concrete abutments and wingwalls for the Hoffman Run bridge.

wingwalls (Fig. 6). Superstructure assembly began at the treating plant where treated deck laminations were nailed together to form two deck sections, each half the bridge width. Temporary steel bars were inserted through the laminations at several locations so that the deck sections could be transported to the bridge site.

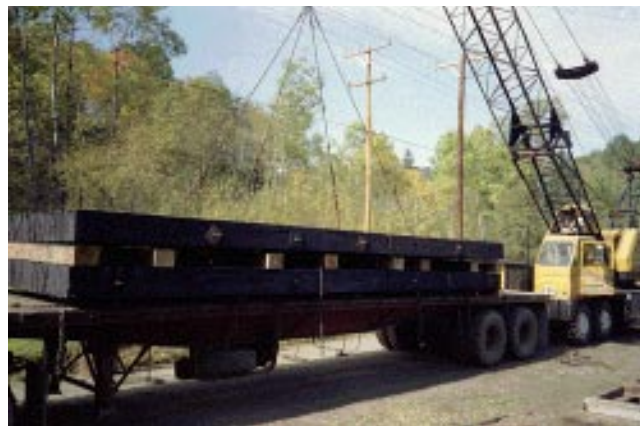
Figure 7—Two deck sections for the Hoffman Run bridge were transported from the treating plant to the bridge site on a flatbed truck.

Upon completion of the concrete abutments and wingwalls, the deck sections were loaded on a flatbed truck at the treating plant and transported to the bridge site (Fig. 7). At the bridge site, the sections were unloaded from the truck and placed side-by-side on temporary supports situated on the approach roadway (Fig. 8). The temporary steel bars were removed, and the stressing bars were inserted through both sections (Fig. 9). A single hydraulic jack was used to tension the bars to the required 65,000 lb (Fig. 10). Following bar tensioning, the entire superstructure was lifted as a unit by a small crane and placed atop the abutments (Fig. 11).

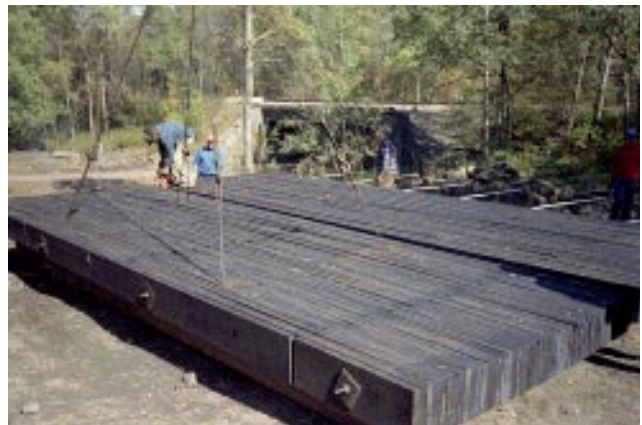
Figure 8—At the bridge site, the two deck sections were placed side-by-side atop temporary abutments located on the approach roadway.

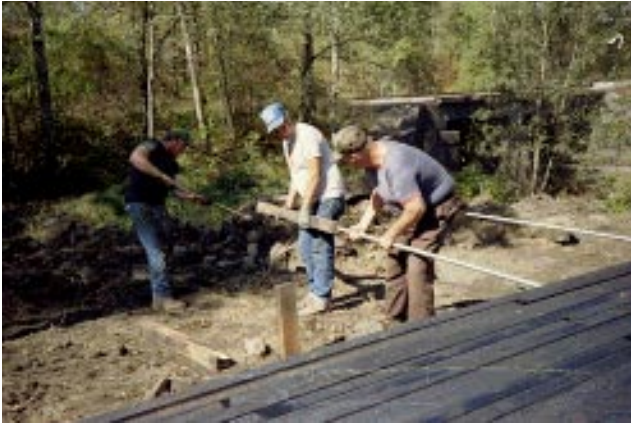
Figure 9—The temporary steel bars in the two deck sections were removed, and stressing bars were inserted through both deck sections.

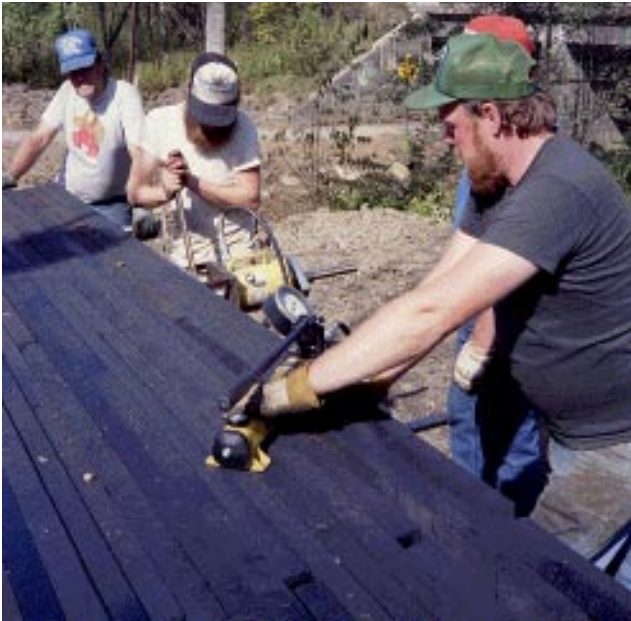
Figure 10—Stressing bars were tensioned with a single hydraulic jack.

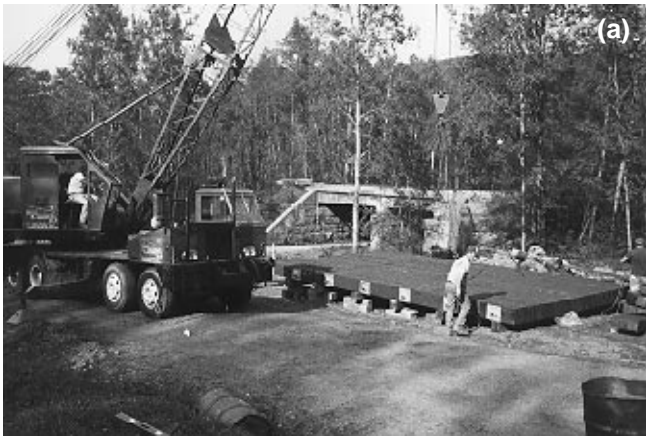
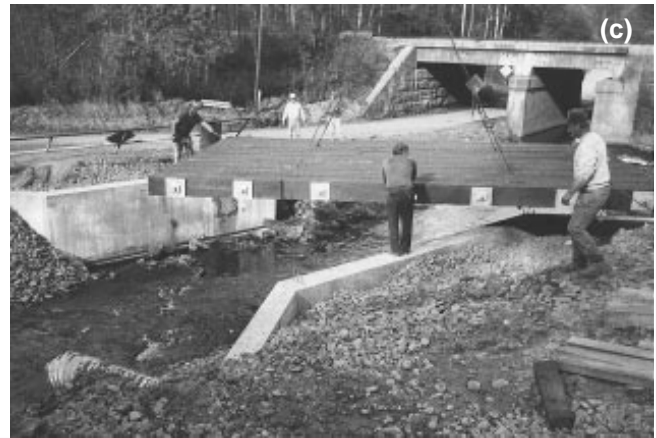
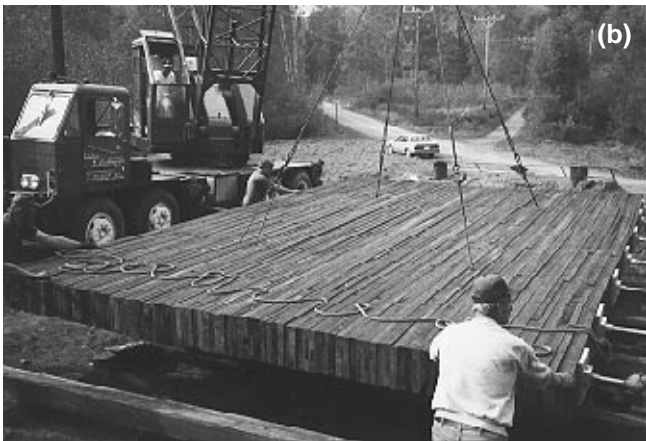
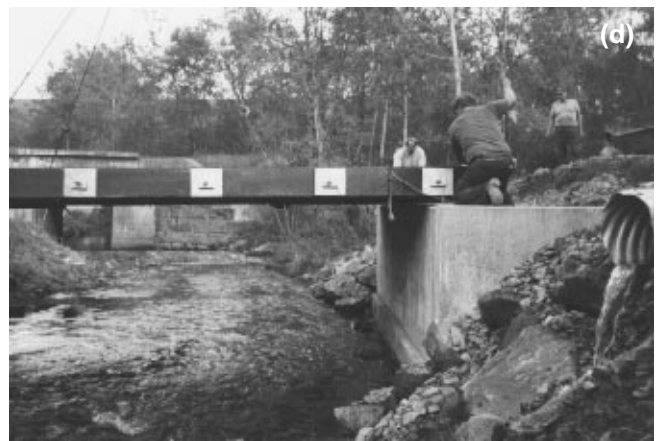
Figure 11—Completed deck placed on abutments: (a) bar tensioning completed, (b) deck lifted from temporary abutments by small crane, (c) deck positioned over Hoffman Run, (d) superstructure placed on abutments.

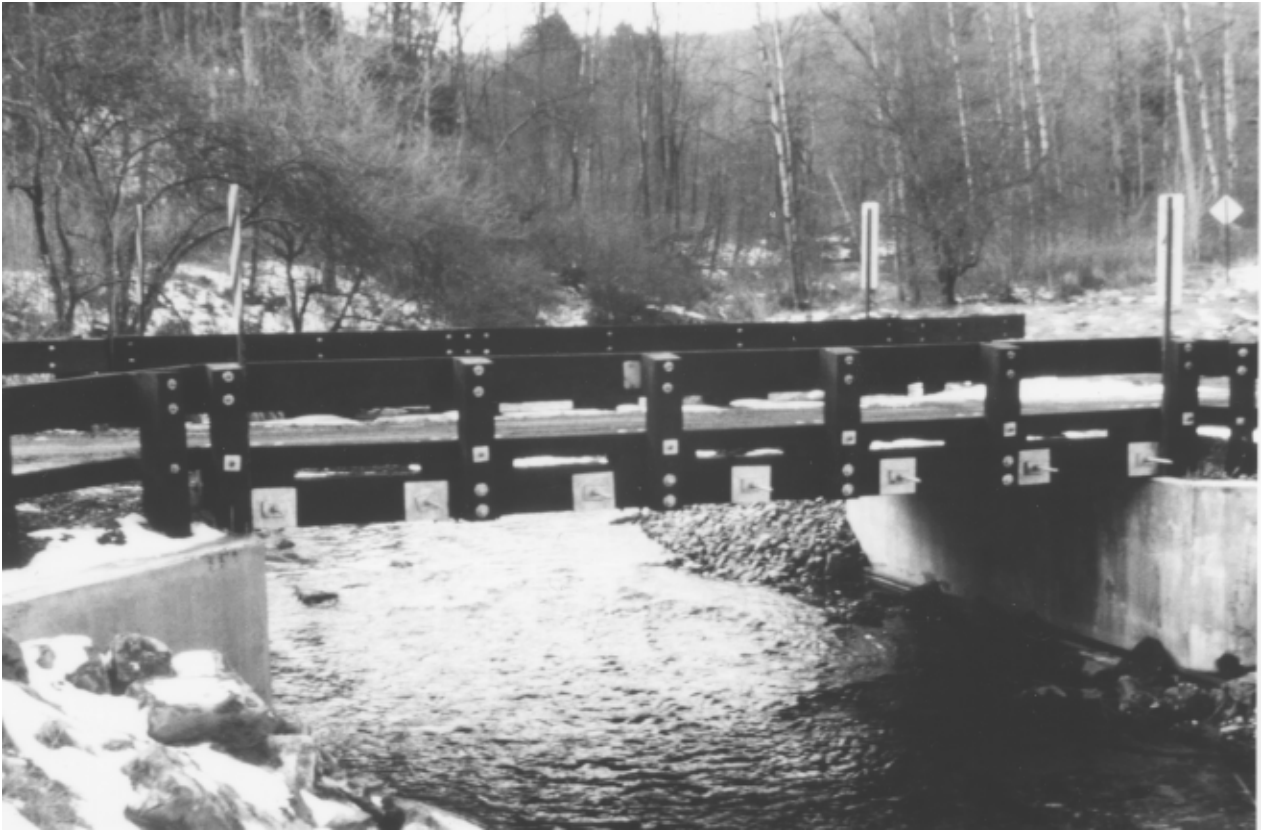
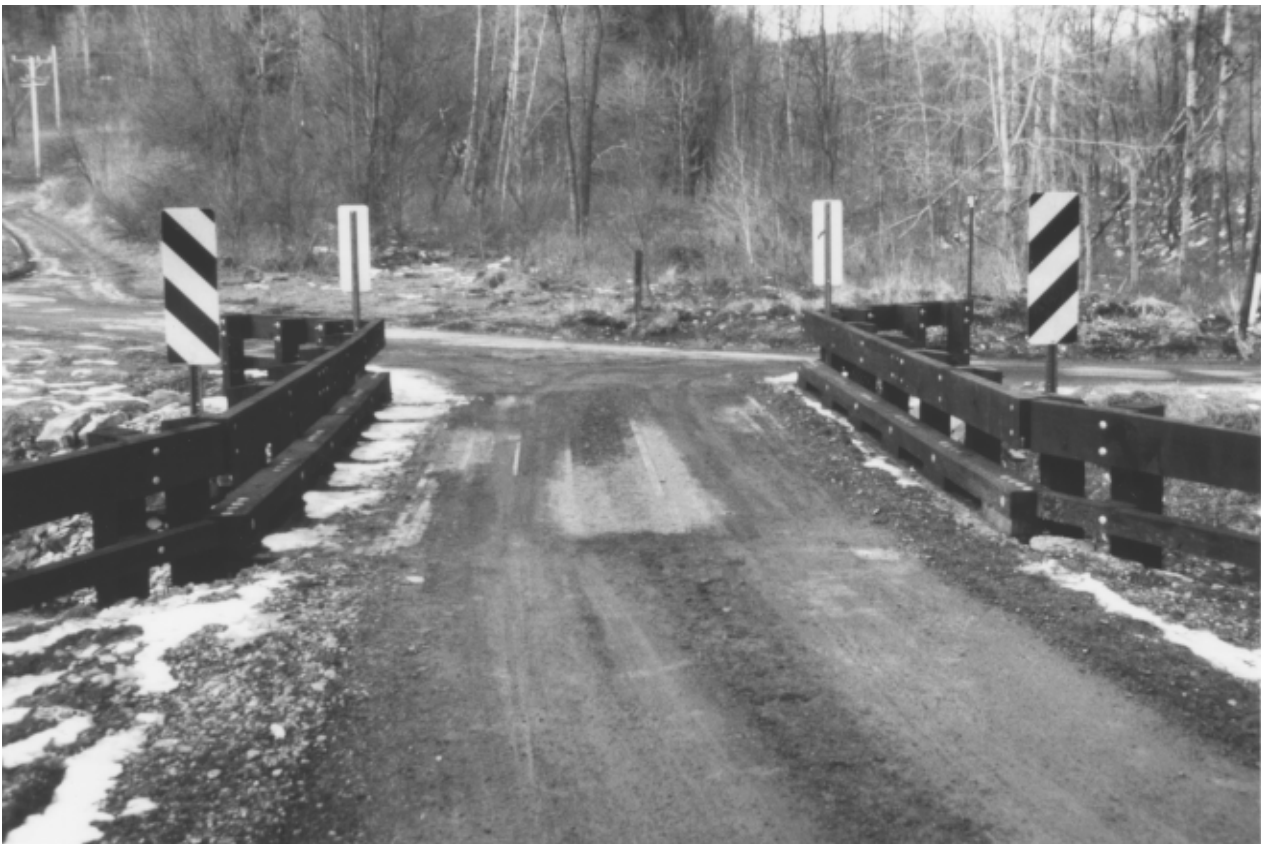
Figure 12—Completed Hoffman Run bridge: (top) side view; (bottom) end view.

The installation of the bridge superstructure was completed in 1 day. After the initial bar tensioning, the bars were retensioned to 65,000 lb, approximately 1 week and 8 weeks after installation. The curb and bridge railing were installed shortly after the second bar tensioning. The completed bridge is shown in Figure 12.

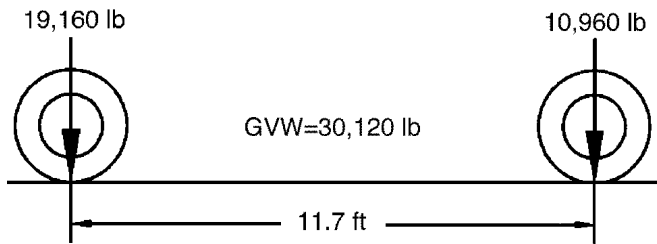
Figure 13—Load test 1 truck configuration and axle loads. Lighter axle is vehicle front. The transverse vehicle track width, measured center-to-center of the rear tires, was 6 ft.

The first load test was completed December 12, 1990, approximately 2 months after bridge installation. The bridge interlaminar compression at the time of the test was 114 lb/in². The test vehicle consisted of a fully loaded, two-axle dump truck with a gross vehicle weight of 30,120 lb (Fig. 13). The vehicle was positioned longitudinally on the bridge so that the rear axle was centered at midspan. Transversely, the vehicle was placed for three load positions (Fig. 14). For load position 1, the vehicle was centered on the bridge width. For load position 2, the vehicle was positioned on the downstream side with the center of the inside wheel line over the bridge centerline. For load position 3, the vehicle was positioned on the upstream side with the center of the inside wheel line over the bridge centerline. Measurements of the bridge deflection from an unloaded to loaded condition were obtained by placing calibrated rules on the deck underside and reading values with a surveyor's level to the nearest 0.06 in. (Fig. 15).

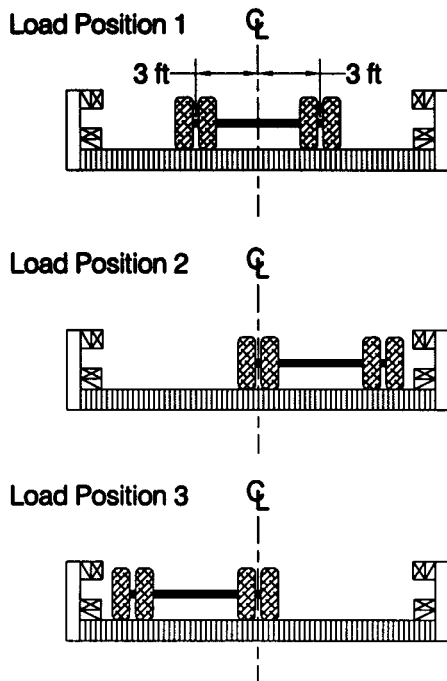
Figure 14—Load test 1 and 2 transverse load positions (looking north). For all load positions, the rear axle was centered over the bridge midspan.

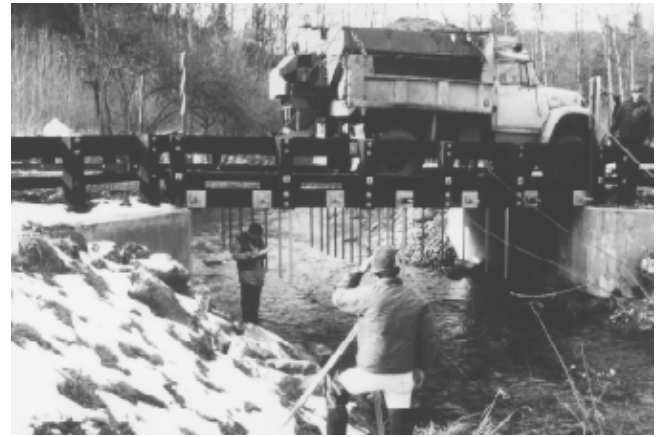
Figure 15—Load test 1 bridge deflections were measured by suspending calibrated rules from the deck underside and reading displacement values with a surveyor's level.

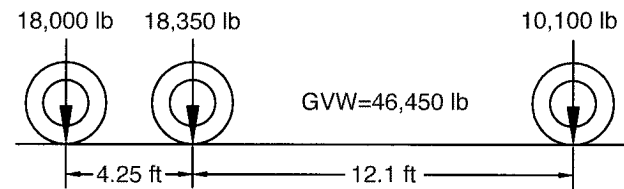
Figure 16—Load test 2 truck configuration and axle loads. The transverse vehicle track width, measured center-to-center of the rear tires, was 6 ft.

The second load test was completed on July 19, 1993, approximately 34 months after bridge installation. At the time of the test, the interlaminar compression was approximately 70 lb/in². The test vehicle consisted of a fully loaded three-axle dump truck with a gross vehicle weight was of 46,450 lb (Fig. 16). Longitudinally, the vehicle was positioned so that the two rear axles were centered at midspan and the front axle was off the bridge span. Transversely, the vehicle was positioned for the same three load positions used for load test 1 (Fig. 14 and 17). Measurements of the bridge deflection from an unloaded to a loaded condition were taken at midspan using string potentiometers and an electronic data acquisition system (Fig. 18). The accuracy of this method for repetitive readings is estimated to be ±0.005 in.

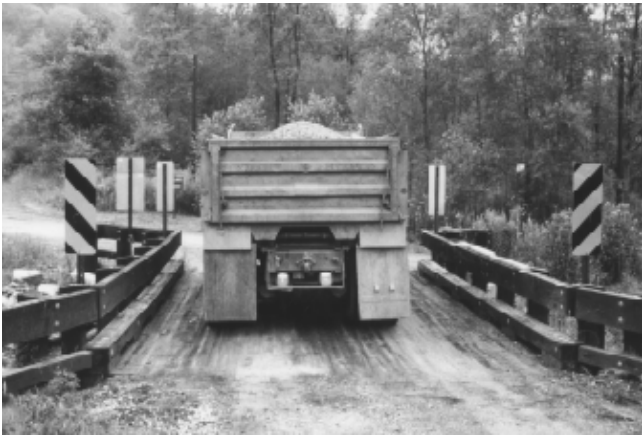
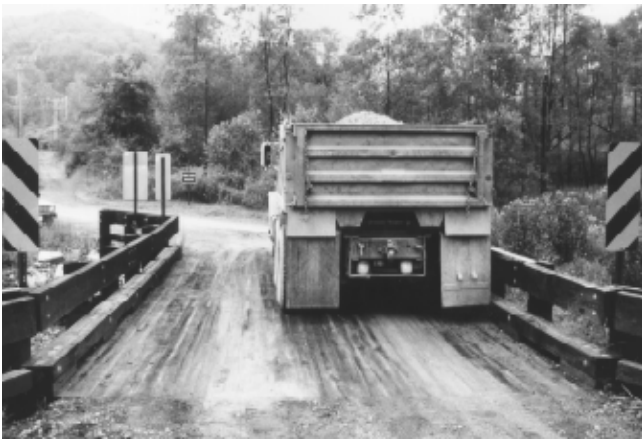
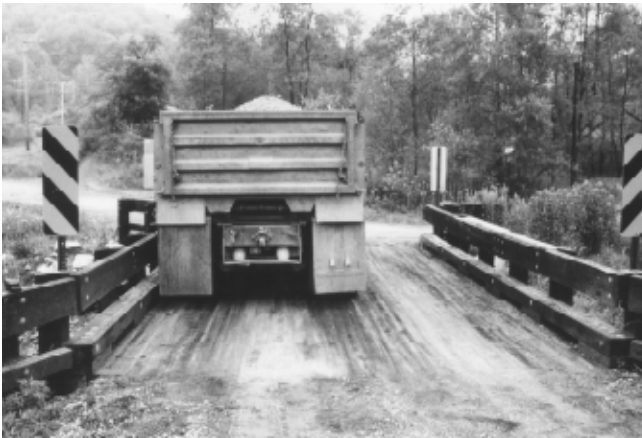
Figure 17—Load test 2 transverse load positions (looking north): (top) load position 1; (middle) load position 2; (bottom) load position 3. For all load positions, the two rear axles were centered over the bridge midspan with the front axle off the span.

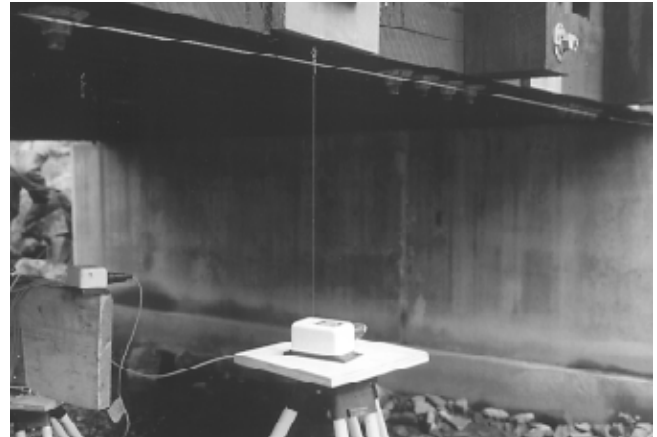
Figure 18—Load test 2 was measured with string potentiometers and an electronic data acquisition system.

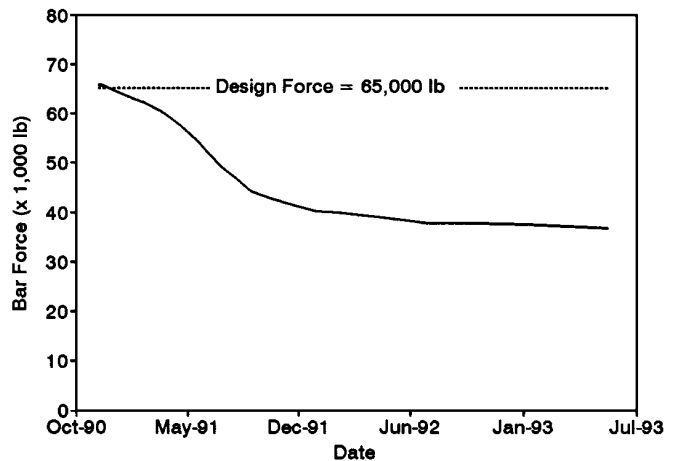
Figure 19—Average trend in bar tension force obtained from load cells installed on two stressing bars.

The trend in average bar tension force for the Hoffman Run bridge is shown in Figure 19. The final bar tensioning, which occurred December 1990, approximately 2 months after installation, was approximately 65,600 lb, or 101 percent of the design force. After the final bar tensioning, the bar force began to decline. The decline continued throughout the monitoring, although the rate of loss decreased with time. At the conclusion of the monitoring, the average bar force was approximately 38,000 lb, or 59 percent of the design force, which corresponds to an average interlaminar compression of

approximately 70 lb/in² and exceeds the recommended minimum interlaminar compression of the 40 lb/in² (Ritter 1990). Because the moisture content of the deck laminations remained greater than the fiber saturation point, there was no lamination shrinkage due to moisture loss. Thus, the decline in bar force is primarily attributed to accelerated stress relaxation in the lumber laminations as a result of the high moisture content level.

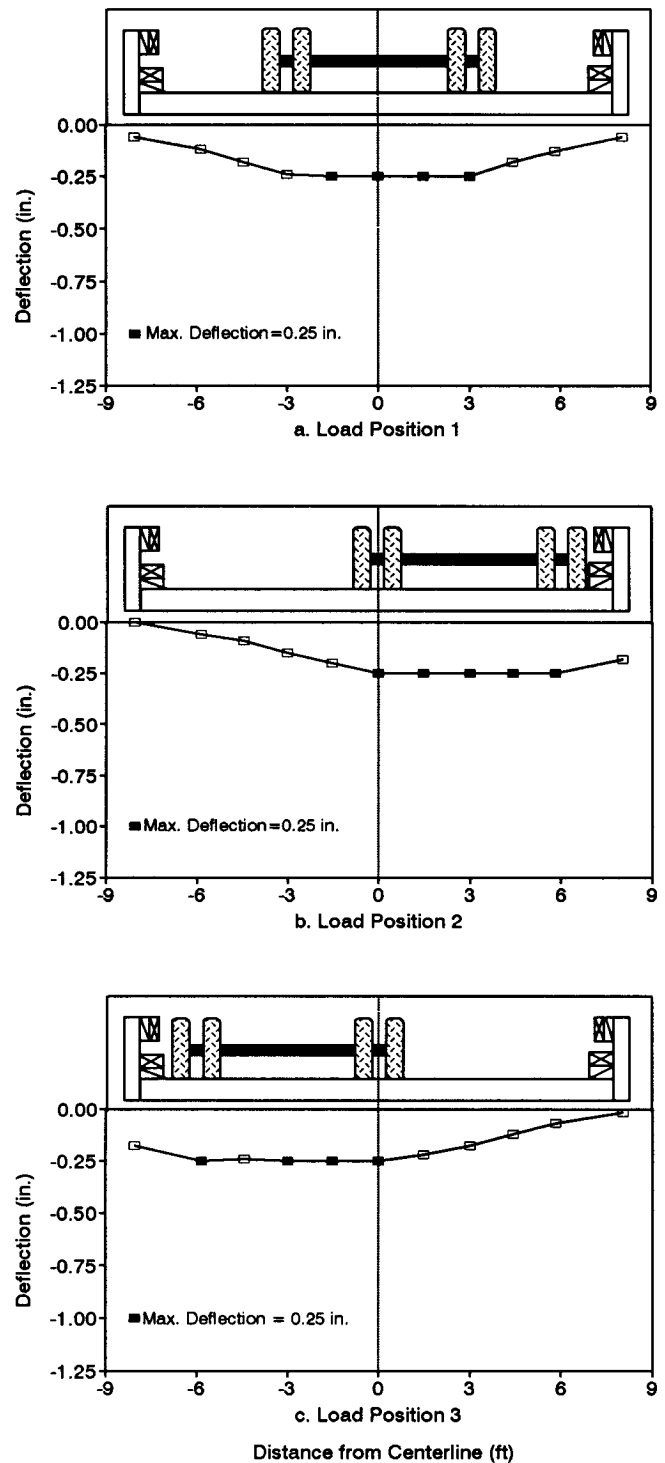
Figure 20—Transverse deflection for load test 1, measured at the bridge midspan (looking north). Bridge cross sections and vehicle positions are shown to aid interpretation and are not to scale.

Transverse deflection values for load test 1 are shown in Figure 20. For each of the three load positions, the deflection results are typical of the orthotropic plate behavior of stress-laminated bridges (Ritter and others 1990). For load position 1 (Fig. 20a), the maximum measured deflection of 0.25 in. occurred at the bridge centerline, at 1.5 ft either side of the centerline, and beneath the wheel line on the downstream (right) side. For load position 2 (Fig. 20b), the maximum deflection of 0.25 in. was measured at the bridge centerline and at all data points up to and including the point beneath the downstream wheel line. For load position 3 (Fig. 20c), the maximum deflection of 0.25 in. was measured beneath both wheel lines and at 1.5 and 3 ft from the centerline on the upstream side of the bridge. For each case, it was impossible to determine the exact maximum deflection location given the accuracy of the readings.

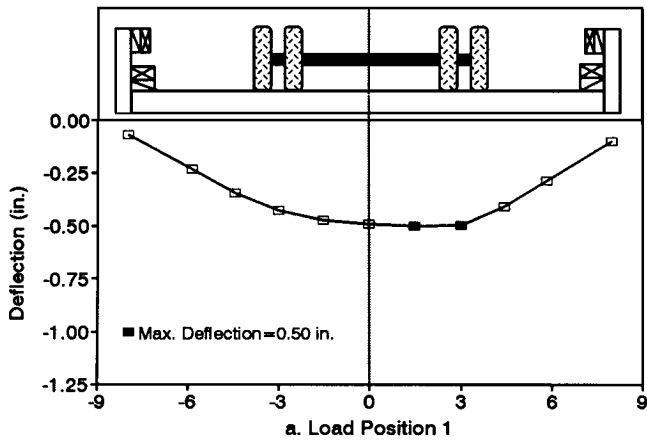
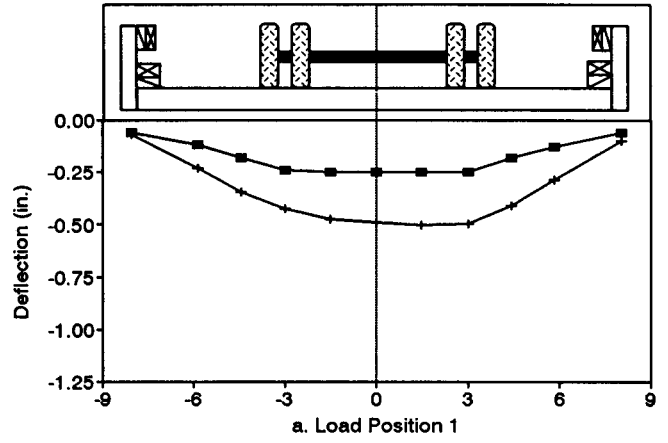
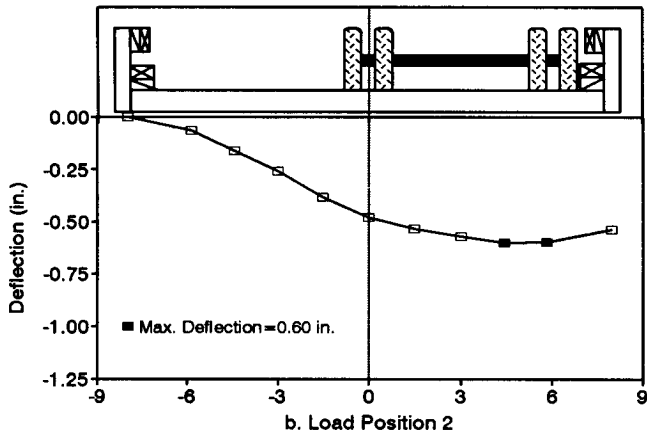
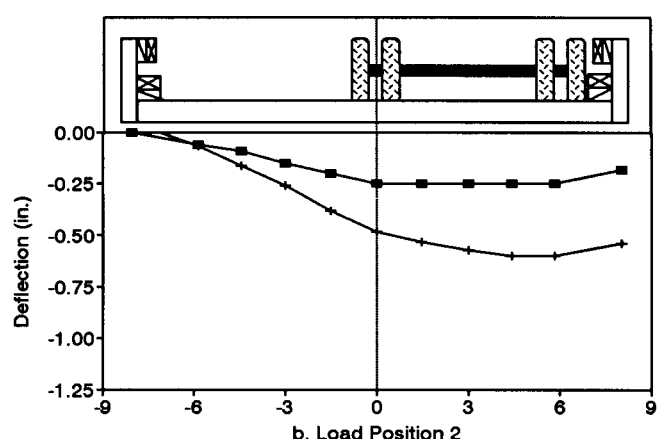
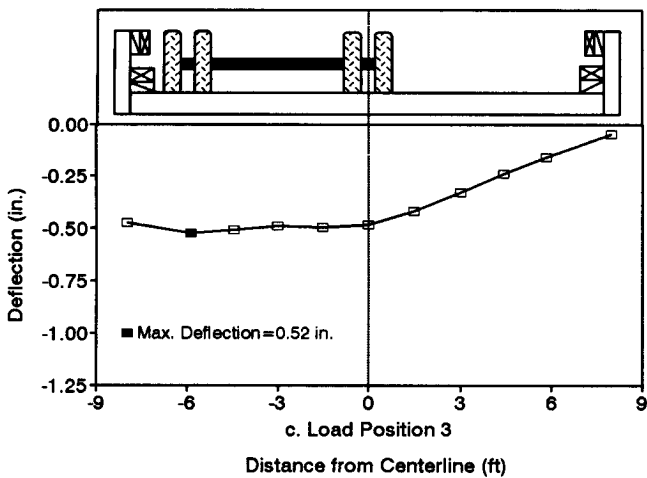
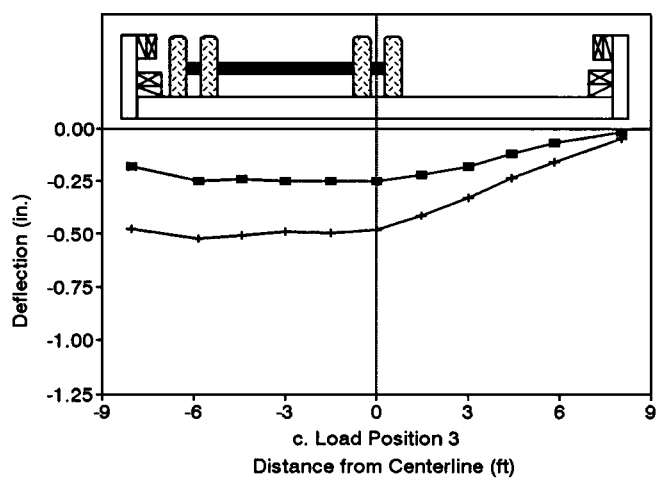
Figure 21—Transverse deflection for load test 2, measured at the bridge midspan (looking north). Bridge cross sections and vehicle positions are shown to aid interpretation and are not to scale.

Transverse deflection values for load test 2 are shown in Figure 21. As with load test 1, the deflections are typical of orthotropic plate behavior. For load position 1 (Fig. 21a), the maximum measured deflection of 0.50 in. occurred beneath the downstream wheel line and 1.5 ft from the bridge centerline on the downstream (right) side. For load position 2 (Fig. 21b), the maximum measured deflection of 0.60 in. occurred beneath the downstream wheel line and the adjacent upstream data point, 17 in. from the wheel line. For load position 3 (Fig. 21c), the maximum measured deflection of 0.52 in. was under the upstream (left) wheel line. Given the accuracy of the measurement method, it is likely that the deflections accurately represent the actual bridge behavior.

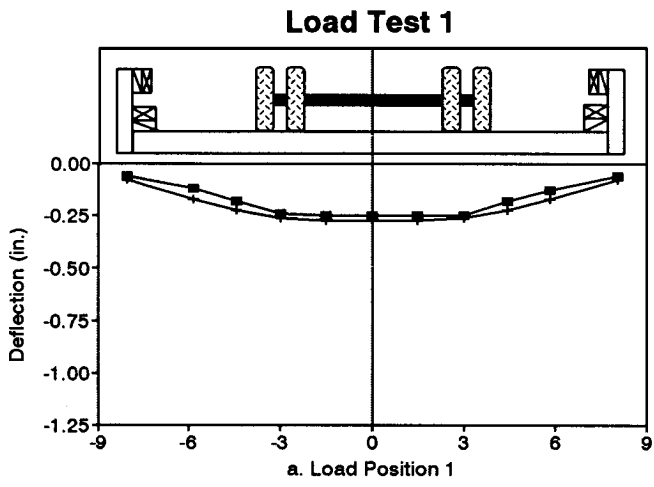
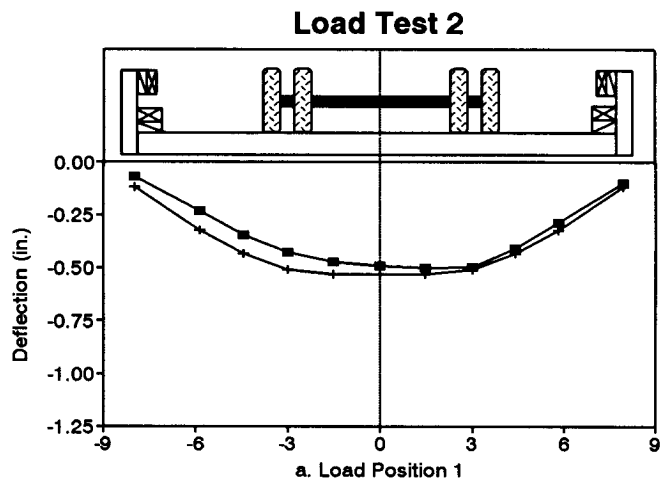
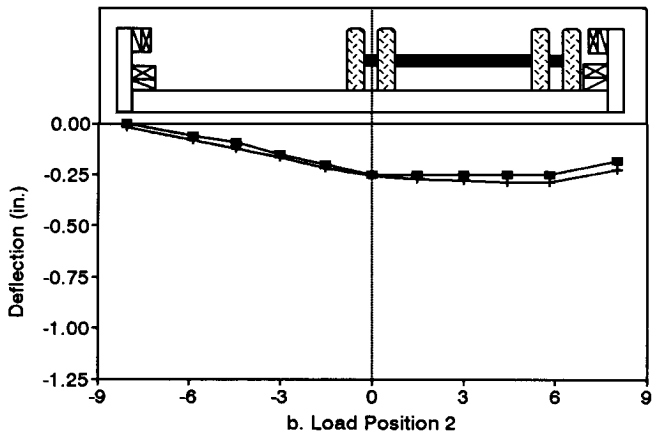
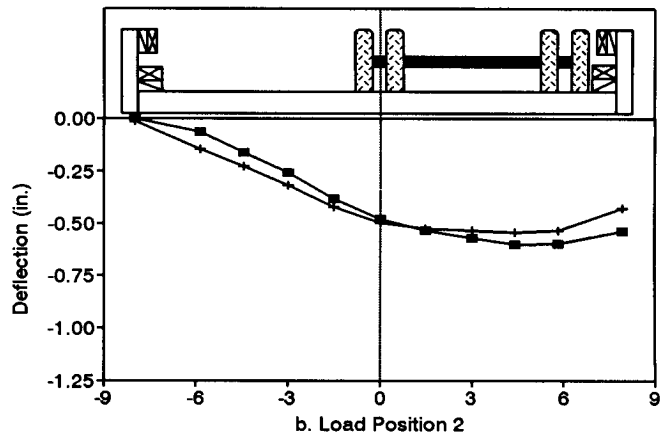
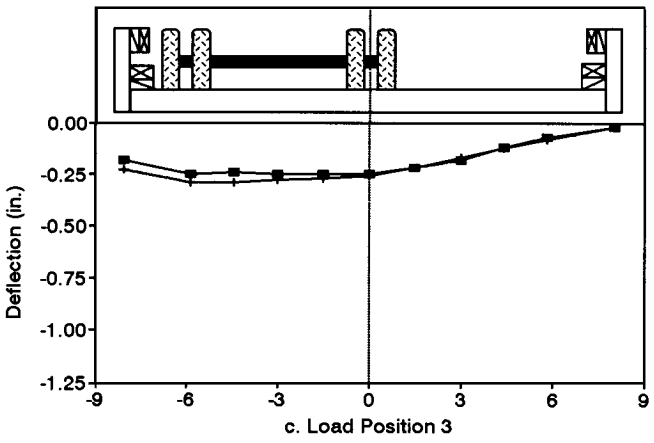
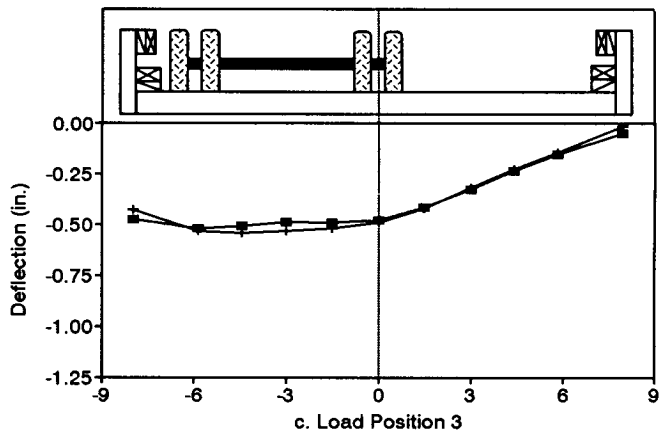
Figure 24—Comparison of the measured deflections for load tests 1 and 2 to the theoretical deflection, based on orthotropic plate analysis (looking north).

Comparisons of the measured load test results to the theoretical bridge response are shown in Figure 24. As illustrated, the theoretical bridge deflection is very close to that measured. Using the same load test analytical parameters, the theoretical deflection for AASHTO HS 20-44 truck loading is shown in Figure 25. Based on this analysis, the predicted maximum AASHTO HS 20-44 static deflection is 0.56 in. or approximately 1/536 of the bridge span for load test 1, and 0.60 in. or approximately 1/500 of the bridge span for load test 2. The theoretical maximum for each load test occurs when the truck is positioned eccentrically at the point between the wheel lines, adjacent to the eccentric wheel line.

Assuming constant bridge properties, the same bridge deflection would normally be expected for the same loading. However, it is known that an increase in interlaminar compression in stress-laminated bridges with butt joints results in an increase in longitudinal bridge stiffness (Oliva and others 1990). The difference in the maximum HS 20-44 deflection for the two load tests is attributable to an approximate 7 percent decrease in bridge stiffness at load test 2, as a result of the decreased level of interlaminar compression of 70 lb/in² for load test 2 compared with 114 lb/in² for load test 1.

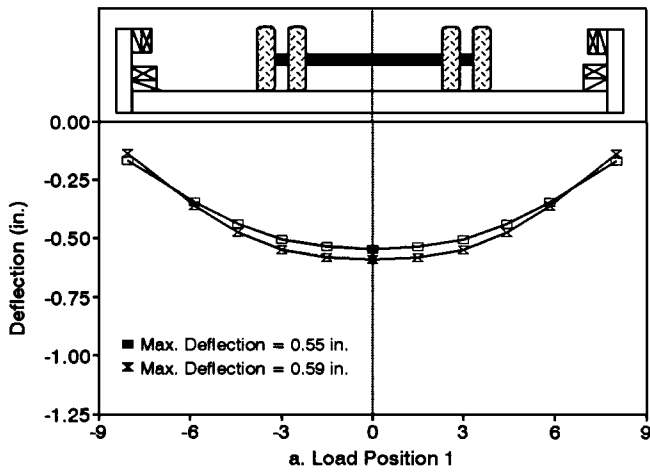
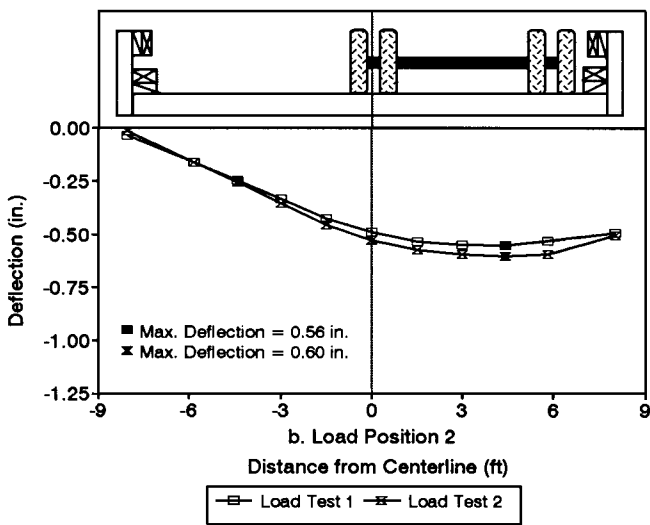
Figure 25—Maximum predicted deflection profile at the bridge midspan for AASHTO HS 20–24 truck loading.

- Load testing and analysis indicate that the Hoffman Run bridge exhibits linear elastic orthotropic plate behavior when subjected to static truck loading. Based on an analytical comparison of load test results at different levels of interlaminar compression, the longitudinal bridge stiffness decreased approximately 7 percent when the interlaminar compression decreased from 114 to 70 lb/in². The maximum predicted bridge deflection as a result of AASHTO HS 20-44 static truck loading is estimated to be 0.56 in. (L/536) at 114 lb/in² interlaminar compression and 0.60 in. (L/500) at 70 lb/in² interlaminar compression.

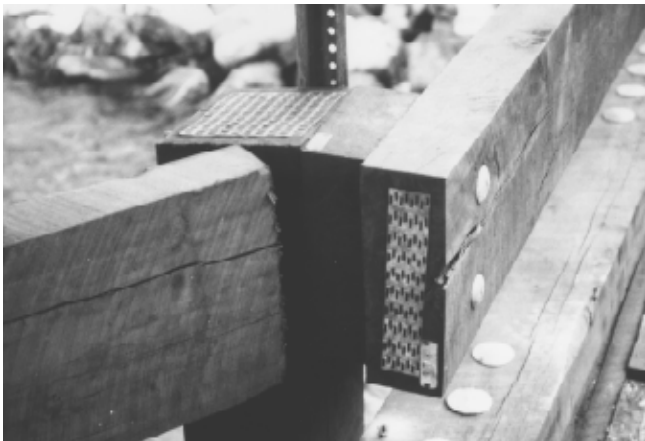
Inspection of the wood components of the bridge showed no signs of deterioration, although some checking was evident on rail members exposed to wet-dry cycles. Shortly after rail installation, truss plates were attached to the ends of the rail and the railposts to hinder checking (Fig. 26). The top of the bridge rail showed minor checking, but the depth of the checks did not appear to penetrate the preservative treatment envelope. Checking was most pronounced in the end grain of the timber rail posts. This would have likely been prevented if an end grain sealer had been applied at the time of construction. There was no evidence of wood preservative loss and no preservative or solvent accumulations on the wood surface.

Figure 26—Truss plates attached to end of bridge rail and rail post to impede checking.

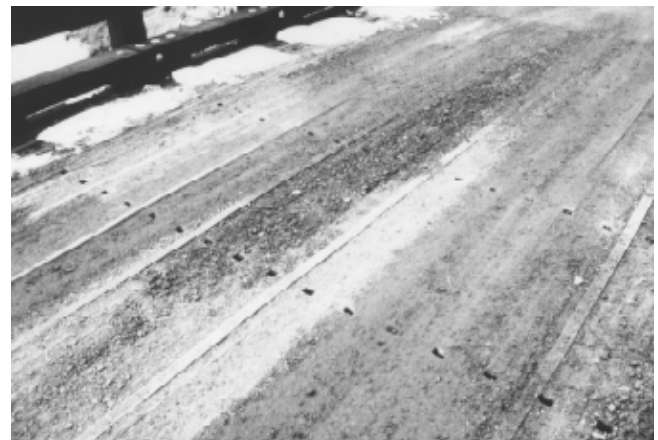
The Hoffman Run bridge was designed and constructed without a wearing surface; hence, the vehicles ride directly on the treated-wood deck. At the time of each load test, heavy accumulations of gravel and other debris from the unpaved approach roadway were present on the surface of the deck (Fig. 27). Deck wear from vehicle tracking and debris abrasion was noted in several locations, although the level of wear was slight and did not significantly reduce the deck section or extend beyond the preservative treatment. Over time, deck wear will continue, potentially causing a reduced deck section as well as accelerating bridge deterioration as the preservative treatment envelope wears away. In addition, the large volume of debris is capable of trapping moisture on the surface of the deck, which creates an environment more suitable to biological attack of the wood.

Figure 27—Debris accumulation on the bridge deck noted during condition assessment.
