Research
Paper
FPL-RP-592

Field Performance of Timber Bridges

20. Gray Stress-Laminated Deck Bridge

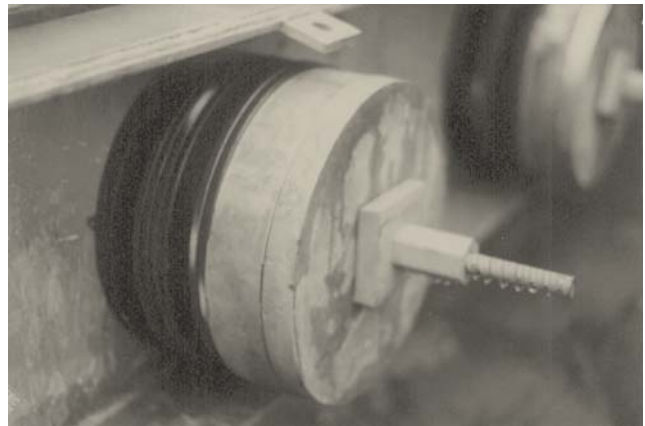
Figure 5—Steel channel and Belleville spring bar anchorage configuration.

For stress laminating, the design specified 5/8-in.-diameter, epoxy-coated, high strength steel threaded bars with an ultimate strength of 150,000 lb/in². The design bar force of 26,000 lb provides an interlaminar compressive stress of 77 lb/in². The stressing system was designed for eleven 5/8-in.-diameter, high strength steel threaded bars. The spacing of the bars was 24 in. on center, beginning 24 in. from the bridge ends. The bar anchorage system used an MC 13 by 40 bulkhead channel with two types of bar anchorage. Five of the 11 bars were anchored using square 8- by 8- by 1/2-in. galvanized steel bearing plates (Fig. 4). The remaining 6 bars were anchored with 10-in.-diameter Belleville springs with a 7/8-in.-thick, 10-in.-diameter bearing plate (Fig. 5). The springs consist of four sets of two Key Belleville K1000-U-312 springs grouped to form stacks on 6 of the 11 bars. The springs were installed to help reduce bar force loss from stress relaxation and reduction in wood moisture content. All components of the stressing system were provided with corrosion protection. The stressing bars and nuts were epoxy coated, and the steel bearing channels and bearing plates were galvanized.

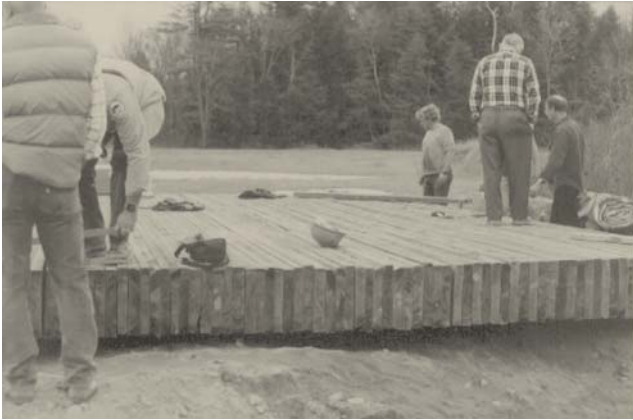
Figure 6—Preassembly of bridge at site on temporary timber supports placed adjacent to east bridge abutment.

Construction of the Gray bridge was completed by a local contractor in the fall of 1991. Following work on the approach alignment and rehabilitation of the bridge abutments, construction of the bridge superstructure began October 31, 1991, and was completed December 3. The bridge was pre-assembled at the site on temporary timber supports placed adjacent to the east bridge abutment (Fig. 6). To construct the deck, laminations were placed edgewise across the supports. Steel prestressing rods were inserted through the

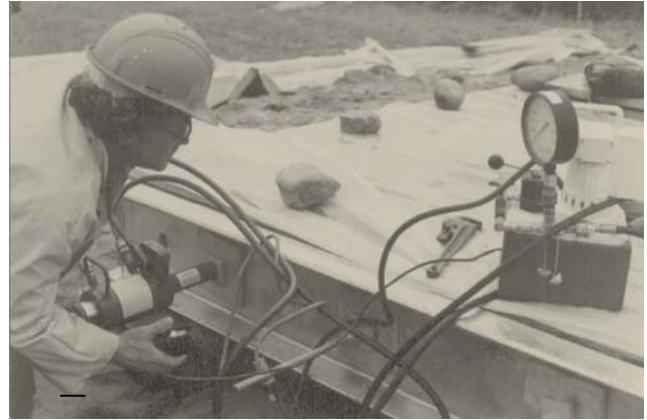
Figure 8—After the stressing system was installed, the bridge was stressed to the full design value.

Following installation of the stressing system, the bridge was stressed to the full design value of 77 lb/in² (Fig. 8). During the initial stressing procedure, the bars were sequentially tightened by a hydraulic jack to the desired stress value. The same process was used to stress the bridge at 1 week, 6 weeks, 4 years, and 6½ years after installation. After the deck was stressed, a 12- by 12-in. CCA-treated eastern hemlock curb was bolted to each edge of the deck. Prior to placing the deck, galvanized steel tie-down angles were bolted to the sides of the concrete cap of each abutment and an

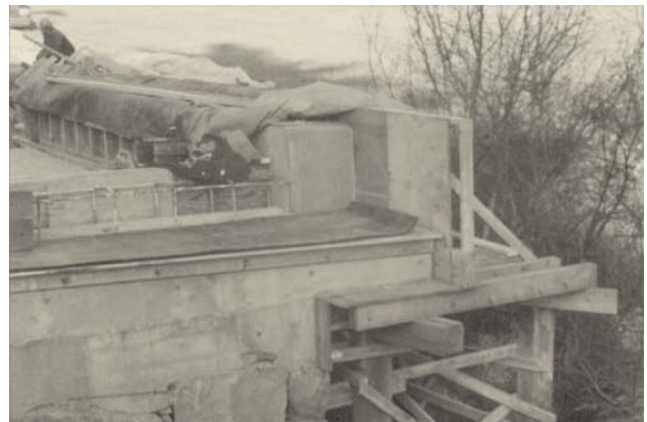
Figure 9—Prior to placing the deck, galvanized steel tie-down angles were bolted to the sides of the concrete cap of each abutment.

elastomeric bearing pad was placed on top of each concrete abutment cap (Fig. 9). The entire deck was lifted from the temporary supports with a large overhead crane (Fig. 10). The deck was moved over the span (Fig. 11) and carefully placed on the abutments (Fig. 12).

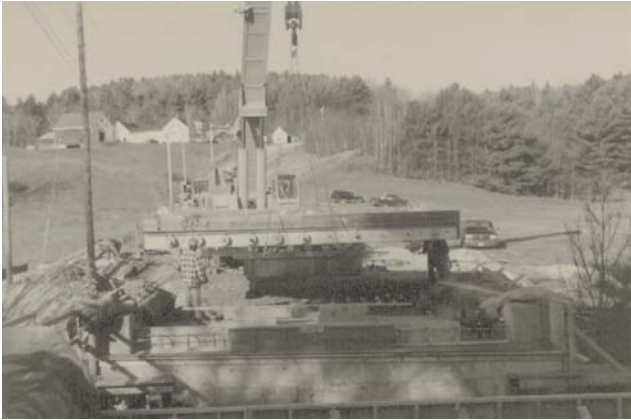
Figure 10—The entire deck was lifted from the temporary supports with a large overhead crane.

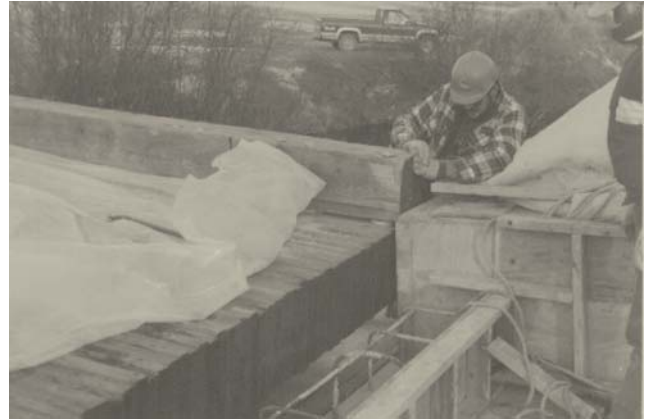
Figure 12—The deck was placed by crane onto the abutments.

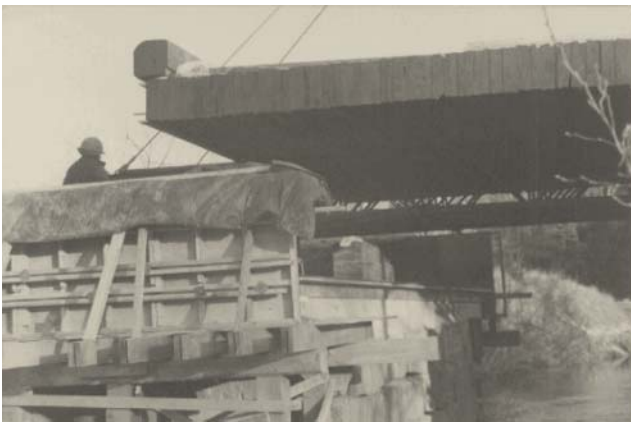
Figure 11—The deck was moved by crane over the span.

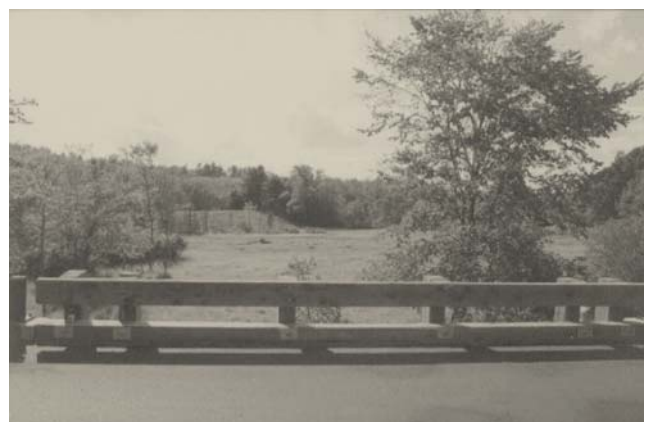
Figure 13—Gray bridge following installation of the post and rail system.

The superstructure was attached by bolting the bottom of the bridge deck to the steel tie-down angles attached to the abutment sides. Following attachment of the deck, the timber post and rails were installed (Fig. 13).

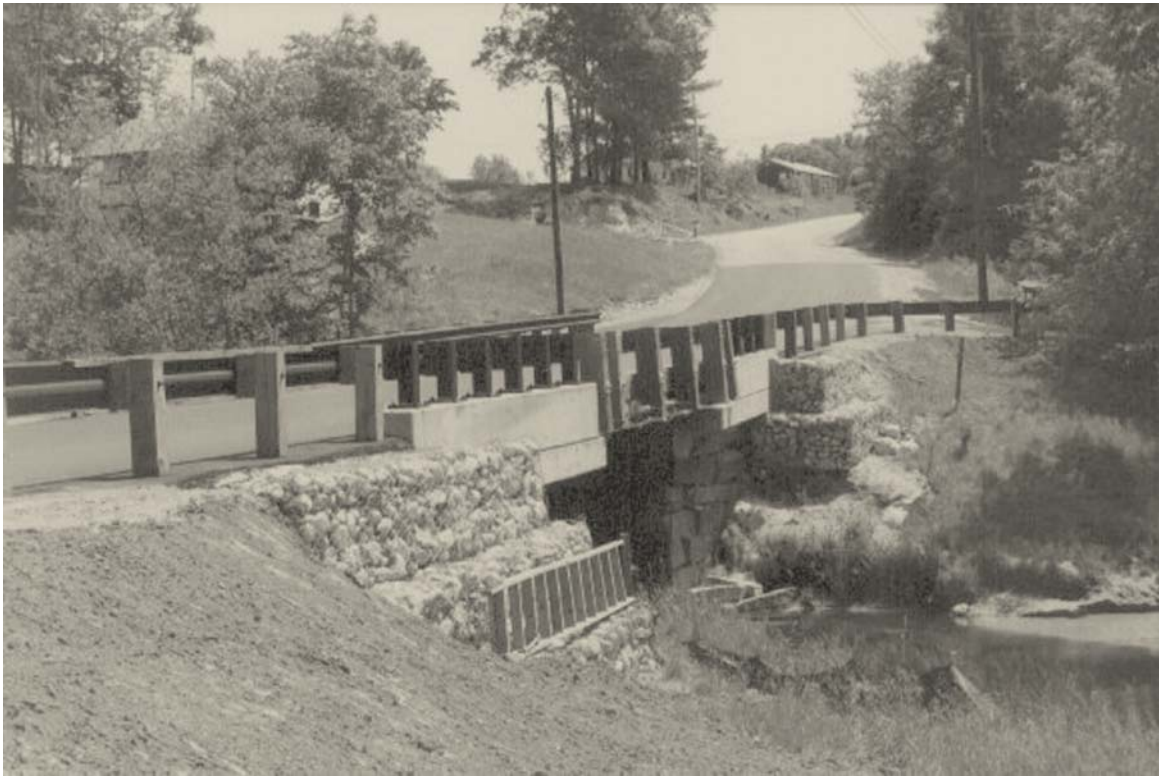
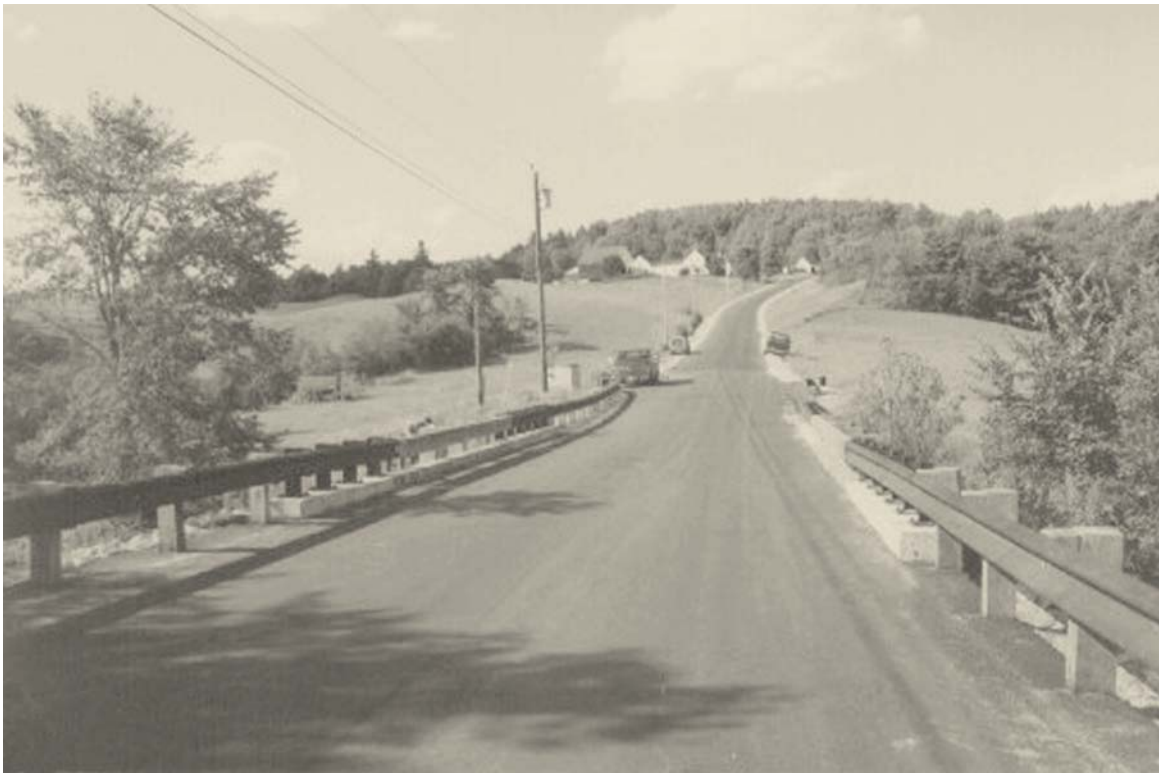
Figure 14—Completed Gray bridge.

To protect the bridge from moisture, one coat of adhesive primer was painted directly onto the wood deck, followed by the installation of two layers of waterproof membrane. The waterproofing membrane was wrapped over the backwalls to completely seal the top surface of the structure from moisture. The bridge was paved with a 3-in.-thick hot bituminous wearing surface. The completed Gray bridge is shown in Figure 14.

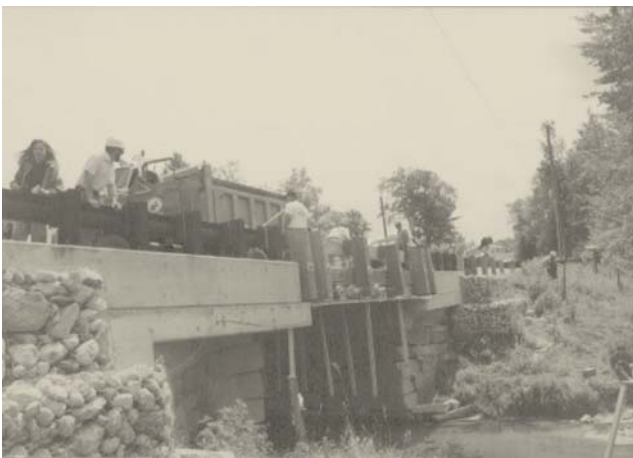
Figure 16—Load test 1. Bridge deflections were measured using a surveyor's level and rulers attached to stiff boards mounted to the underside of the bridge.

Deflection measurements for load test 1 were obtained using a surveyor's level and rulers attached to stiff boards mounted to the underside of the bridge (Fig. 16). Deflection measurements for load test 2 were obtained using displacement transducers mounted to a temporary support erected under the centerspan of the bridge. The transducer measurements were read with a voltmeter and converted to units of displacement by applying a laboratory calibration factor. Deflection

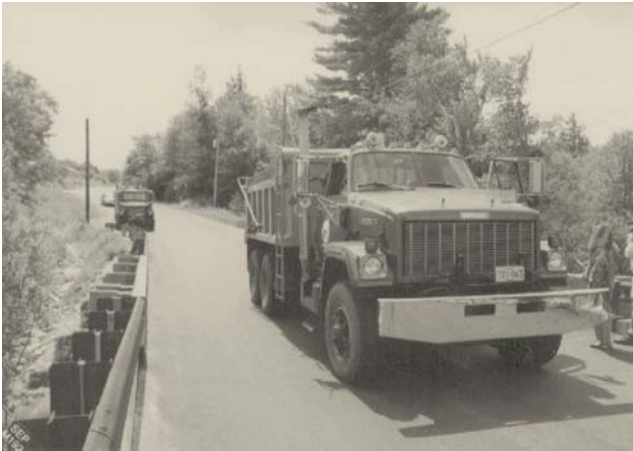
Figure 18—One of the two trucks used for load test 1.

measured to within 0.06 in. One of the two trucks used for load test 1 is shown in Figure 18.

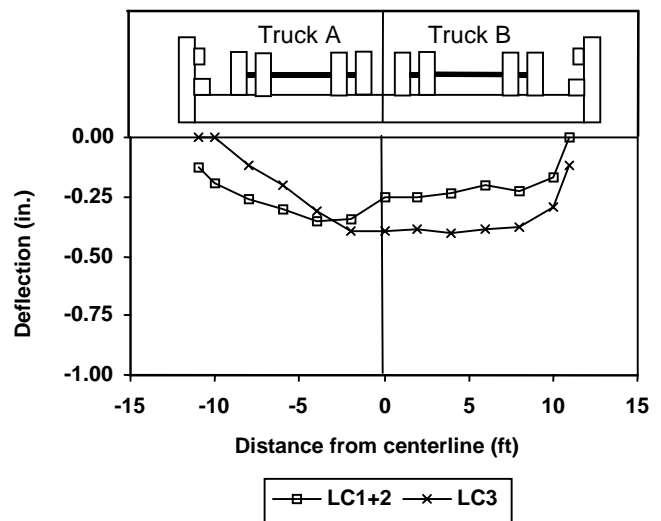
Figure 23—Load test 1 comparison: sum of measured deflections from load cases 1 plus 2 compared with deflections from load case 3.

Assuming accurate load test results and linear elastic behavior, the sum of the deflections resulting from individual truckloads should equal the deflections from both trucks applied simultaneously. Figure 23 shows the load test 1 comparison of individual and simultaneous truck loading. As shown in this figure, the two plots are similar, with variations within the accuracy of the measurements. From this information, it is concluded that the bridge behavior is within the linear elastic range.

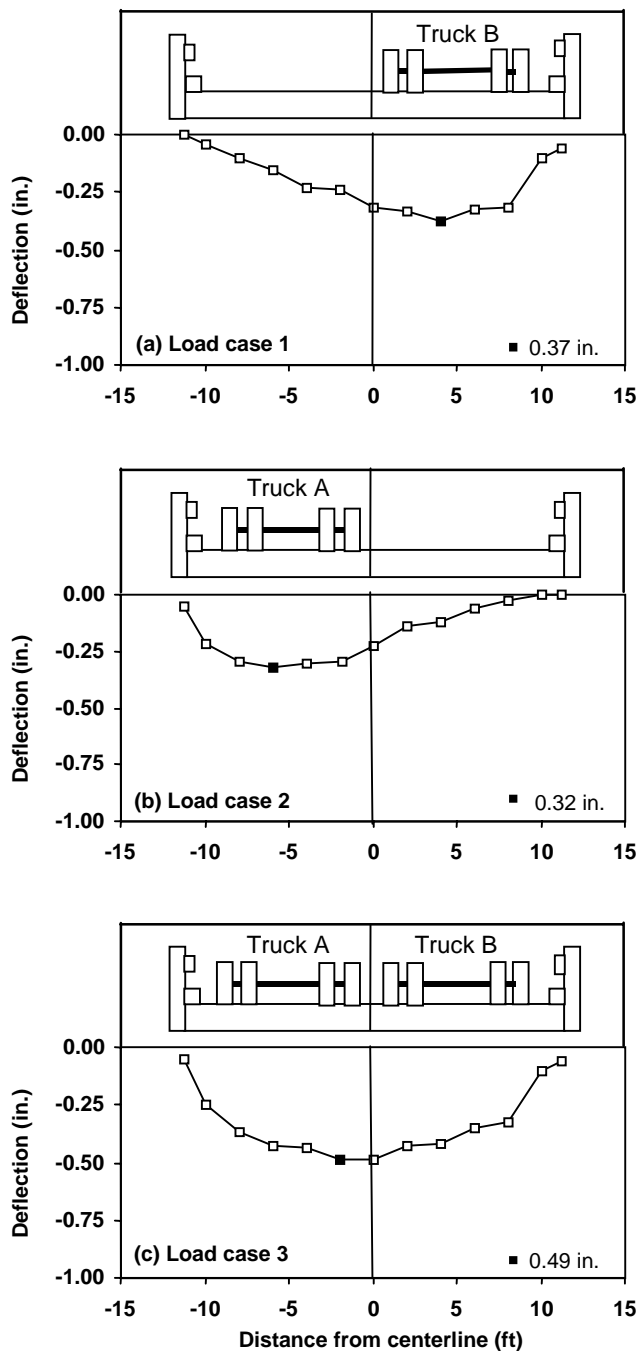
Figure 24—Transverse deflections for load test 2, measured at bridge centerspan (looking north). Bridge cross-sections and vehicle positions are presented for the purpose of interpretation only and are not drawn to scale.

Transverse deflections from load test 2, which was conducted November 7, 1995, are shown in Figure 24. The maximum deflection for load case 1 occurred between the truck wheel lines and measured 0.37 in. (Fig. 24a). The maximum deflection for load case 2 also occurred between the truck wheel lines and measured 0.32 in. (Fig. 24b). The maximum deflection for load case 3 of 0.49 in. occurred under the inside wheel line of truck A and represented the largest deflection of all load cases (Fig. 24c).

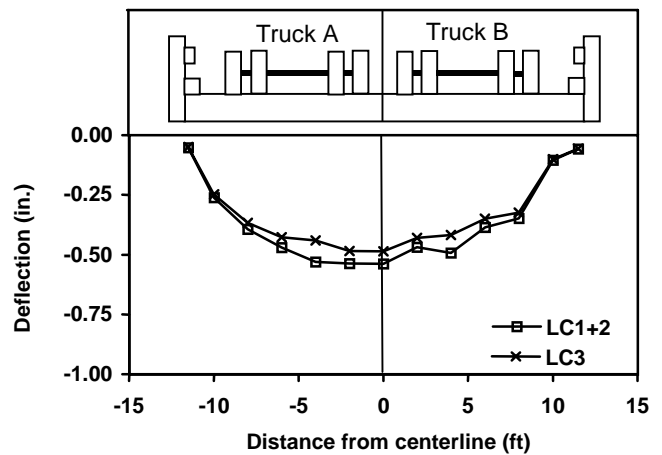
Figure 25—Load test 2 comparison: sum of deflections from load cases 1 plus 2 compared with deflections from load case 3.

Figure 25 shows the load test 2 comparison of individual and simultaneous truck loading. The two plots are nearly identical, again indicating that the bridge behavior is within the linear elastic range.
