# **In-Service Evaluation of Railroad Signal and Stop Arm Pole Protection**

**Final Report  
March 2020**

**Sponsored by**  
Iowa Department of Transportation  
(InTrans Project 17-621)

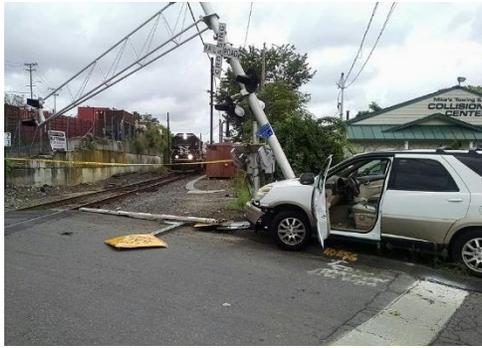
*(a) Motor vehicle crash with signal mast and cantilever (Danbury, Connecticut)*

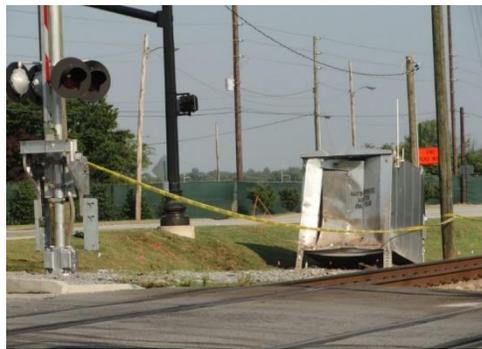
*(b) Motor vehicle crash with controller box (Smyrna, Georgia)*

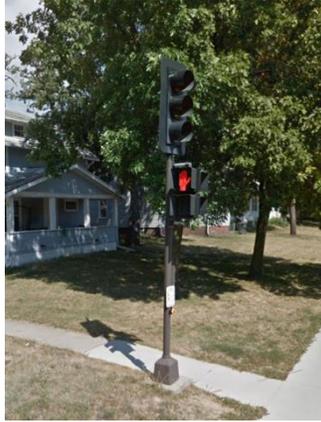
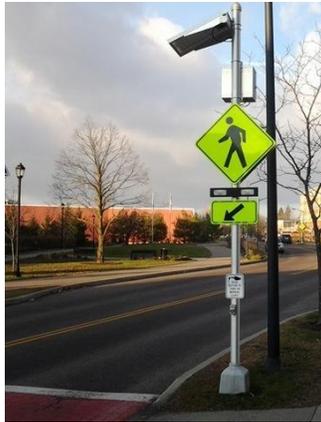
**Figure 2. Example of two crashworthy hardware supports**

*(a) Pedestal-style traffic signal (Ames, Iowa)*

*(b) Pedestrian crossing signal (North Reddington Beach, Florida)*

The use of non-frangible masts at railroad crossings contradicts the current practice for similar hardware supports located in clear zones, including pedestal-style traffic signals and pedestrian crossing signals (Figure 2).

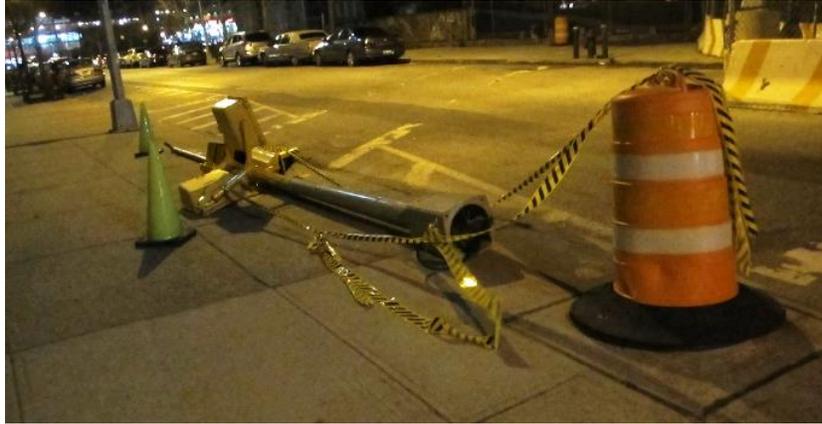
Typically, these devices are designed to conform to the requirements of the American Association of State Highway and Transportation Officials (AASHTO) *Roadside Design Guide* (RDG) (AASHTO 2011). AASHTO also provides specifications for structural supports; a widely used approach is to mount the signal mast on a frangible base (AASHTO 2015). Ultimately, an errant vehicle will impact the side of the base, causing the signal mast to pivot and fall away from the point of impact (Figure 3).

**Figure 3. Traffic signal hardware that has fallen away from the direction of impact (New York, New York)**

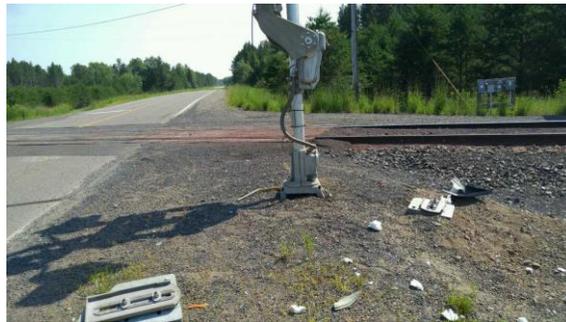
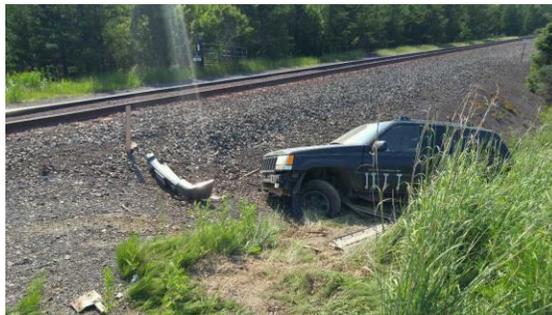
Conversely, photos of crashes involving railroad signal masts show the pole remaining upright after it has been subjected to impact energies that appear to be well beyond those sufficient to knock over RDG-compliant masts (Figure 4).

*(a) Signal mast damage from motor vehicle crash (Brimson, Minnesota)*

*(b) Motor vehicle damage from striking signal mast (Brimson, Minnesota)*

**Figure 4. Comparison of damage to (a) railroad signal mast and (b) motor vehicle after a crash**

Railroad signal masts can experience little damage when involved in a vehicle crash. The only noticeable damage to the mast is often to the counterweights for the gate assembly; however, the vehicle can become disabled and undriveable from the scene of the crash.

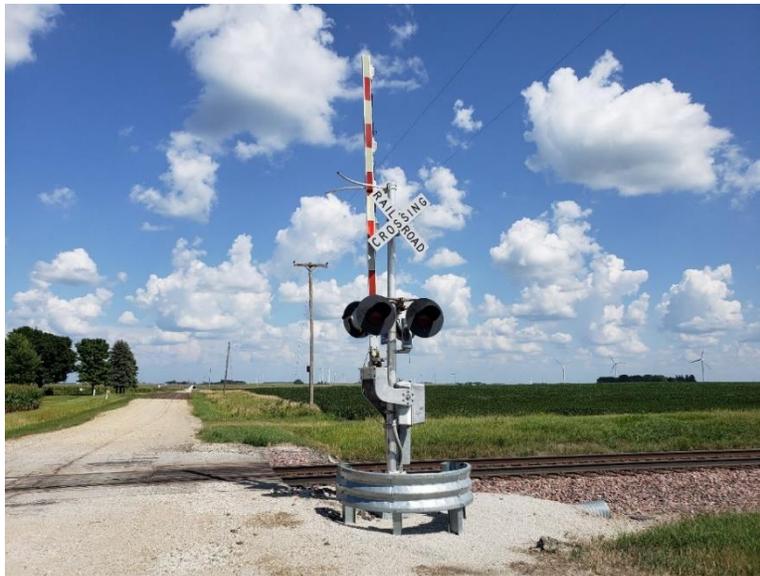
The two handbooks note that guardrails may be used when there is a steep slope and state that, if used, the guardrail should protect motor vehicles and not to be used to protect the mast itself. In low-speed locations with high truck traffic, such as industrial areas, the FHWA Handbook does suggest protecting the signal mast using a ring-style guardrail (Figure 5) (Ogden 2007).

**Figure 5. Ring-style guardrail example (Garden City, Iowa)**

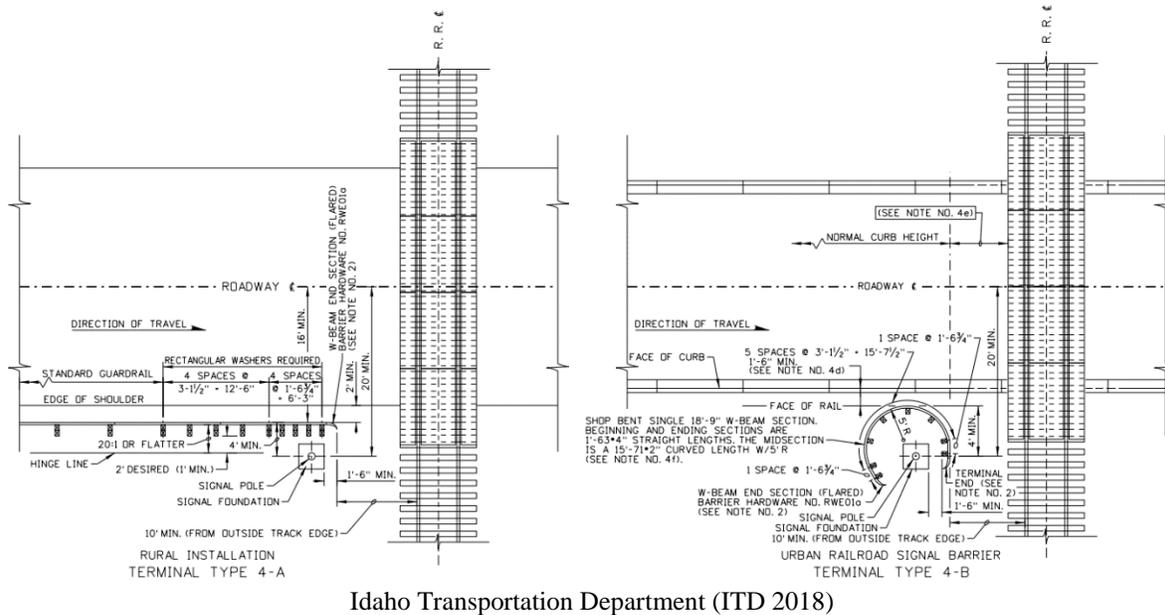
In Idaho, standard drawing G-1-J (Figure 6) illustrates both longitudinal and ring-style designs, which the agency labels as rural installation and urban railroad signal barriers, respectively.

**Figure 6. ITD Standard Drawing G-1-J Revision 6 dated May 3, 2006**

The back of the posts on the longitudinal guardrail are desired to have a 2-foot offset from the center of the pole and a 4-foot minimum offset from the guardrail face. In the ring-style design, The Idaho Transportation Department (ITD) indicates a 5-foot radius from the signal foundation and a minimum of 4 feet of clearance from the guardrail face. In urban areas, the ITD sets a maximum threshold of 40 miles per hour (mph) for these installations, which are set a minimum of 18 inches behind the face of the curb when no pedestrian traffic is present.

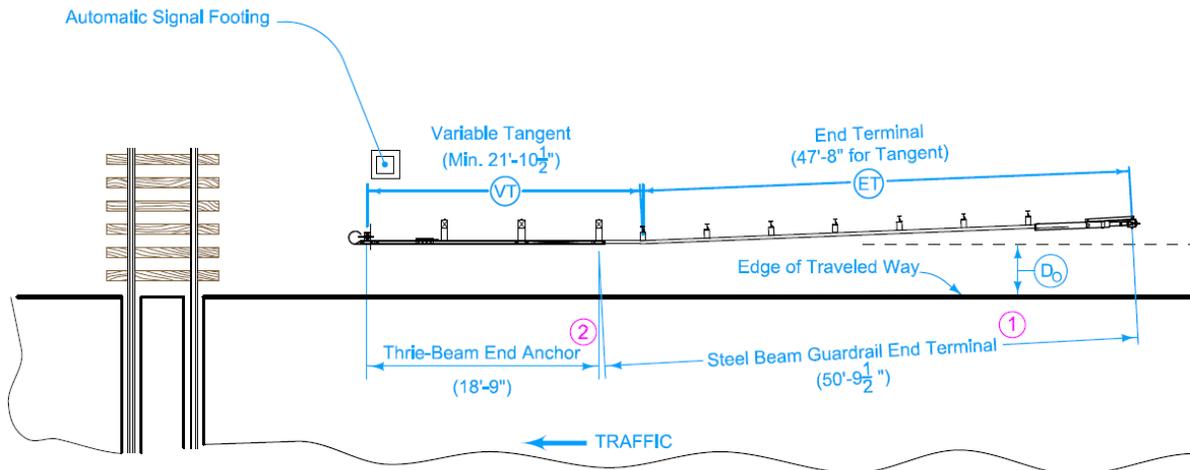
In the state of Iowa, Standard Road Plan BA-253 (Figure 7) calls for a longitudinal guardrail with a crashworthy end terminal to be installed at railroad crossings on federal-aid highways.

**Figure 7. Iowa DOT Standard Road Plan BA-253 Revision 3 dated April 19, 2016**

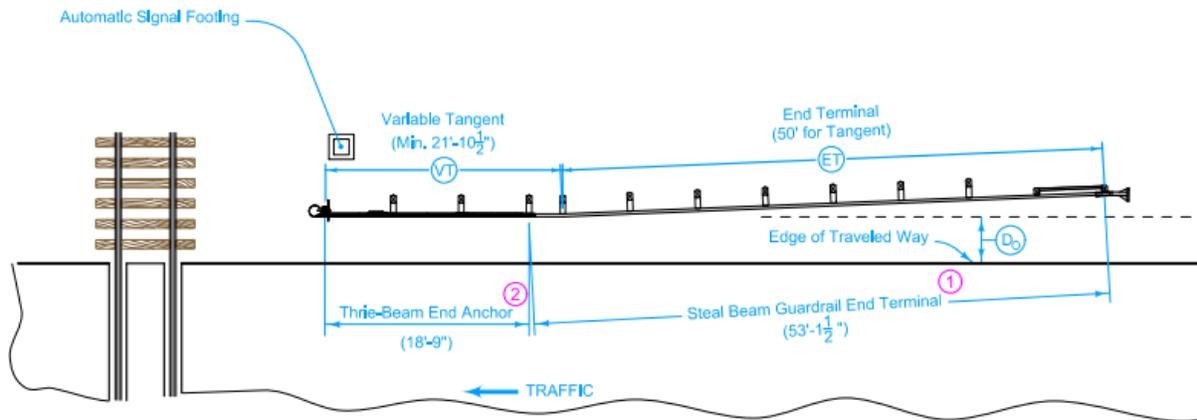
Iowa also has Standard Road Plan LS-633, part of the Local Systems series, which differs from Standard Road Plan BA-253 only in the flared guardrail piece and the end terminal (Figure 8).

**Figure 8. Iowa DOT Standard Road Plan LS-633 dated April 19, 2016**

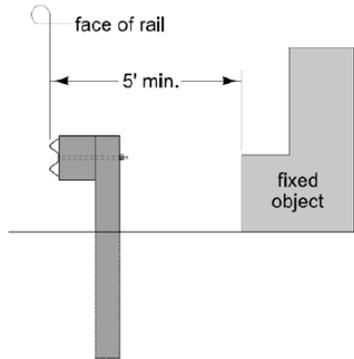
the guardrail is not explicitly stipulated within the design standards. While the state's guardrail guidelines call for 5 feet of clearance distance between the guardrail and the fixed object (reduced to 4 feet if the posts are installed at half of the standard spacing) (Figure 9) (Iowa DOT 2017), this is rarely the case for railroad signals. This problem can be encountered because the railroad signal mast is usually installed prior to the installment of the guardrail.

**Figure 9. Guardrail placement in front of a fixed object**

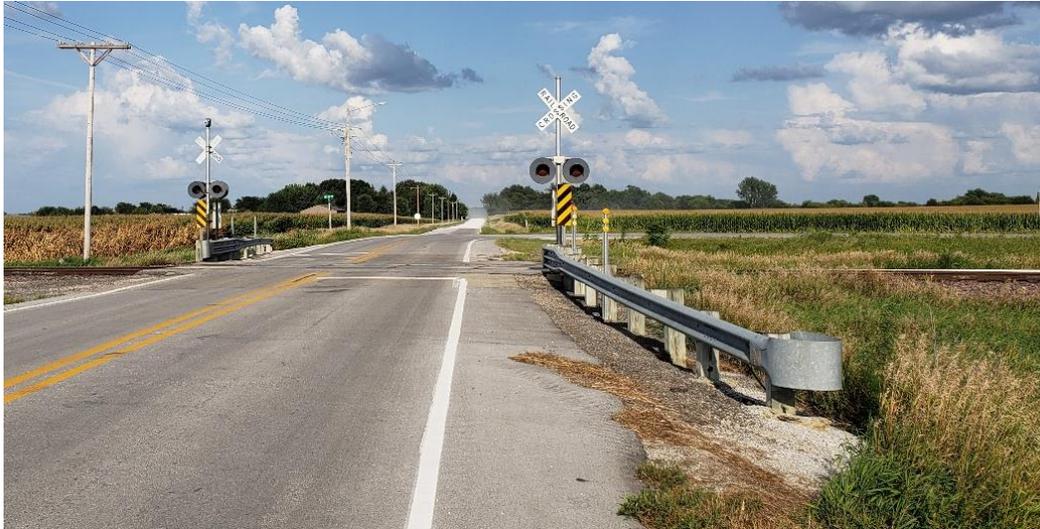
The guardrail design detailed thus far is from the third revision of Standard Road Plan BA-253. Figure 10 shows an example of a previous design, one that does not include the crashworthy end treatment.

**Figure 10. Longitudinal guardrail design from a previous standard (Elkhart, Iowa)**

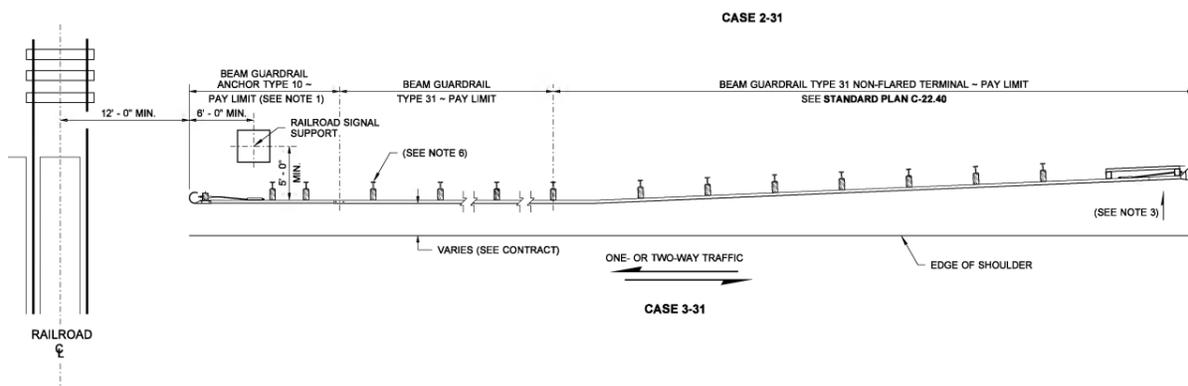
In Washington State, Standard Plan C-20.14-03 Beam Guardrail Type 31 Placement Case 3-31 includes an example of a longitudinal guardrail at a railroad crossing (Figure 11). In this design from the Washington State DOT (WSDOT), the signal support offset is a minimum of 5 feet from the guardrail face, and it is noted that the distance from edge of the shoulder and the face of the guardrail varies by case.

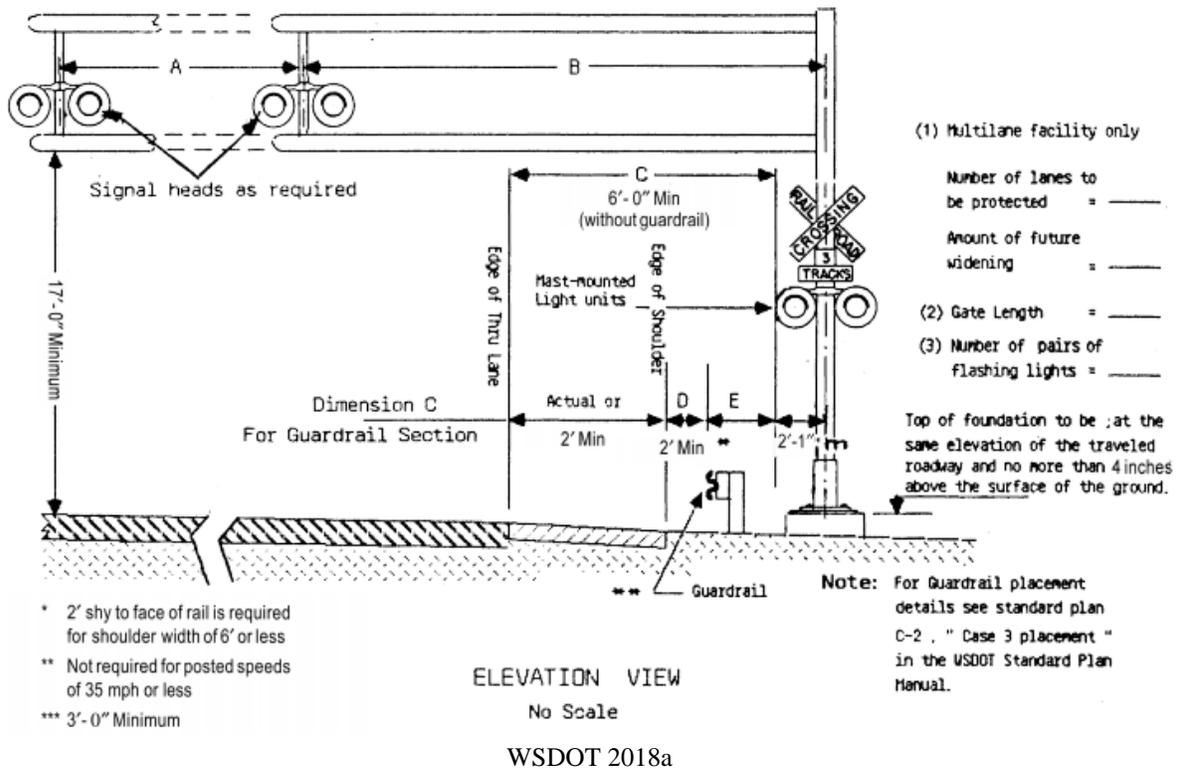
Chapter 32 of the WSDOT Local Agency Guidelines describes a minimum of 2 feet between the guardrail face and the edge of the shoulder (WSDOT 2018a) (Figure 12).

**Figure 12. WSDOT Shoulder Section Elevation View for Submittal from WSDOT Local Agency Guidelines M 36-63.36 (June 2018)**

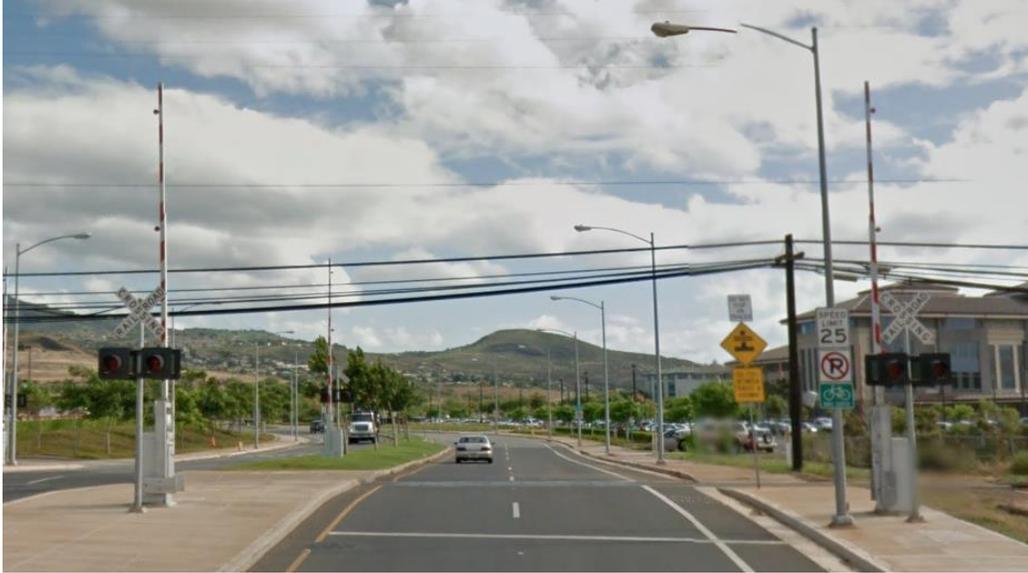
**Figure 13. Example of a signalized railroad crossing on Oahu (Kapolei, Hawaii)**

Although Hawaii does not have a railroad division within its state transportation agency, it does have some at-grade crossings. Figure 13 shows a signalized railroad crossing with separate apparatus for its gate assembly and signal mast. It also appears to have traffic signal hardware for the flashing lights. Other countries, such as Australia, Finland, Germany, and Japan, do install devices to shield the mast from being struck.

In other countries, railroad at-grade crossings can differ significantly in appearance and the types of traffic control devices used to warn drivers. Even remote locations within the US can differ, such as crossings in Hawaii (Figure 13).

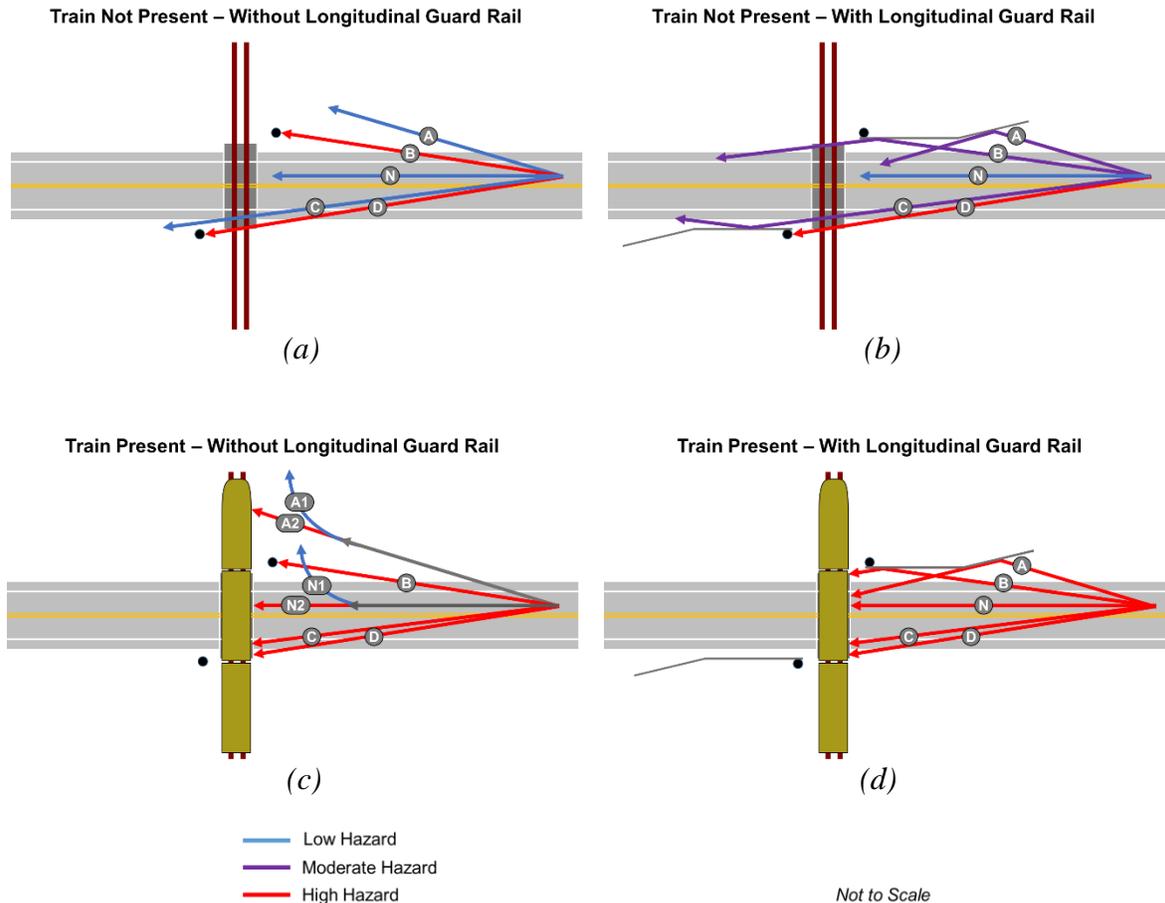
The presence of a guardrail affects the path a vehicle would normally take in a run-off-road (ROR) situation. Figure 17 outlines a few basic scenarios under two different conditions (with and without a train present).

**Figure 17. Hypothetical vehicle trajectories for various conditions**

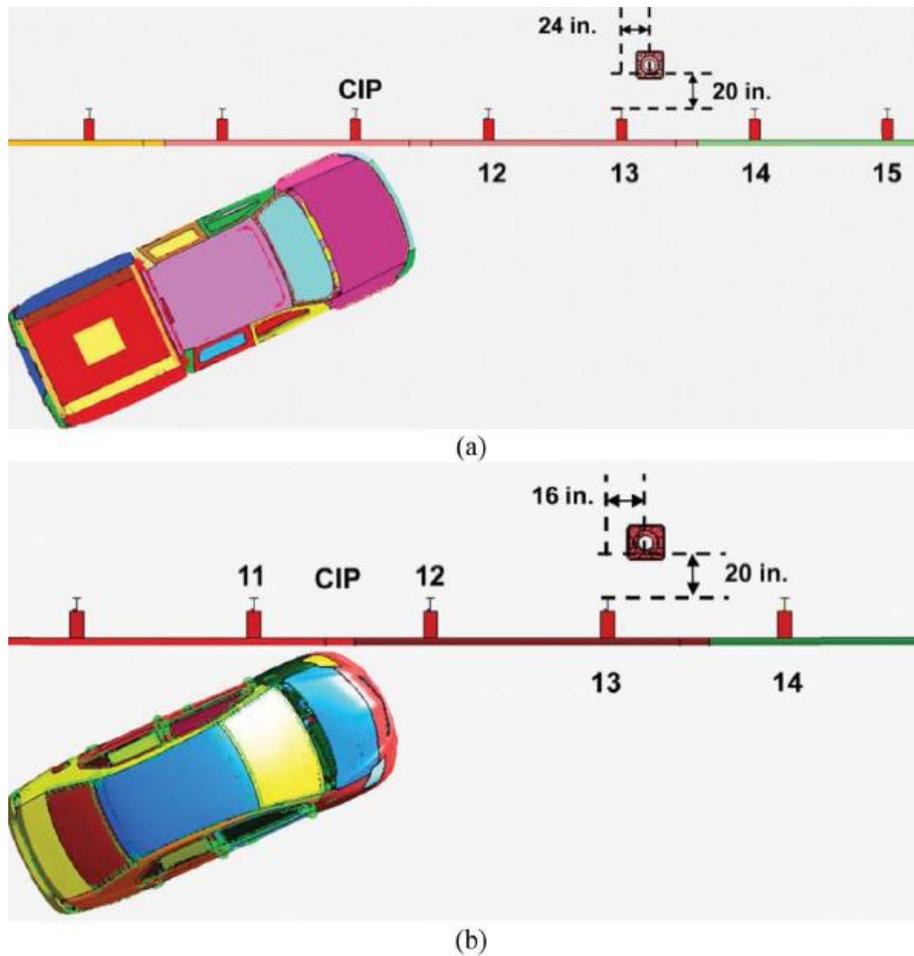
Pajouh et al. (2017b) conducted another study using computer simulations and compared the results with full-scale crash testing. Based on the simulation, it was found that the most critical pole offset was 20 inches laterally behind the back of the guardrail post and 24 inches longitudinally downstream from post number 13 for a pick-up truck. For a passenger car, offsets of 20 inches laterally and 8 inches longitudinally downstream from post number 13 were found to be the most critical pole placement. In comparison to the crash tests according to TL-3 MASH test designations 3-10 and 3-11 (Figure 18), the MGS contained and safely redirected both vehicles, which indicated that the 41 inch offset between the face of the guardrail and the front face of the pole leads the guardrail system to perform safely.

**Figure 18. Recommended pole placement: (a) MASH test designation 3-11 and (b) MASH test designation 3-10**

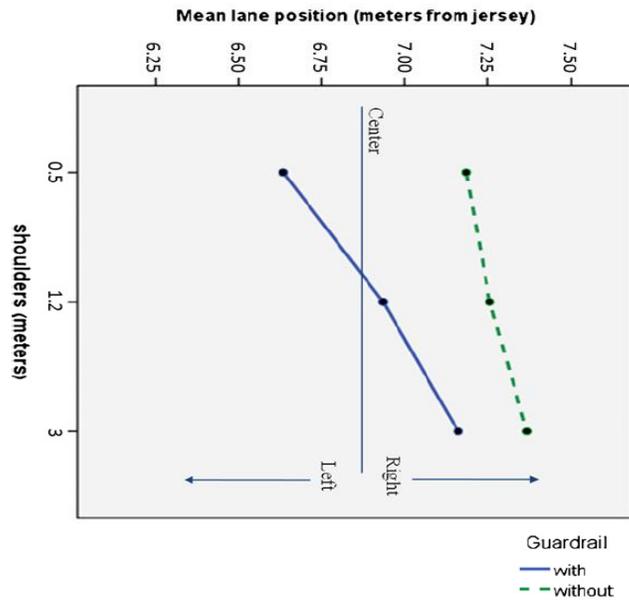
presence of guardrails increased the perceived safety. Drivers in the simulation tended to shift away from the guardrail as a result and drove significantly closer to the left lane (Figure 19).

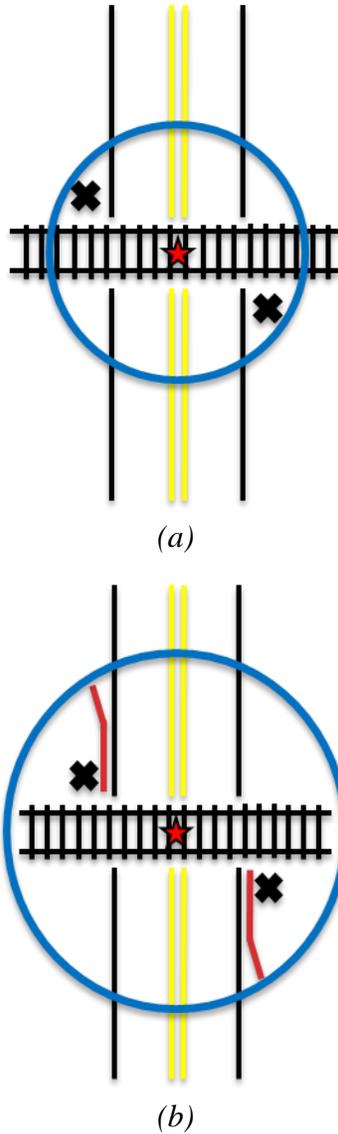
Figure 21 is a diagram outlining the procedure used to gather crashes.

**Figure 21. Buffer zone radii used to collect crashes of interest: (a) railroad crossing without guardrail and (b) railroad crossing with longitudinal guardrail**

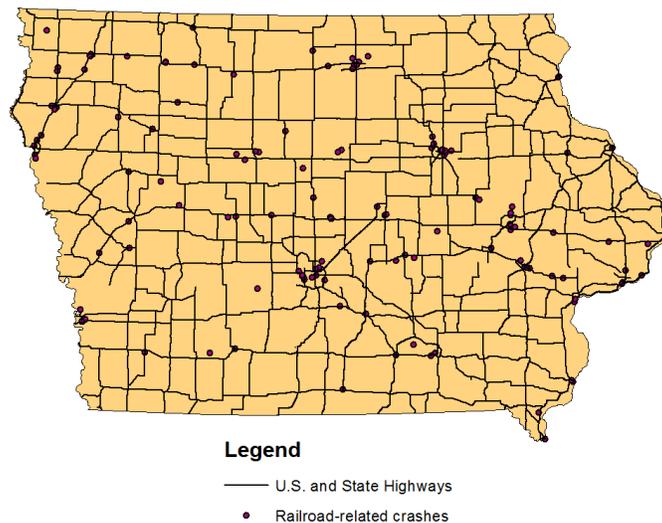
The crashes of interest were collected through various query searches and reviews of the crash code narratives. From the 1,874 crashes that occurred within the radius of the crossings, 200 crashes did not include a narrative. Filtered searches included variations and misspellings on the following words: “railroad,” “train,” “crossing,” “pole,” “mast,” “signal,” “guardrail,” and “barrier.” A total of 156 railroad-related crashes were found and can be seen in Figure 22.

**Figure 22. Railroad-related crashes in Iowa 2007–2016**

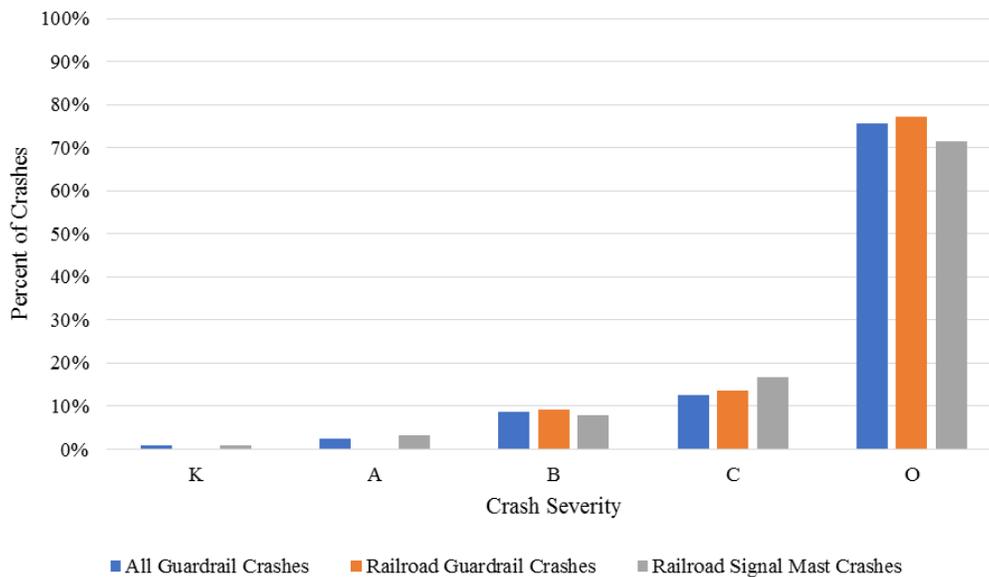
A statistically significant difference in crash severity was not found between crashes where a vehicle struck a railroad signal mast (4.55) versus those where a vehicle struck a guardrail or other barrier (4.68). The only significant differences were observed when crashes involving a train pushing a vehicle into a railroad apparatus were compared to other crash types. Only 13 crashes occurred when a train was present or was soon to be present, with two crashes resulting in minor injuries. Due to the small sample of railroad-related crashes in which a vehicle hit a guardrail or other barrier, these crashes were also compared to all single-vehicle crashes during the same time period (2007–2016) in Iowa on non-Interstate roads in which the guardrail (face or end) was a part of the sequence of events. The comparison yielded similar findings. The crash severities of crashes with railroad signal masts also had a distribution similar to those of the guardrail crash types. A graph comparing the three crash types can be seen in Figure 23.

**Figure 23. Comparison of crash severity distributions between three types of crashes**

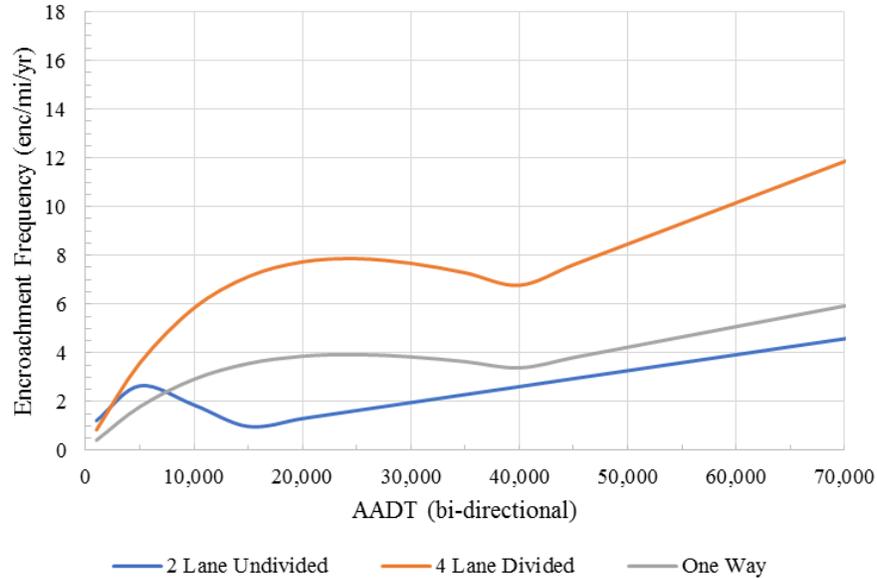
The average traffic volume on rural primary highways from the railroad inventory was approximately 2,500 vehicles per day. To study the impact of traffic volume on crash likelihood, AADTs of 1,000 and 5,000 were also studied. AADT values larger than 5,000 were not analyzed due to the unnatural encroachment frequency curve (see Figure 24).

**Figure 24. Encroachment module used in RSAP v3**

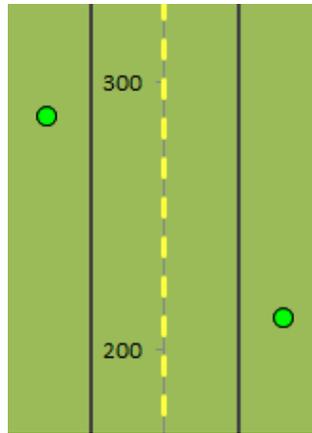
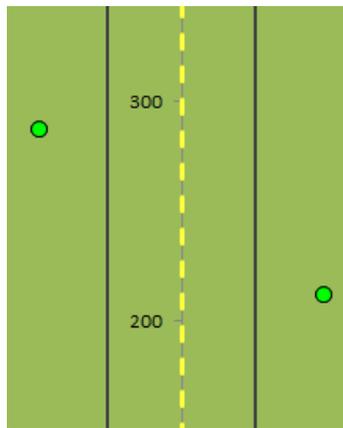
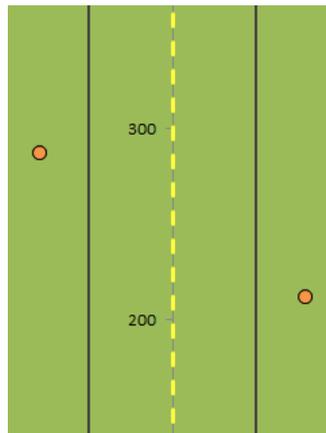
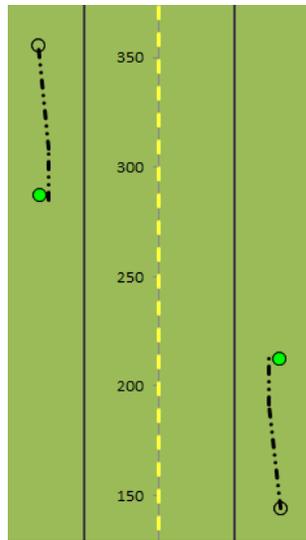
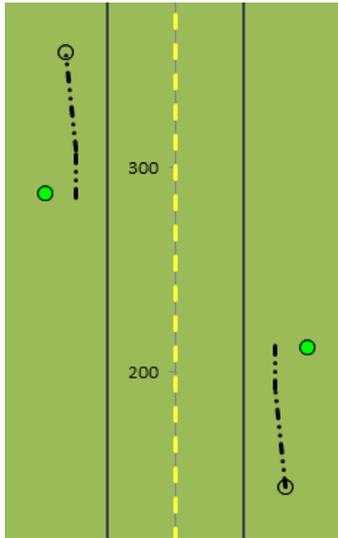
<b>Condition</b>	<b>Alt. 1 (a)</b>	<b>Alt. 2 (b)</b>	<b>Alt. 3 (c)</b>	<b>Alt. 4 (d)</b>	<b>Alt. 5 (e)</b>
Railroad signal mast?	Yes	Yes	Yes	Yes	Yes
Is it breakaway?	No	No	Yes	No	No
Offset from edge of traveled way	6 ft	10 ft	6 ft	6 ft	10 ft
Longitudinal guardrail?	No	No	No	Yes	Yes
Offset from edge of traveled way	N/A	N/A	N/A	5 ft	5 ft

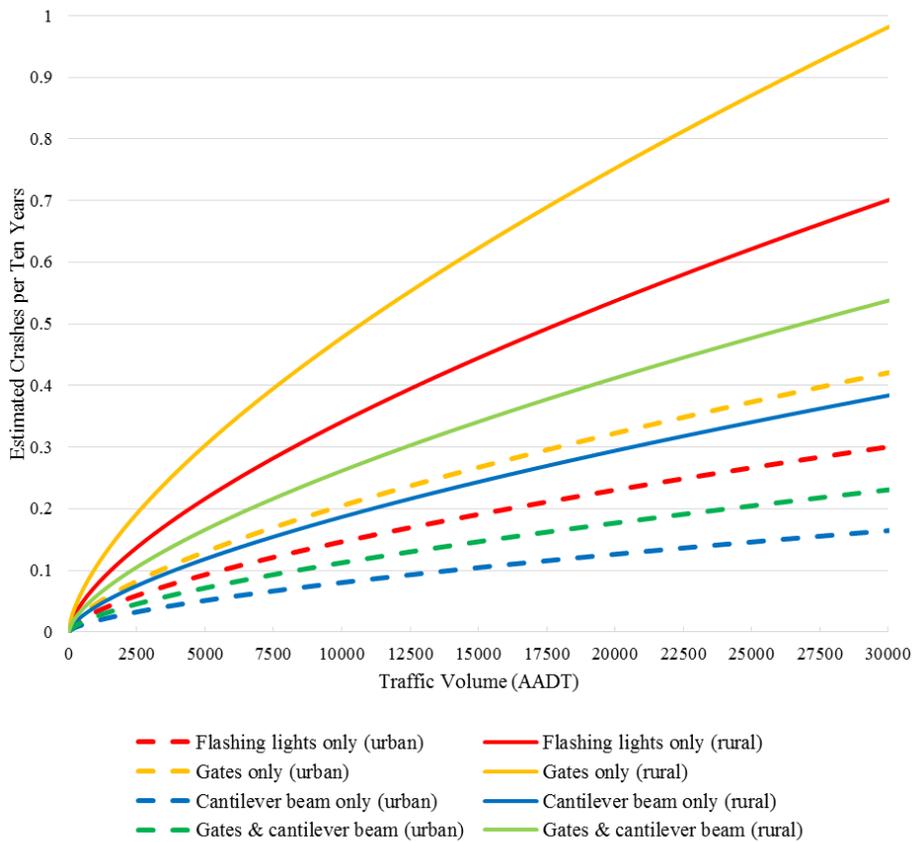
This analysis included the presence of a longitudinal guardrail as a predictor variable. However, the results did not show that the presence of a longitudinal guardrail made a substantial difference in crash likelihood, which is partially attributable to the limited number of locations where a guardrail was installed, as shown in Table 9. A graph visualizing the eight possible combinations of crossing can be seen in Figure 26.

**Figure 26. Estimated railroad signal mast strikes per 10 years given traffic volume**

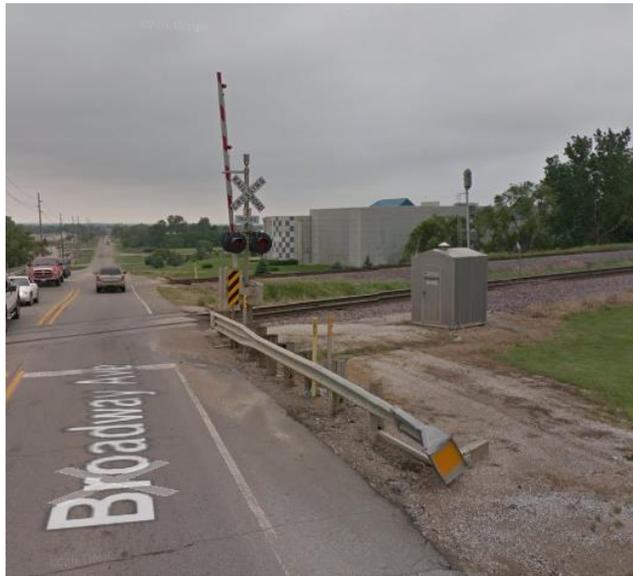
**Figure 27. Example of guardrail damage at a crossing that had no railroad-related crashes during the study period**

was not provided. An example of a crossing that had visible damage but no corresponding crashes can be seen in Figure 27.

Upon investigation, unreported crashes were found to be present in this study and were identified at the quality control stage. Damage was found at several crossings either on the signal support or on the protection device. No railroad-related crash was recorded at eight of these crossings during the study, meaning that the crash was either unreported or a narrative of the circumstances

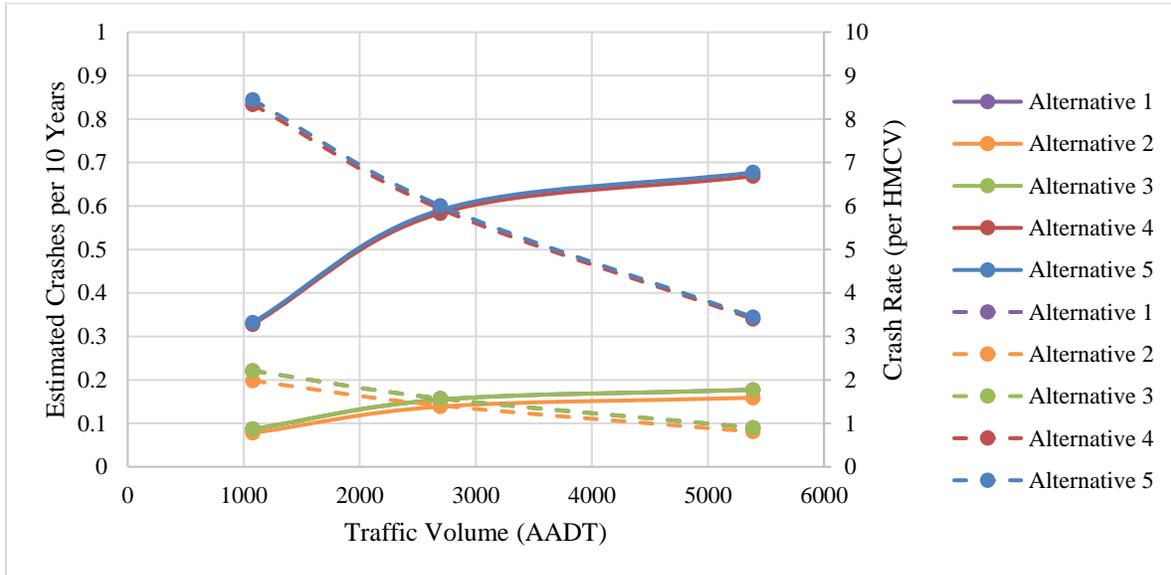
In each alternative, the number of crashes increased with increased traffic volumes, but the rate of increase decreased as AADT increased. Thus, the crash rates decreased with higher traffic volumes. This can be visualized in Figure 28, where the crash frequencies are represented by solid lines and the crash rates are represented by dashed lines.

**Figure 28. Estimated railroad-related crashes per 10 years and crash rates using RSAP**

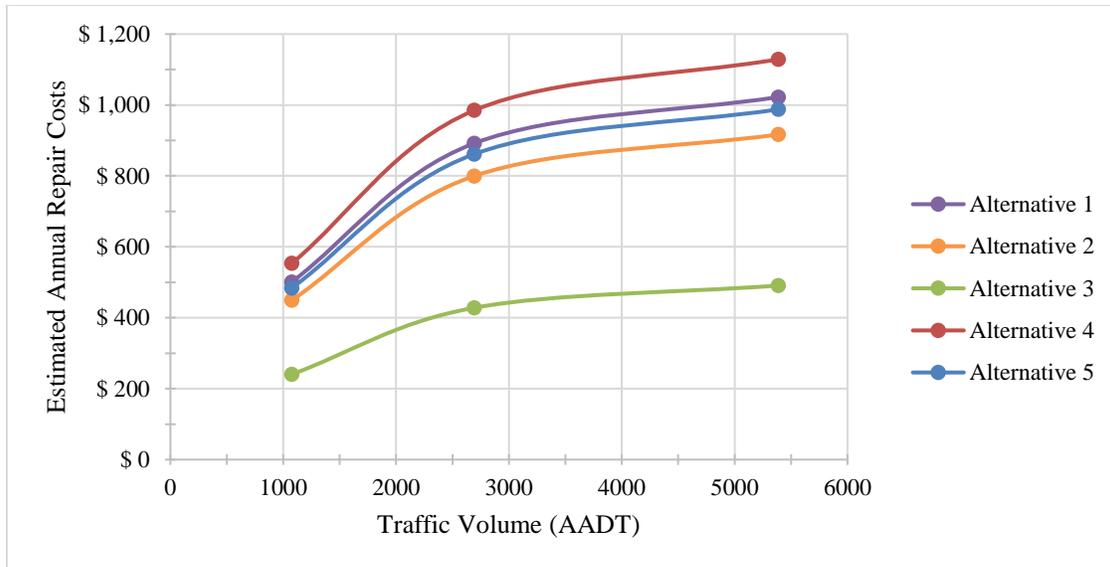
When looking at the annual repair costs, all of the alternatives appear to be relatively similar except Alternative 3 (see Figure 29).

**Figure 29. Estimated annual repair costs by traffic volumes using RSAP**

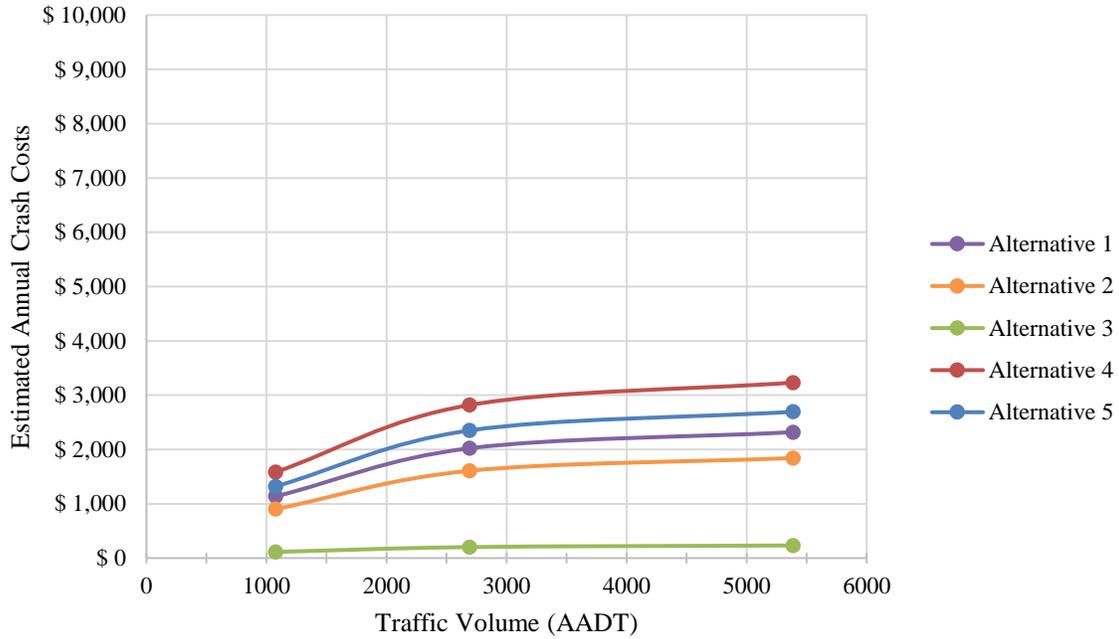
The assumed VSL is critical to the benefit-cost analysis. The calculated annual crash costs under the two different VSL values are plotted in Figure 30 and Figure 31 for assumed values of \$4.5 million and \$9.6 million, respectively.

**Figure 30. Estimated annual crash costs using a VSL of \$4.5 million**

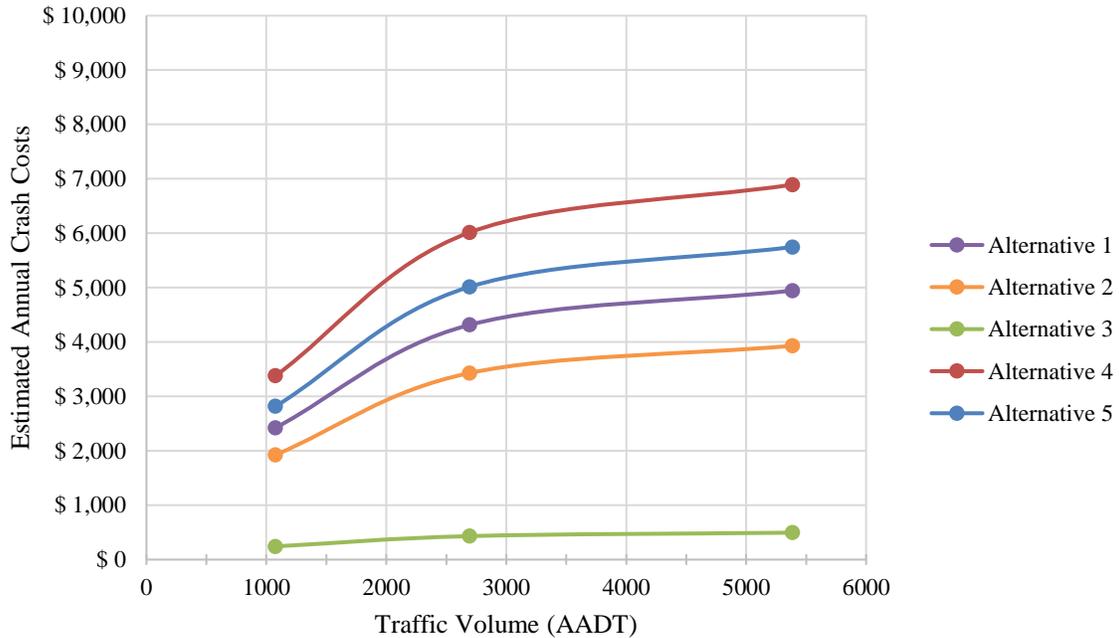
**Figure 31. Estimated annual crash costs using a VSL of \$9.6 million**

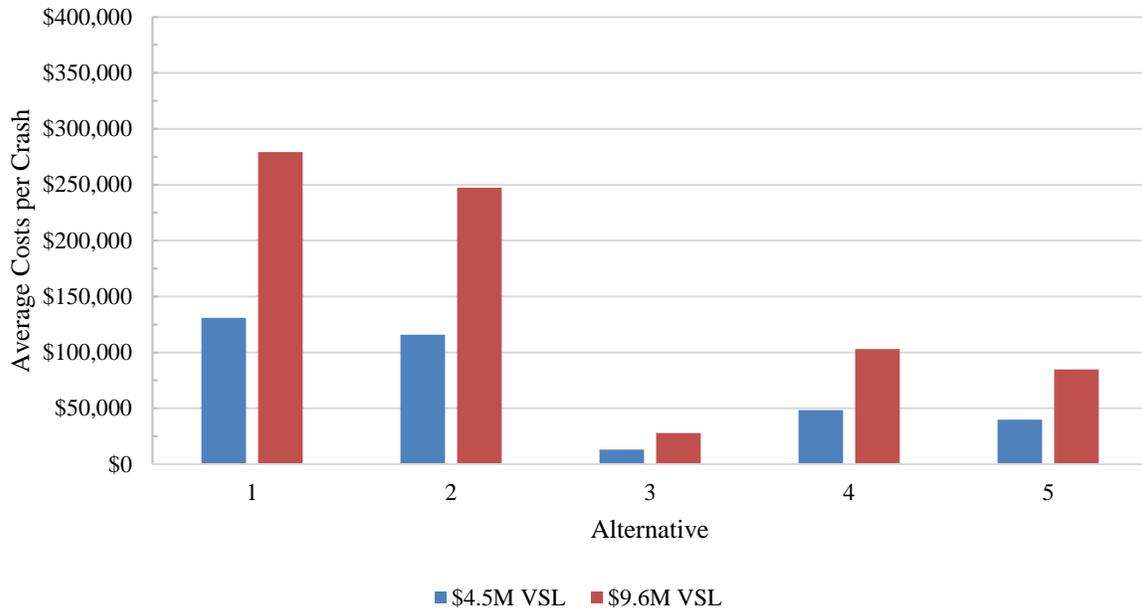
Although the two alternatives that provided guardrail protection to the signal mast had higher repair and crash costs, when the average cost per crash was considered these alternatives had much lower costs than the two alternatives without guardrails (see Figure 32).

**Figure 32. Average costs per crash at each alternative with different VSLs**

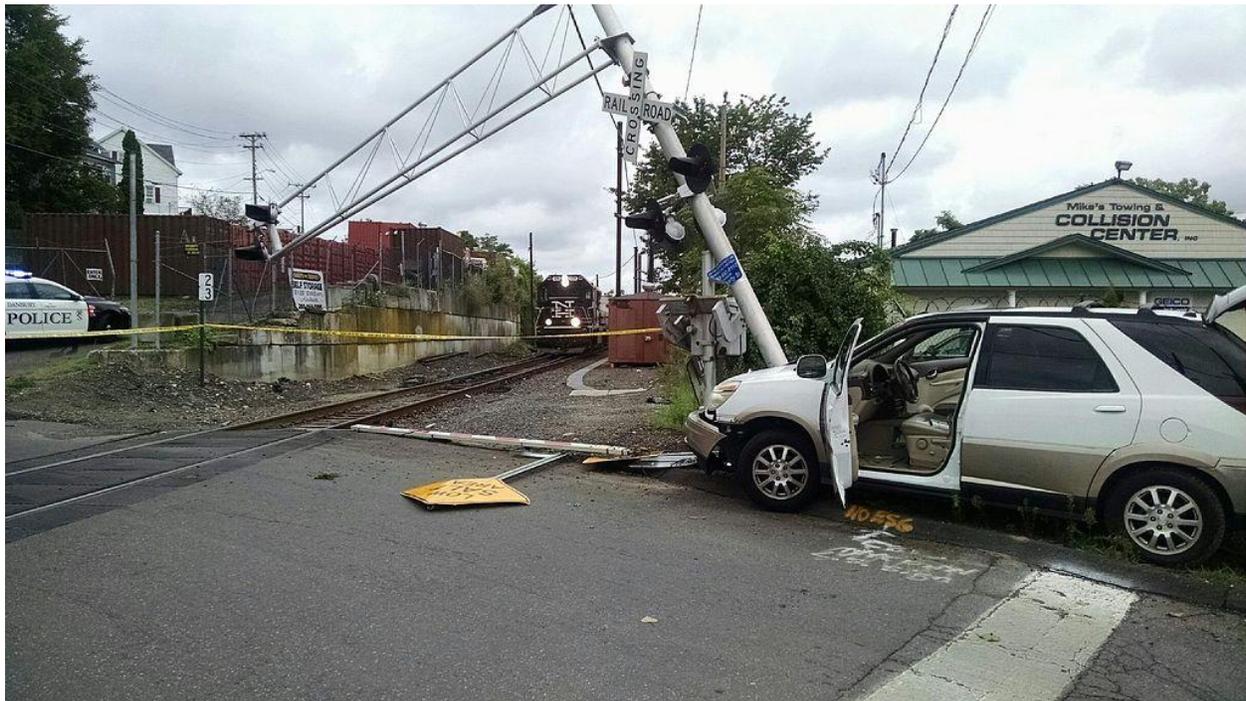
Motor vehicle collision with railroad crossing signals near Danbury, CT (Aug 2016). Photo: Metropolitan Transportation Authority of NY
