# Effectiveness and Guidance of Aggressive Rehabilitation of Gravel Roads

**Final Report**  
**November 2025**

**IOWA STATE  
UNIVERSITY**  
**Institute for  
Transportation**

**Sponsored by**  
Iowa Highway Research Board  
(IHRB Project TR-823)  
Iowa Department of Transportation  
(InTrans Project 23-859)

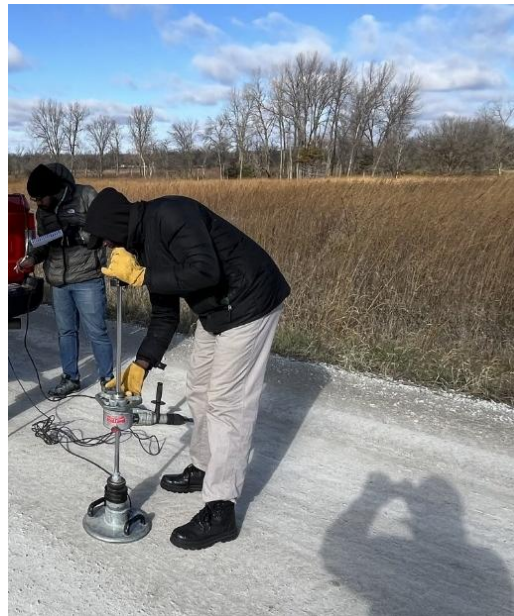
**Figure 2. Zorn ZFG 3000 LWD device**

The LWD test provides a rapid assessment of the composite elastic modulus of a roadway's surface and subgrade layers. It involves application of an impulse load to the ground through a loading plate. The resulting plate deflection is recorded by an internal transducer, and surface stiffness is computed. For this project, the Zorn ZFG 3000 LWD device shown in Figure 2 was used, with the specifications summarized in Table 1. The test was performed in accordance with ASTM E2835-11.

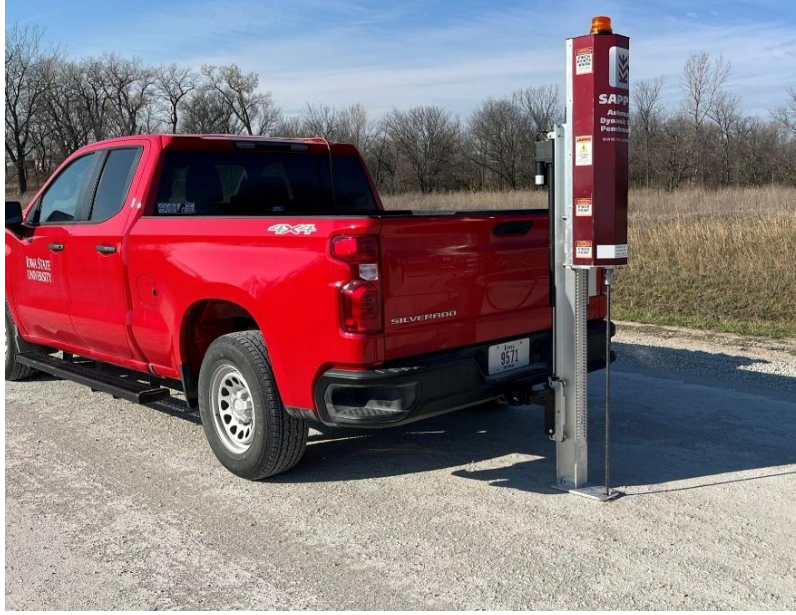
**Figure 3. KSE Sapper Automatic DCP device**

To evaluate the in situ shear strength profiles of the aggregate and soil layers, ADCP tests were conducted in accordance with ASTM D6951/D6951M-18. The dynamic cone penetrometer (DCP) test involves applying a dynamic load with a drop hammer weighing 17.6 lb (8 kg) from a height of 22.6 in. (574 mm) to drive a conical tip into the soil. The resulting penetration depth and number of blows are recorded, from which the CBR value is calculated using correlations developed by the U.S. Army Corps of Engineers and provided in ASTM D6951/D6951M-18. The Sapper Automatic DCP device from Kessler Soils Engineering was used, as shown in Figure 3.

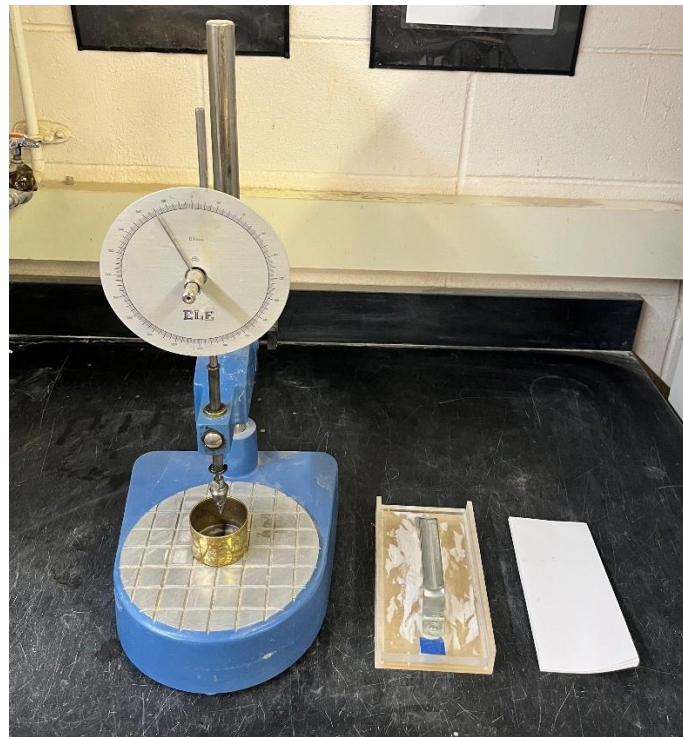
**Figure 7. Fall cone test device and plastic limit rolling device**

Atterberg limits (liquid limit, plastic limit, and plasticity index) were determined per ASTM D4318 on both surface aggregate and subgrade materials. Samples that passed the No. 40 (425  $\mu\text{m}$ ) sieve were used for the tests. The plastic limit was measured using a plastic limit rolling device as per ASTM standard, and the liquid limit was assessed by the fall cone method. The plastic limit rolling and fall cone devices are shown in Figure 7.

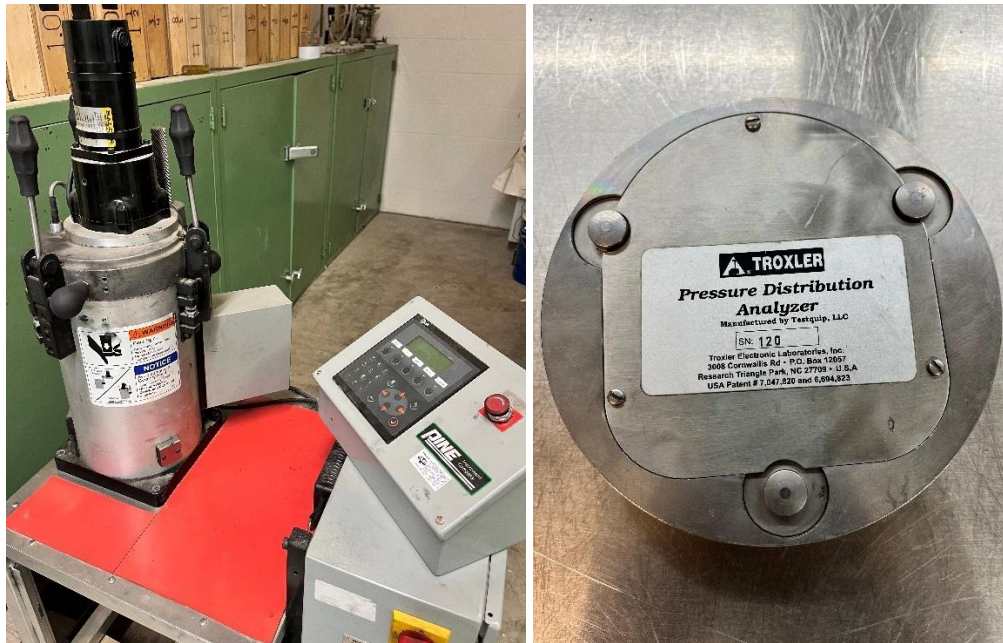
**Figure 8. Gyrator compactor (left) and pressure distribution analyzer (right)**

The gyratory compaction test was originally developed to evaluate the compaction behavior of asphalt mixes and has recently been successfully adapted for granular materials (Li et al. 2017). The device enables measurement of key properties such as dry unit weight, shear resistance, void ratio, and compaction energy across a controlled number of gyrations of a constant vertical load. This is especially important for coarse and well-graded aggregates used in unpaved roads, where particle shape and packing influence how well the material performs under traffic loading (Bozorgzad 2017, Ghasemi et al. 2016, Ghasemi et al. 2018). The test was generally performed in accordance with ASTM D6925, which is the standard procedure for preparing and measuring the density of hot-mix asphalt specimens using a gyratory compactor. Although this standard is designed for asphalt, it was adapted here to test unbound granular aggregate. The aggregate test samples were prepared using a riffle splitter and then separated into two test specimens of approximately 4,500 g each. The tests were performed using a Brovold Gyratory Compactor from Pine Instrument Co. and a Troxler pressure distribution analyzer (PDA), as shown in Figure 8.

During the tests, the gyratory compactor was set to a vertical pressure of 600 kPa (the same value used for Superpave specifications) and an angle of gyration of  $1.25^\circ$  and was operated at 30 revolutions per minute (rpm). These parameters simulate the kneading effect of traffic on road surfaces, as the gyratory head on top rotates while applying a constant vertical pressure to the specimen. The specimen height was recorded to the nearest 0.1 mm after each gyration by the

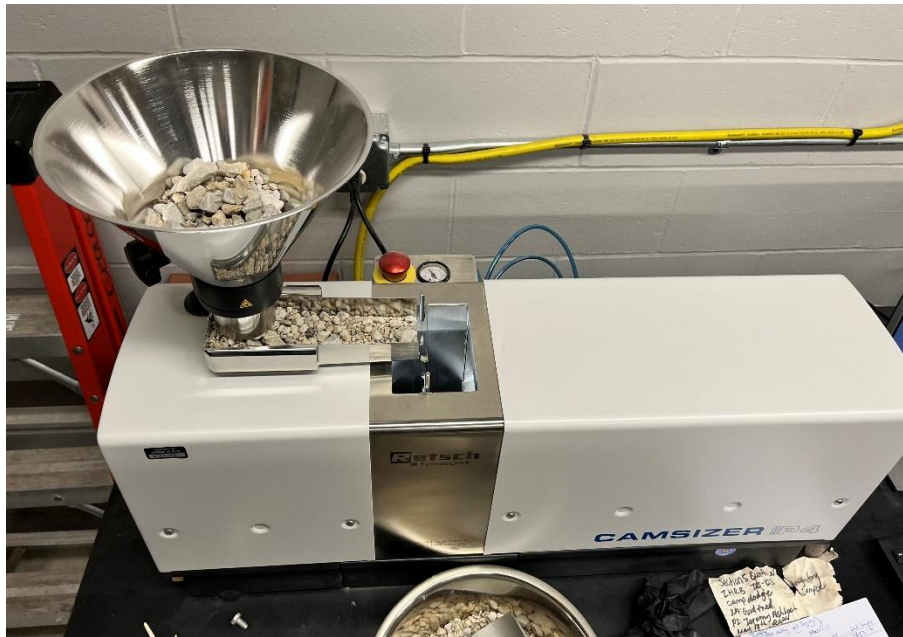
**Figure 10. Iowa DOT Camsizer device**

Image analysis was conducted on the coarse fraction of the gyratory compaction samples (material retained on the No. 10 sieve, washed and oven dried) both before and after compaction using the Iowa DOT's Camsizer P4 device (Figure 10). This device uses advanced image processing technology to measure particle size and shape for particles ranging from 0.02 mm to

30.0 mm in diameter (Dawson 2021). This procedure was performed in accordance with AASHTO T 381-181.

Particle size distributions determined by image analysis using the Iowa Department of Transportation's (Iowa DOT's) Camsizer device (but limited to material coarser than the No. 10 sieve) were found to produce results consistent with traditional sieve analysis.

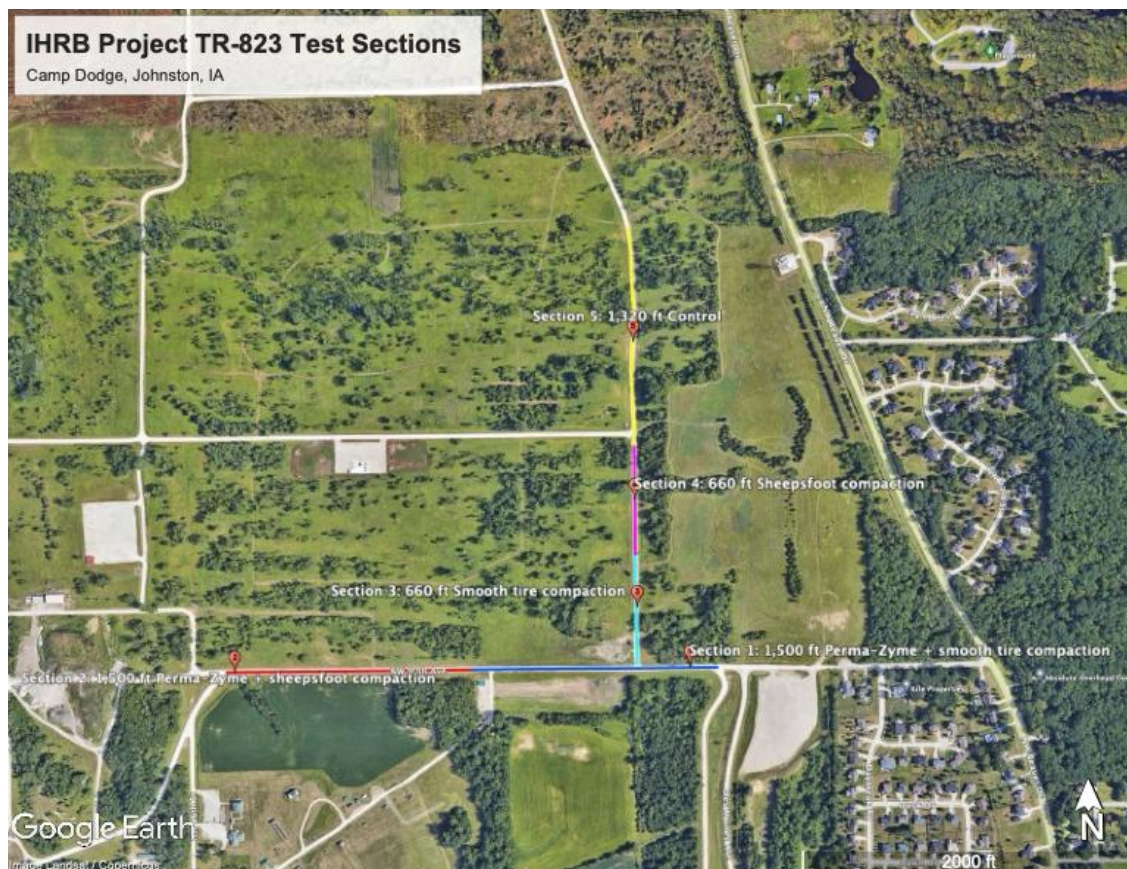
**Figure 31. Project test section layout**

- Section 1: Enzymatic stabilization with smooth-tired compaction (1,500 ft)
- Section 2: Enzymatic stabilization with sheepsfoot compaction (1,500 ft)
- Section 3: Smooth-tired compaction only (660 ft)
- Section 4: Sheepsfoot compaction only (660 ft)
- Section 5: Control section with no stabilization or compaction (1,320 ft)

Sections 1 and 2 each spanned 1,500 ft and were treated with Perma-Zyme, an enzymatic liquid chemical stabilizer. After material from the ditches and from the previous granular surface, which consisted of a few inches of deteriorated crushed limestone aggregates, was incorporated into the rebuilt roadway profile, the stabilizer was blended into the upper 6 in. of the resulting blend of materials. The most important requirement for soil to be compatible with Perma-Zyme is that it possess some organic content, which is usually achieved in the form of clay (Substrata 2022). Therefore, soil having some degree of plasticity should be compatible, but a range of particle sizes is also essential for the soil to bind with the stabilizer. For design with Perma-Zyme, the manufacturer recommends performing a sieve analysis and verifying that the soil possesses at least 20% fines passing the No. 200 sieve, along with a range of particle sizes for proper binding. Proctor compaction tests are recommended to determine the soil's optimum moisture content, along with Atterberg limits tests to assess the soil's plasticity and thus compatibility with the stabilizer.

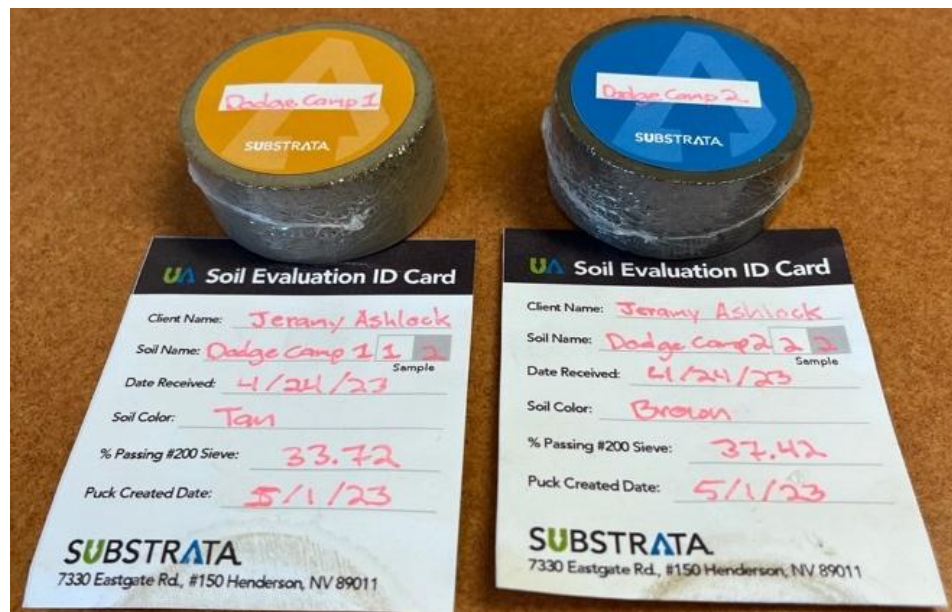
**Figure 32. Soil samples from project site treated with Perma-Zyme stabilizer**

To ensure that the stabilizer would be effective for the soil conditions at the site, two soil samples were collected from the subgrade next to Section 1 and sent to the manufacturer several months before construction. As shown in Figure 32, the two samples had 34% to 37% fines, and the stabilizer effectively cemented the loose, silty soils into a hardened, brick-like material expected to enhance field performance. Previous applications of Perma-Zyme by various Iowa counties have also yielded favorable results.

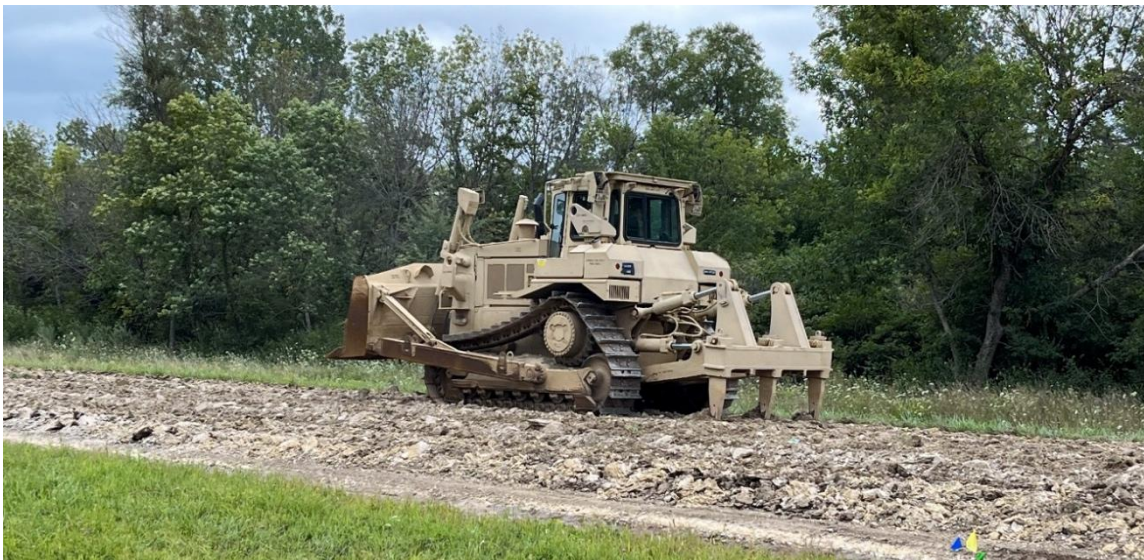
**Figure 34. Ripping existing roadway materials**

On Day 1 of construction (August 14, 2023), the existing roadway surfaces of Sections 1 through 4 were ripped using teeth attached behind a dozer (Figure 34). For typical gravel roads, ripping can usually be achieved with a scarifier or ripper attachment on a motor grader. However, the roadway in this study had been constructed with very large construction debris up to 10 in. or more in width (Figure 35), for which the larger dozer teeth were more effective. The road was then aggressively rehabilitated by excavating subgrade material from the ditches (Figure 36), bringing in the excavated ditch material to build up the central profile elevation (Figure 37), and spraying with water and mixing with motor graders (Figure 38) while also compacting with either the smooth-tired (Figure 39) or sheepfoot compactor (Figure 40). A new corrugated culvert drainage pipe was also installed on Day 1 to replace a smaller one on the north edge of the intersection of Sections 1 and 3 (Figure 41).

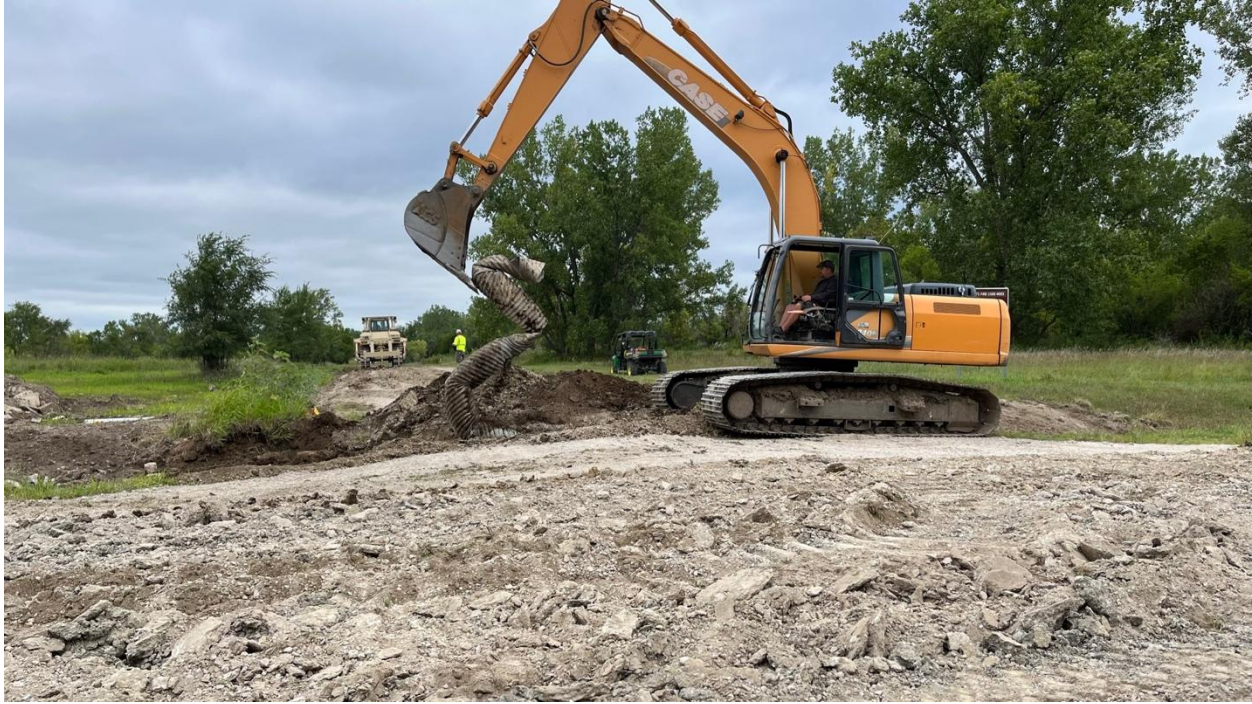
**Figure 41. Removal of old corrugated culvert pipe for replacement**

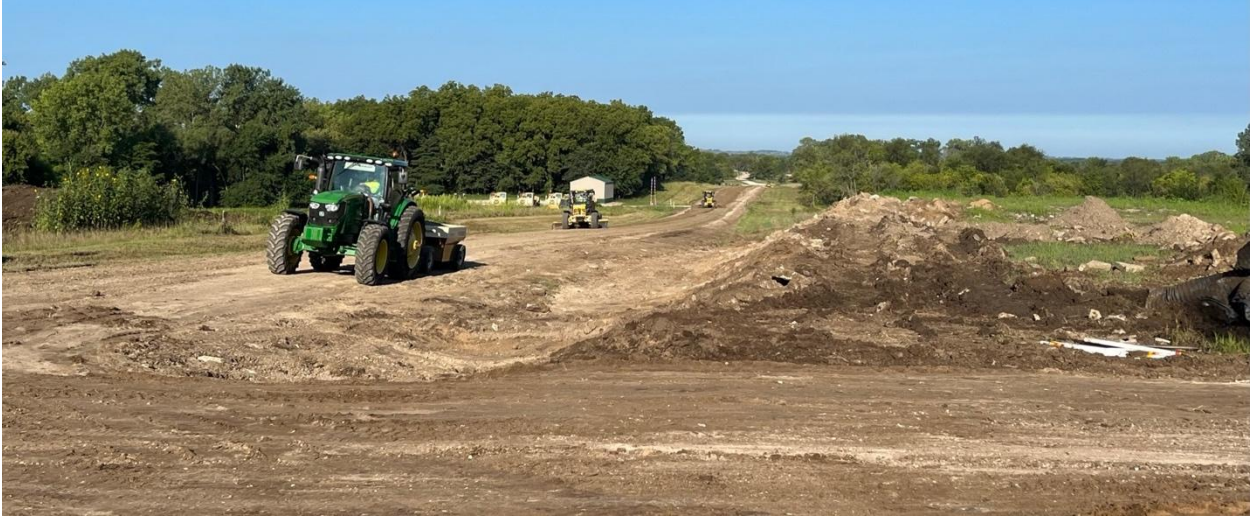
**Figure 42. Continued shaping and compaction of reconstructed road profile on Day 2**

These procedures rebuilt the road's cross-sectional shape while increasing the surface elevation, narrowing the width, and re-establishing the crown and side ditches to improve drainage. The combined reclaimed and in-place materials were compacted throughout the construction process to improve density and stability. After the cross-sections were rebuilt, the rehabilitated width of Sections 1 and 2 was 28 ft, whereas the width of all other sections was 22 ft. Rebuilding the aggressively rehabilitated profiles of Sections 1 through 4 required all of Day 1 (August 14, 2023) and half of Day 2 (August 15, 2023, shown in Figure 42). In the afternoon of Day 2, Sections 3 and 4 were completed by spreading Class A roadstone on the rebuilt surface, followed by spraying water and compacting (Figure 43 and Figure 44).

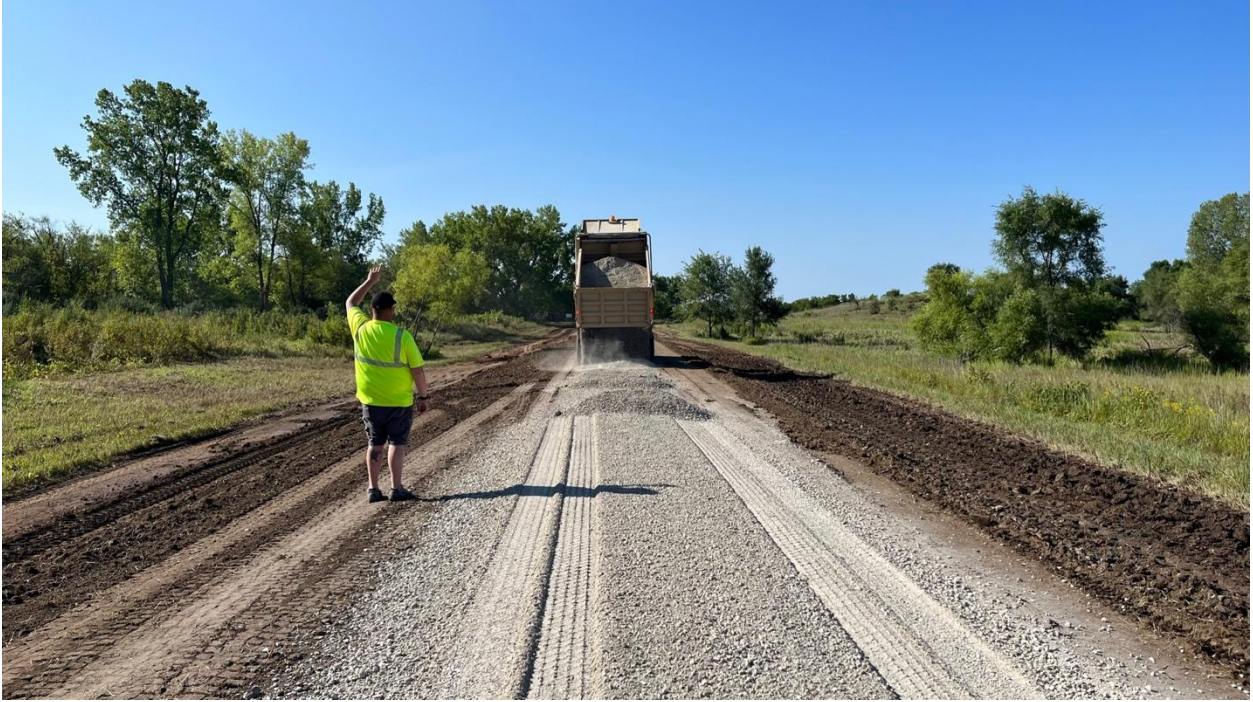
**Figure 44. Spreading Class A roadstone on surface of Section 4 on Day 2 (August 15, 2023)**

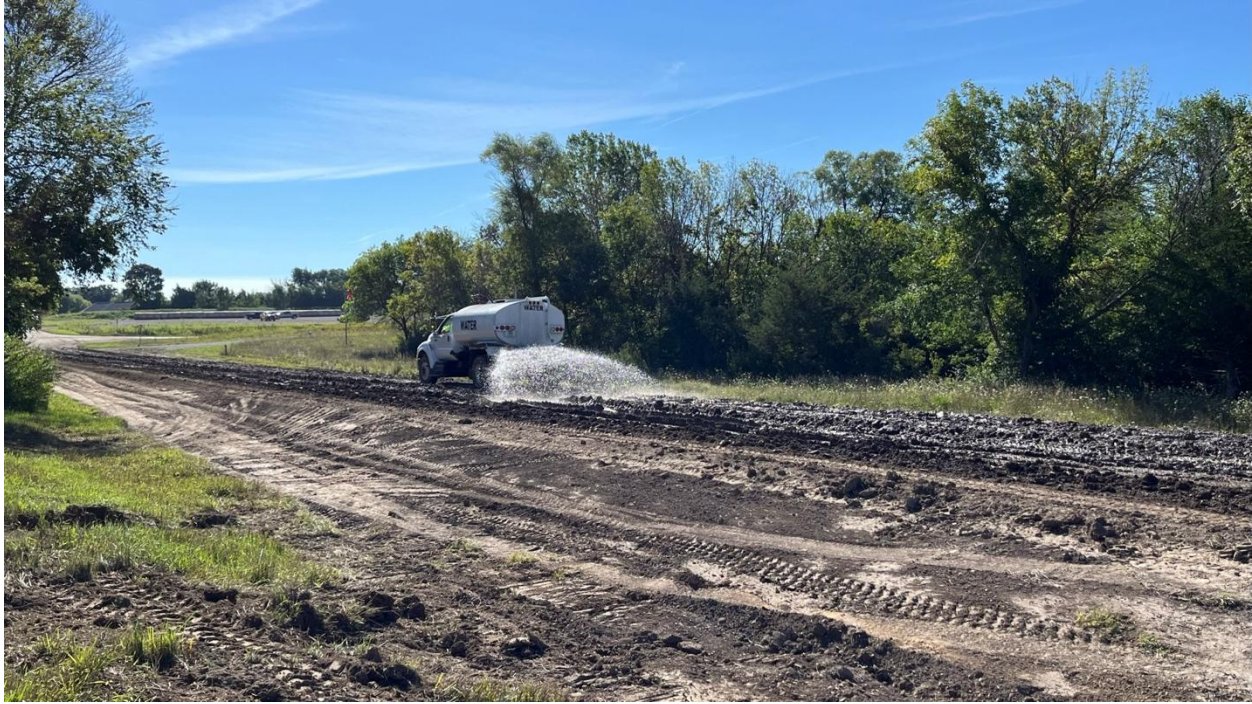
**Figure 45. Spraying water on surfaces of Sections 1 and 2 on Day 3 prior to spraying stabilizer**

On the morning of Day 3 (August 16, 2023), water was sprayed on the surface of Sections 1 and 2, and the top 6 in. of material was scarified in preparation for applying the stabilizer (Figure 45). The stabilizer was incorporated into the top 6 in. of Sections 1 and 2 at the manufacturer's recommended rate of 1 gal per 160 yd<sup>3</sup> of soil. For the 28 ft width of these two sections, incorporating the stabilizer over their combined length of 3,000 ft to a depth of 6 in. resulted in the following calculated amount of stabilizer:

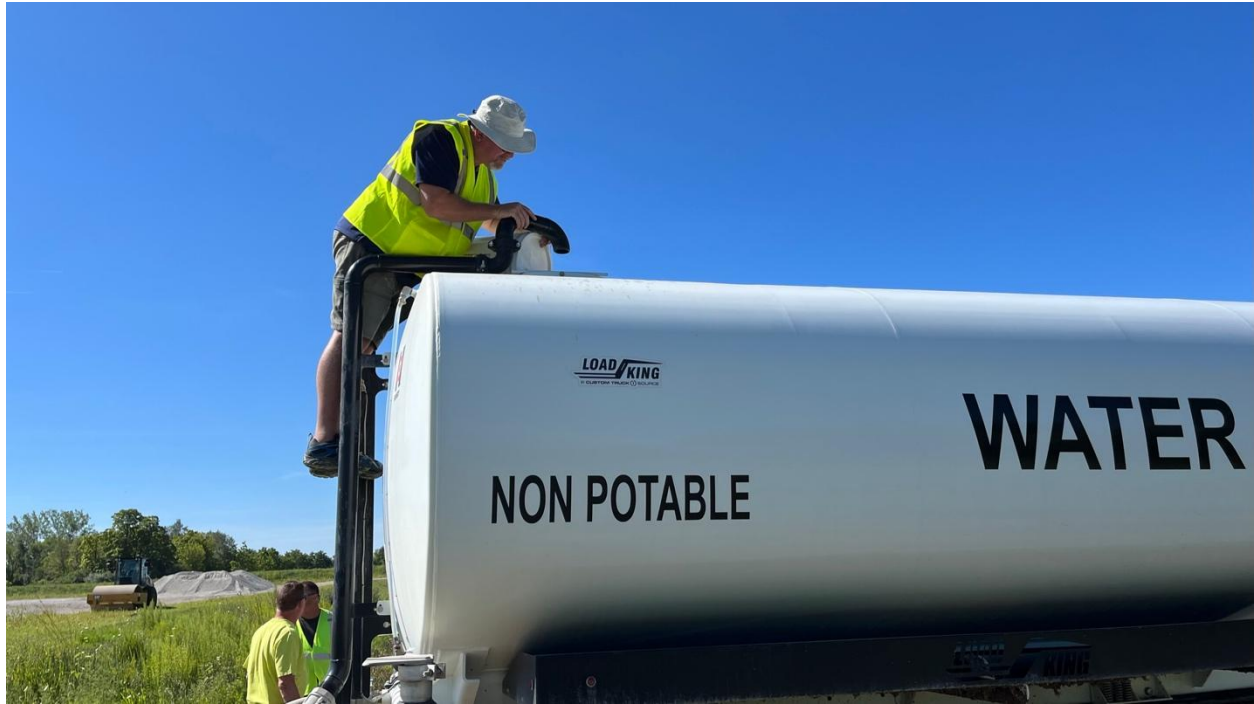
**Figure 46. Adding liquid stabilizer to nearly full 2,200 gal water truck**

To incorporate the stabilizer, small windrows were first formed to help reduce runoff, then the liquid stabilizer was poured into the tank of a nearly full 2,200 gal water truck (Figure 46) and sprayed over the surface of Sections 1 and 2 (Figure 47 and Figure 48). Motor graders were then used to bring the windrows in while mixing the applied stabilizer into the top 6 in. of the subgrade material (Figure 49, Figure 50, and Figure 51). After the stabilizer was incorporated and the surface was shaped, additional compaction passes were applied to the stabilized subgrade over the course of a few hours (Figure 52).

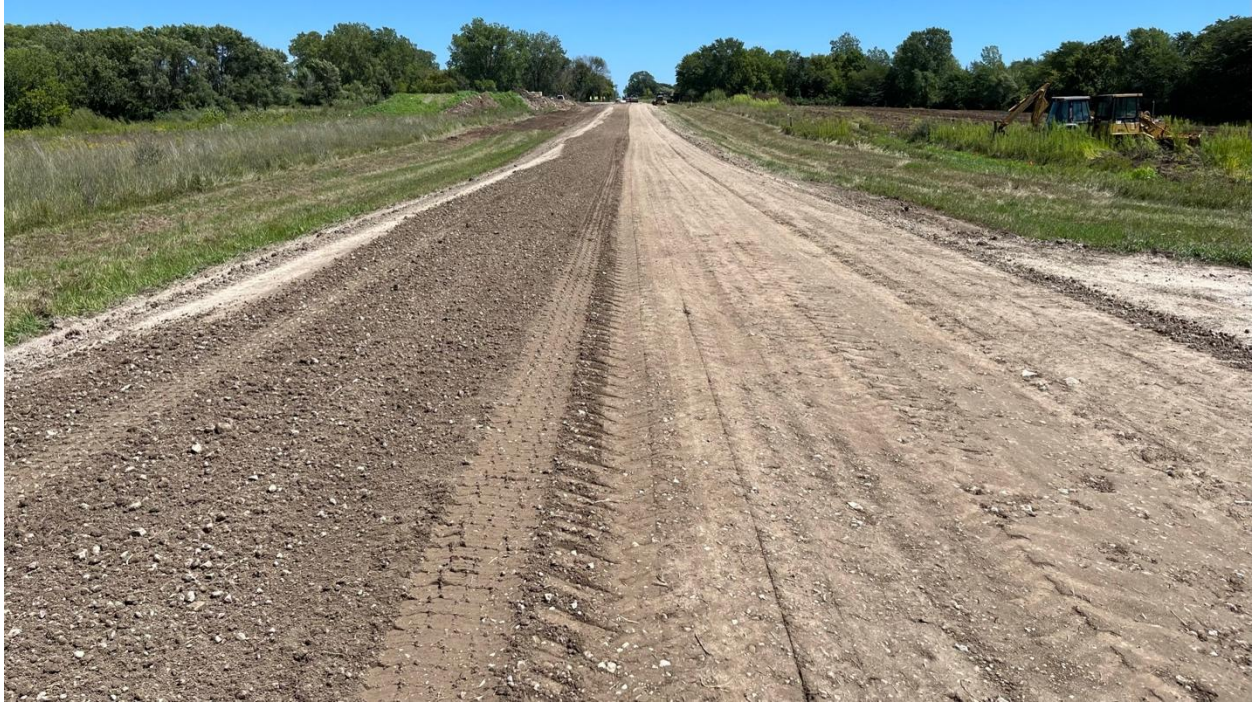
**Figure 52. Perma-Zyme treated subgrade in Section 1 before (left) and after (right) first compaction pass of smooth-tired roller**

The manufacturer's recommended construction procedure is to form the soil into windrows and pre-wet them with water, then let them sit overnight before unfolding the windrows and applying the stabilizer. After stabilization, it is also recommended to wait for the treated soil to fully cure and gain strength prior to applying a gravel surface, which could require several days. However, for this project it was decided to apply the stabilizer and mix and compact for three hours, then spread a light cover of roadstone the same day and leave the road overnight (Figure 53). This construction procedure was adopted because it is the road rehabilitation scenario that Iowa county engineers would likely use. Then on Day 4, the majority of the Class A roadstone was spread (Figure 54), and additional water was applied for compaction of the final surface by a few passes of the smooth-tired roller (Figure 55). Construction was completed by noon on Day 4. The finished surfaces of Sections 1 through 4 and the untouched control Section 5 are shown in Figure 56 through Figure 60.

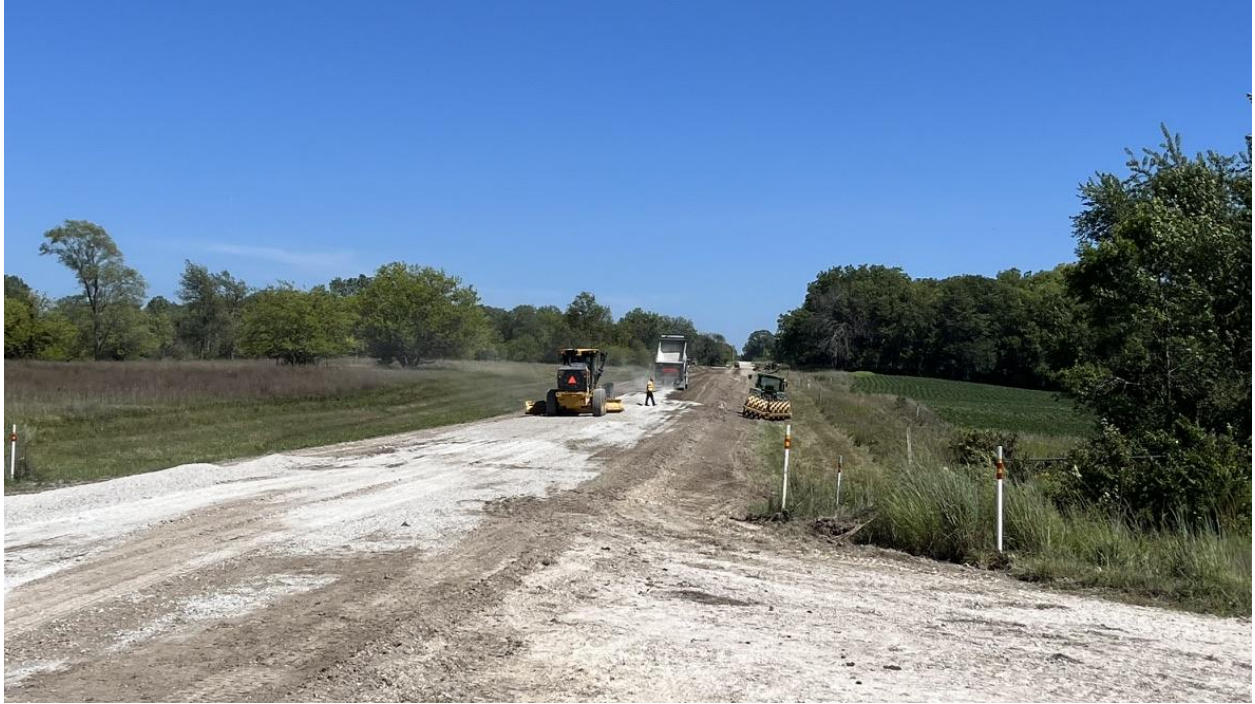
**Figure 53. Spreading of light roadstone cover to leave on road overnight**

By the end of construction, a total of 1,315.7 tons of Class A roadstone had been uniformly spread over the rehabilitated Sections 1 through 4. On average, this equates to a thickness of 2.2 in., comprising 488.8 tons of roadstone on each of Sections 1 and 2 and 169.0 tons on each of Sections 3 and 4. These application rates equate to 1,721 tons per mile (TPM) for the 28 ft wide Sections 1 and 2 and 1,352 TPM for the 22 ft wide Sections 3 and 4, with the differences in TPM attributed only to the different widths.

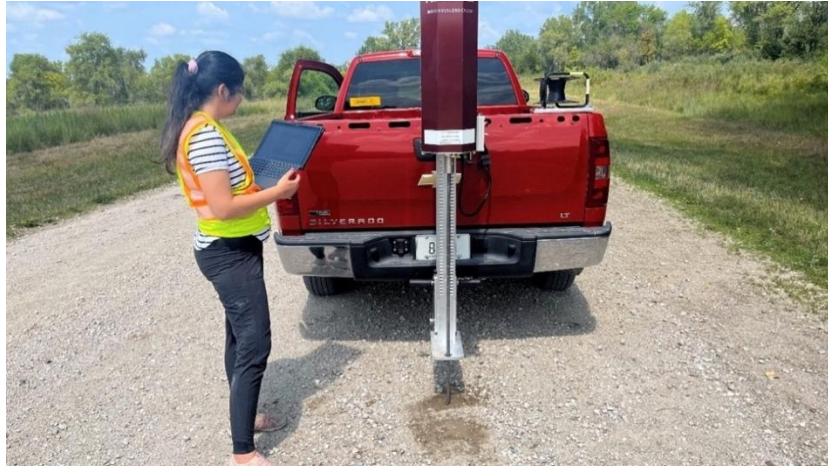
**Figure 61. ADCP tests in August 2023 prior to construction**

Two pre-construction ADCP tests per section were performed as shown in Figure 61. Several of the tests encountered refusal due to the presence of large cobbles, boulders, and buried construction debris within the subgrade, some examples of which are shown in Figure 62. The pre-construction ADCP test results are shown in Figure 63 through Figure 67, which contain plots of the cumulative blows, DCP index, and correlated CBR values versus penetration depth. In any test, refusal was identified as 20 blows producing no advancement of the DCP rod. This limit was chosen because it was found that multiple blows with zero penetration could damage the DCP cone tip adapter at the bottom or the rod clamp at the top, requiring their replacement and possibly making extraction of the driving rod difficult when the tip deformed around the rod adapter, preventing its easy release. Refusal can be identified in the DCP plots by curves that terminate within the upper 12 in. of depth. In Section 1, two additional test points (appended with “b”) were attempted within a few feet of Points 1 and 3 after they gave refusal. Point 1b was successful, but Point 3b also resulted in refusal. In Section 5, all tests resulted in refusal, and complete soil profiles could not be obtained.

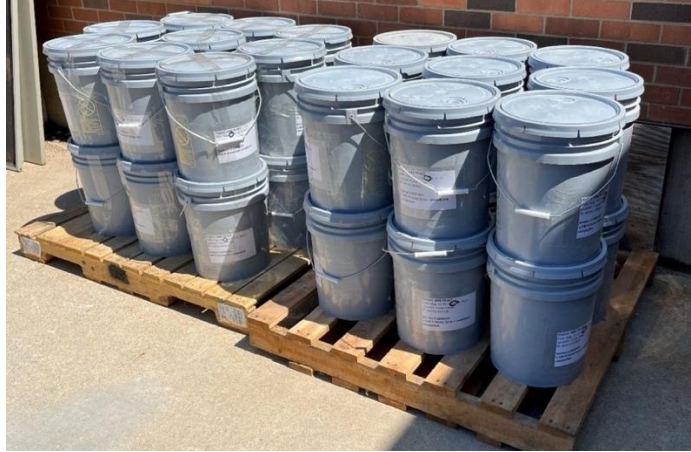
**Figure 83. Sample materials collected during field testing**

During each round of field testing from spring 2024 onward, samples of surface materials were collected from all test sections (Figure 83). In each test section, the samples were obtained from two points in the wheel paths using a hammer drill with a chisel bit to loosen the top 4 in. of material (Figure 84). The two samples were then combined and mixed to obtain a representative sample for the section. Laboratory gradation tests were performed on the samples to track changes in PSD curves over time, from which aggregate breakage was quantified. Atterberg limits tests were also performed to determine the plasticity of the fines fractions. The resulting PSD curves are presented in Appendix A, and a summary of the corresponding particle size analysis results, Atterberg limits, and classification results are presented in Table 16 through Table 18 for spring 2024, fall 2024, and spring 2025. The corresponding results for fall 2023 after construction were previously provided in Chapter 4.

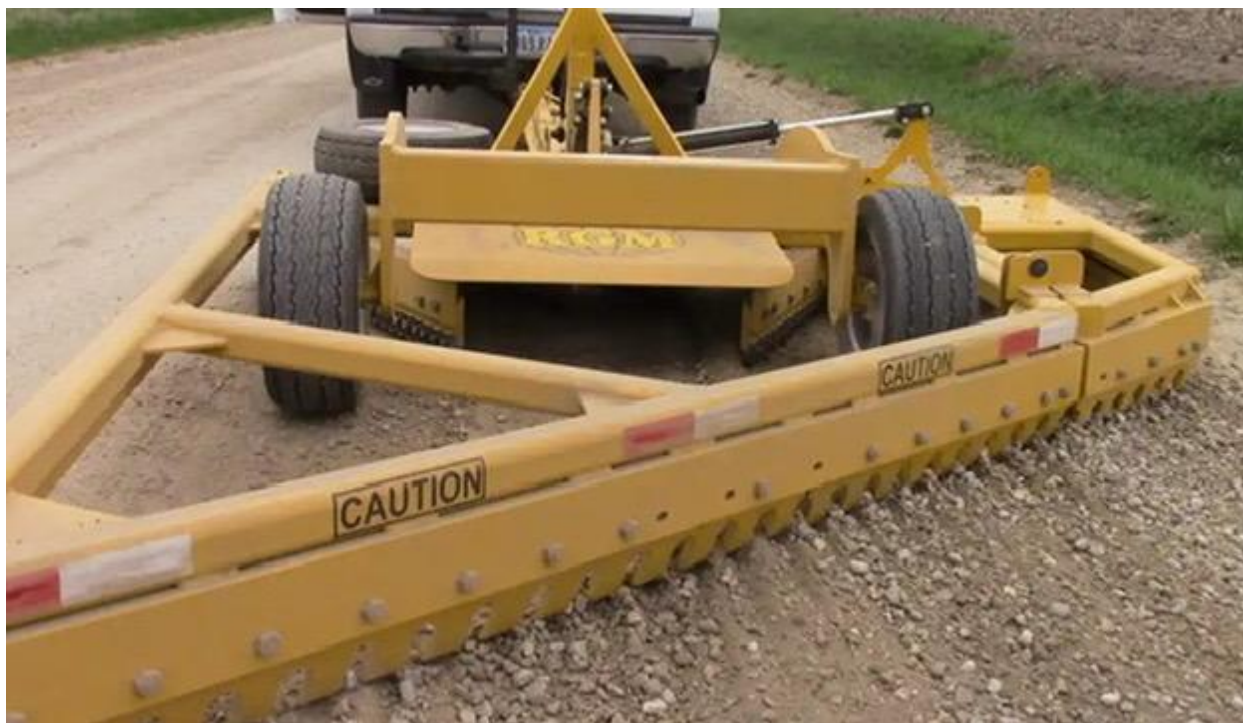
**Figure 85. Gravel rake used to retrieve coarse aggregates from shoulders**

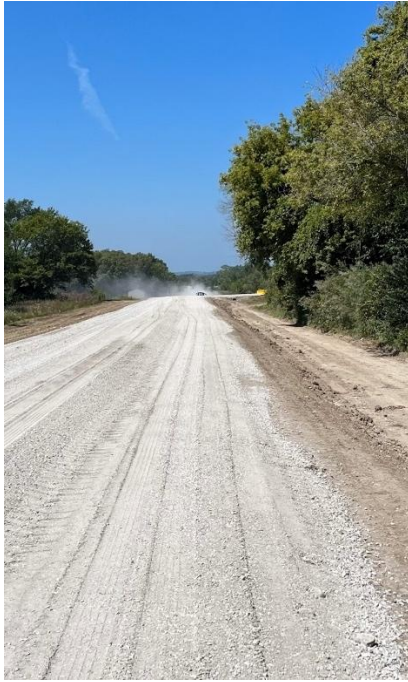
End of construction, Summer 2023

During each round of field tests, visual condition surveys were conducted, with digital photographs taken to provide documentation of the surface conditions and reveal any signs of distress. The survey photographs for each section and testing period are provided in Figure 91 through Figure 95.

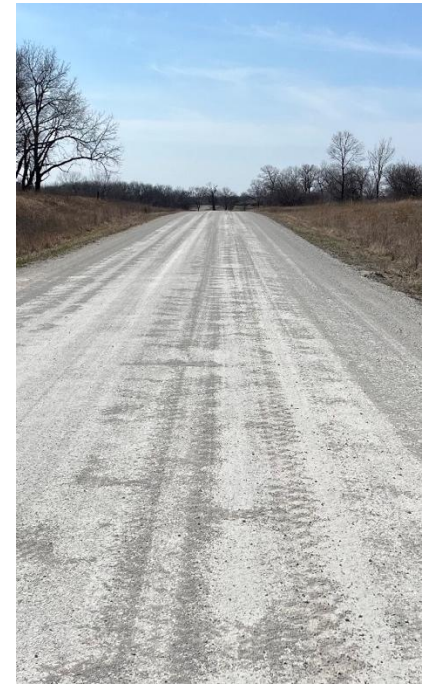
Spring 2025

**Figure 92. Survey photos of Section 2 over time**

In contrast, the stabilized Sections 1 and 2 demonstrated the least surface deterioration. Their surfaces remained relatively smooth and dry, closely resembling concrete pavement, with only minor evidence of rutting or corrugation (Figure 91 and Figure 92). Some shoulder material migration was observed in these two sections by fall 2024, similar to that seen in the untreated sections, though to a lesser extent.

According to the visual condition surveys, the enzyme-stabilized Sections 1 and 2 experienced the least surface deterioration, with only minor evidence of rutting or corrugation. Sections 3 and 4, which were rehabilitated using compaction without stabilizer, experienced the most visible signs of deterioration in the form of rutting and depressions along the wheel paths and migration of material to the shoulders. The control section also exhibited minor rutting and showed more noticeable migration of material to the shoulders.

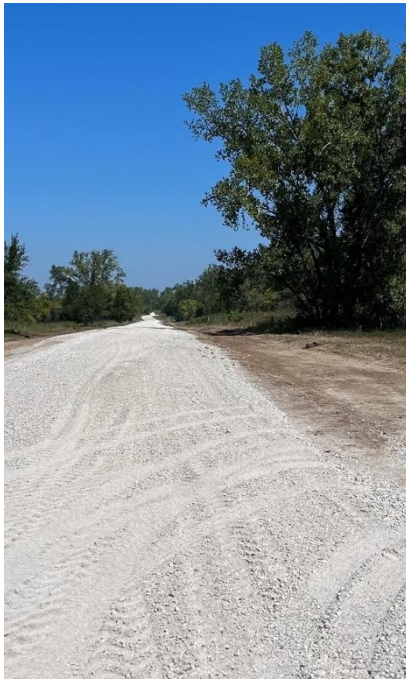
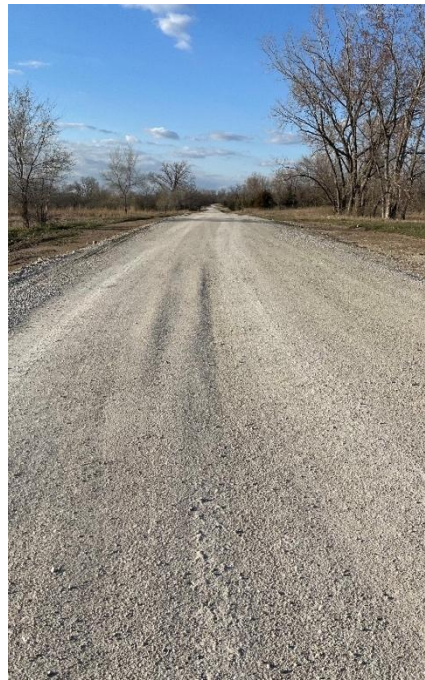
**Figure 93. Survey photos of Section 3 over time**

Overall, surface conditions across the test sections showed minimal to moderate levels of distress during the observation period. Sections 3 and 4, which did not receive chemical stabilization, exhibited the most visible deterioration beginning in spring 2024, with the development of moderate rutting and depressions along the wheel paths (Figure 93 and Figure 94). By fall 2024, these untreated sections also showed signs of shoulder material migration, indicating lateral displacement of gravel under traffic.

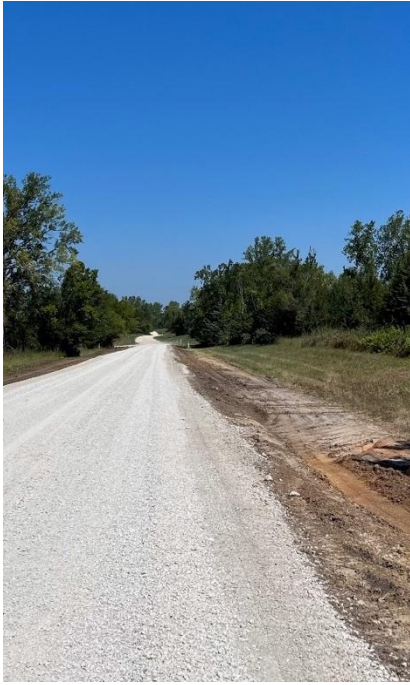
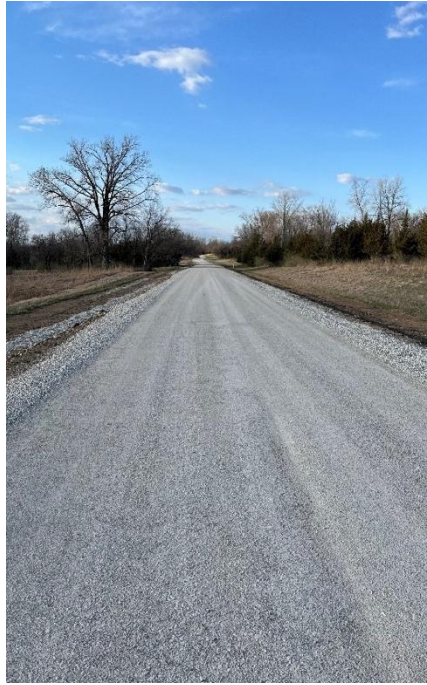
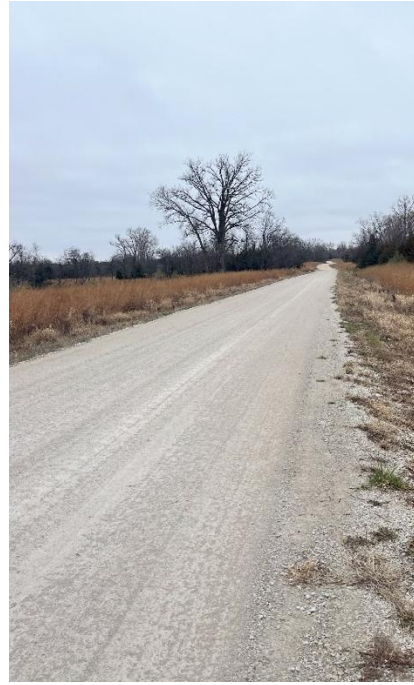
**Figure 94. Survey photos of Section 4 over time**

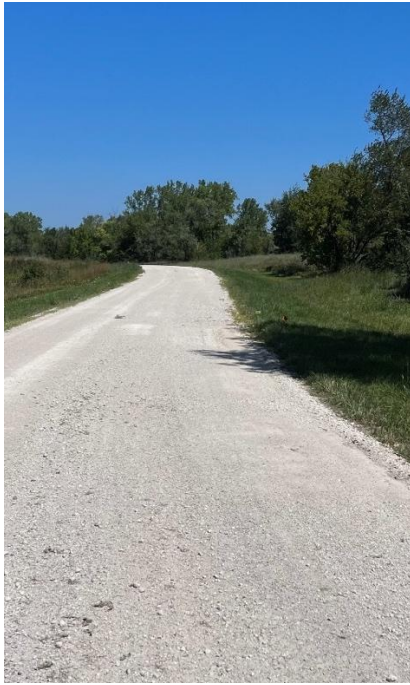
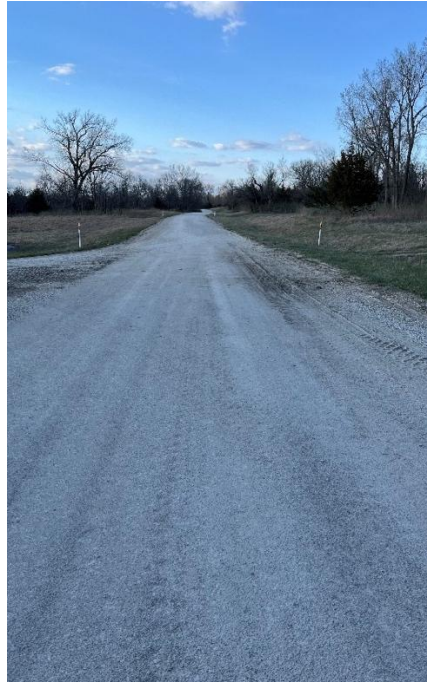
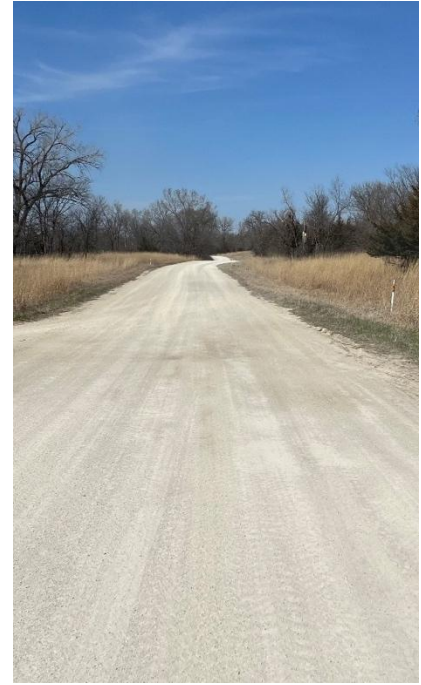
**Figure 95. Survey photos of Section 5 over time**

Section 5 (control), which had experienced long-term traffic loading prior to the study, maintained a densely compacted and polished surface. It exhibited minor rutting but showed more noticeable surface material migration, likely due to the cumulative effects of long-term loading and the lack of rehabilitation (Figure 95).

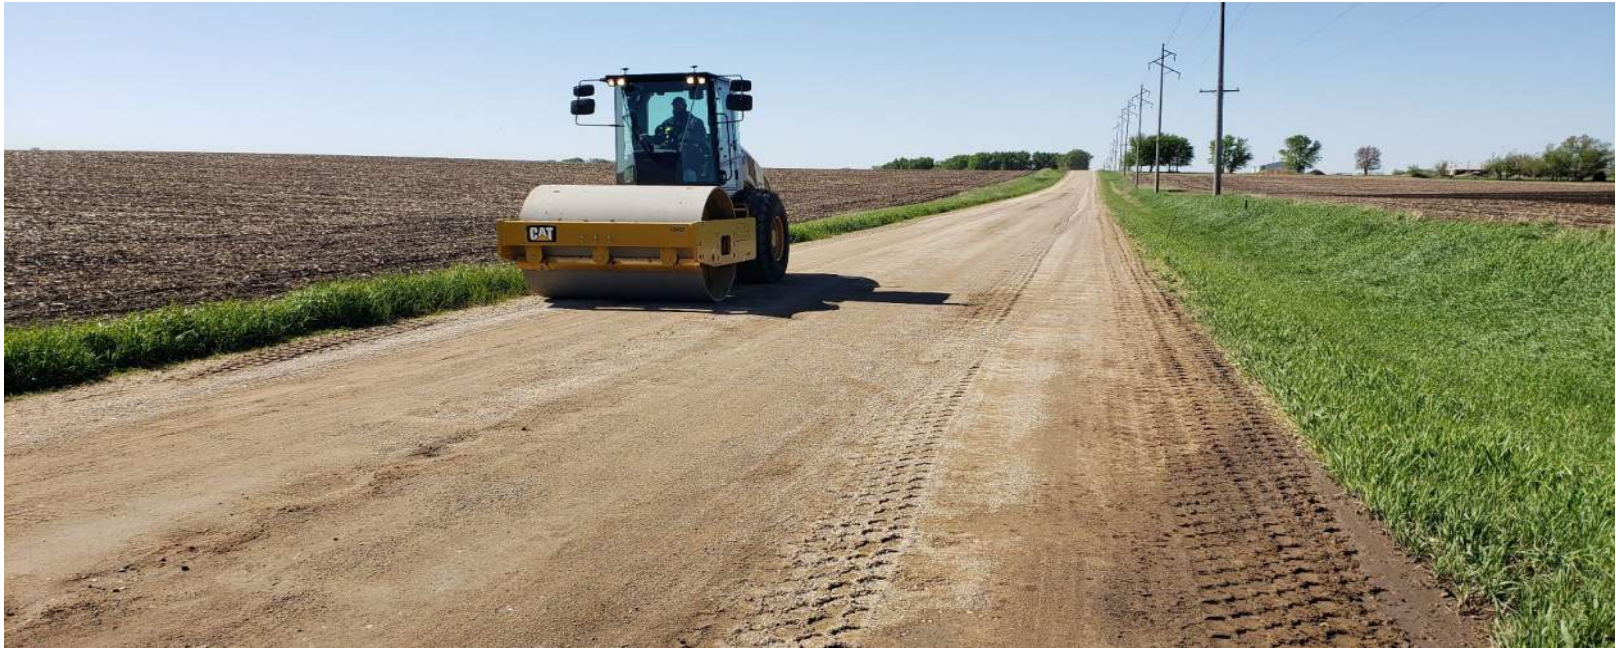
Figure 1. Picture of the COMP-Score RT enabled roller mapping (Picture taken on 05/27/22 at 10:04 am)

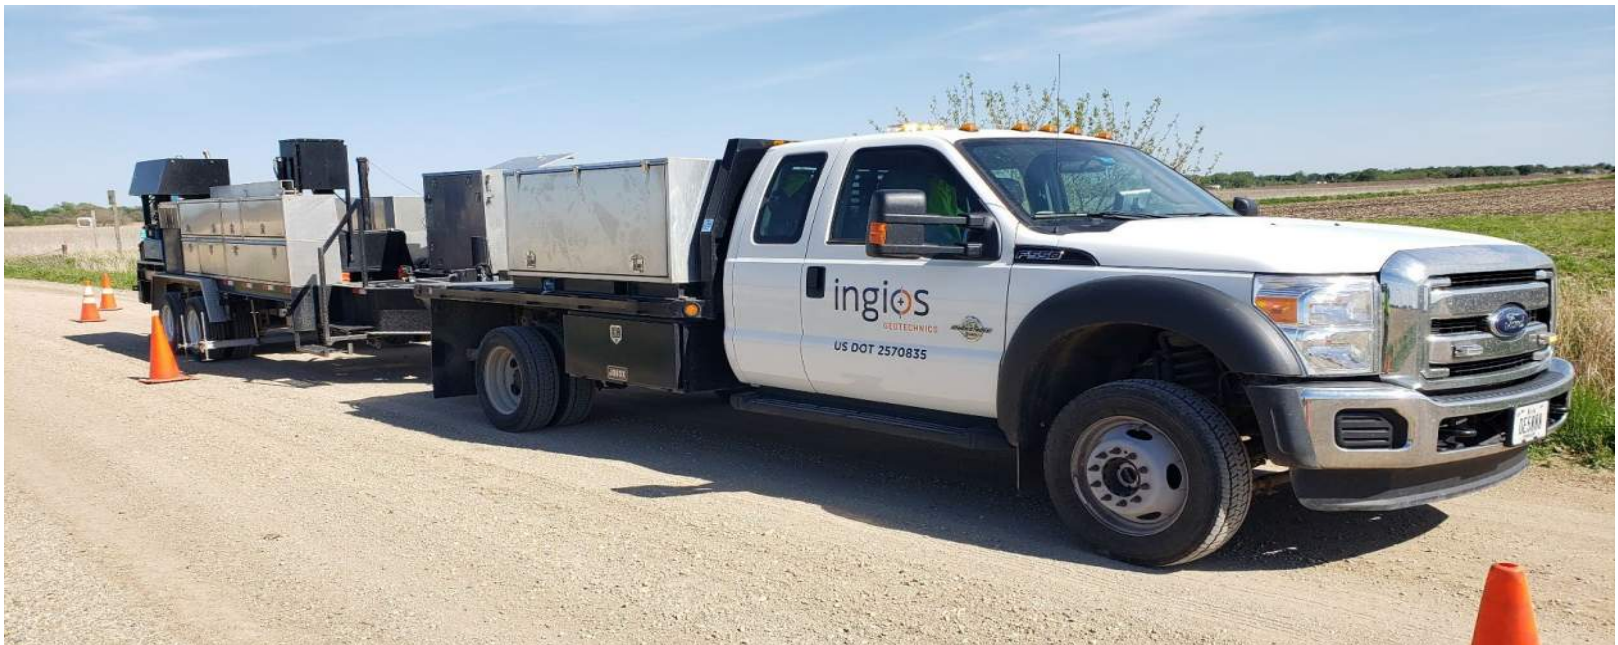
Figure 2. Picture of APLT setup (Picture taken on 05/27/2022 at 05:27 pm)
