# Effectiveness and Guidance of Aggressive Rehabilitation of Gravel Roads

**Final Report**  
**November 2025**

**IOWA STATE  
UNIVERSITY**  
**Institute for  
Transportation**

**Sponsored by**  
Iowa Highway Research Board  
(IHRB Project TR-823)  
Iowa Department of Transportation  
(InTrans Project 23-859)

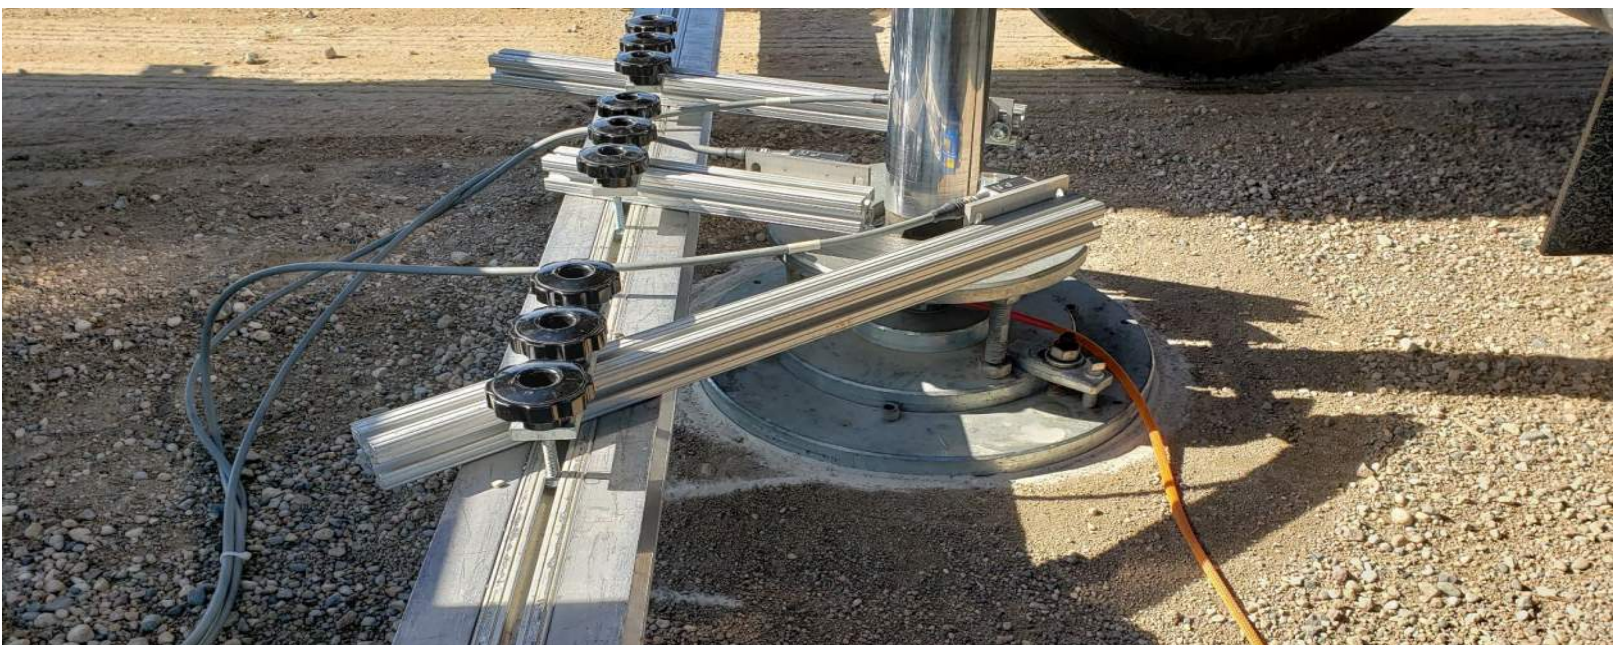
Figure 3. Picture of APLT setup with 18 in. diameter loading plate (Picture taken on 05/27/2022 at 05:18pm)

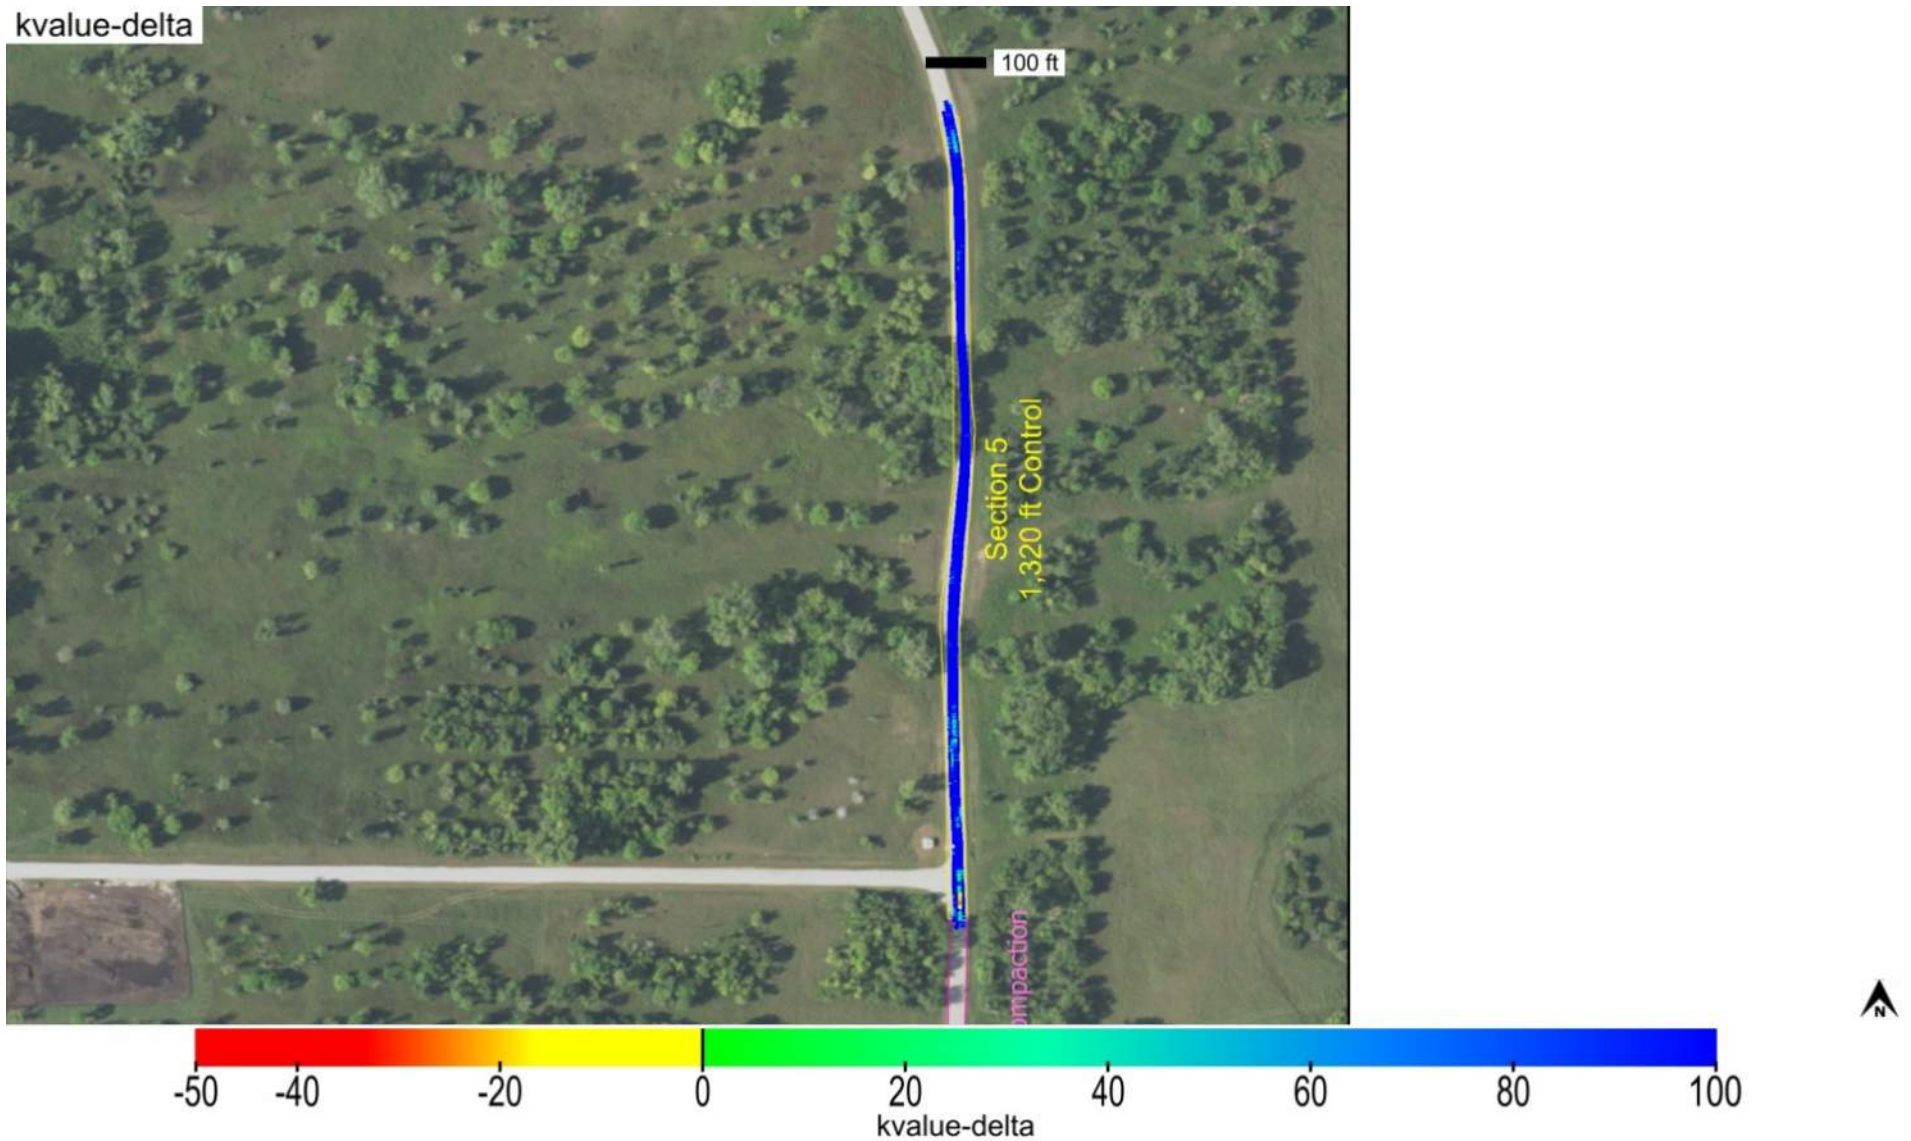
Map ID: ing\_polk77-campdodge-2023\_cs56b-01047\_2023\_08\_31\_151652

| Parameter | Measured | % Passing | CQI | CI | Calc. TV | min. | avg. | max. | std. dev. | cov(%) | min.-delta | avg.-delta | max.-delta |
|---|---|---|---|---|---|---|---|---|---|---|---|---|---|
| k-value | Yes | 99.3 | 114.8 | 0.4 | 100.0 | 74.6 | 367.4 | 550.0 | 143.6 | 39.1 | -25.4 | 267.4 | 450.0 |

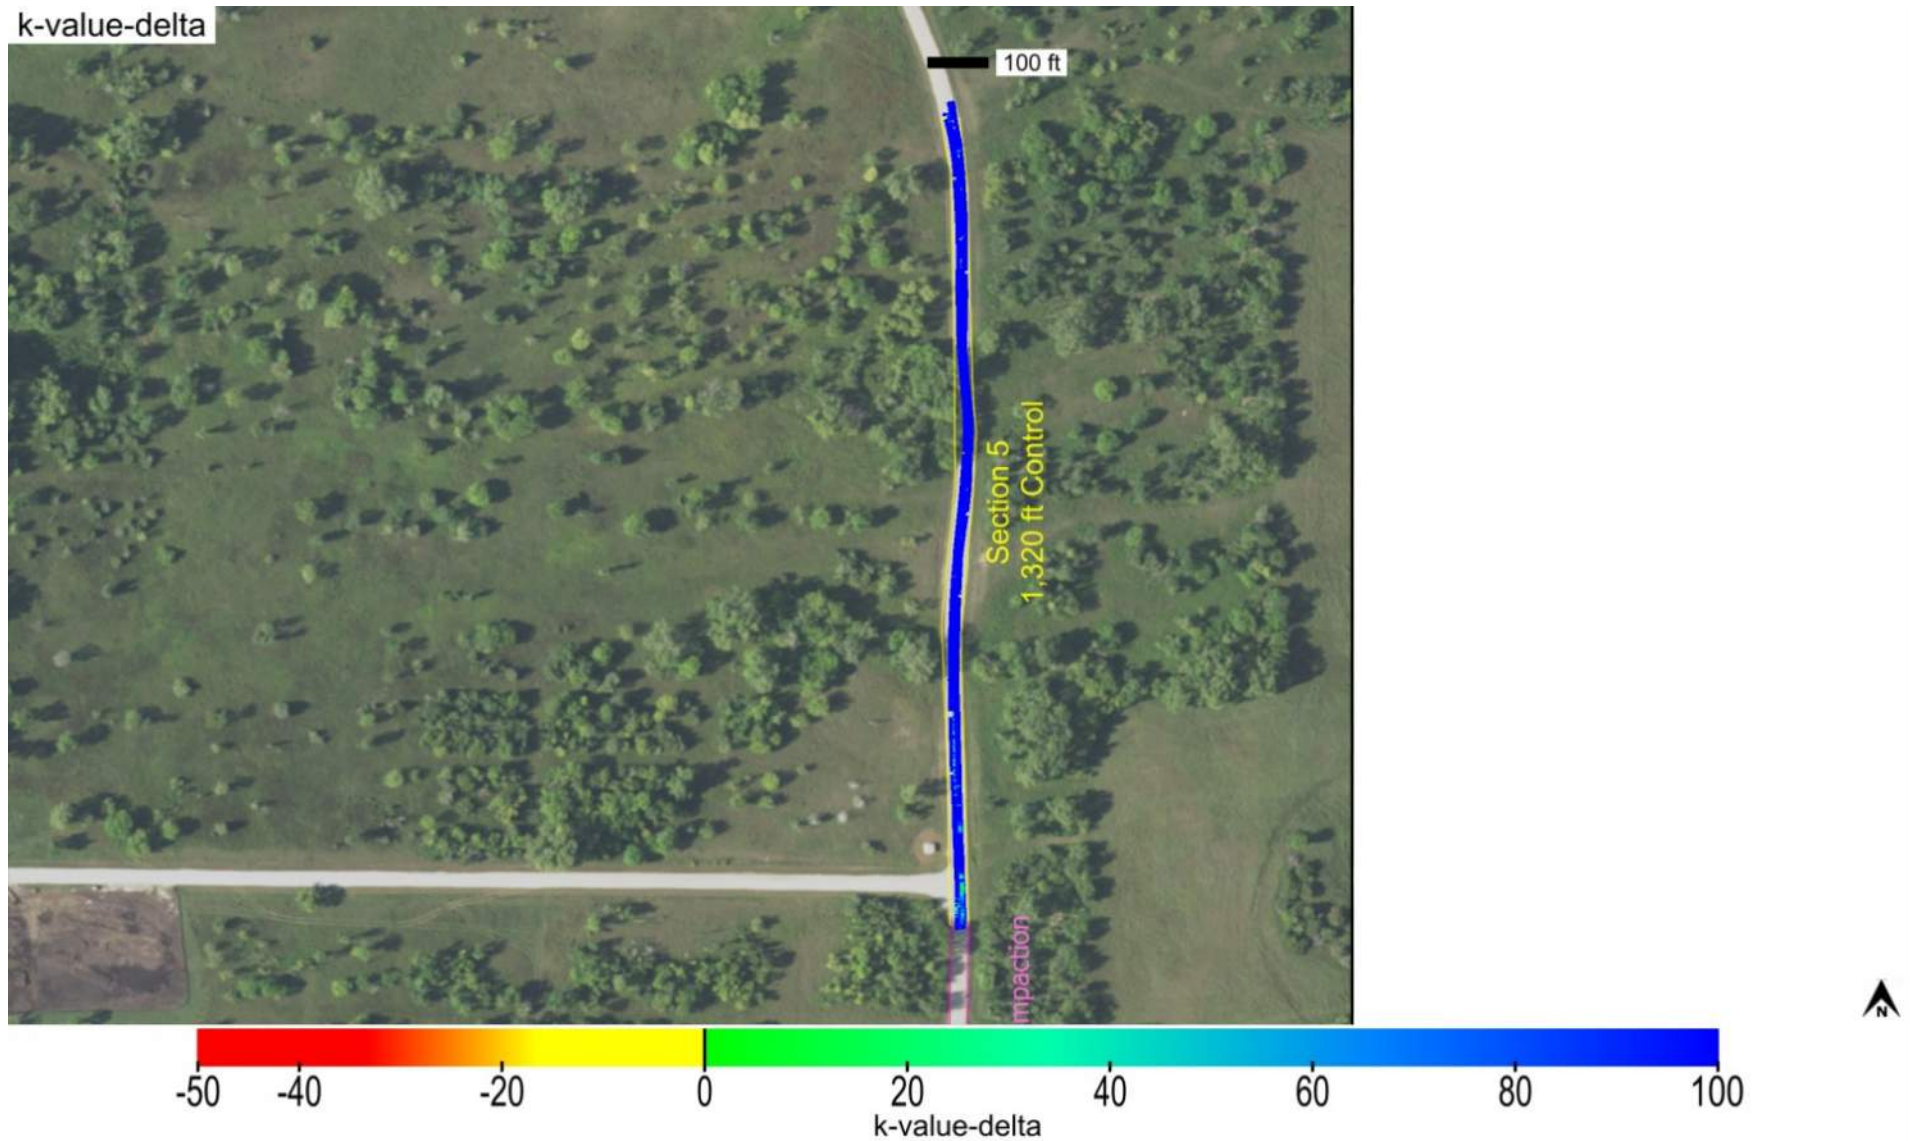
| Parameter | Measured | % Passing | CQI | CI | Calc. TV | min. | avg. | max. | std. dev. | cov(%) | min.-delta | avg.-delta | max.-delta |
|---|---|---|---|---|---|---|---|---|---|---|---|---|---|
| k-value | Yes | 100.0 | 120.0 | 0.5 | 100.0 | 107.5 | 374.2 | 550.0 | 112.5 | 30.1 | 7.5 | 274.2 | 450.0 |

| Parameter | Measured | % Passing | CQI | CI | Calc. TV | min. | avg. | max. | std. dev. | cov(%) | min.-delta | avg.-delta | max.-delta |
|---|---|---|---|---|---|---|---|---|---|---|---|---|---|
| resilient modulus | Yes | 99.8 | 108.1 | 0.7 | 3600.0 | 3491.2 | 11847.6 | 20000.0 | 3965.3 | 33.5 | -108.8 | 8247.6 | 16400.0 |
