Field Performance of Fiber-Reinforced Concrete Overlays

**Final Report
April 2025**

1. Report No.	2. Government Accession No.	3. Recipient's Catalog No.	
IHRB Project TR-816			
4. Title and Subtitle		**5. Report Date**	
Field Performance of Fiber-Reinforced Concrete Overlays		April 2025

6. Performing Organization Code	
7. Author(s)		**8. Performing Organization Report No.**	
Dan King (orcid.org/0000-0001-8824-1818), Bo Yang (orcid.org/0000-0002-7774-5233), Peter Taylor (orcid.org/0000-0002-4030-1727), and Halil Ceylan (orcid.org/0000-0003-1133-0366)		InTrans Project 22-829

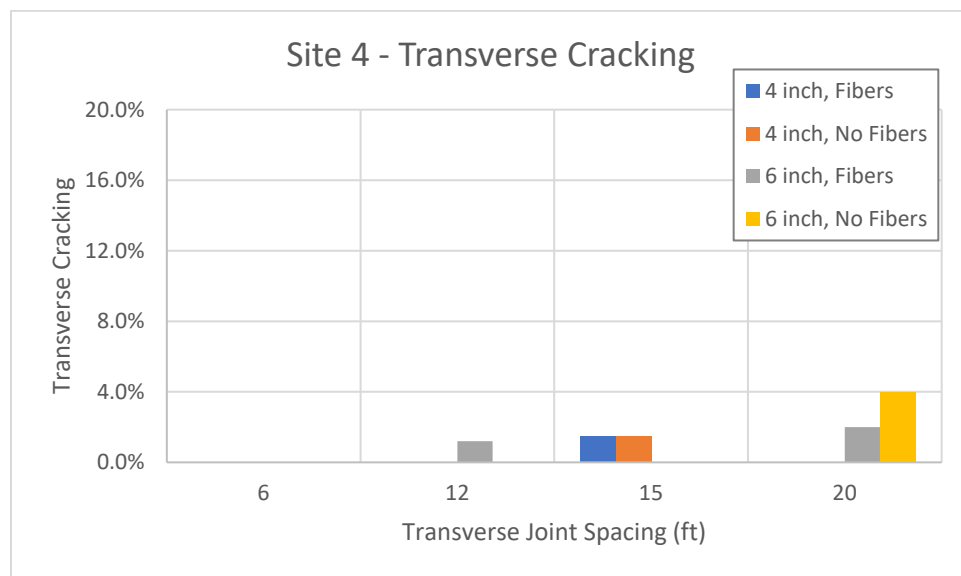
Three distresses were observed at Site 4: transverse cracking, corner cracking, and longitudinal cracking. All of the cracking at Site 4 was classified as low severity according to FHWA's Long-Term Pavement Performance (LTPP) Distress Identification Manual (Miller and Bellinger 2014). Figures 30 and 31 show the transverse and corner cracking results at Site 4, organized by thickness, joint spacing, and whether or not the mix contained fibers. Figures 32(a) and 32(b) show typical examples of transverse and longitudinal cracking observed at Site 4.

Figure 30. Transverse cracking observed at Site 4

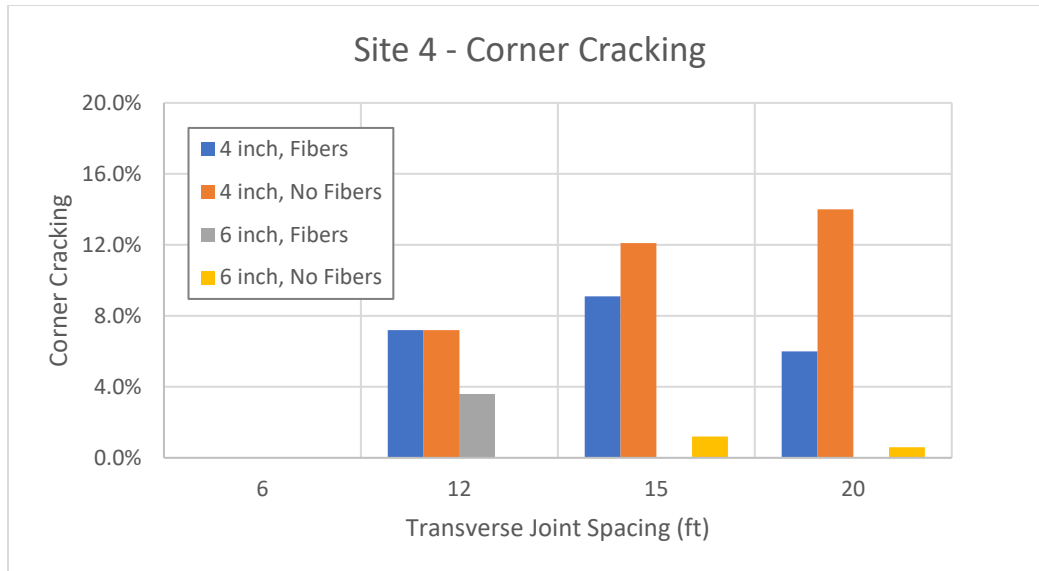
Figure 31. Corner cracking observed at Site 4

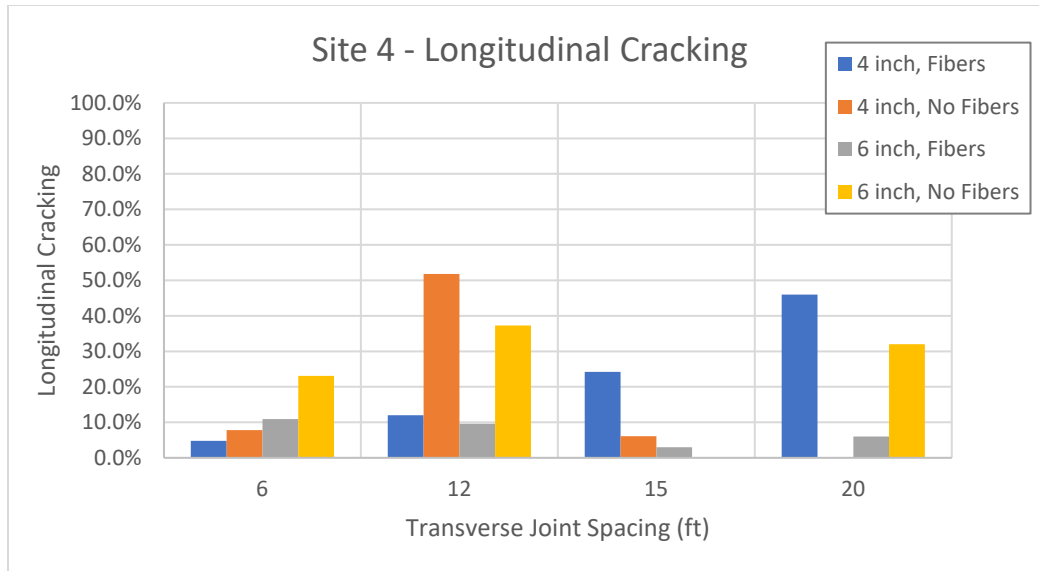
Figure 33 shows longitudinal cracking results at Site 4, organized by joint spacing, thickness, and whether or not the mix contained fibers. Note that this longitudinal cracking appeared to be reflective cracking that resulted from longitudinal cracks in the underlying pavement. Figure 34(a) shows the existing asphalt surface prior to overlay, with longitudinal cracks that were prevalent throughout the project. Figure 34(b) shows a typical example of longitudinal cracking in the concrete overlay.

Figure 33. Longitudinal cracking observed at Site 4

As demonstrated in Figures 34(a) and 34(b), the pattern of longitudinal cracking that developed in the overlay was very similar to that of the existing asphalt surface prior to overlay. The cracking appeared within one year of construction and did not appear to result from traffic loads. Notably, as of 2023, the longitudinal reflective cracking in the sections with fibers has held together more tightly than in the sections without fibers. The Mitchell County secondary roads department has filled the cracks in the sections without fibers, as pictured in Figure 34(b), but has left them unsealed to date in the sections containing fibers.

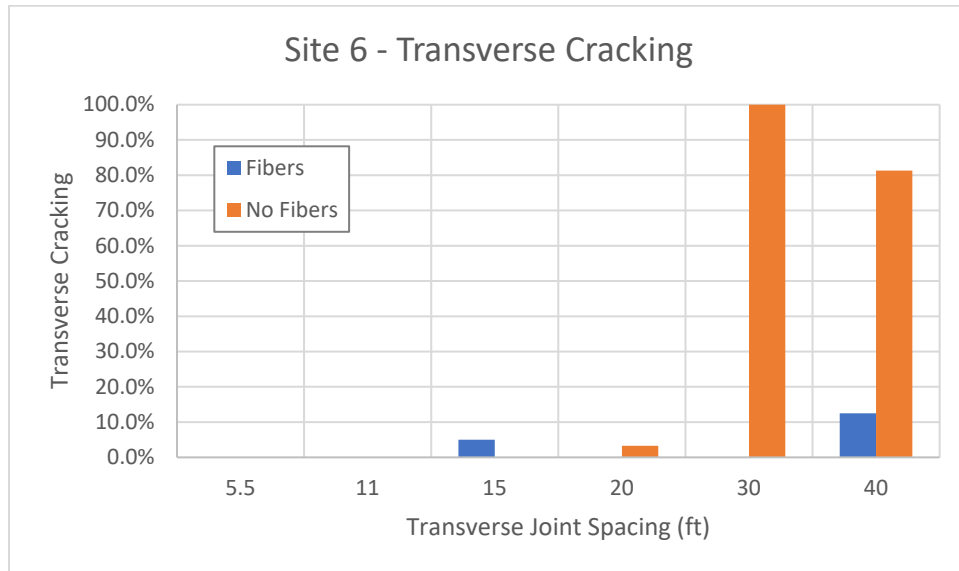
Few distresses were observed at Site 6, except for transverse cracking in the sections with 30 ft and 40 ft transverse joint spacing that did not contain fibers. These transverse cracks appeared in

the middle of nearly every slab in Sections 6F and 6G, as plotted in Figure 35, and were classified as medium severity according to the FHWA LTPP Distress Identification Manual. Figure 36 shows a typical example of one of these mid-panel transverse cracks, which was also beginning to exhibit some spalling. Figures 37 and 38 plot the observed corner and longitudinal cracking, respectively, which were also generally more likely to occur at longer joint spacing designs.

Figure 35. Transverse cracking observed at Site 6

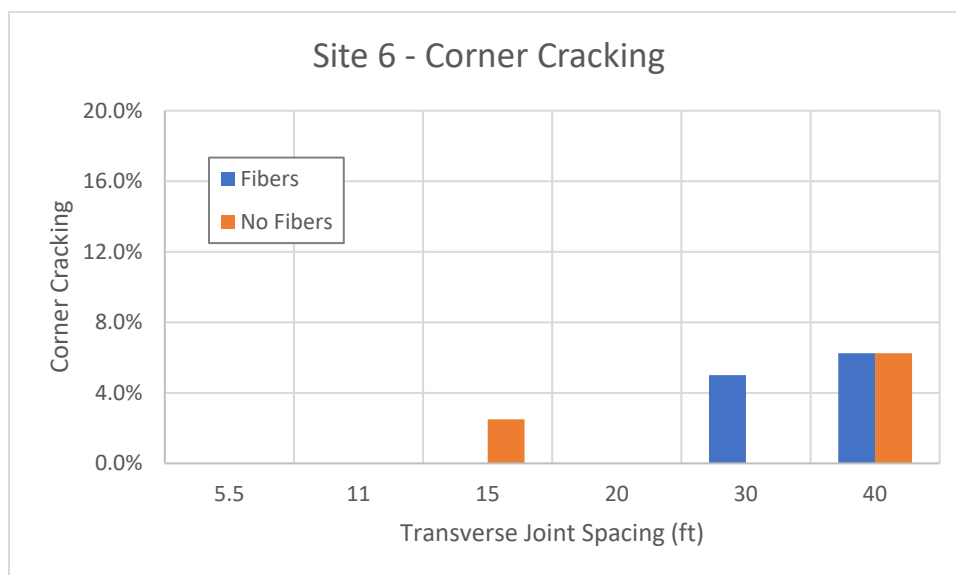
Figure 37. Corner cracking observed at Site 6

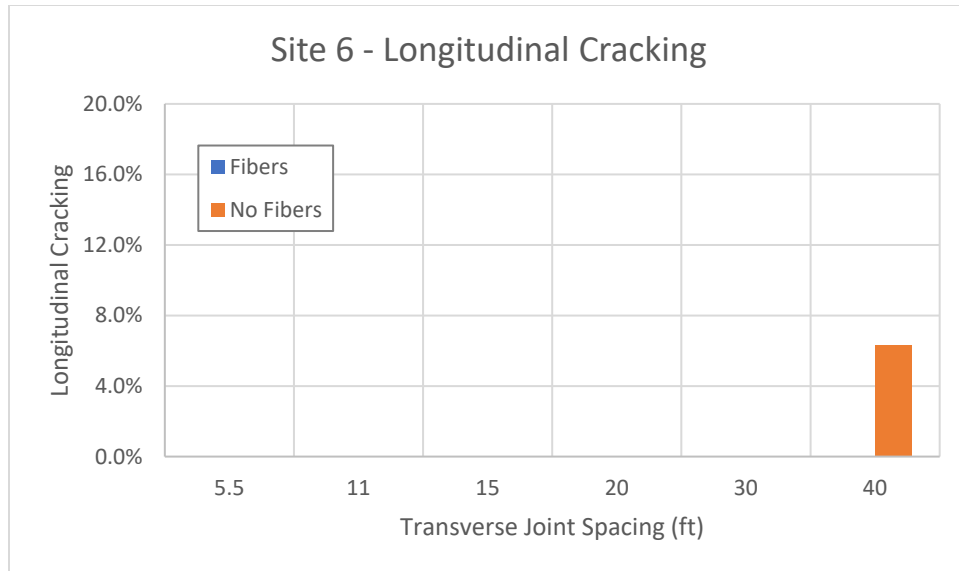
Figure 38. Longitudinal cracking observed at Site 6

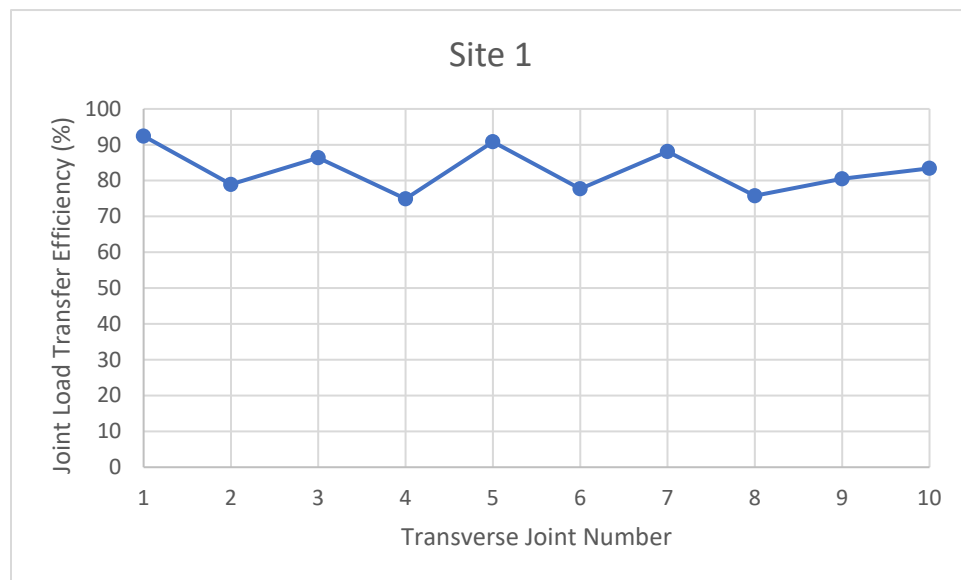
Figure 39. Joint-by-joint joint LTE results for Site 1

Table 10 lists the results of FWD testing for load transfer at Site 1, including the average deflection in the loaded slab (d_l) and the average joint LTE calculated at all 10 transverse joints. Figure 39 plots the LTE results on a slab-by-slab basis. Average joint LTE at Site 1 was classified as good according to Table 6, though some variation was observed between slabs, with differences as great as 16% between adjacent joints.

As discussed in Section 3.4, FWD testing to measure joint LTE found several projects with significant variation in LTE between adjacent joints. For example, the joint-by-joint LTE results at Site 1 (Figure 39), Site 6B (Figure 45), and Site 6L (Figure 46) exhibited a characteristic "up-

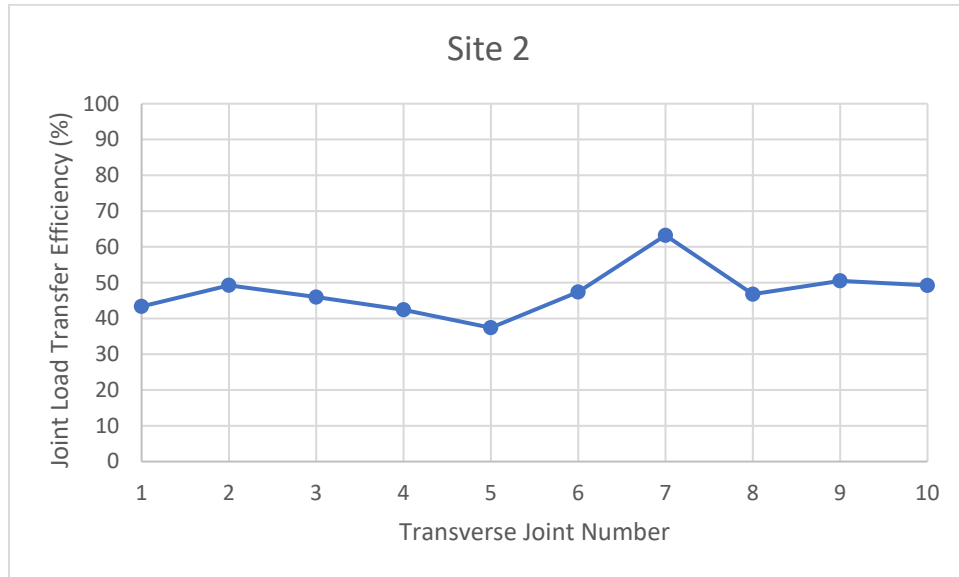
Figure 40. Joint-by-joint LTE results for Site 2

Table 11 lists the results of FWD testing for joint LTE at Site 2, including the average deflection in the loaded slab and the average LTE calculated at all 10 transverse joints. Figure 40 plots the LTE results on a slab-by-slab basis. Average joint LTE at Site 2 was classified as poor according to Table 6. Besides a spike in joint LTE at the seventh transverse joint in Figure 40, joint LTE did not deviate by more than 10% between adjacent slabs.

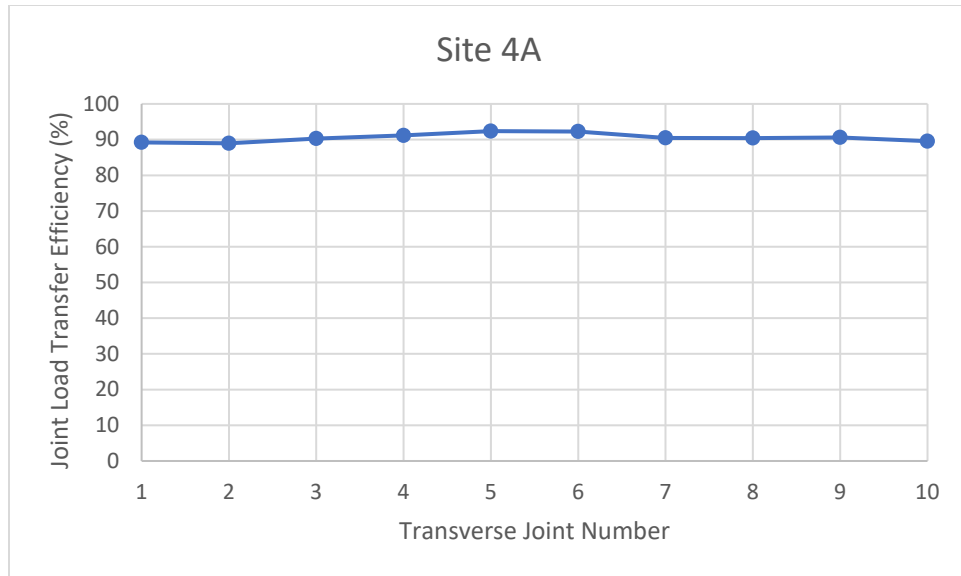
Figure 42. Joint-by-joint LTE results for Site 4A

Each of the individual sections in Site 4 demonstrated consistently high joint LTE values, ranging from good to excellent according to Table 6, without any major jumps or dips between joints. Figure 42 presents the joint-by-joint LTE data for Site 4A, which was typical of all of the Site 4 sections. Appendix B contains figures corresponding to each of the other Site 4 sections.

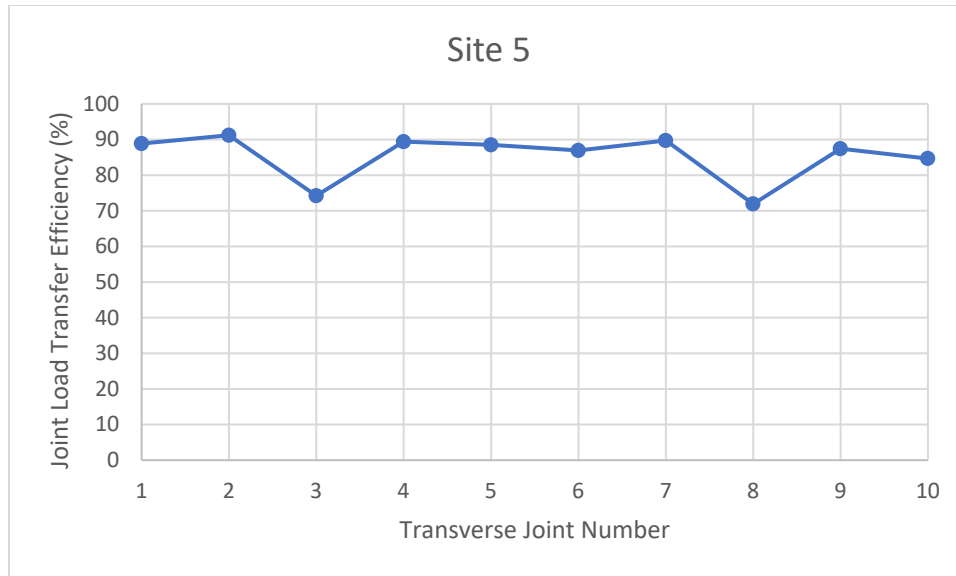
Figure 43. Joint-by-joint LTE results for Site 5

Table 13 lists the results of FWD testing for joint LTE at Site 5, including the average deflection in the loaded slab and the average LTE calculated at all 10 transverse joints. Figure 43 plots the LTE results on a slab-by-slab basis. Average joint LTE at Site 5 was classified as good according to Table 6. LTE results were consistent from slab to slab, with two dips of about 15% to 18% at Slabs 3 and 8 observed in Figure 43.

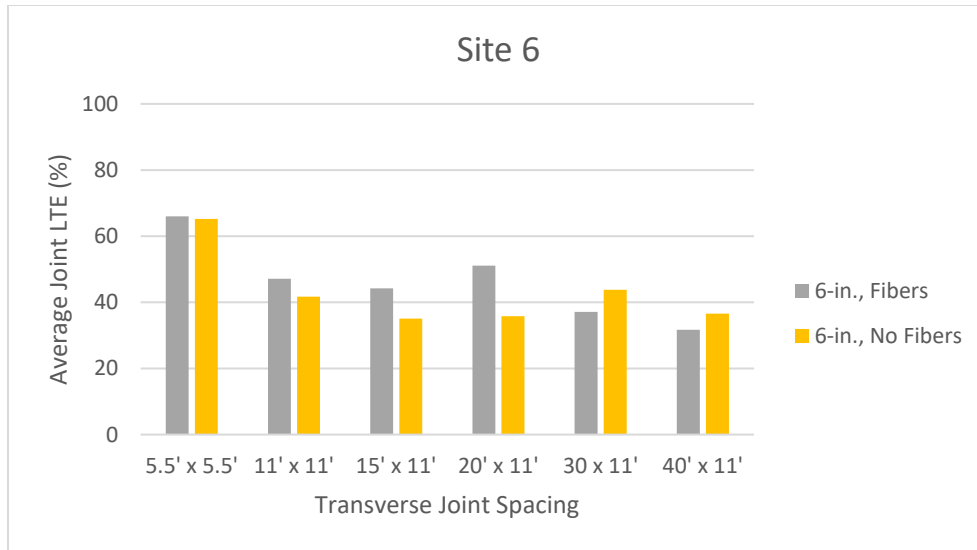
Figure 44. Summary of joint LTE results for Site 6

At Site 6, average joint LTE for the sections with shorter joint spacing (5.5 ft x 5.5 ft) were classified as fair according to Table 6, while all other sections were classified as poor. A variety of slab-by-slab LTE patterns were observed within individual sections at Site 6. Figures 45 and 46 plot the joint-by-joint LTE results for Site 6B and Site 6L, respectively, which were the two sections with 5.5 ft x 5.5 ft joint spacing. These sections demonstrated significant variation in joint LTE between adjacent slabs, with many instances of joint LTE measuring between 80% to 90% (good to excellent) in one slab followed by 30% to 50% (poor) in the adjacent slab.

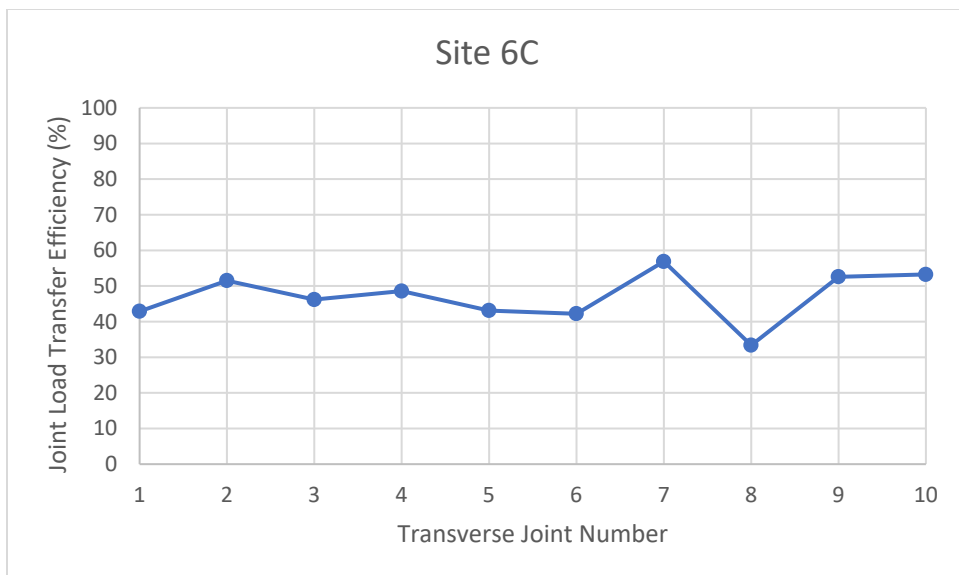
Figure 47. Joint-by-joint LTE results for Site 6C

For the most part, the other sections at Site 6 demonstrated consistently low joint LTE values. Figures 47 and 48 plot slab-by-slab results for Site 6C (12 ft joint spacing, containing fibers) and Site 6D (15 ft joint spacing, containing fibers), which show typical results at Site 6. In these sections, LTE values at adjacent joints generally remained within 10% of each other but occasionally demonstrated bumps and dips in the range of 20% to 30%. Figure 49 plots one of the more unusual joint-by-joint LTE results observed in this study at Site 6F (30 ft joint spacing, containing fibers). LTE values at Site 6F varied between 14.8% and 70.2%, although the pattern was not consistently up and down between adjacent slabs as at Sites 6B and 6L (Figures 45 and 46). Appendix B contains figures corresponding to each of the other Site 6 sections.

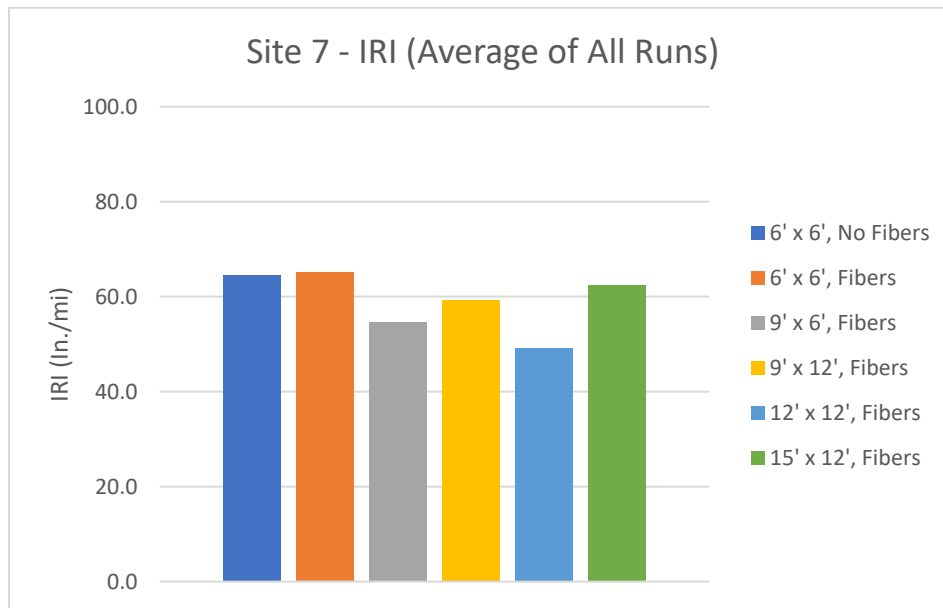
Figure 83. Average IRI results across all visits for Site 7

Few trends in IRI or Curvature IRI were discerned from the data for Site 7. Site 7C with 12 ft x 12 ft joint spacing had the lowest average IRI and Curvature IRI of any of the sections at Site 7, while the sections at Sites 7A and 7F with 6 ft transverse joint spacing had the highest average IRI and Curvature IRI values. Minimal variation was observed in IRI and Curvature IRI readings between different seasons and times of day. The range of IRI and Curvature IRI values across all six measurements for any given section did not exceed 10 in./mi, except for Sites 7A and 7F (6 x 6 ft joint spacing both with and without fibers), which had ranges of 10 to 12 in./mi in Curvature IRI.

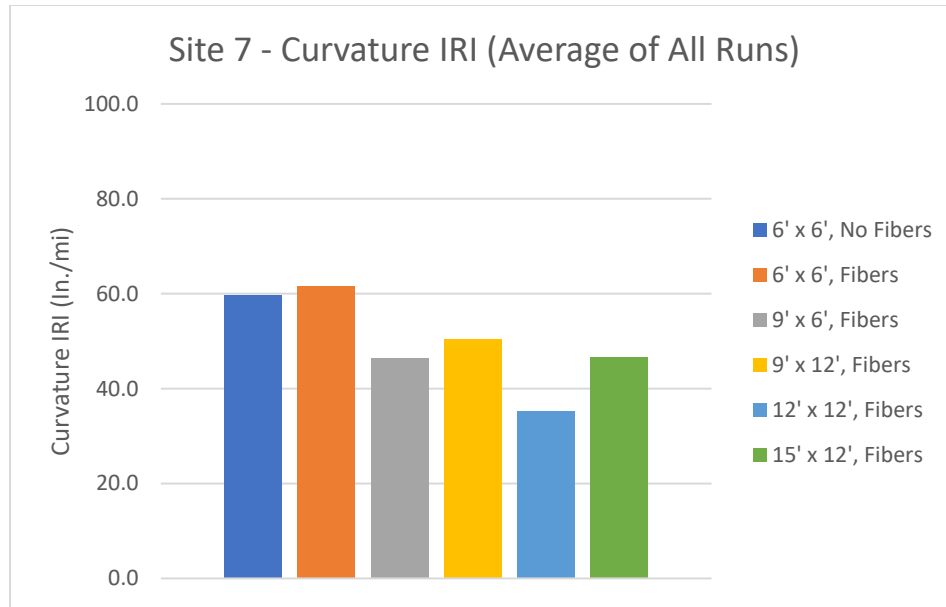
Figure 84. Average Curvature IRI results across all visits for Site 7

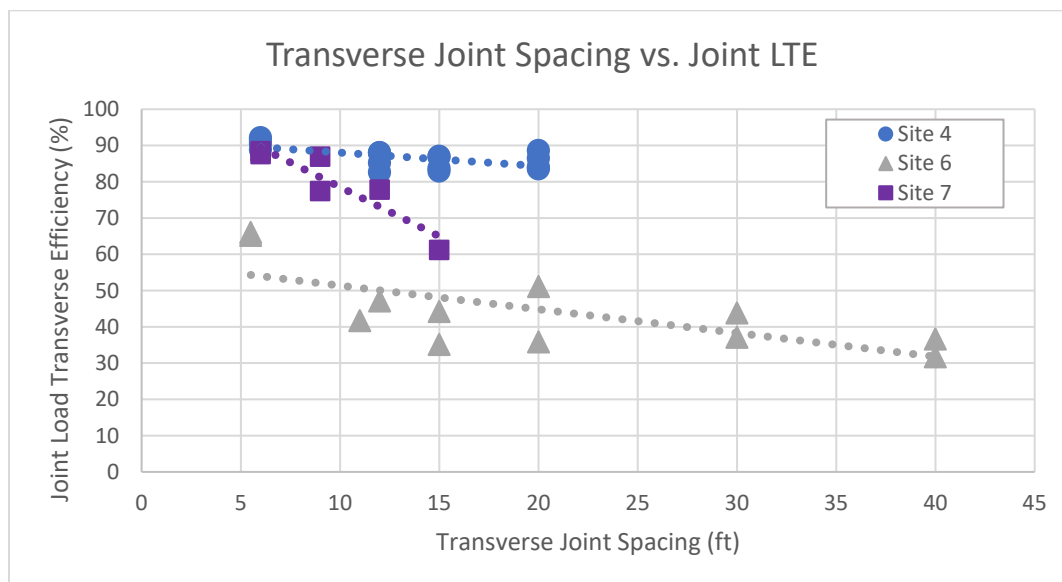
To further analyze trends between transverse joint spacing and joint LTE, Figure 85 plots a linear regression at Site 7, including linear trendlines. The results from Sites 4 and 6 were also plotted as a point of comparison. Table 30 contains slope (m) and coefficient of determination (R^2) values for each of the linear trendlines. Each test site demonstrated a trend of decreasing joint LTE with increasing joint spacing, although as discussed in Tables 27 and 29, only the differences between sections with 5.5 ft and 6 ft joint spacing and sections with longer joint spacings were significant at Site 4 and Site 6. The relationship at Site 7 had the slope with the greatest decreasing magnitude, as well as the highest R^2 value.

Figure 85. Transverse joint spacing versus joint LTE at Sites 4, 6, and 7

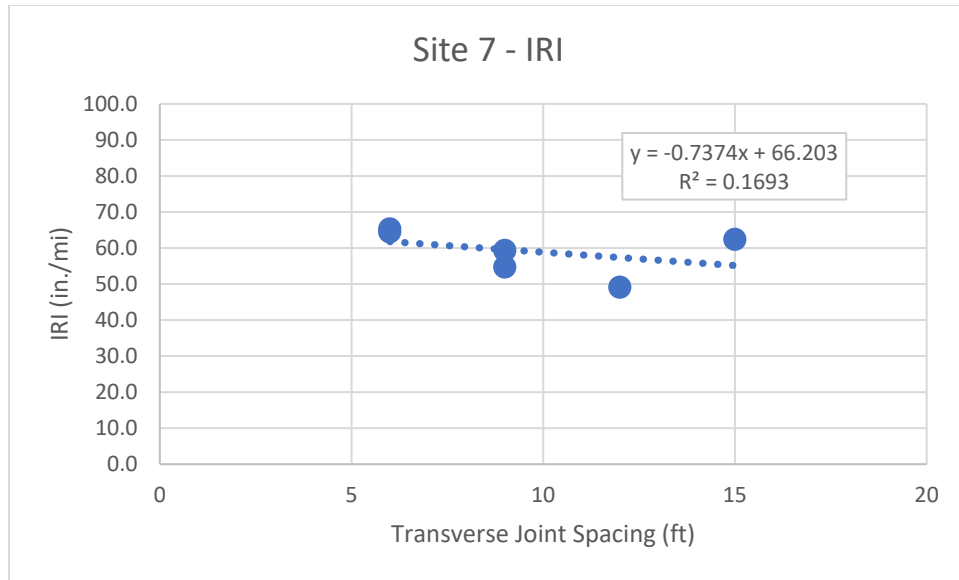
Finally, Figures 86 and 87 plot linear regressions of transverse joint spacing versus IRI and Curvature IRI, respectively, at Site 7. The relationship between joint spacing and IRI was weak, with a low R^2 value. The relationship between transverse joint spacing and Curvature IRI showed a clearer decrease in Curvature IRI with increasing joint spacing and had a higher R^2 value.

Figure 86. Transverse joint spacing versus IRI at Site 7

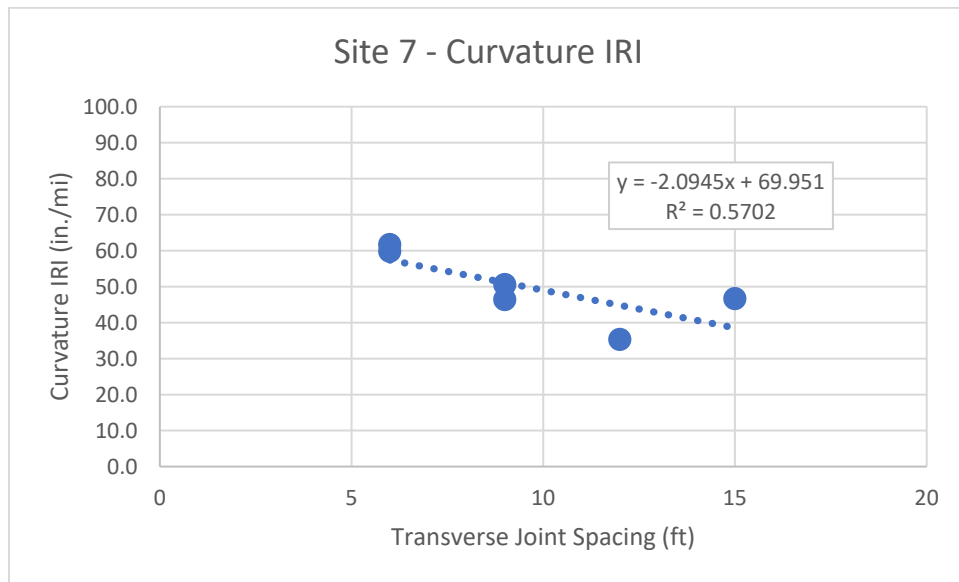
Figure 87. Transverse joint spacing versus Curvature IRI at Site 7

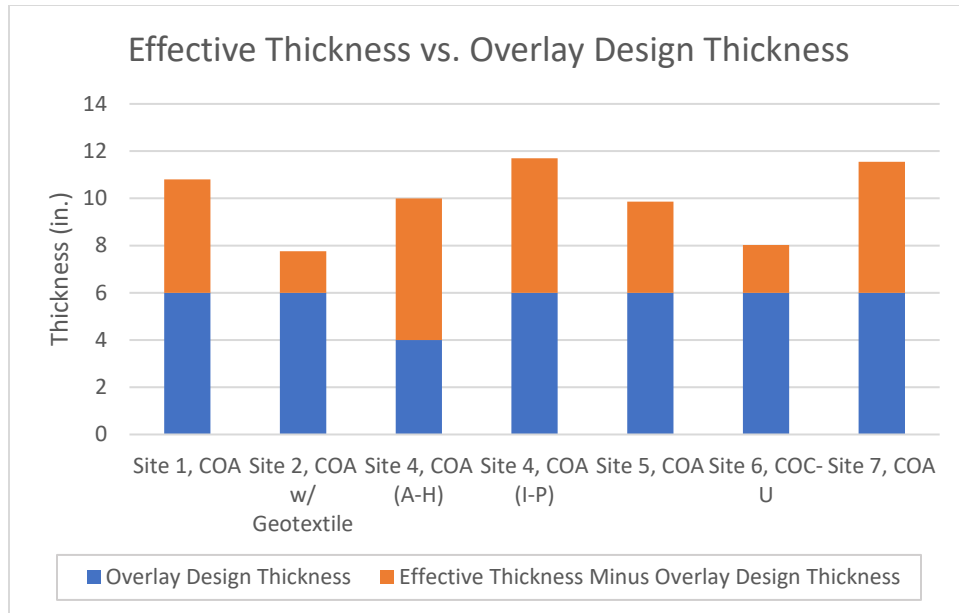
Figure 88 plots the average backcalculated effective thickness at each site. This figure is similar to Figure 57, except in this case the columns in the chart distinguish between the overlay design thickness in blue and the portion of the effective thickness that exceeds the design thickness in orange. Presenting the data in this way helps make clear how much the underlying structure at each site contributes to the total backcalculated effective thickness. Table 41 lists these values along with the average maximum deflection, d_0, measured underneath the load plate at each center slab test.

Figure 88. Effective thickness at each test site, including contribution from underlying layer

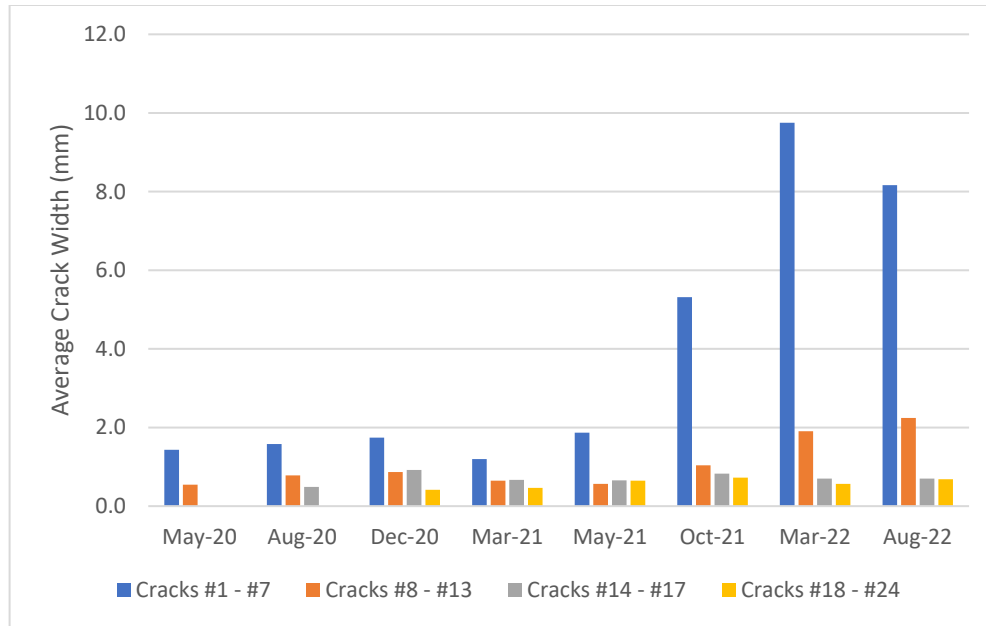
The progression of crack width over time is plotted in Figure 115. Cracks are grouped according to when they were first observed, with cracks #1 through #7 forming in the first two weeks after construction, cracks #8 through #13 first observed in February 2020, cracks #14 through #17 first observed in August 2020, and cracks #15 through #24 first observed in December 2020.

Figure 115. Crack width progression over time for the Worth County test section

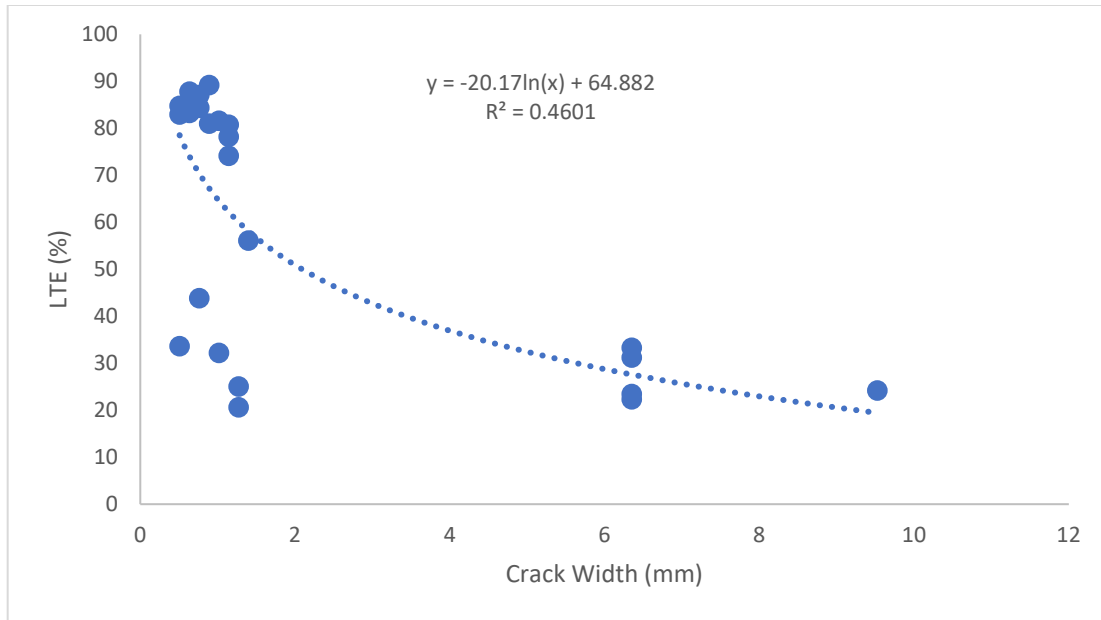
Falling weight deflectometer (FWD) testing was also performed after the October 2021 survey to measure the joint load transfer efficiency (LTE) across each transverse crack. In Figure 116, LTE measurements at each joint are plotted as a function of the crack width (as of October 2021). In Figure 117, the average joint LTE and average width are presented for each group of cracks. Cracks #1 through #7 had an average LTE of 27%, cracks #8 through #13 had an average LTE of 52%, and the remaining sets of cracks had an average LTE of 85%.

Figure 116. Crack width versus joint LTE for the Worth County test section, October 2022

As shown in Figures 116 and 117, LTE decreased with increasing crack width, and cracks that formed earlier had a lower average LTE than cracks that developed later. These findings make sense, as the aggregate interlock at a crack decreases as it widens. While the data in Figure 116 vary somewhat from the logarithmic trendline ($R^2 = 0.46$), this variation may result from the fact that crack width was measured at the surface and may not reflect the width of the crack through the depth of the overlay at the test location.

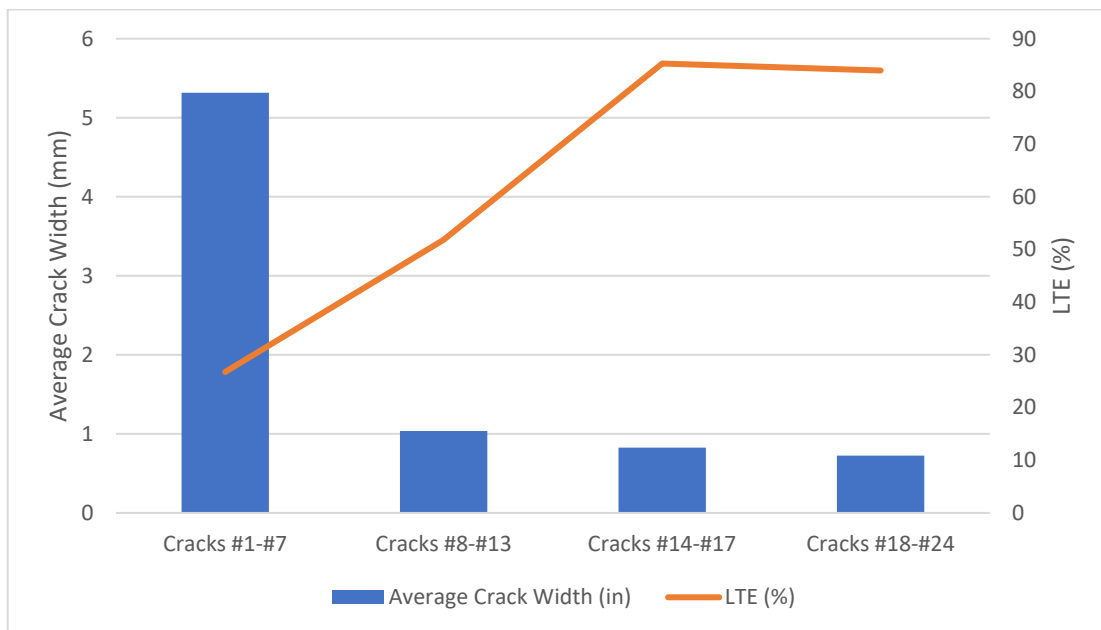
Figure 117. Average crack width and LTE for the Worth County test section, organized by group

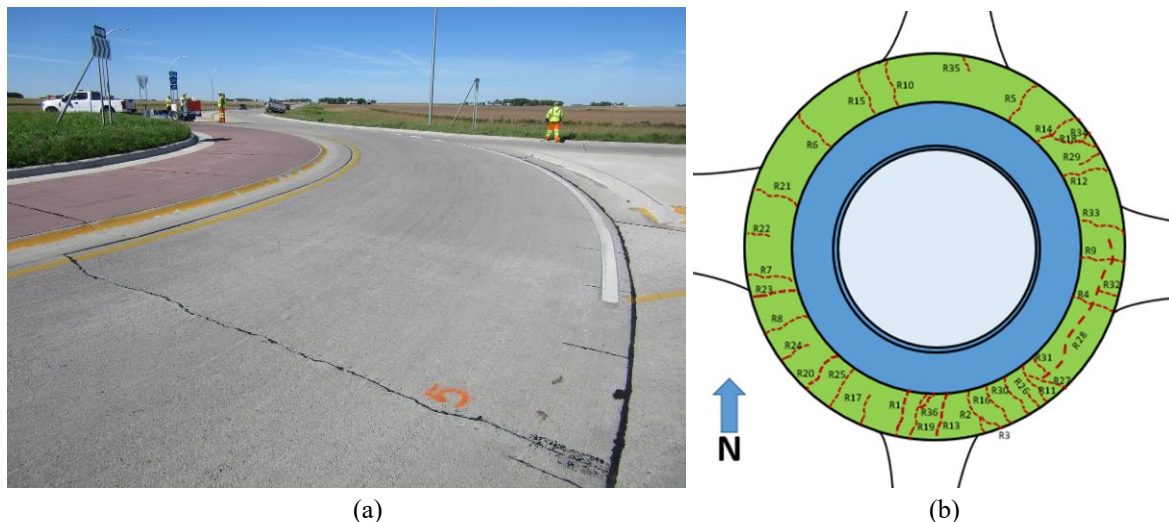
No issues were reported with mixing or placement of the concrete, and the roundabout was paved using a roller screed. Like the Worth County FRC overlay, cracks began to form a few days after construction, with eight transverse cracks developing inside the ring within a week. The FRC roundabout was visited once each year after construction for three years to monitor crack development and perform testing. Through September 2021, 36 cracks developed within the ring, which is pictured in Figure 119(a). The cracks were mostly transverse across the pavement within the ring, but a few longitudinal cracks were also observed. The crack pattern is shown in Figure 119(b).

Figure 119. The (a) condition and (b) observed crack pattern in the FRC roundabout

As seen in Figure 119(b), a much greater number of cracks formed in the southern/eastern quadrants of the ring compared to the northern/western quadrants. One potential explanation for this disparity was that the roundabout was paved on a windy day with winds out of the southeast,

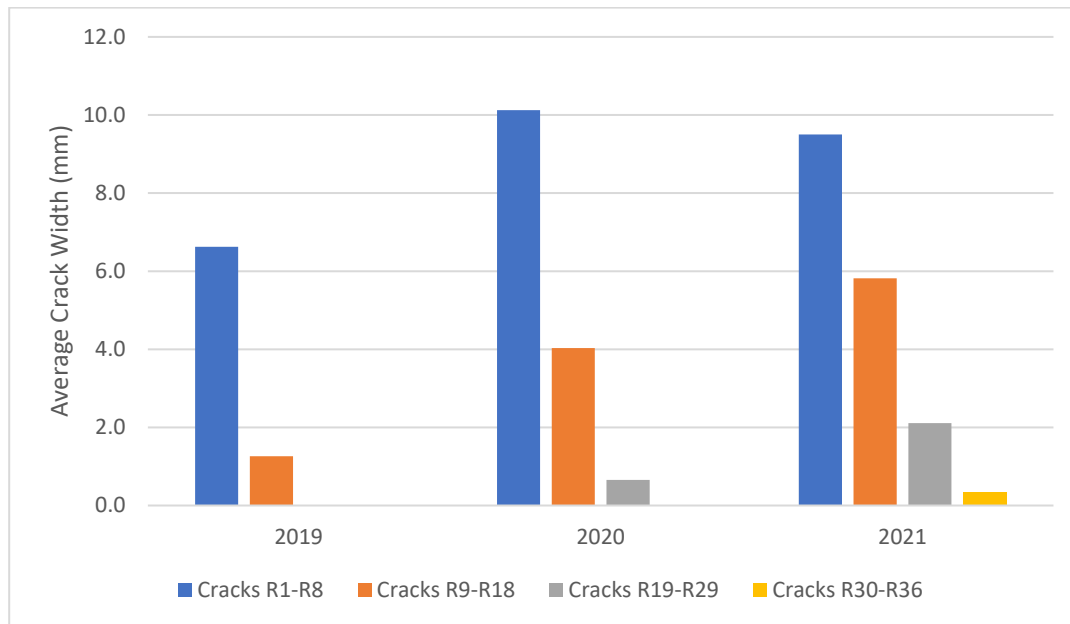
Figure 120. Crack width progression over time in the FRC roundabout

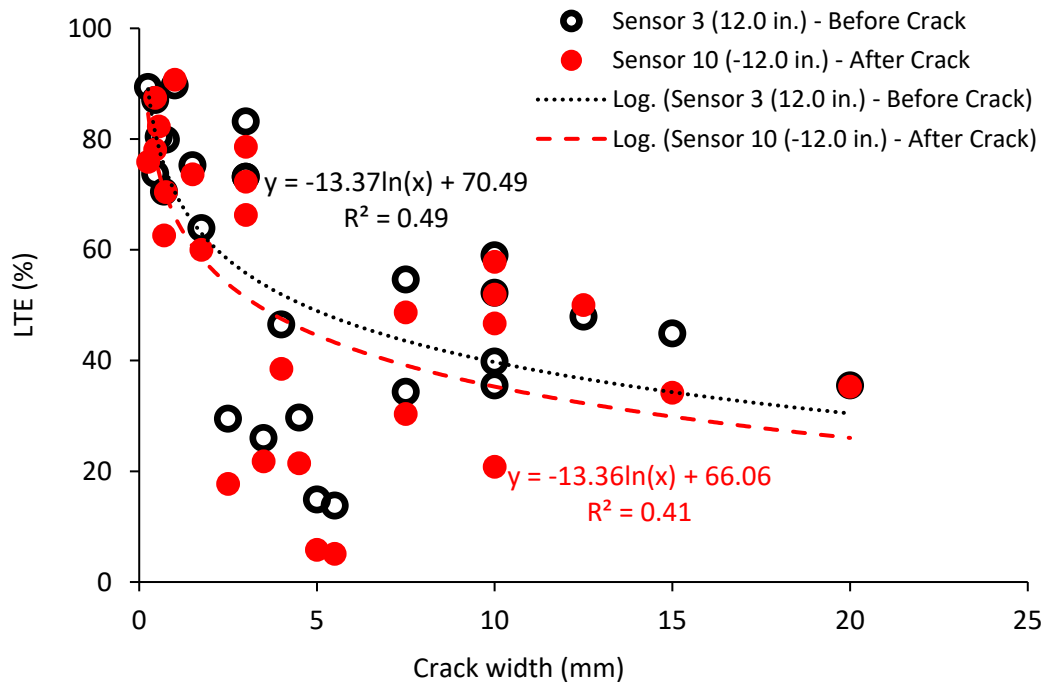
FWD testing and faulting measurements were performed across a select number of the transverse cracks to characterize their performance. Results for crack width versus LTE are plotted in Figure 121, including measurements taken on both sides of the cracks. The observed trend was very similar to that of the FRC overlay test section in Worth County, with a clear decline in LTE with increasing crack width.

Figure 121. Crack width versus LTE for the FRC roundabout, September 2021

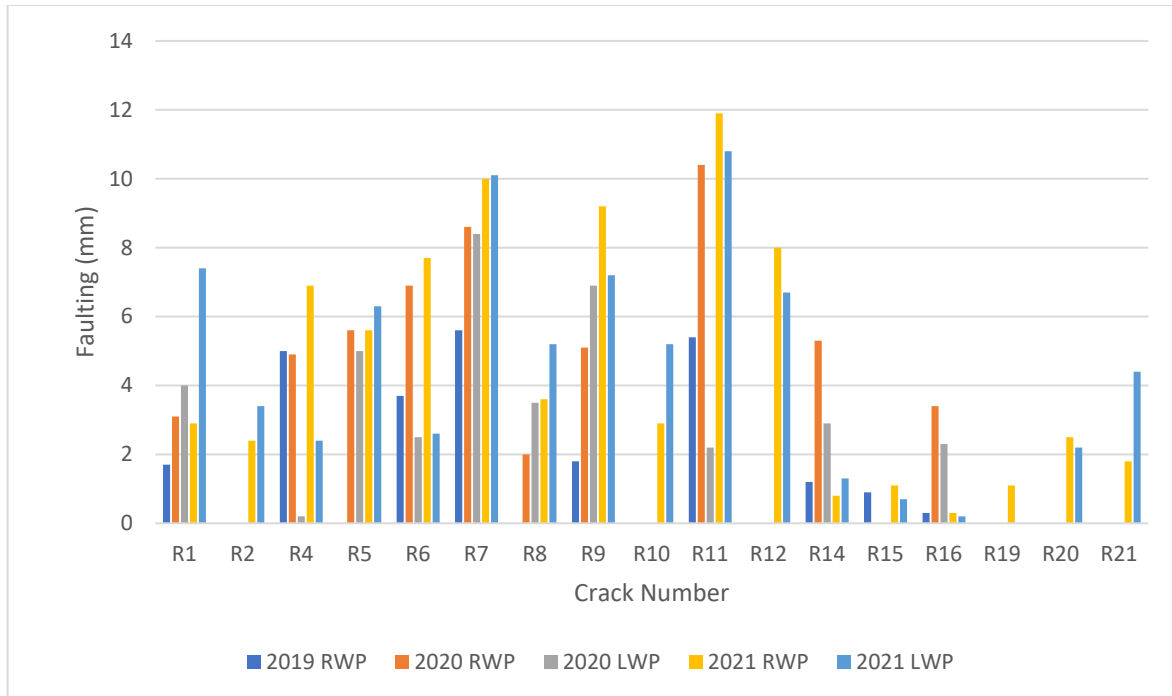
Unlike in Worth County, measurable faulting across the transverse cracks in the roundabout was detected using a digital faultmeter, with results plotted in Figure 122. Faulting as great as 12 mm (0.47 in.) was observed across the right wheel path (RWP) of crack R11, and a number of other cracks had faulting greater than 6 mm (0.24 in.) across both the RWP and left wheel path (LWP).

Figure 122. Faulting test results for the FRC roundabout

In spite of the faulting, through September 2021 the roundabout was generally in good condition. While a number of the cracks had opened up to a considerable degree with loss of load transfer and faulting, ride quality was reasonable, helped by the fact that vehicles must slow down to navigate the roundabout. There were no other signs of early distress or deterioration.
