Evaluation of Rumble Stripes on Low-Volume Rural Roads in Iowa—Phase I

**Final Report
July 2009**

EVALUATION OF RUMBLE STRIPES ON LOW-VOLUME RURAL ROADS IN IOWA—PHASE I

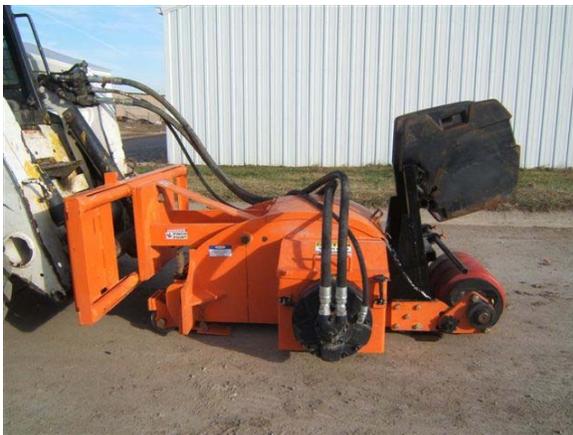
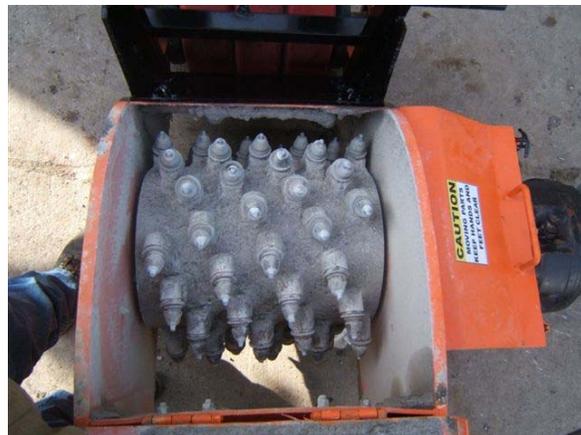
Figure 3-8. Milling equipment (photos courtesy Iowa Plains Signing, Inc.)

Work was suspended in early June to allow the contractor time to work on modifications to another piece of equipment that could complete the work that had been omitted on the inside of curves due to operational problems that will be described in the next section. The equipment shown in Figure 3-8 was adapted to allow milling along the low side of horizontal curves and to be performed more adequately, although the milling depth was still minimal and the alignment was less than ideal.

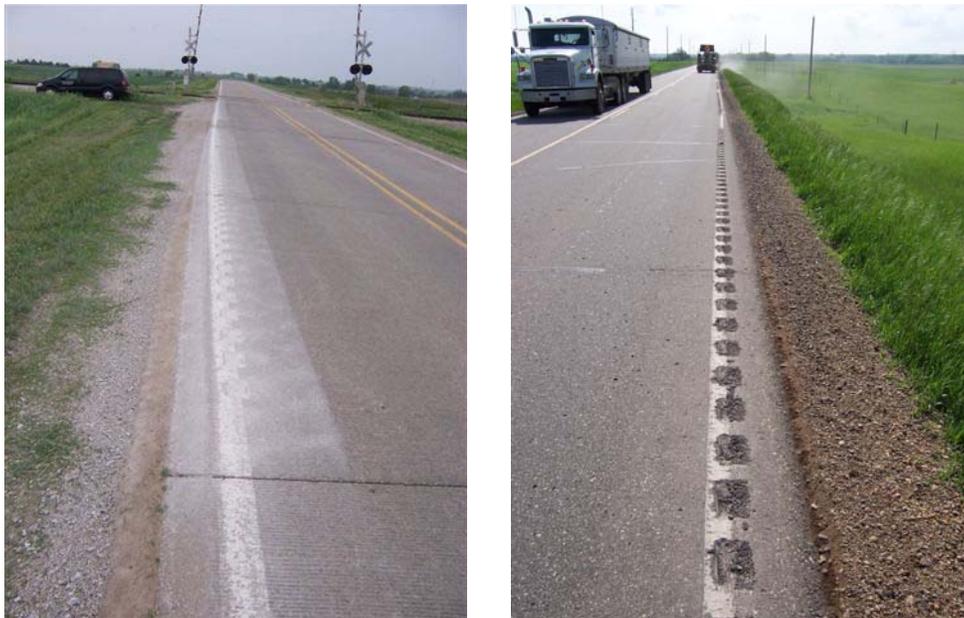
Figure 3-9. Examples of milling work

The contractor resumed milling work on October 16, 2008, and completed all contract work on November 3, 2008. Examples of that work are shown in Figure 3-9.

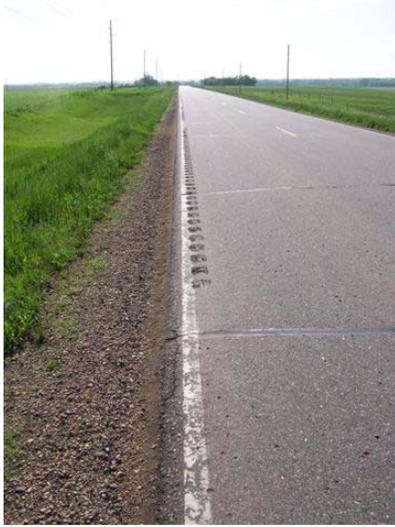
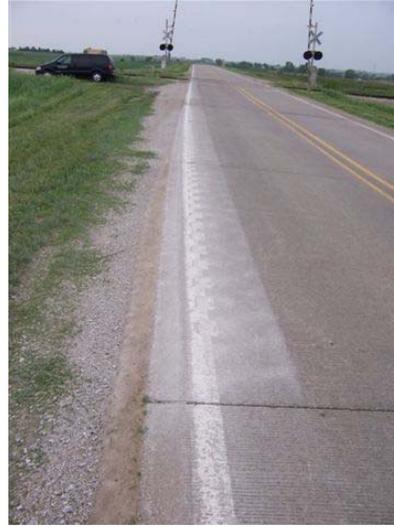
Figure 3-10. Milling in Sioux and Dallas Counties

Installation work was quite satisfactory in the tangent sections of roadway, but problems with machine stability were encountered when milling was attempted along the low side of super-elevated horizontal curves due to the high center of gravity of the milling machine. Milling machine instability, less than desirable milling depth, and difficulty in maintaining a satisfactory alignment through curves required omitting these sections until a modified machine was developed later in the season. In addition, it was necessary to add an air compressor to the process to remove millings from the pavement edge prior to application of pavement markings. Figure 3-10 shows sections on County Roads B-30 and P-53 after rumble stripes were cut into the pavement surface. Figure 3-11 shows the machine tipping.

First, as described earlier in this report, some installation problems were encountered during milling operations. If rumble stripe installation is to be adopted as a recommended tool for mitigating roadway departure on lower-volume rural roadways, milling machine design will need to be modified to allow placement of these narrow width rumble strips along the pavement edge, regardless of shoulder quality along that edge. The modified machine developed by Iowa Plains Signing performed much better than the higher center of gravity machine owned by Diamond Surfaces, but the design should still be improved further to provide adequate and predictable alignment and milling depth in a variety of alignment situations and pavement types, especially on PCC pavement, where a heavier machine is necessary to consistently achieve desired milling depth.

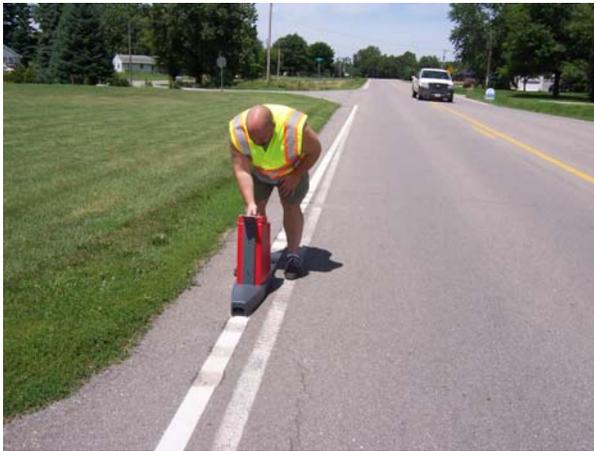
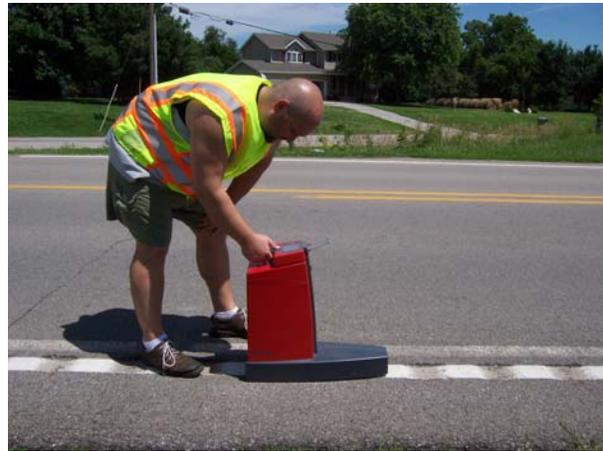
Figure 5-1. Retroreflectivity data being taken

Retroreflectometer readings were taken at two positions within each test section. Readings were taken directly over the rumble stripes at approximately 500- to 1,000-foot intervals at locations where the rumble stripes were actually present (within the grooved portion). Four readings were taken in each location and then averaged. When the rumble stripes were installed, an extra 500 feet of edge line was painted beyond the rumble strip so data could be compared for sections without rumble strips. However, some of these areas were repainted by the counties during the period, and while the county repainted areas outside the rumble stripes, they did not repaint the rumble stripes themselves. As a result, those sections could no longer be used as controls. Therefore, data were collected intermittently on the solid painted areas between rumble stripes to further define the comparison. This was used as a control section. Initial data were collected mainly within those 500-foot sections but was expanded (and later eliminated) at each project for subsequent collections. This is shown in Figure 5-1.

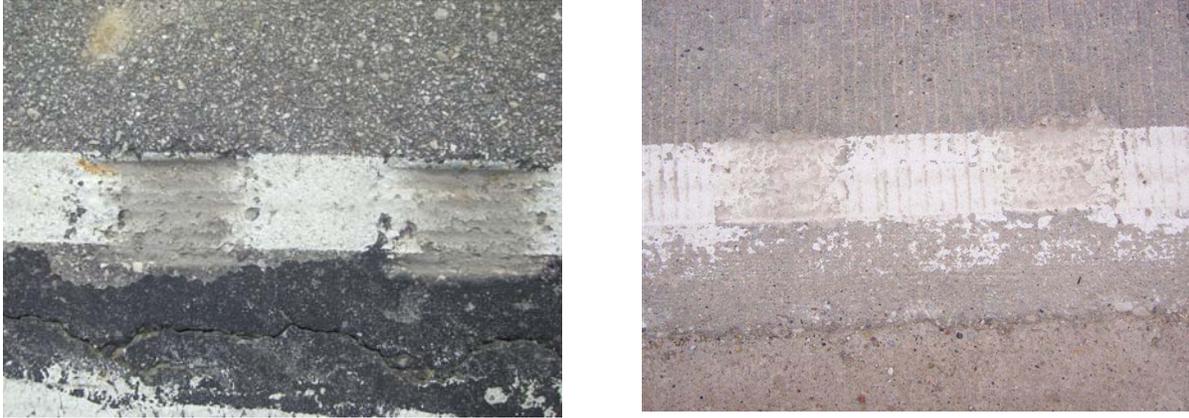
Figure 5-4. Swept stripe areas on asphalt and PCC pavements

Stripes that were caked and only partially filled showed better retroreflectivity readings than those that were completely filled. Although the authors did not wish to introduce a possible maintenance activity for using these stripes, they did consider that the performance might be better if the loose (or caked) material was broomed from the stripe. See Figure 5-4. Therefore, they did broom (by hand) several stripes of each type and shot them for performance. In all cases, the retroreflectivity of the swept stripes measured lower than the untouched ones. The authors believe that this may have occurred due to dust created by the brooming covering most of the reflective beads and/or due to the brooming action itself removing much of the beading from the paint surface. Using a stiff or soft bristle hand broom seemed to make no difference.

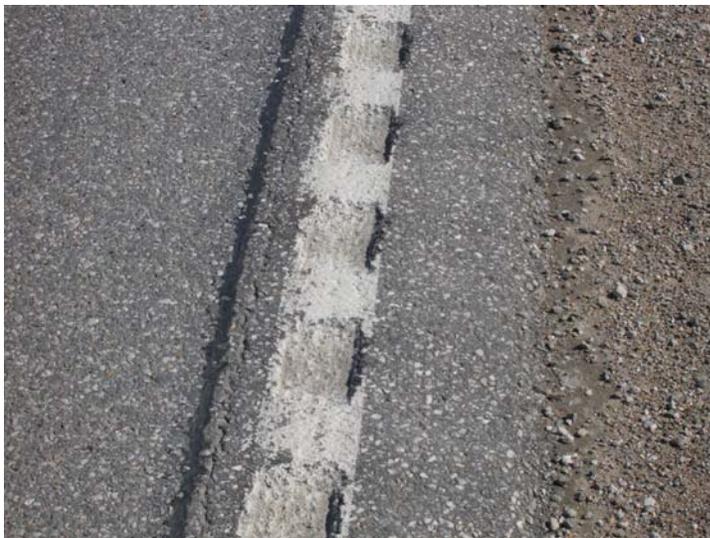
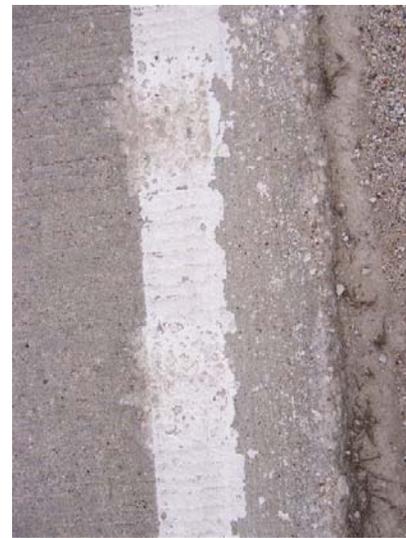
In other areas, the paint seemed to be holding up well in both the rumble stripes and flat sections. Figure 5-15 shows a portion of F-29 taken in spring 2009. Figure 5-16 shows a portion of E-18 taken in spring 2009.

Figure 5-15. Similar wear for rumble stripe and flat section (taken spring 2009). F-29 is on the left and P-53 is on the right.

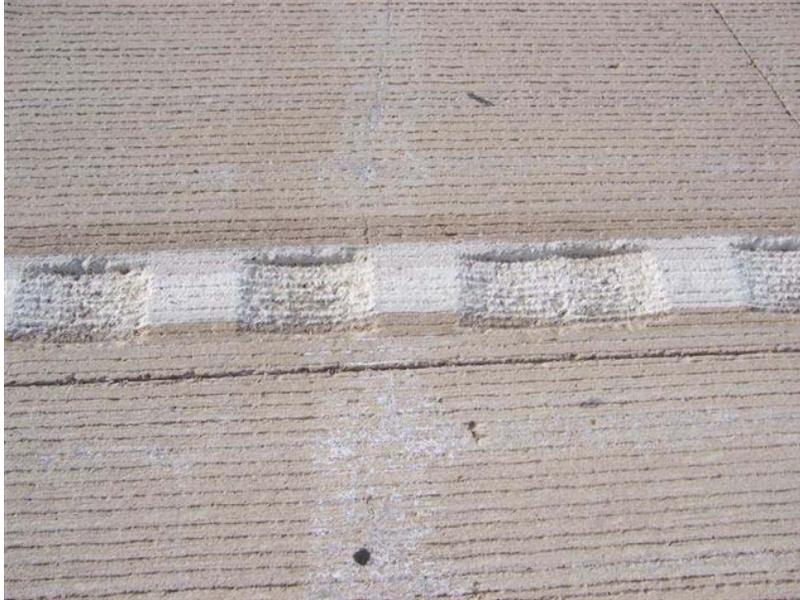
Figure 5-16. Similar wear for rumble stripe and flat section on E-16 (taken spring 2009)

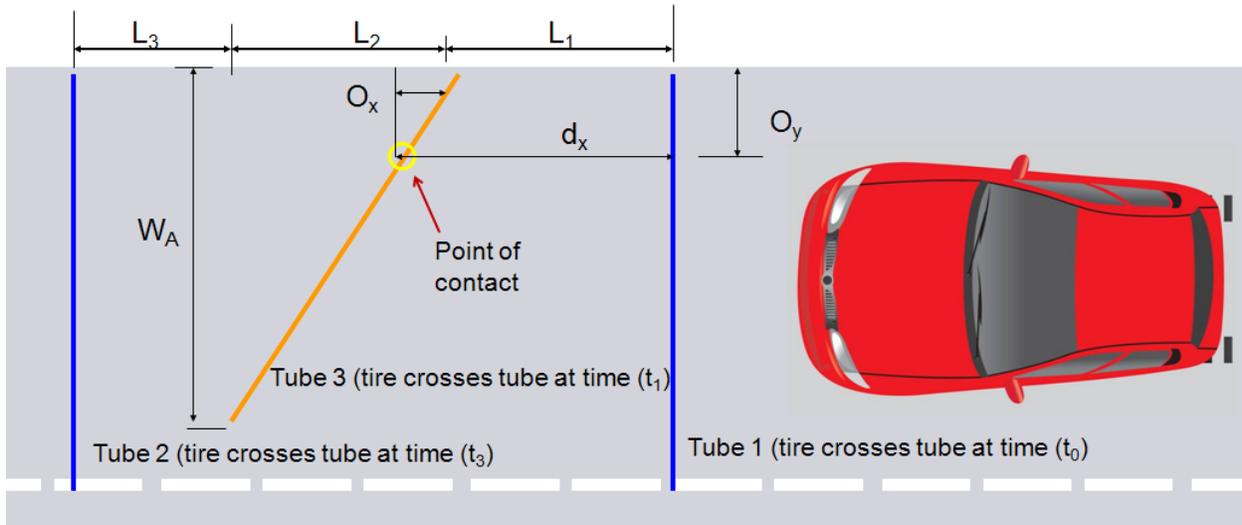
Figure 5-19. Layout configuration of road tubes to measure lateral displacement

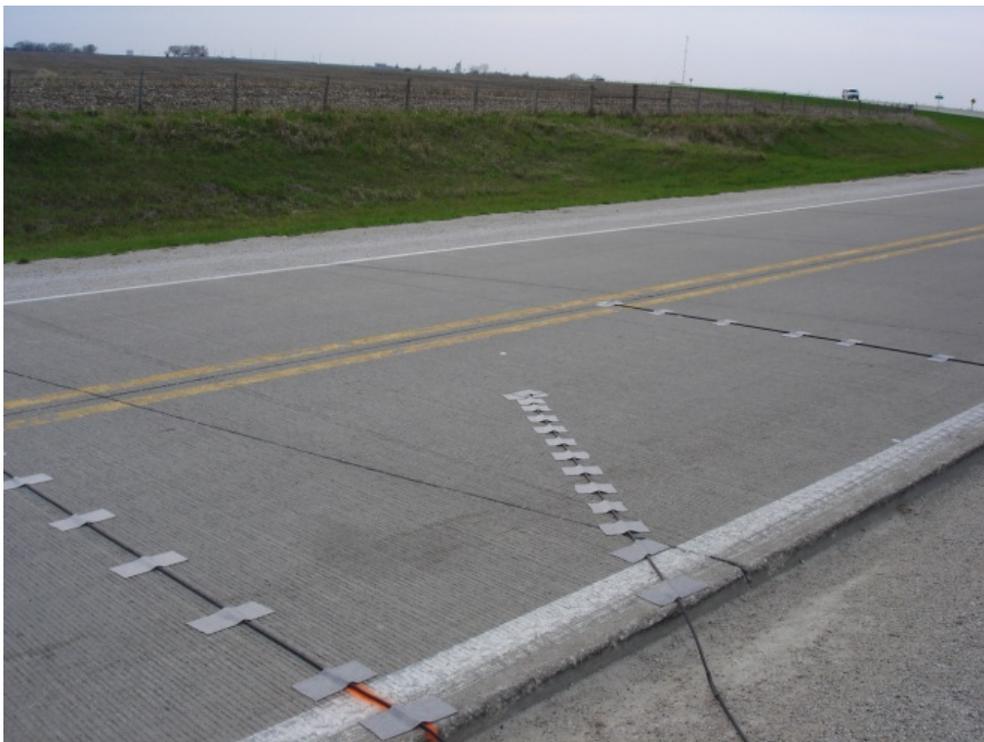
Figure 5-20. Road tube layout to measure lateral displacement in the field

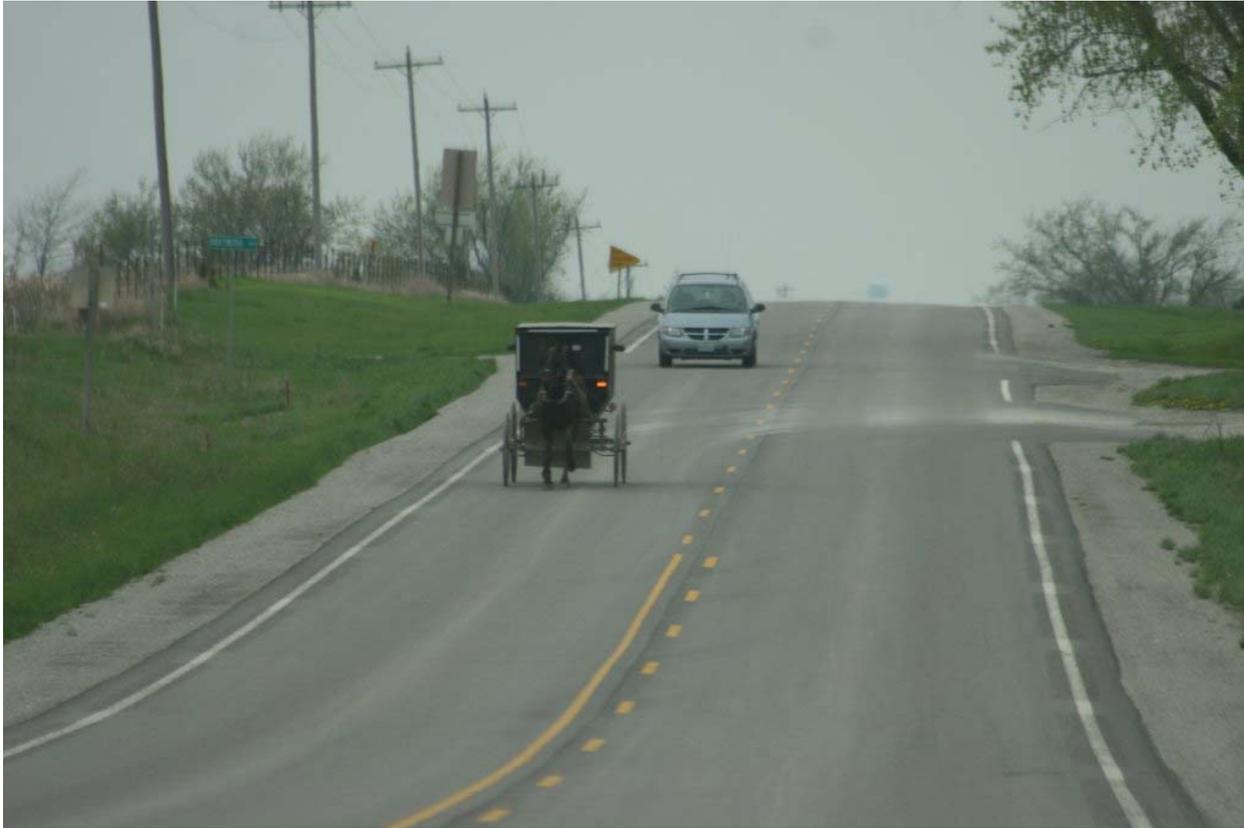
There are no test sections in Davis County as part of this research. However, rumble stripes are present along Iowa 2 in that county, as shown in Figure 5-21. As shown, the rumble strip is wider than that used along test sections. The Amish group in Davis County indicated that recently installed rumble strips were a problem for the horse and buggies. They indicated that the horses were reluctant to cross the strips and could easily injure their feet. They also indicated that the vibrations caused by rumble strips were hard on the buggies and that the buggies can

fishtail when crossing the strips. The Amish indicated that they would prefer not to have rumble strips on roadway sections that they commonly use. Note the narrow shoulders present on Iowa 2 along with the rumble strips, as shown in Figure 5-21. In this section, there is very little room for the buggies to maneuver around the rumble strips. It should be noted that the standard width for milled rumble strips on Iowa DOT roadways such as Iowa 2 is 16 inches.

Figure 5-21. Edge line rumble strips in place along Iowa 2 (image courtesy of Neal Hawkins, CTRE)
