Research  
Note  
FPL-RN-0289

# Creosote Retention Levels of Timber Highway Bridge Superstructures in Michigan's Lower Peninsula

August 2003

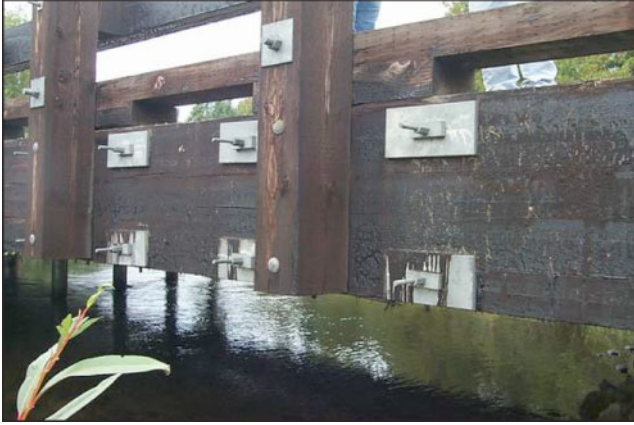
Figure 5—Cameron bridge in Crawford County.

Creosote bleeding was extensive on the deck underside and along the edge beams at the Cruzen bridge superstructure in Alcona County (Fig. 4). The glulam (web) beams were actively bleeding at the bridge underside and along the edge beams at the Cameron bridge superstructure in Crawford County (Fig. 5). Several of the glulam beams in the middle span appeared to have an oily residue on the deck underside of the Houlihan bridge superstructure within the Shiawassee National Wildlife Refuge (Fig. 6). The control bridges, Barlow in Alcona County (Fig. 7) and Old Vanderbilt in Otsego County (Fig. 8), had minimal amounts of creosote crud on the exposed wood members and were not visibly bleeding.

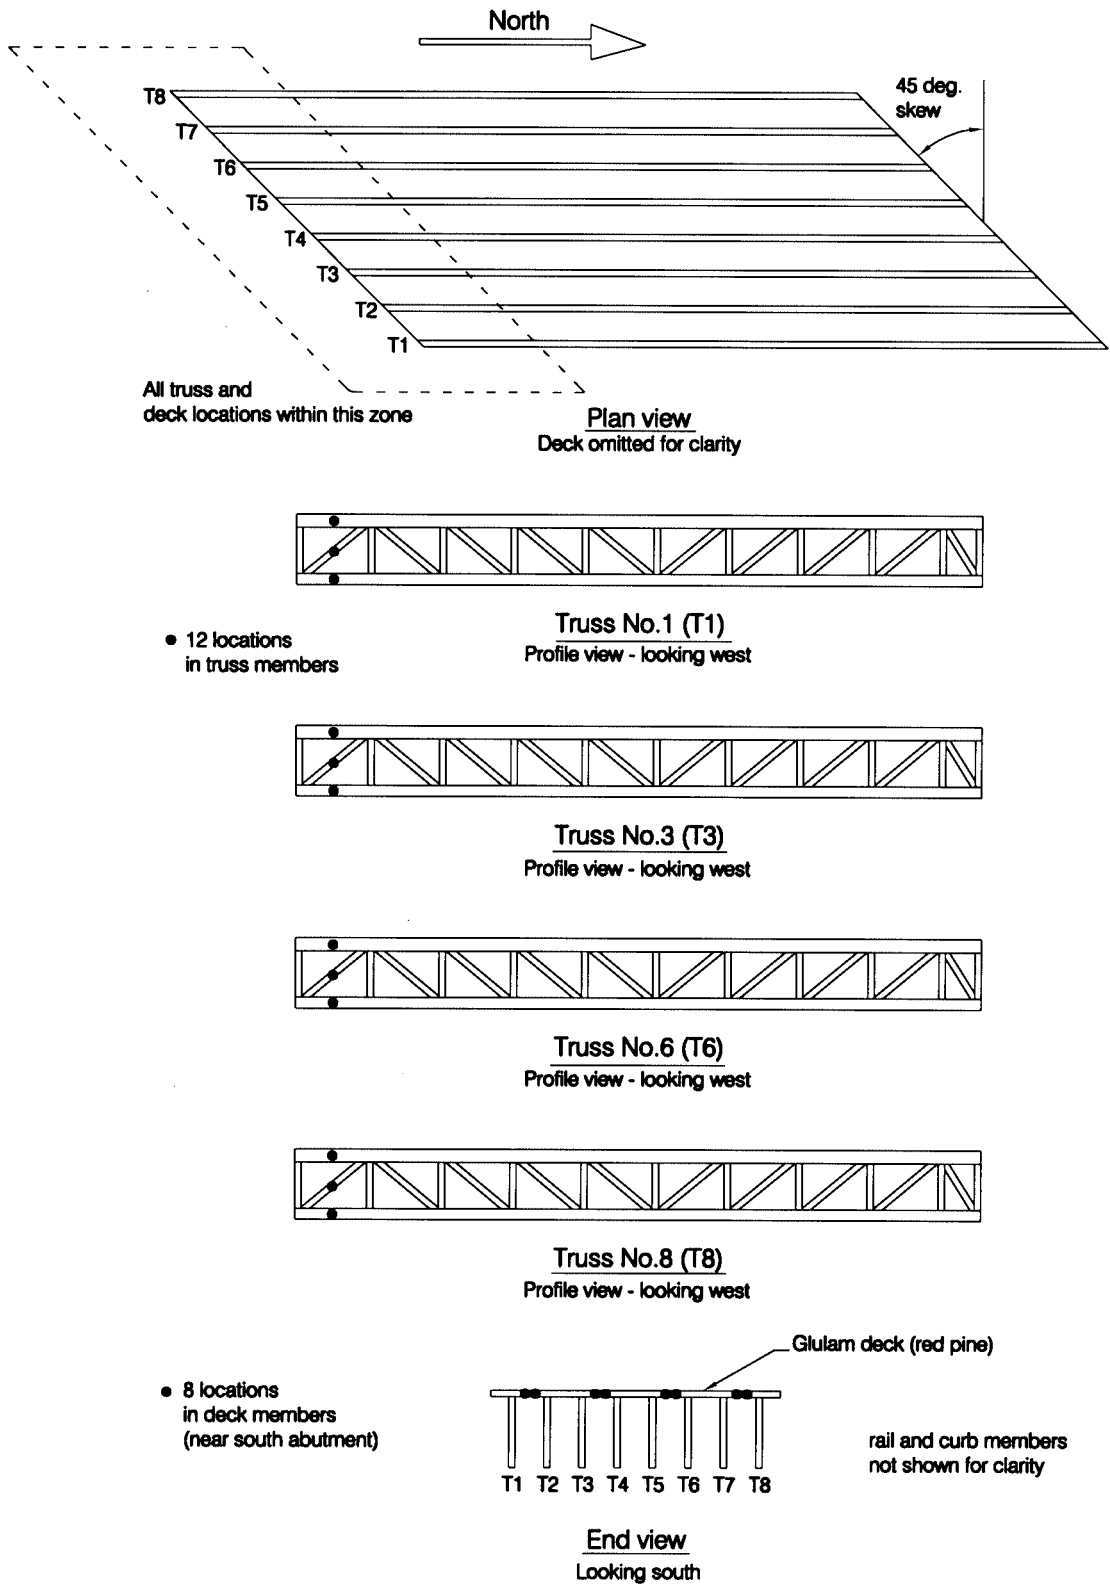
Figure 11—Core sample locations for the La Chance bridge (Missaukee County).

Core Samples Taken: Twelve from truss members (taken from the first truss cell adjacent to the south abutment), eight from deck members (taken from the underside of the deck near the south abutment) (Fig. 11).

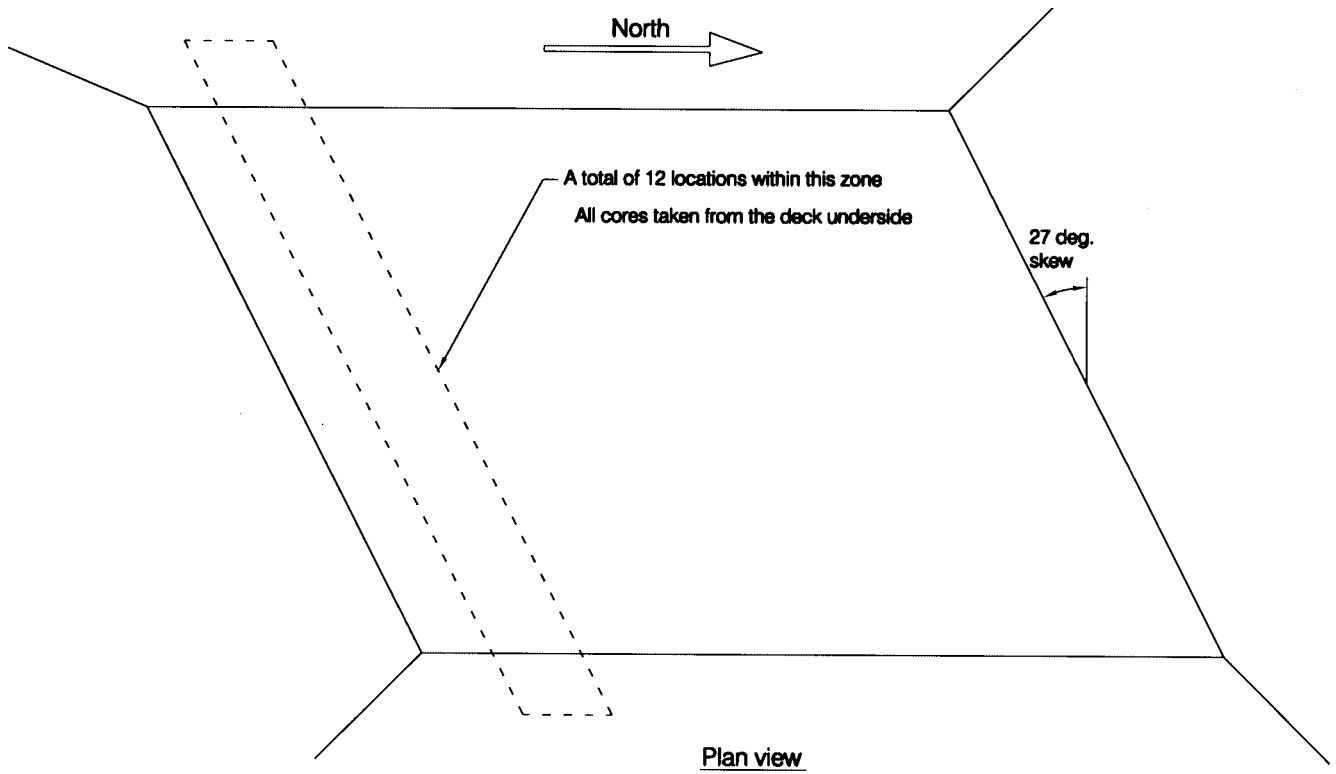
Figure 12—Core sample locations for the Cruzen bridge (Alcona County).

Core Samples Taken: Twelve (taken from the deck underside adjacent to the south abutment) (Fig. 12).

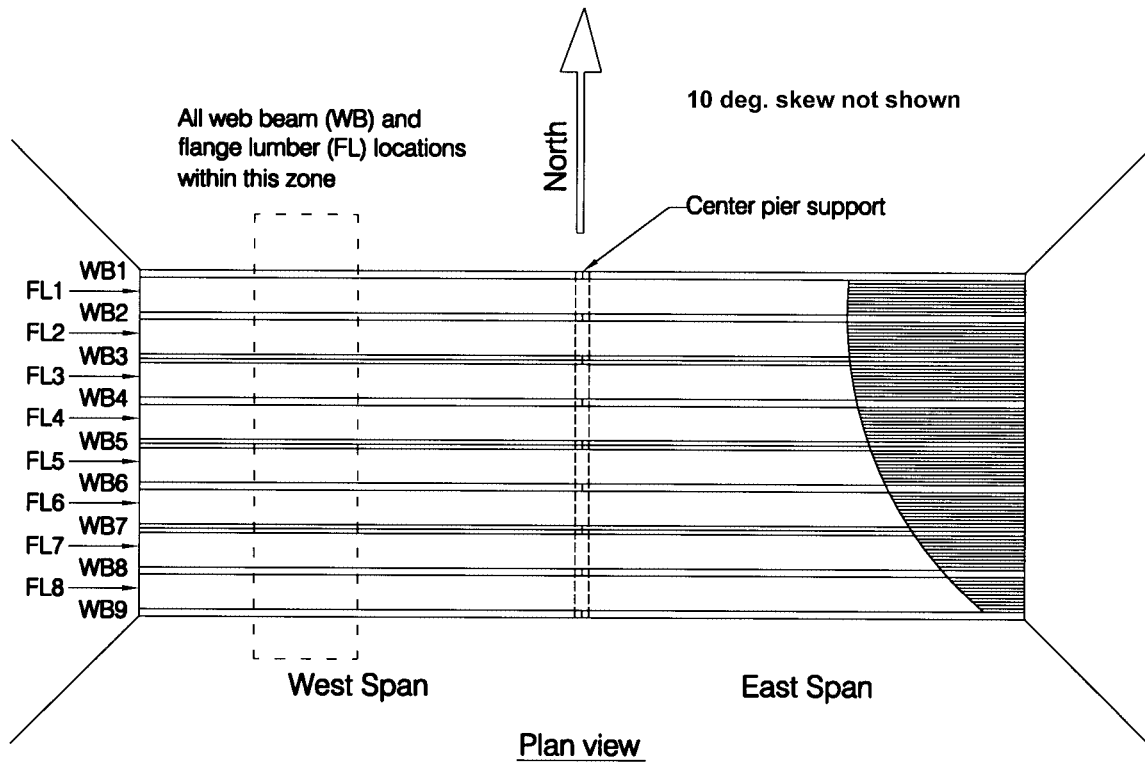
Figure 13—Core sample locations for the Cameron bridge (Crawford County).

Core Samples Taken: Nine from web members, eight from flange members (taken from the superstructure underside about 10 ft (3.1 m) from the west abutment) (Fig. 13).

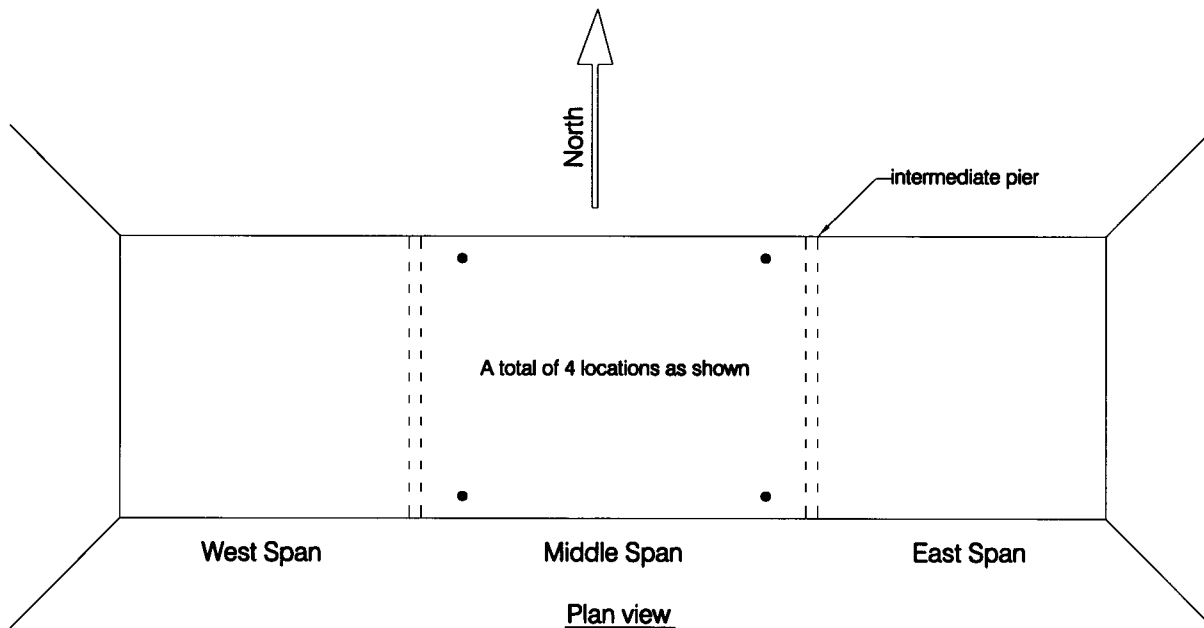
**Figure 14—Core sample locations for the Houlihan bridge (Shiawasse National Wildlife Refuge).**

Core Samples Taken: Four (taken at topside of middle span only) (Fig. 14).

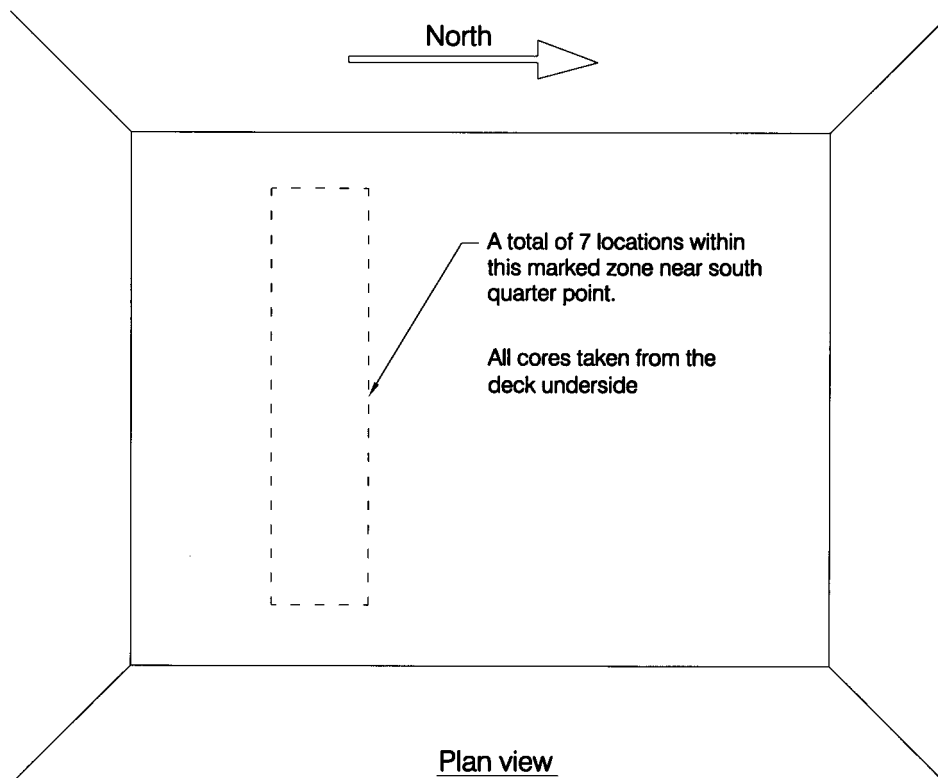
**Figure 15—Core sample locations for the Barlow bridge (Alcona County).**

Core Samples Taken: seven (taken from deck underside near midspan) (Fig. 15).

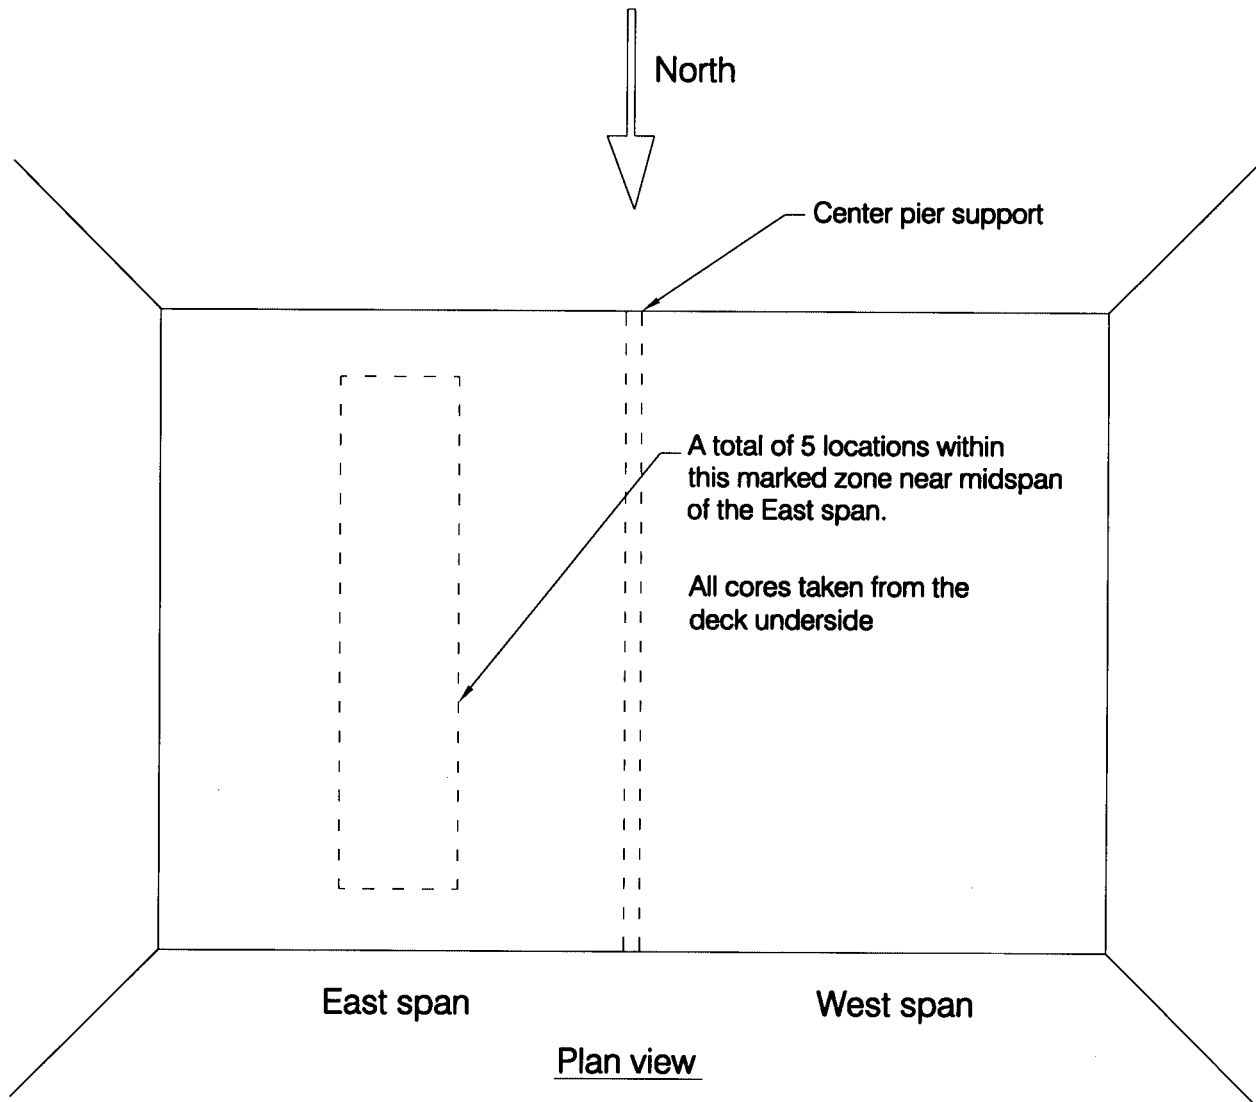
Figure 16—Core sample locations for the Old Vanderbilt bridge (Otsego County).

Comments: Wood members appeared dry with no surface residues.

Core Samples Taken: five (taken from the deck underside of the southernmost span, near centerspan) (Fig. 16).
