Research
Paper
FPL-RP-563

Field Performance of Timber Bridges

13. Mohawk Canal Stress-Laminated Bridge

Paula D. Hilbrich Lee
Xanthi Lauderdale

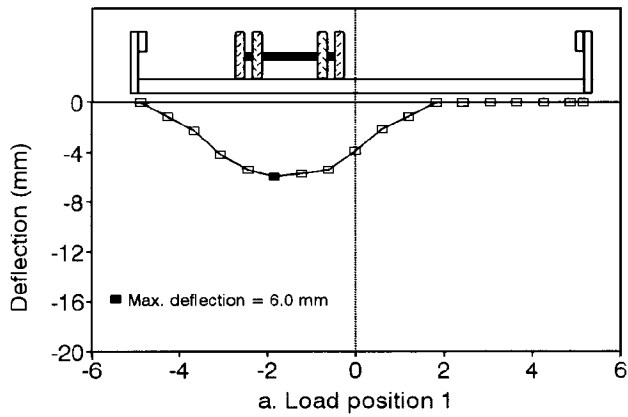
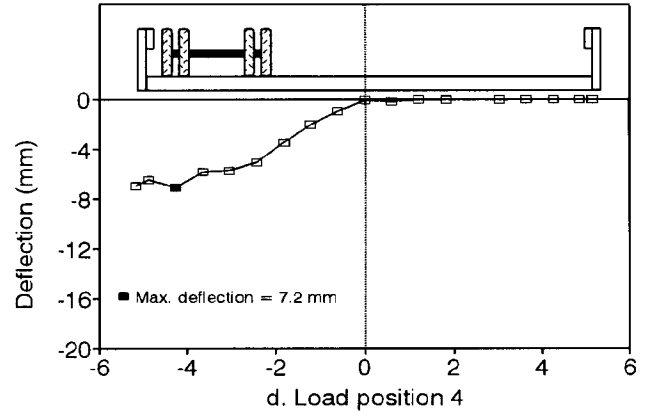
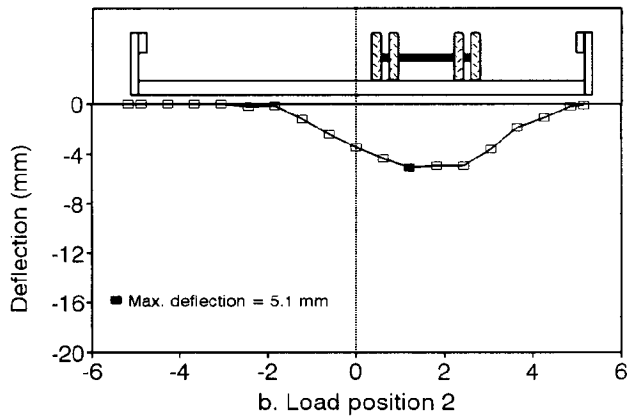
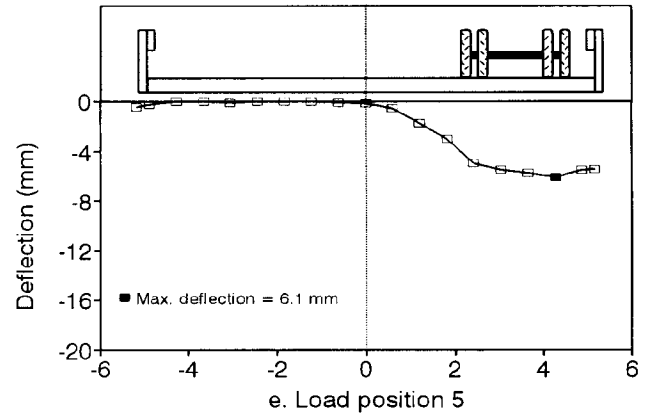
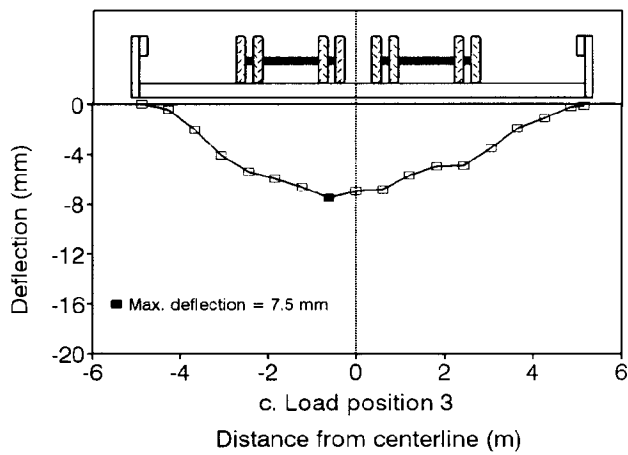
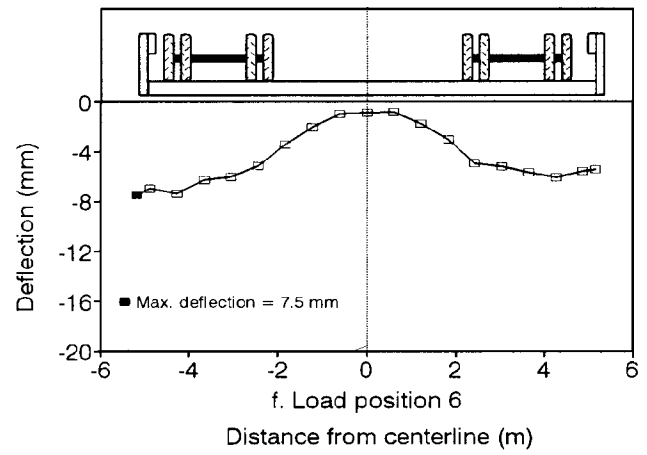
Transverse deflections for load test 1 are shown in Figure 16. As indicated, the maximum deflections for load positions 1 and 2 occurred between the wheel lines, 610 mm (24 in.) south of the upstream (left) wheel line. For load positions 4 and 5, the maximum deflections were measured beneath the

Figure 16—Transverse deflections for load test 1, measured at the bridge midspan (looking east). Bridge cross-sections and vehicle positions are shown to aid interpretation and are not to scale.

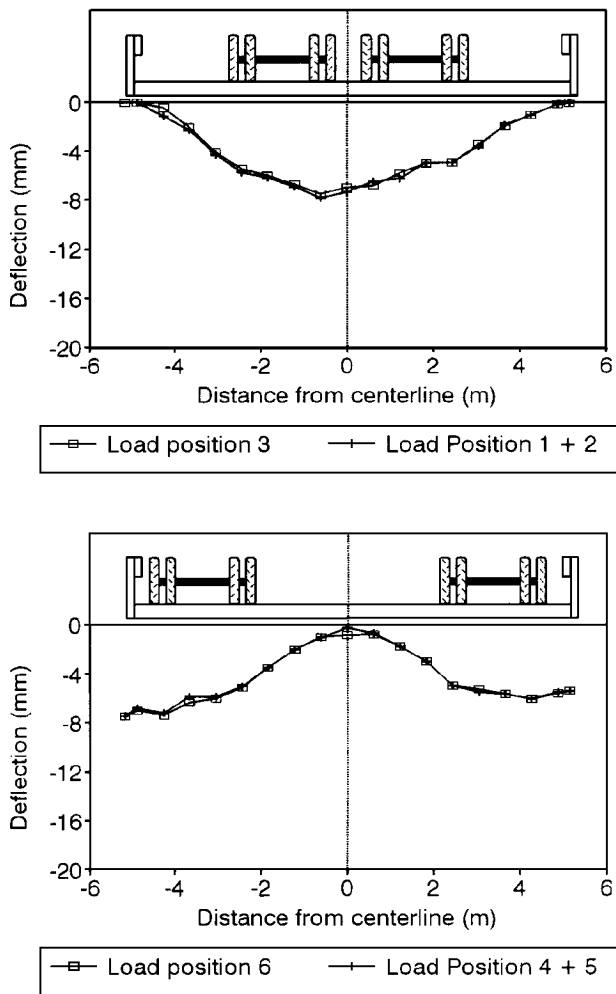
Assuming linear elastic behavior, uniform material properties, proper vehicle placement, and accurate deflection measurements, the summation of the deflections resulting from two individual truck loads applied separately should equal the deflection resulting from both trucks applied simultaneously. This is illustrated in Figure 17, where the sum of load positions 1 and 2 and load positions 4 and 5 are compared with load positions 3 and 6, respectively. The deflections are similar, with minor variations that are within the accuracy of the measurement methods, indicating that the bridge is behaving in a linear elastic manner under the applied loads.

Figure 17—Transverse deflections for load test 1, comparing the sum of measured deflections from load positions 1 and 2 and load positions 4 and 5 with load positions 3 and 6, respectively. Bridge cross-sections and vehicle positions are shown to aid interpretation and are not to scale.

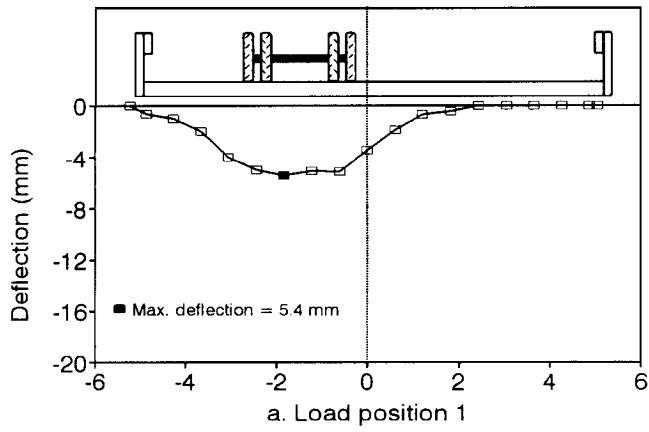
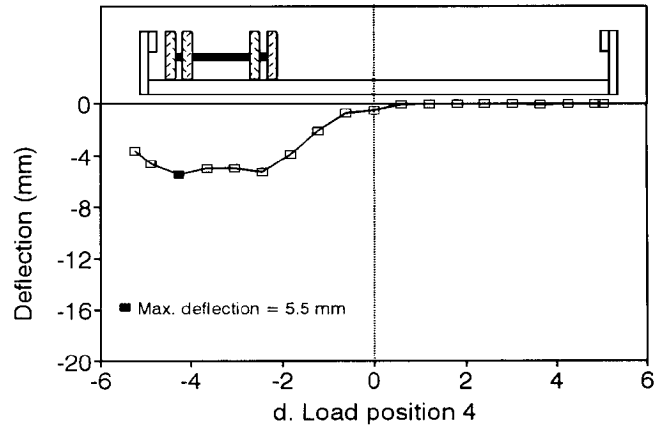
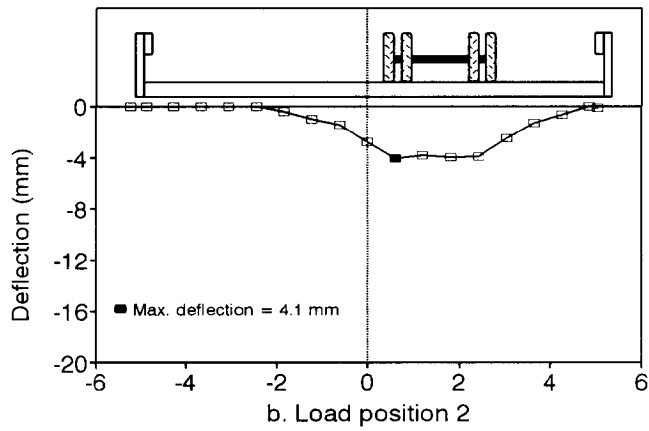
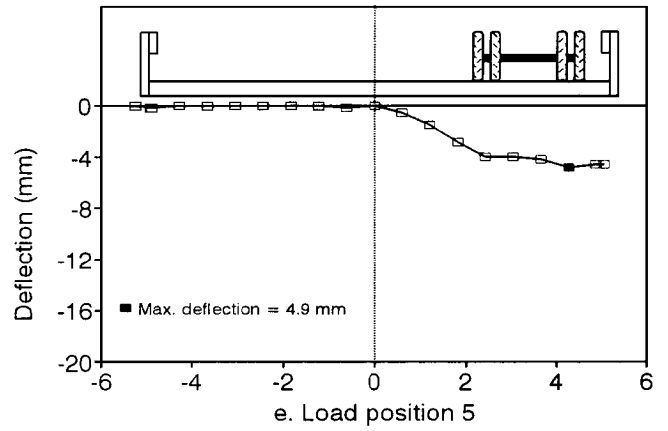
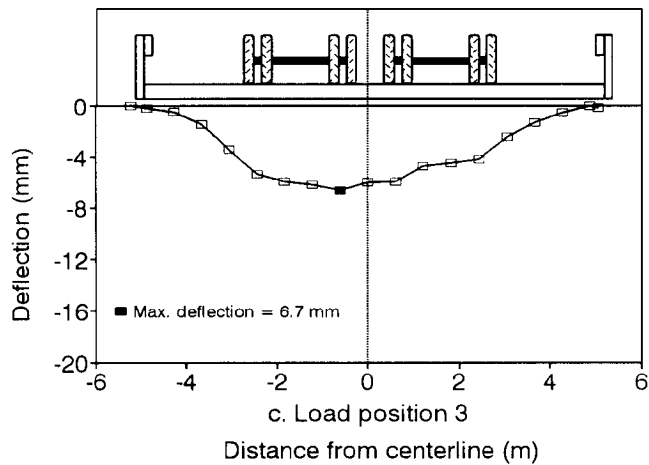
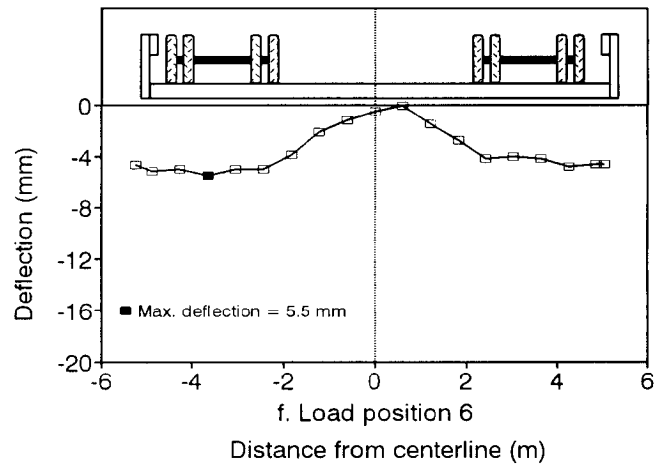
Transverse deflections for load test 2 are shown in Figure 18. As with load test 1, the deflections are typical of orthotropic plate behavior. The maximum measured deflection for load position 1 occurred between the wheel lines. For load position 2, the maximum deflection occurred beneath the upstream (left) wheel line. As with load test 1, the maximum deflections for load position 4 and 5 occurred beneath the outside wheel line of the test vehicle. For load position 6, the maximum deflection occurred between the wheel lines of truck A. The absolute maximum deflection of 6.7 mm (0.26 in.) occurred during load position 3, beneath the downstream (right) wheel line of truck A.

Figure 18—Transverse deflections for load test 2, measured at the bridge midspan (looking east). Bridge cross-sections and vehicle positions are shown to aid interpretation and are not to scale.

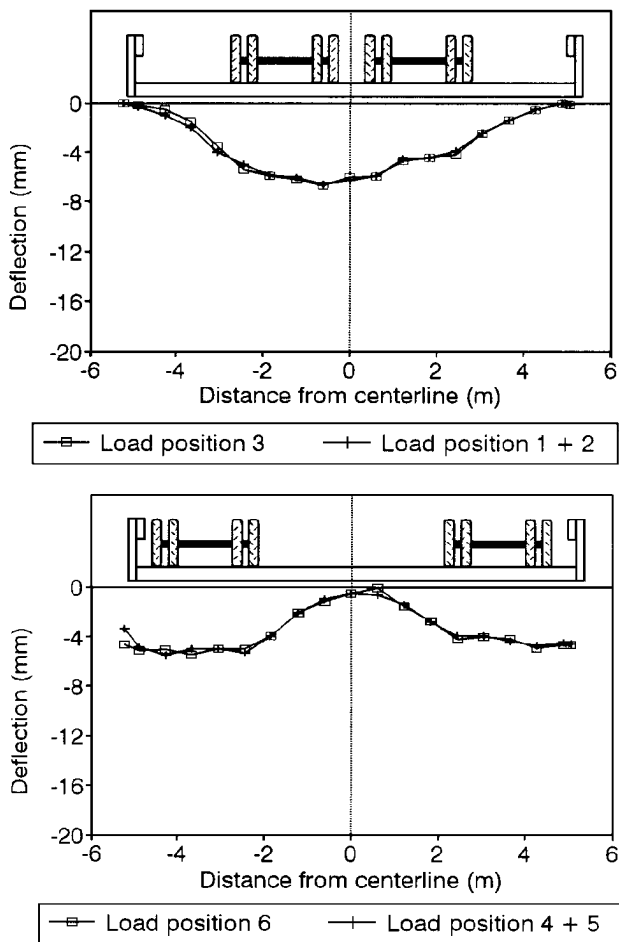
As illustrated with the measured deflections of load test 1, the summation of deflections resulting from two separately applied loads should equal the deflection of both loads applied together, if uniform material properties, proper vehicle placement, and accurate deflection measurements are assumed. This principal of superposition is illustrated in Figure 19, where the sum of load positions 1 and 2 and load positions 4 and 5 are compared with load positions 3 and 6, respectively. As with load test 1, the deflections are virtually the same, with slight variations within the accuracy of the measurement methods, demonstrating that the behavior of the bridge is within the linear elastic range under the applied loads.

Figure 19—Transverse deflections for load test 2, comparing the sum of measured deflections from load positions 1 and 2 and load positions 4 and 5 with load positions 3 and 6, respectively. Bridge cross-sections and vehicle positions are shown to aid interpretation and are not to scale.

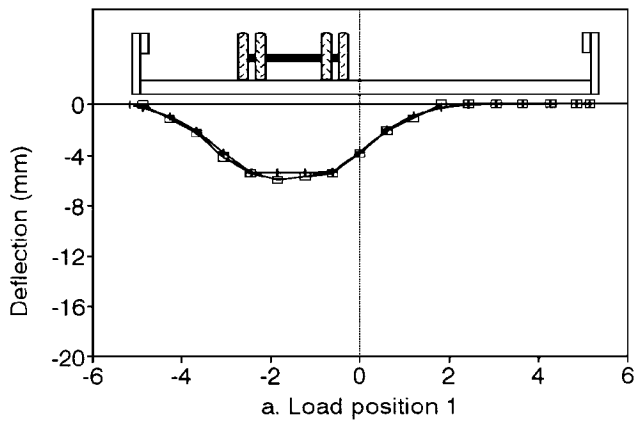
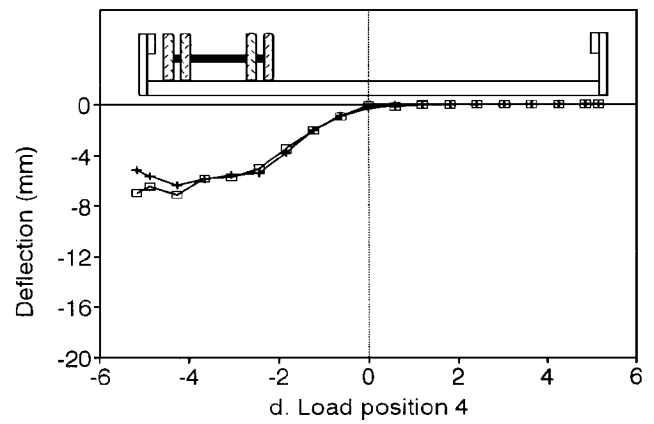
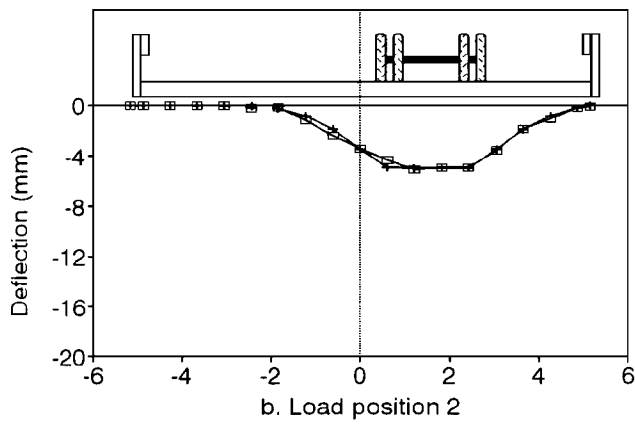
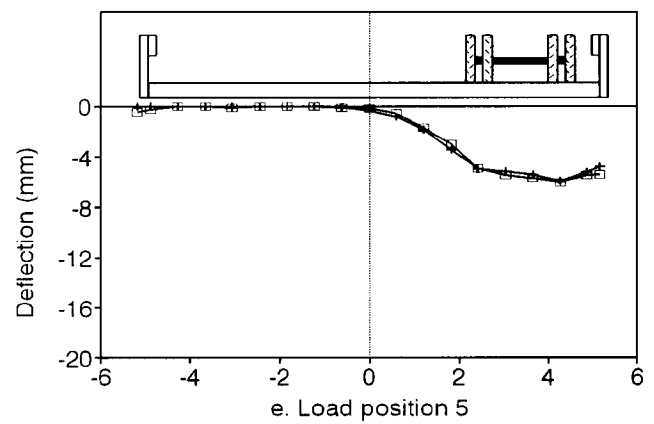
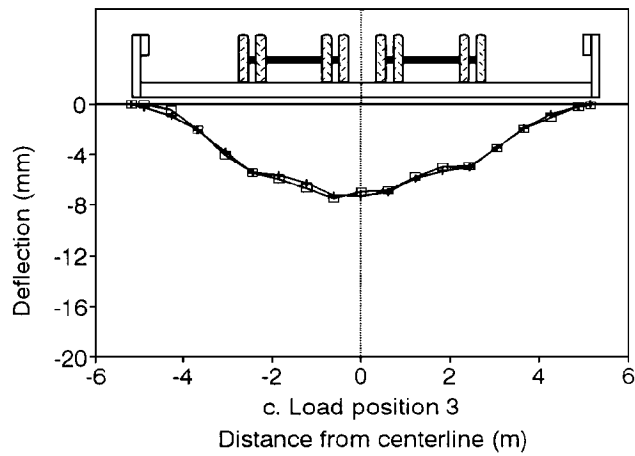
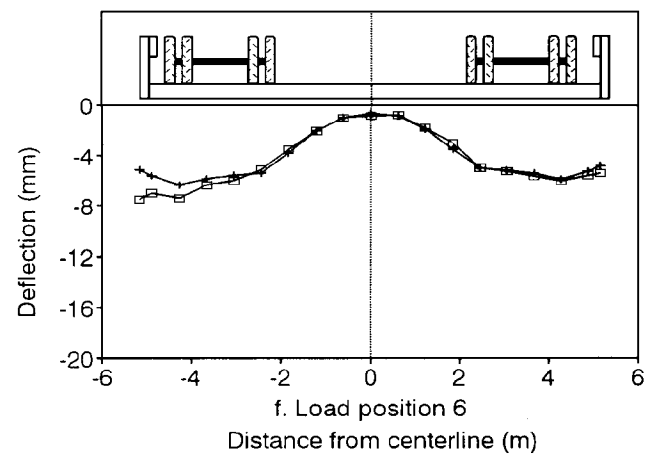
Comparisons of the measured load test deflections to the theoretical bridge response are shown in Figures 20 and 21 for load test 1 and 2, respectively. As illustrated, the theoretical bridge deflection is very close to that measured, with the greatest differences occurring at the edges of the bridge. Employing the same analytical parameters used to determine the theoretical bridge response, the theoretical deflection for

Figure 20—Comparison of the measured deflections for load test 1 with the theoretical deflections using orthotropic plate analysis (looking east). Bridge cross-sections and vehicle positions are shown to aid interpretation and are not to scale.

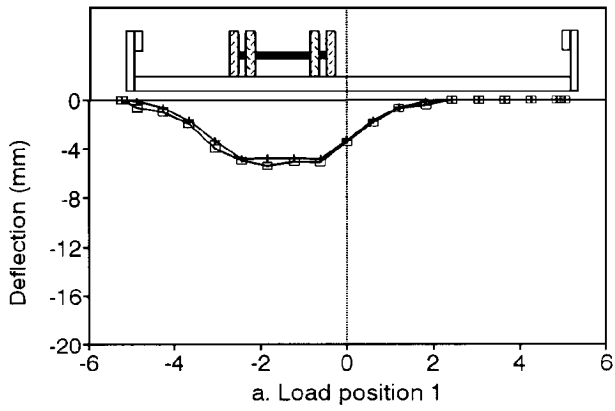
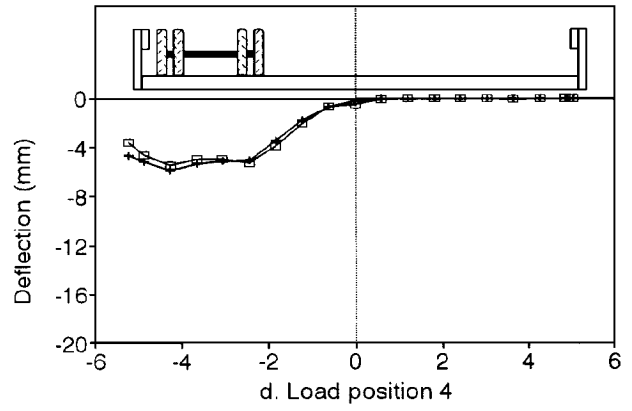
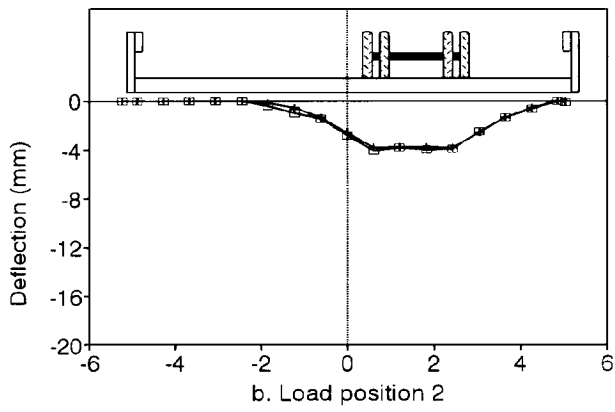
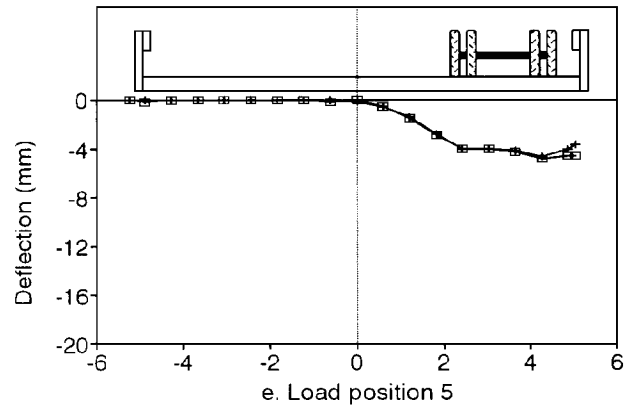
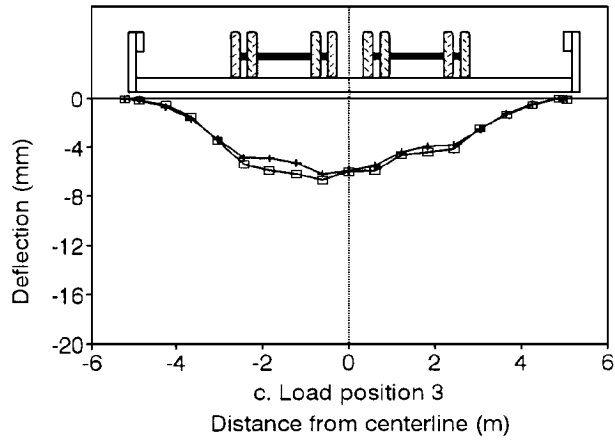
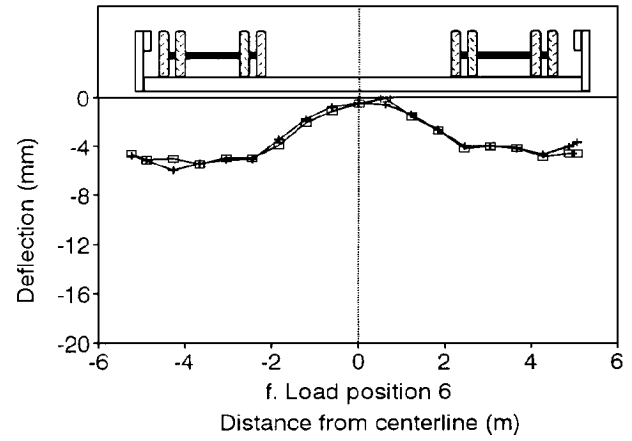
Figure 21—Comparison of the measured deflections for load test 2 with the theoretical deflections using orthotropic plate analysis (looking east). Bridge cross-sections and vehicle positions are shown to aid interpretation and are not to scale.

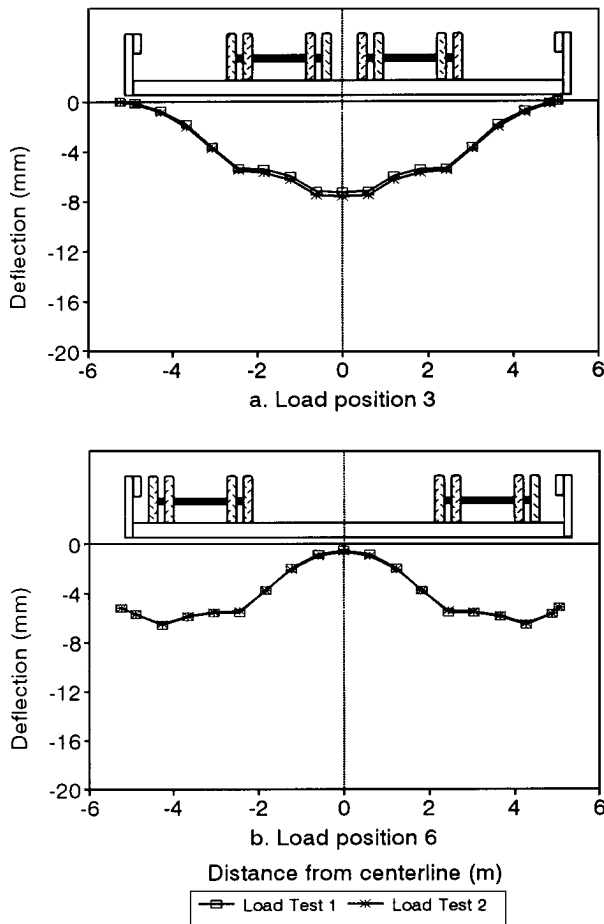
AASHTO HS20–44 truck loading is shown in Figure 22. Based on this analysis, the maximum AASHTO HS20–44 static deflection occurred at centerline when two HS20–44 vehicles were placed centrally on the bridge. The resulting theoretical maximum deflection is approximately 7.6 mm (0.30 in.) or 1/804 of the bridge span for load test 1, and approximately 7.3 mm (0.29 in.) or 1/831 of the bridge span for load test 2. The results indicate that the longitudinal bridge stiffness was approximately the same for both load tests.

Figure 22—Maximum predicted deflection profiles at the bridge midspan for AASHTO HS20-44 truck loading for load positions 3 and 6 (looking east). Bridge cross-sections and vehicle positions are shown to aid interpretation and are not to scale.
