Corrosion of Fasteners in Wood Treated with Newer Wood Preservatives for Potential Rehabilitation of Covered Bridges

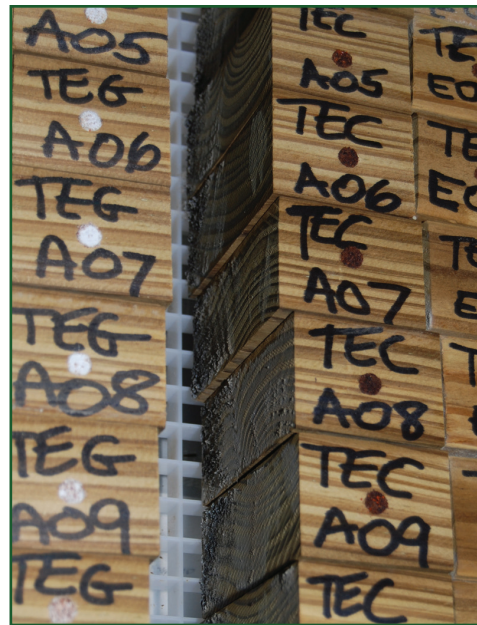
Hot-dip galvanized (left) and common steel (right) fasteners exposed to treated wood during a 1-year exposure at 27°C, 100% relative humidity.

Long-term exposure tests of ferrous and zinc-galvanized fasteners will provide useful data on performance of fasteners used with treated wood in rehabilitated bridges. The fasteners will be exposed for 1 year to an environment of 27°C and close to 100% relative humidity, conditions that have been historically used as a baseline for measuring corrosion of metals in contact with wood. In addition to newer preservatives, such as ACQ, CuAz, and MCQ, chromated copper arsenate (CCA) and untreated wood will also be tested to benchmark performance.
