Design of a Timber Bridge to Evaluate Deck Design Details

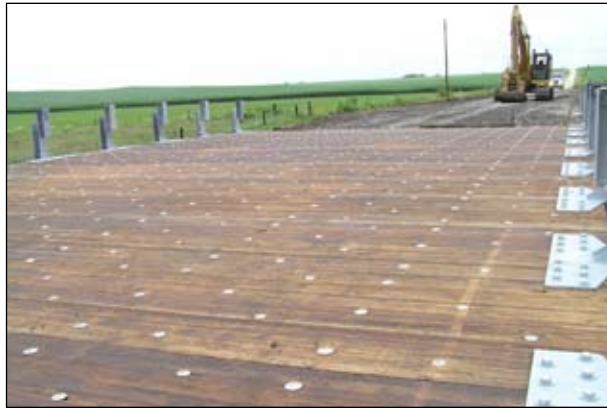
Modern timber bridge decks are typically panelized systems constructed on engineered wood products.

Differential panel deflection, the relative deflection of one panel relative to an adjacent panel, results in increases in the magnitude and frequency of stress reversals in the wearing surface. Consequently, the most common and severe deterioration found on the majority of the subject bridges was transverse cracking at the deck panel joints on girder bridges with transverse decks and longitudinal
