Center Islands with Raised Curbing for Rural Traffic Calming

A number of traffic-calming devices were evaluated to determine their effectiveness in reducing speeds along the main road through a small rural community. Five different treatments were selected and installed in six rural lowa communities. This tech brief highlights use of temporary curbing to create center islands.

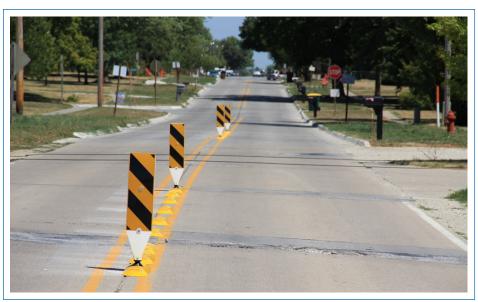
Mountable curbing at south entrance to St. Charles

The treatment was installed at three locations in the community of St. Charles, Iowa (population 653). Speed problems were present at all four community entrances. County Road R-35 is oriented north/south and has a volume of 410 vehicles per day (vpd) at the north community entrance and 940 vpd at the south entrance. State Highway 251/West Main Street is oriented east/west and has a volume of 1,200 vpd at the west community entrance and 2,240 at the east entrance. The roadway serves as a major collector route for drivers commuting to metro Des Moines, Iowa.

Temporary islands were created using mountable curbing at the north, west, and south entrances. (A different treatment was placed at the east entrance to St. Charles). Mountable curbing was not appropriate for the east entrance given a horizontal curve, which may lead to some sight-distance issues for drivers being able to see the curbing in time.

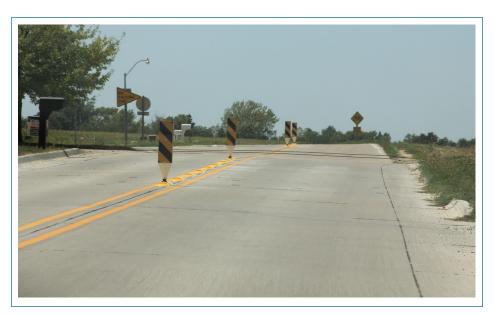
Mountable curbing installed at west St. Charles community entrance

The temporary curbing that was purchased is approximately 2 inches high by 40 inches long by 8 inches wide. The curbing has a rounded design that can be mounted by errant vehicles.

The treatment was placed at community entrances and extended into the community by several hundred feet depending on location. The first several sections of 40 inch curb sections were placed approximately 1 foot apart and subsequent sections were placed about 5 feet apart.

Decreases in mean speed and 85th percentile speed between 1 and 3 mph resulted for two of the locations. Decreases in the fraction of vehicles traveling 5 or more mph over the speed limit of up to 37 percent were noted and decreases of up to 50 and 71 percent in the fraction traveling 10 and 15 or more mph over, respectively. At the third location, little change in speed resulted for any of the speed metrics.
