# Evaluating Roadway Subsurface Drainage Practices – Phase II

**Final Report**  
**April 2015**

**IOWA STATE UNIVERSITY**  
**Institute for Transportation**

**Sponsored by**  
Iowa Highway Research Board  
(IHRB Project TR-662)  
Iowa Department of Transportation  
(InTrans Project 13-473)

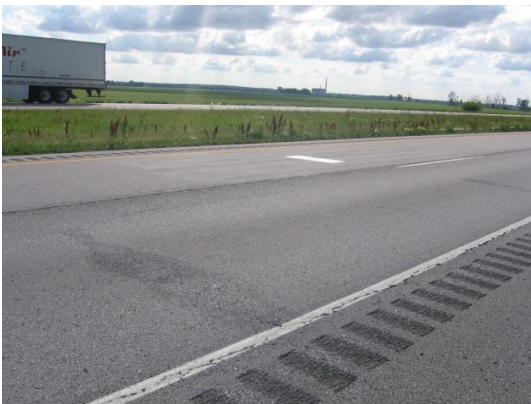
**I-29/N/MP3.05/Fremont County**

In a manner similar to the field investigations of newly constructed pavement sites, the HMA-overlaid surface locations having a high severity of moisture-related distress or patching were also inspected. Figure 25 presents moisture-related damage observed on HMA over JPCP sites where no drainage outlet was found. These findings demonstrate the importance of the subsurface drainage system for mitigating pavement surface failures in HMA over JPCPs.

- Pavement type: HMA over JPCP (6.0 in HMA/8.0 in JPCP)
- Construction year: 2007 (overlay)/1972 (existing pavement)
- AADTT: 12,000
- Raveling/patching

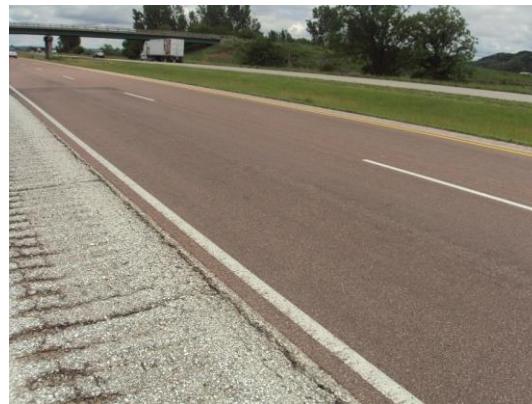
**I-29/S/MP 28.45/Mills County**

- Pavement type: HMA over JPCP (8.0 in HMA/8.0 in JPCP)
- Construction year: 1999(overlay)/1971 (existing pavement)
- AADTT: 12,000
- Rutting

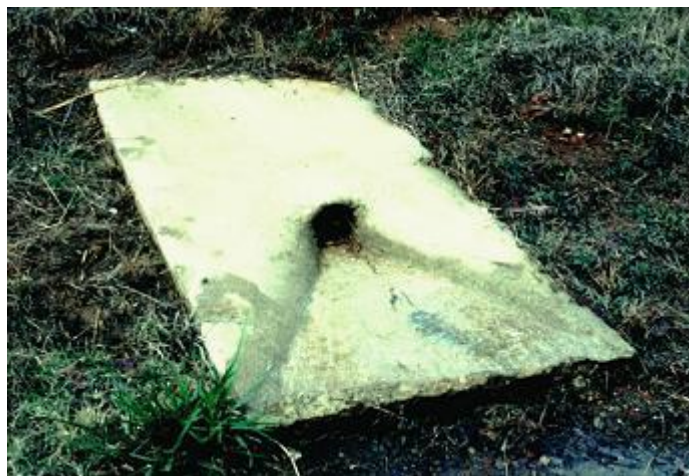
**Figure 26. Headwall**

The presence of a headwall (Figure 26) can potentially prevent blockage of drainage outlet pipes from vegetation and debris, reduce erosion, and prevent damage to drainage outlet pipes from maintenance activities (i.e., grass mowing on roadside).

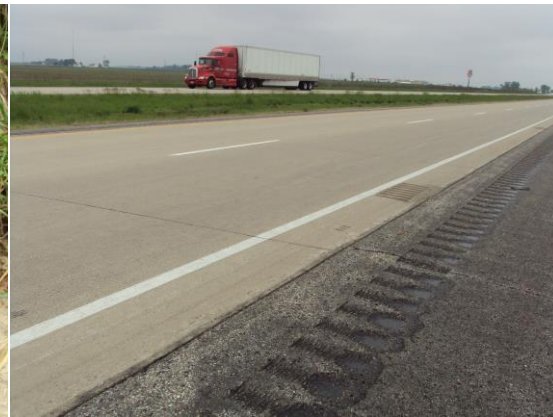
No pavement surface distress

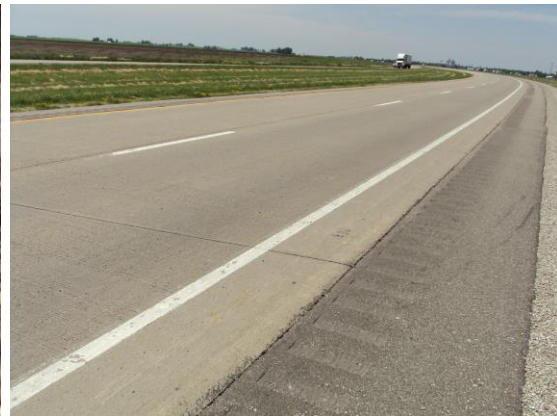
No pavement surface distress

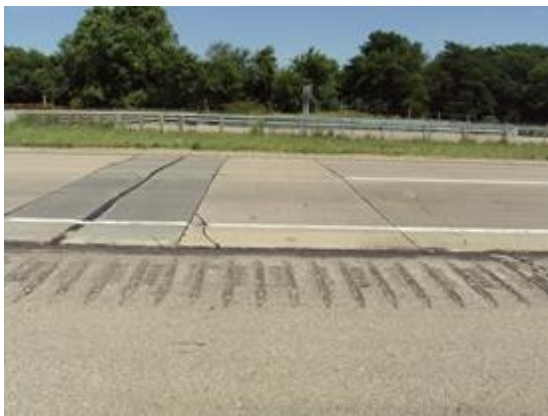
Transverse patching

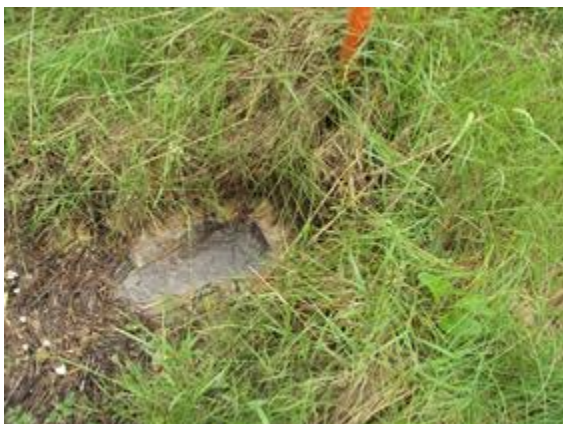
- Number of outlet pipe: 1
- Type of outlet pipe: Corrugated steel
- Size of outlet pipe: 6 inch
- Condition of outlet pipe: 90% blockage (soil blockage)
- Water present inside outlet pipe: Yes (standing)
- Type of rodent guard: Fork
- Tufa/Dead zone (due to tufa) present: Yes
- Embankment slop condition: Less than 30 degree
- Slope condition at outlet: Uphill

Soil backup

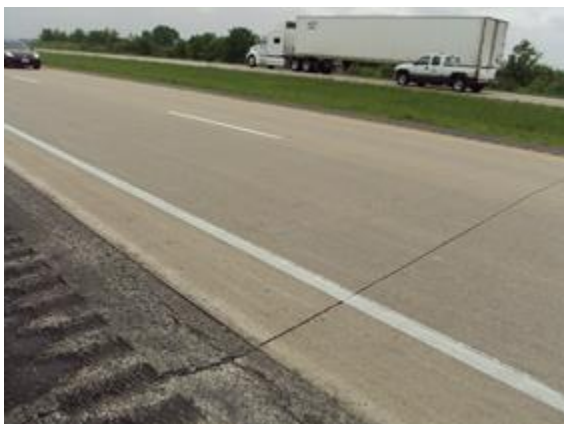
No pavement surface distress

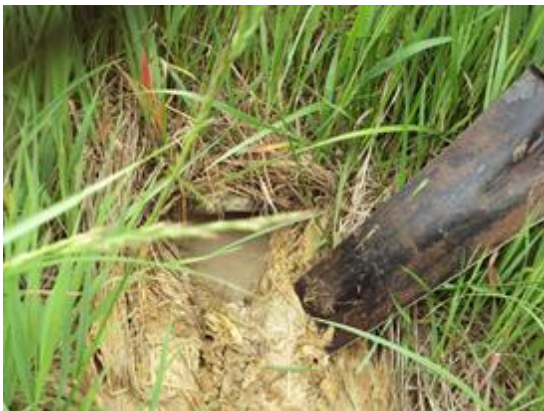
- Number of outlet pipe: 1
- Type of outlet pipe: Corrugated steel
- Size of outlet pipe: 6 inch
- Condition of outlet pipe: 50% blockage (tufa blockage and damaged)
- Water present inside outlet pipe: Yes (standing)
- Type of rodent guard: Fork
- Tufa/Dead zone (due to tufa) present: Yes
- Embankment slop condition: More than 30 degree
- Slope condition at outlet: Uphill

Tufa blockage

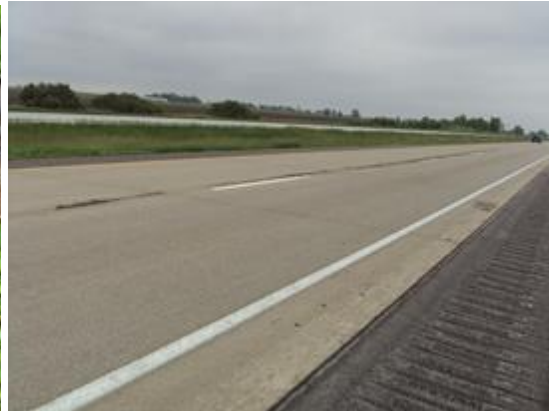
No pavement surface distress

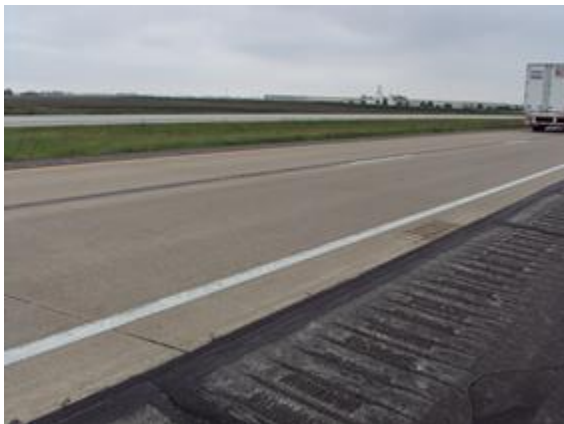
No pavement surface distress

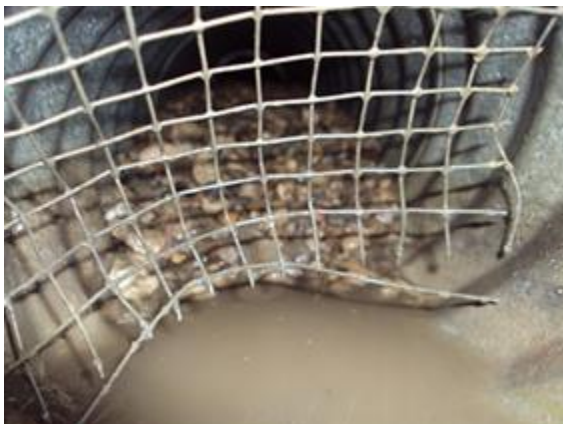
- Number of outlet pipe: 1
- Type of outlet pipe: Corrugated steel
- Size of outlet pipe: 6 inch
- Condition of outlet pipe: 20% blockage (sediment blockage)
- Water present inside outlet pipe: Yes (free flowing)
- Type of rodent guard: Gate
- Tufa/Dead zone (due to tufa) present: No
- Embankment slop condition: More than 30 degree
- Slope condition at outlet: Downhill

Sediment blockage

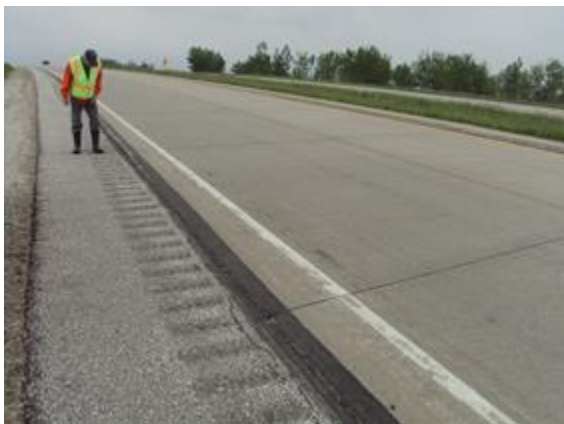
No pavement surface distress

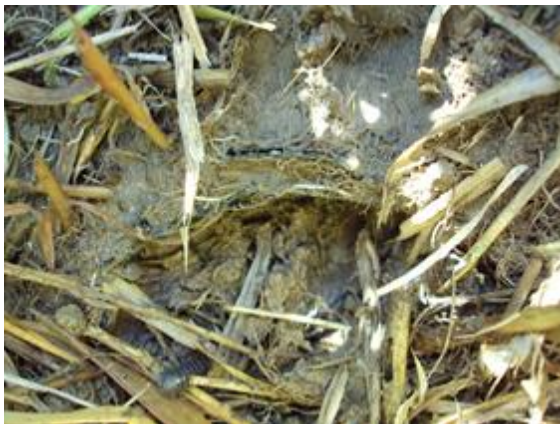
- Number of outlet pipe: 1
- Type of outlet pipe: Corrugated plastic
- Size of outlet pipe: 6 inch
- Condition of outlet pipe: 100% blockage (soil blockage)
- Water present inside outlet pipe: No
- Type of rodent guard: Gate
- Tufa/Dead zone (due to tufa) present: No
- Embankment slop condition: More than 30 degree
- Slope condition at outlet: Downhill

Covered pipe

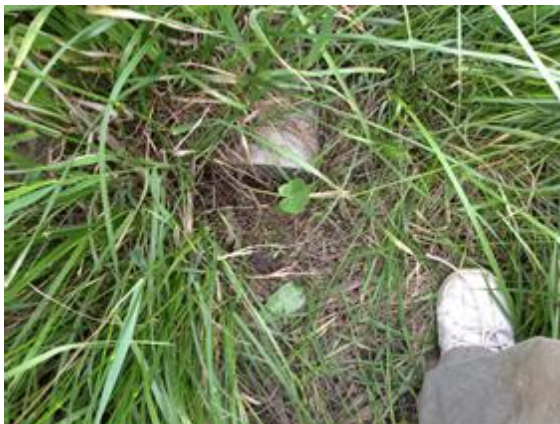
No blockage

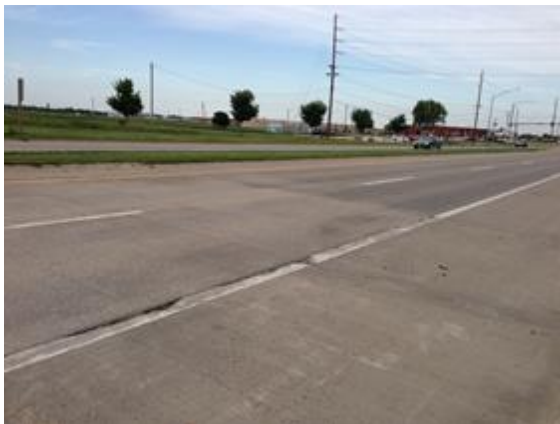
No pavement surface distress

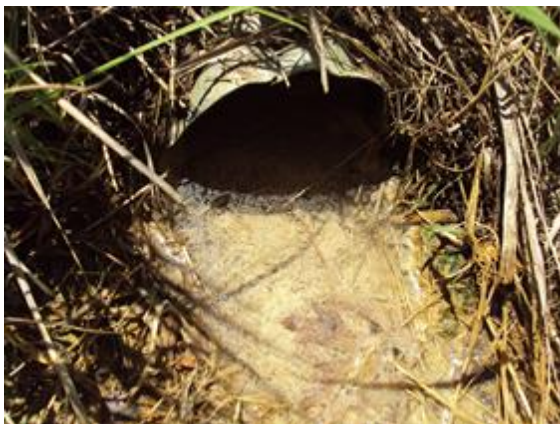
Tufa blockage

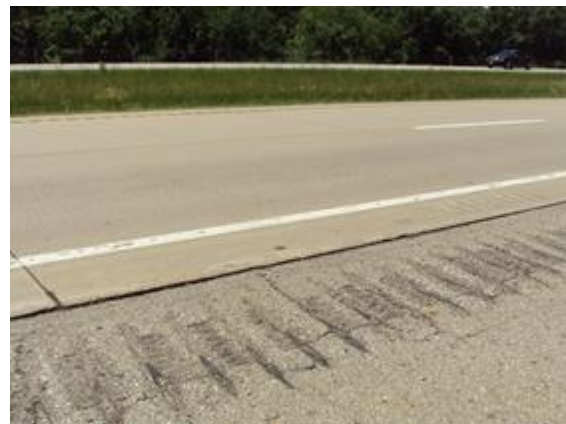
No pavement surface distress

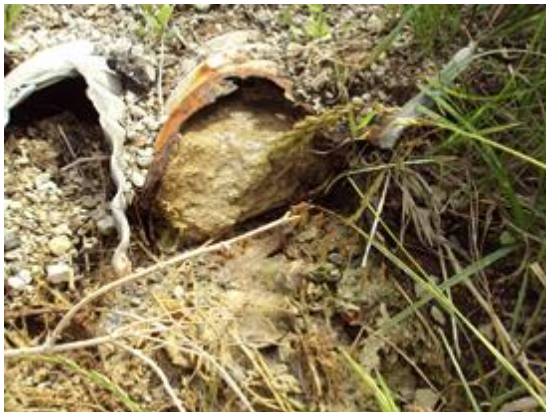
Tufa blockage

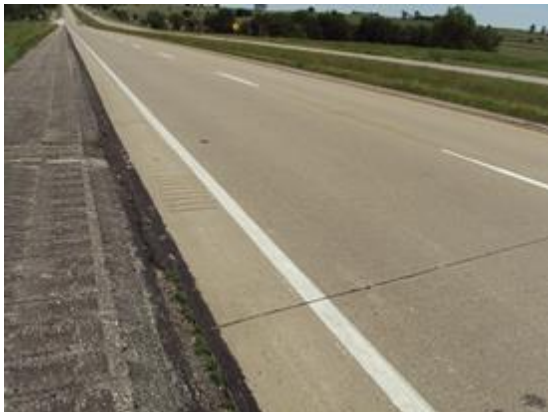
No pavement surface distress

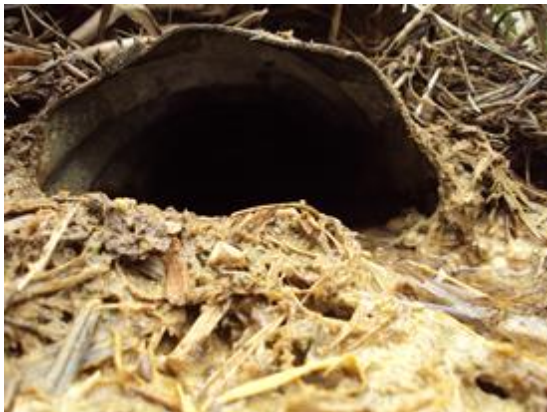
Tufa blockage

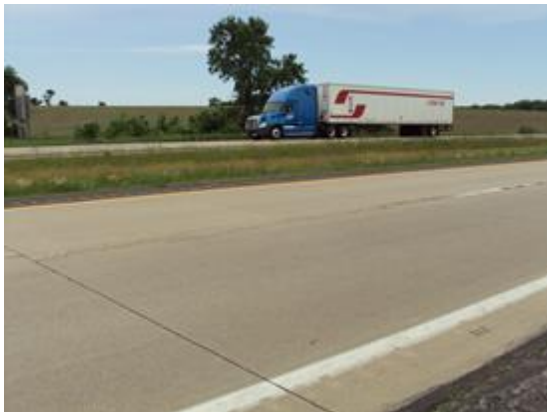
Longitudinal cracking along centerline

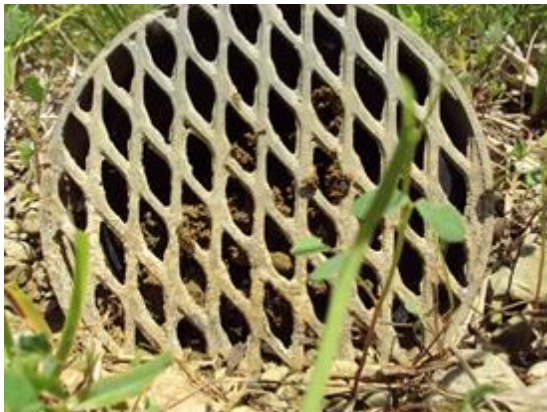
Sediment blockage

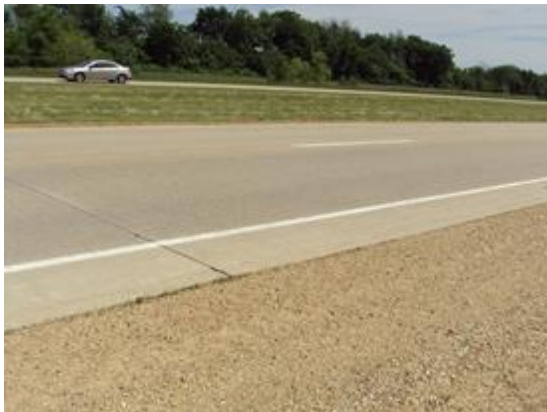
No pavement surface distress

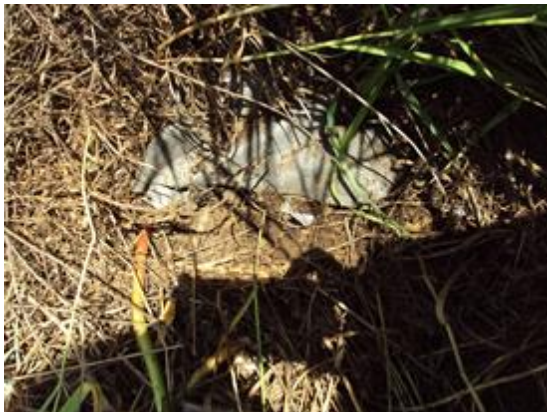
- End of the pipe is clamped shut

End clamped shut

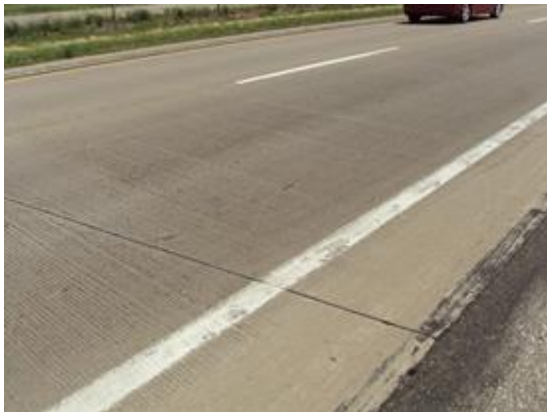
Longitudinal cracking

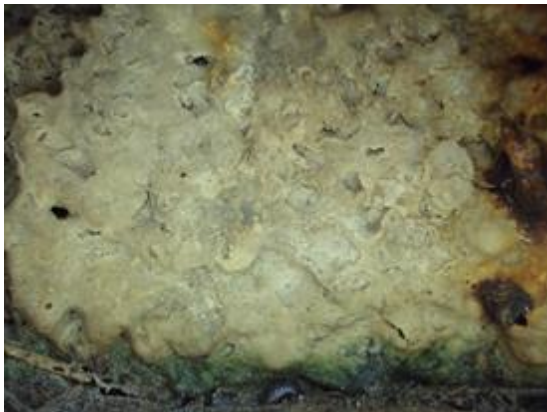
Tufa blockage

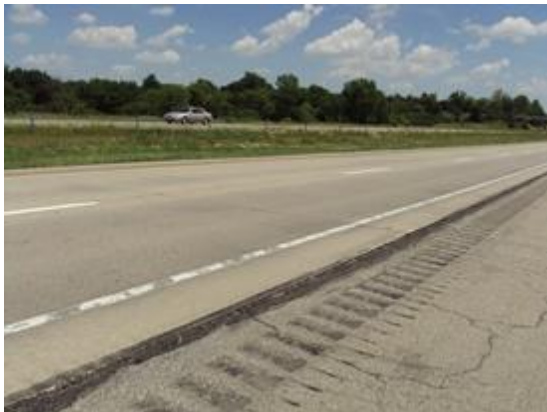
No pavement surface distress

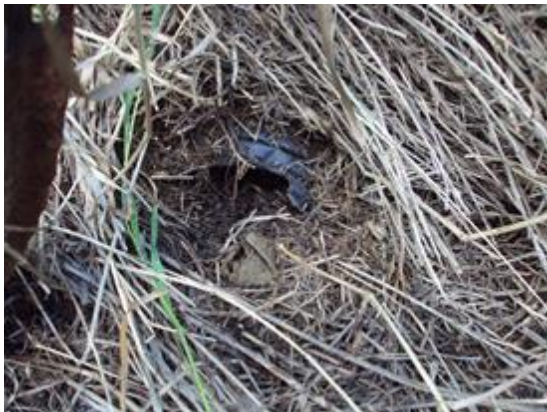
Soil blockage

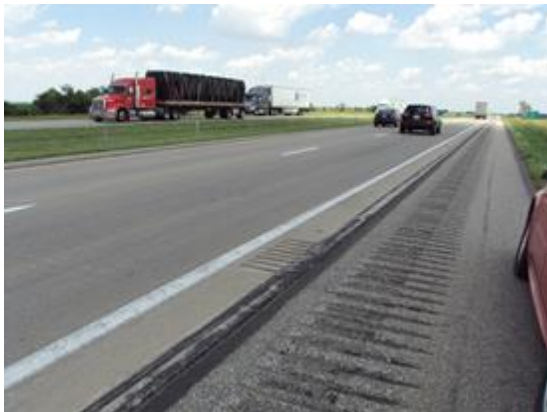
No pavement surface distress

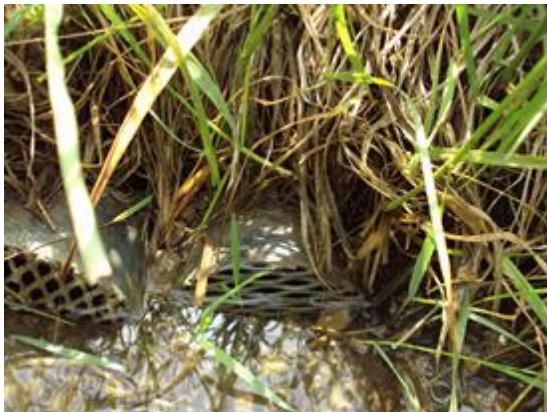
Soil blockage

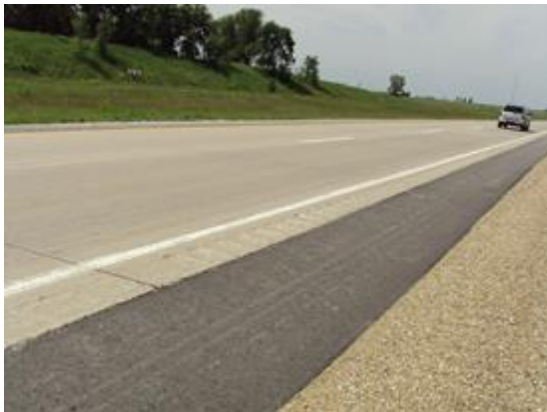
No pavement surface distress

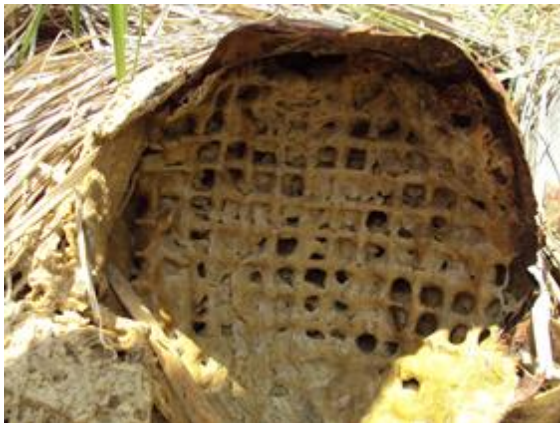
Tufa blockage

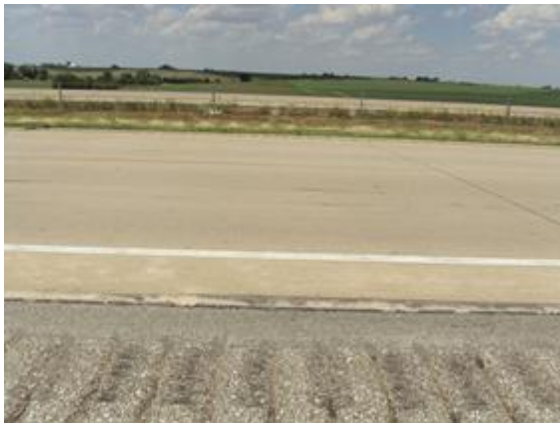
No pavement surface distress

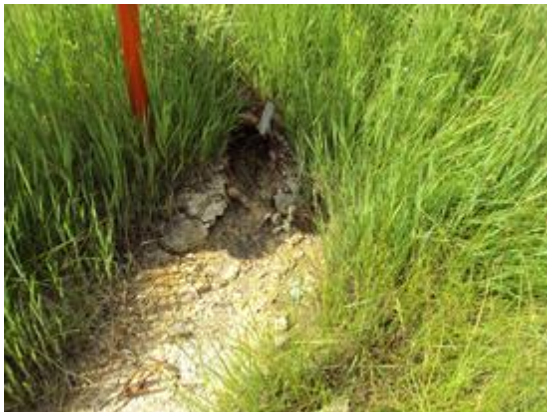
- Example of outlet damaged during tufa removal

Pipe damaged during tufa removal

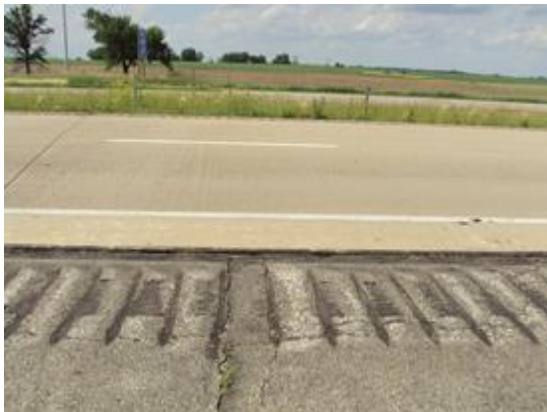
No pavement surface distress

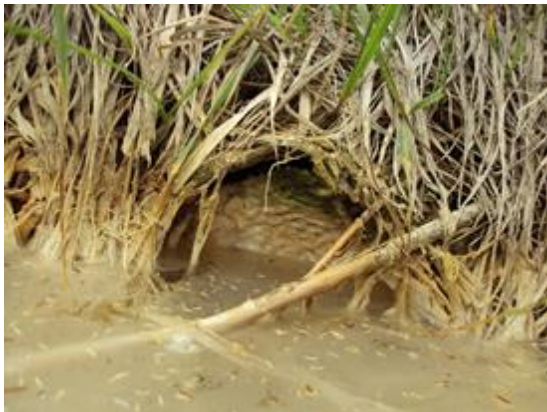
Tufa blockage

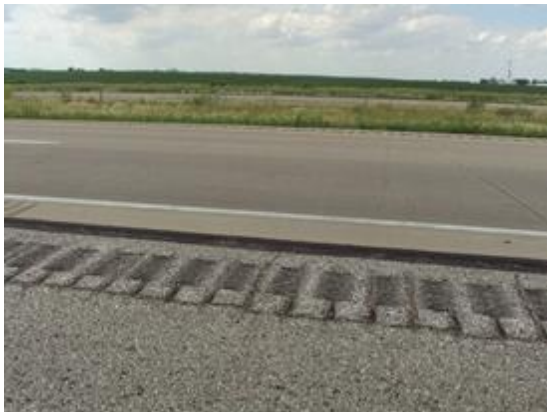
No pavement surface distress

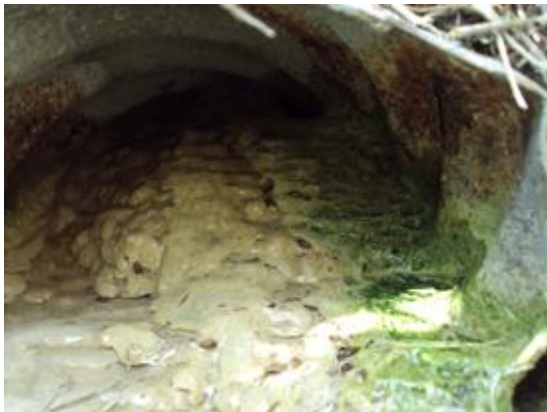
Tufa blockage

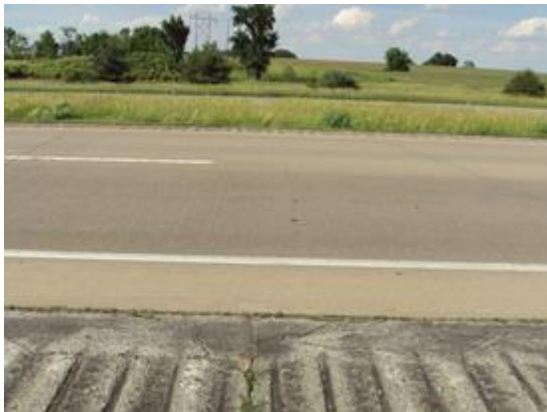
No pavement surface distress

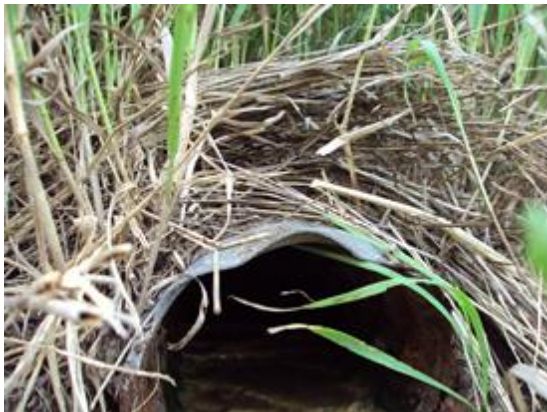
Tufa blockage

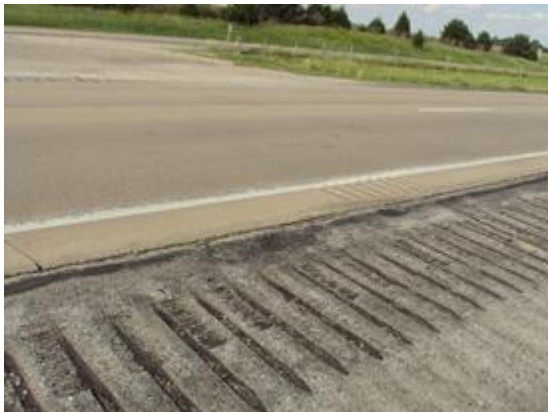
No pavement surface distress

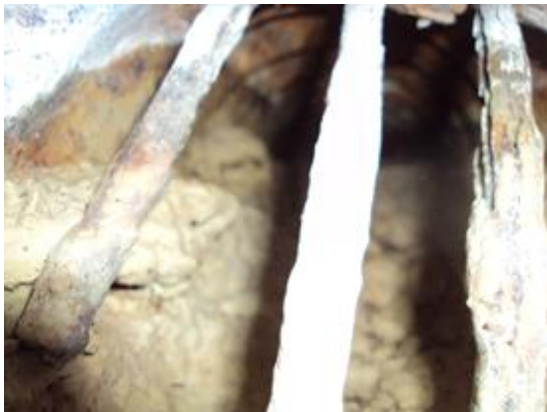
Tufa blockage

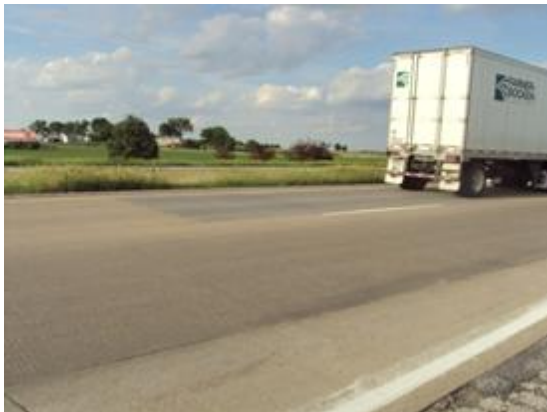
Pavement patching

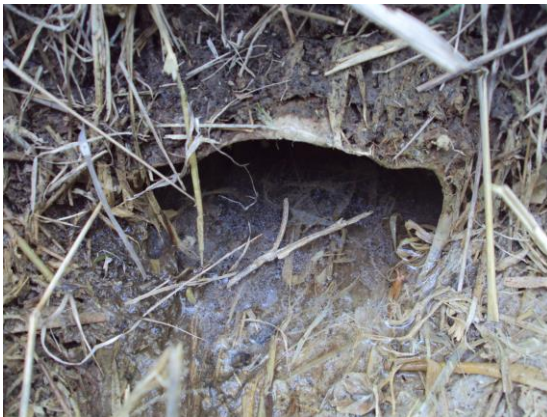
## **I-80/E/MP270.80**

- Number of outlet pipe: 1
- Type of outlet pipe: Corrugated steel
- Size of outlet pipe: 6 inch
- Condition of outlet pipe: 50% blockage (tufa blockage)
- Water present inside outlet pipe: Yes (standing)
- Type of rodent guard: N/A
- Tufa/Dead zone (due to tufa) present: Yes
- Embankment slop condition: Less than 30 degree
- Slope condition at outlet: Parallel/Less than 1-ft. downhill

Tufa blockage

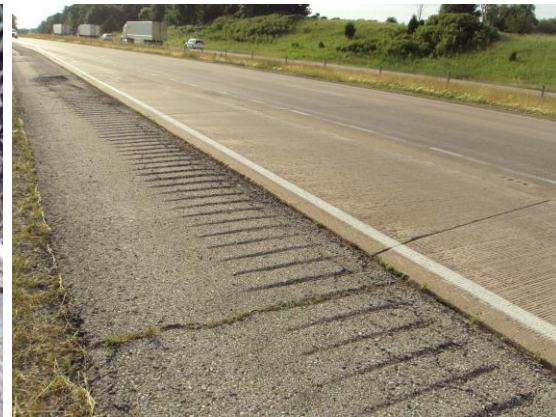
No pavement surface distress

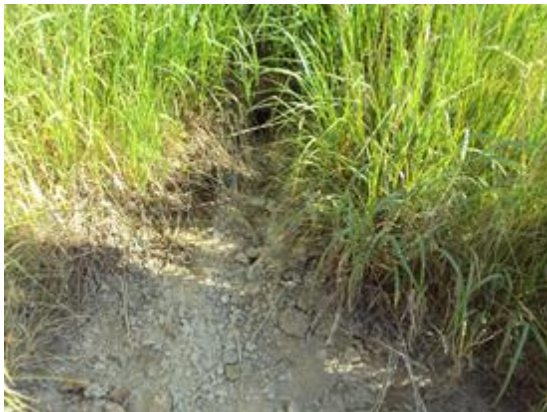
## **I-80/E/MP274.86**

- Number of outlet pipe: 1
- Type of outlet pipe: Corrugated steel
- Size of outlet pipe: 6 inch
- Condition of outlet pipe: 40% blockage (tufa blockage)
- Water present inside outlet pipe: No
- Type of rodent guard: Fork
- Tufa/Dead zone (due to tufa) present: Yes
- Embankment slop condition: Less than 30 degree
- Slope condition at outlet: Parallel/Less than 1-ft. downhill

Tufa blockage and dead zone

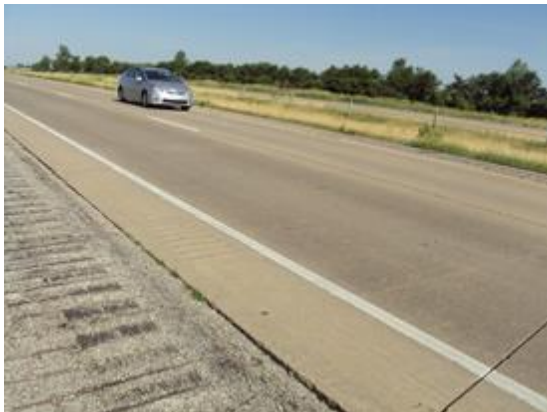
No pavement surface distress

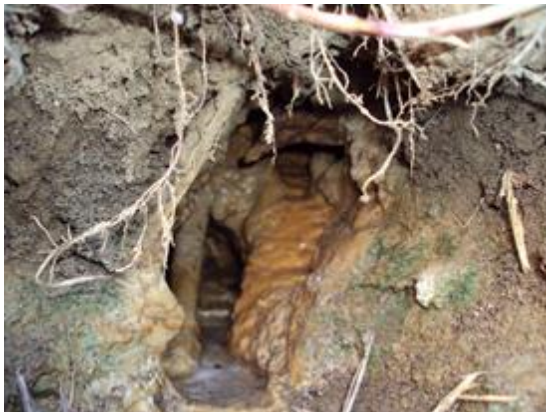
## **I-80/E/MP277.85**

- Number of outlet pipe: 1
- Type of outlet pipe: Corrugated steel
- Size of outlet pipe: 6 inch
- Condition of outlet pipe: 95% blockage (tufa blockage)
- Water present inside outlet pipe: Yes (standing)
- Type of rodent guard: Fork
- Tufa/Dead zone (due to tufa) present: Yes
- Embankment slop condition: Less than 30 degree
- Slope condition at outlet: Downhill

Tufa blockage

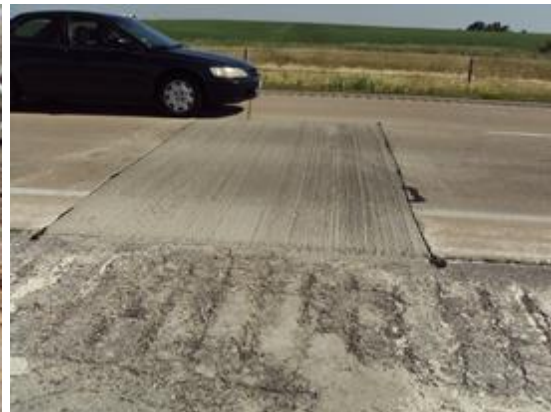
- Cracking and patching 50-ft. away

Pavement patching 50-ft. away

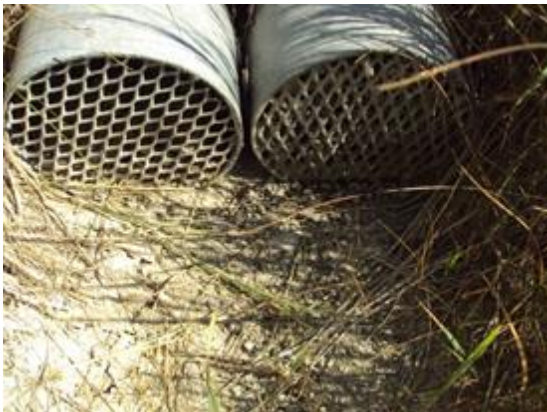
## **I-80/E/MP280.30**

- Number of outlet pipe: 1
- Type of outlet pipe: Corrugated steel
- Size of outlet pipe: 6 inch
- Condition of outlet pipe: 20% blockage (tufa blockage)
- Water present inside outlet pipe: No
- Type of rodent guard: Gate
- Tufa/Dead zone (due to tufa) present: Yes
- Embankment slop condition: Less than 30 degree
- Slope condition at outlet: Parallel/Less than 1-ft. downhill

Tufa blockage

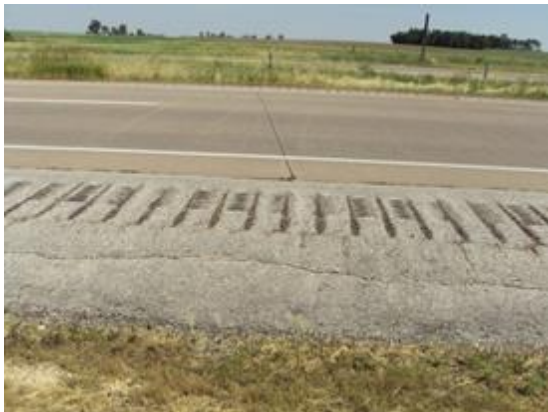
Pavement patching

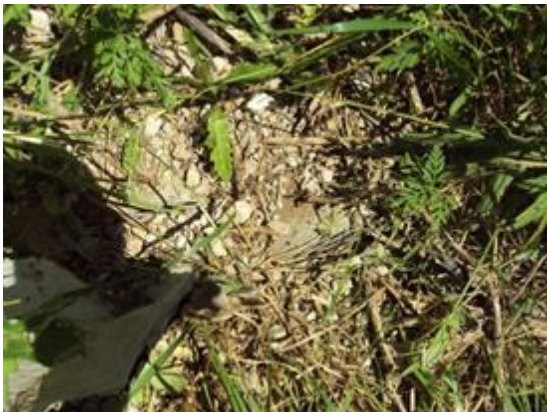
## US 61/E/MP107.67

- Number of outlet pipe: 1
- Type of outlet pipe: Corrugated plastic
- Size of outlet pipe: 4 inch
- Condition of outlet pipe: 95% blockage (soil blockage)
- Water present inside outlet pipe: No
- Type of rodent guard: Gate
- Tufa/Dead zone (due to tufa) present: No
- Embankment slop condition: Less than 30 degree
- Slope condition at outlet: Downhill

Soil blockage

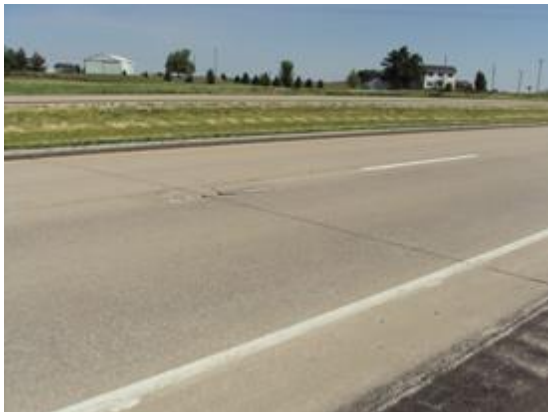
- Corner cracking

Corner crack

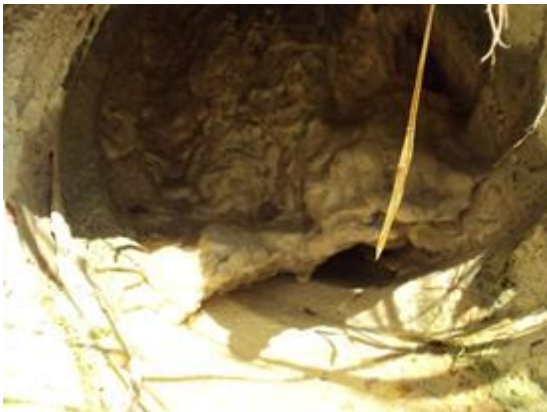
## **I-80/E/MP298.07**

- Number of outlet pipe: 1
- Type of outlet pipe: Corrugated steel
- Size of outlet pipe: 6 inch
- Condition of outlet pipe: 95% blockage (tufa blockage)
- Water present inside outlet pipe: Yes (free flowing)
- Type of rodent guard: Fork
- Tufa/Dead zone (due to tufa) present: Yes
- Embankment slop condition: Less than 30 degree
- Slope condition at outlet: Downhill

Tufa blockage

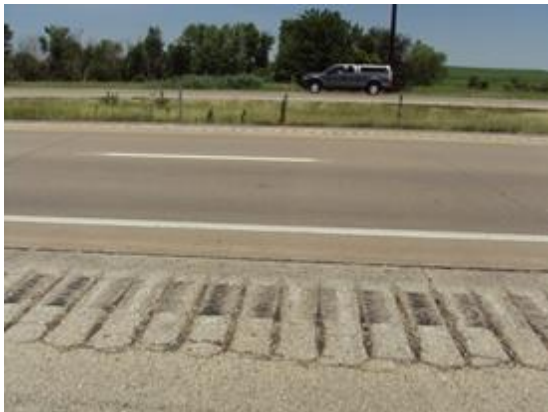
No pavement surface distress

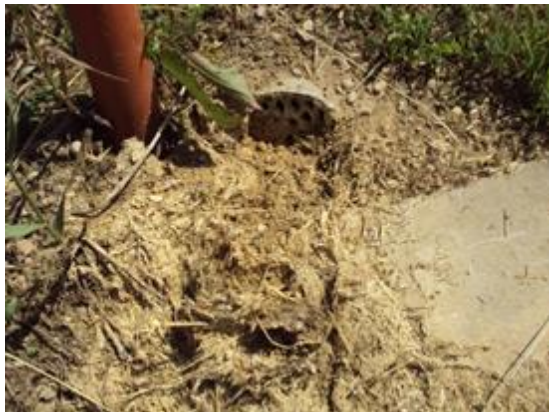
## US 151/S/MP71.60

- Number of outlet pipe: 1
- Type of outlet pipe: Corrugated plastic
- Size of outlet pipe: 4 inch
- Condition of outlet pipe: 95% blockage (tufa blockage)
- Water present inside outlet pipe: No
- Type of rodent guard: Gate
- Tufa/Dead zone (due to tufa) present: Yes
- Embankment slop condition: Less than 30 degree
- Slope condition at outlet: Downhill

Tufa blockage

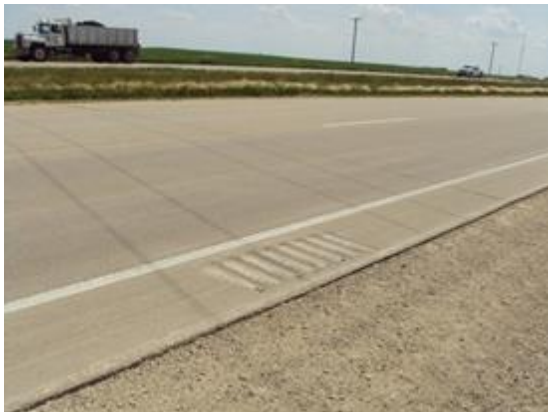
No pavement surface distress

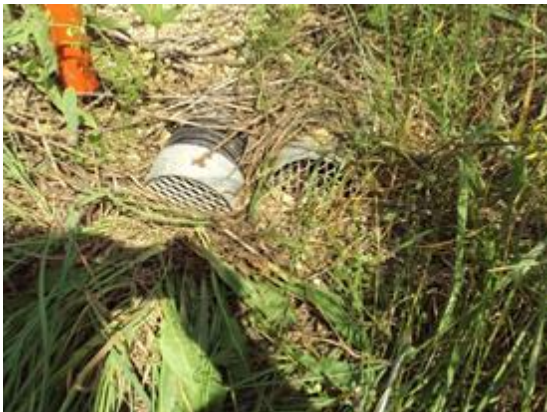
## US 151/S/MP65.57

- Number of outlet pipe: 1
- Type of outlet pipe: Corrugated plastic
- Size of outlet pipe: 4 inch
- Condition of outlet pipe: 40% blockage (soil blockage)
- Water present inside outlet pipe: No
- Type of rodent guard: Gate
- Tufa/Dead zone (due to tufa) present: No
- Embankment slop condition: Less than 30 degree
- Slope condition at outlet: Parallel/Less than 1-ft. downhill

Soil blockage

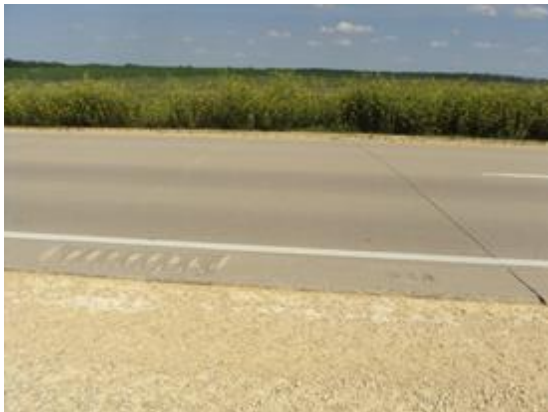
No pavement surface distress

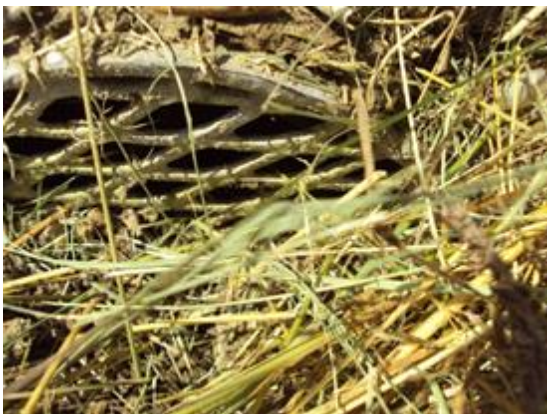
## US 151/N/MP63.30

- Number of outlet pipe: 1
- Type of outlet pipe: Corrugated plastic
- Size of outlet pipe: 4 inch
- Condition of outlet pipe: 65% blockage (soil blockage)
- Water present inside outlet pipe: No
- Type of rodent guard: Gate
- Tufa/Dead zone (due to tufa) present: No
- Embankment slop condition: Less than 30 degree
- Slope condition at outlet: Parallel/Less than 1-ft. downhill

Soil blockage

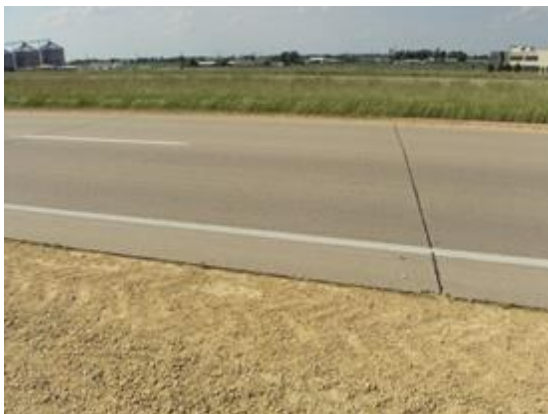
No pavement surface distress

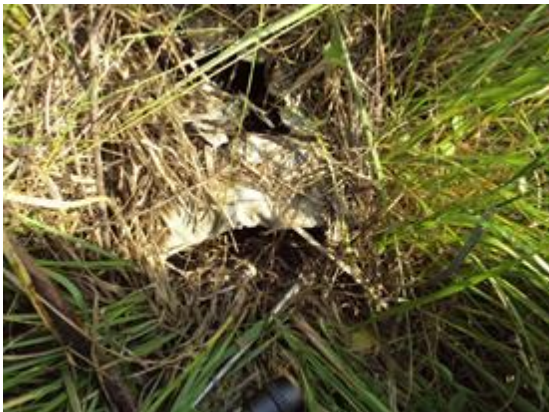
## US 151/N/MP44.50

- Number of outlet pipe: 1
- Type of outlet pipe: Corrugated steel
- Size of outlet pipe: 6 inch
- Condition of outlet pipe: 50% blockage (soil blockage and damaged)
- Water present inside outlet pipe: No
- Type of rodent guard: Gate
- Tufa/Dead zone (due to tufa) present: No
- Embankment slop condition: Less than 30 degree
- Slope condition at outlet: Parallel/Less than 1-ft. downhill

Soil blockage

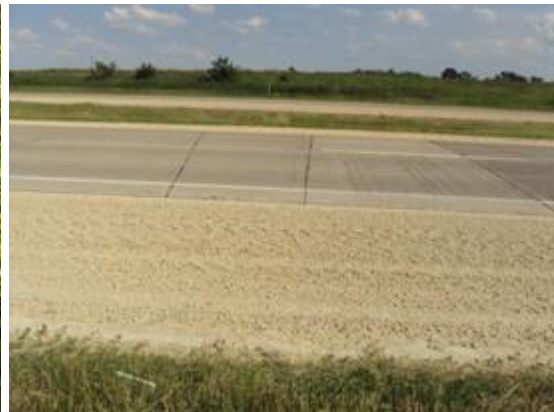
Pavement patching due to culvert

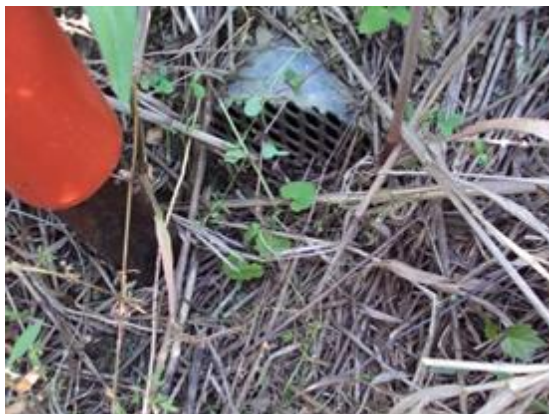
## US 30/W/MP260.58

Soil blockage

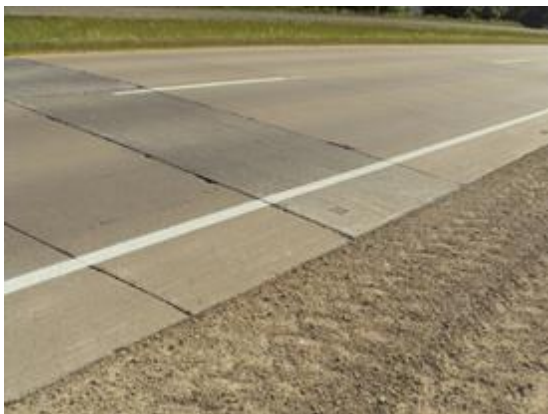
Pavement patching due to culvert

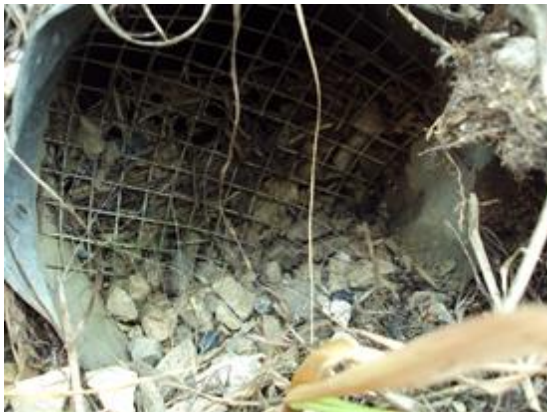
## **I-80/W/MP193.80**

Sediment blockage

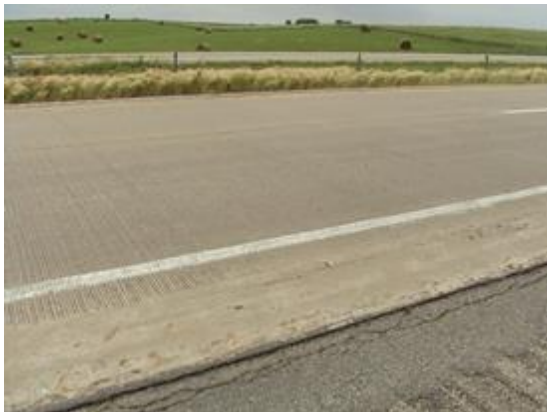
No pavement surface distress

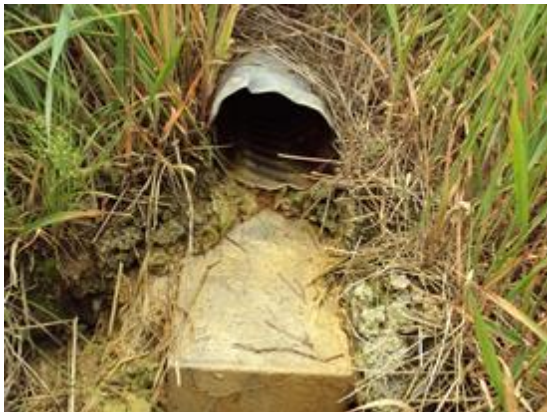
## **I-80/W/MP168.23**

- Good drainage installation practice

Good drainage pad installation

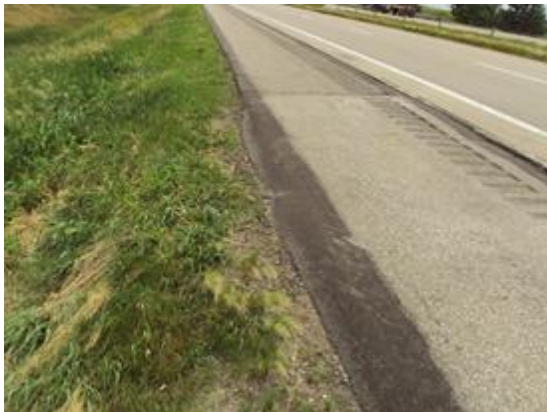
Slight shoulder dip

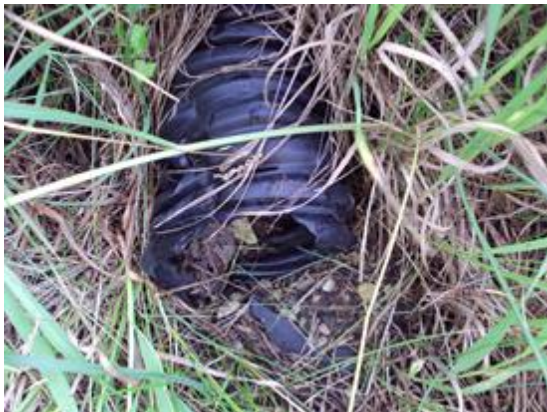
## **I-80/W/MP150.67**

Sediment blockage

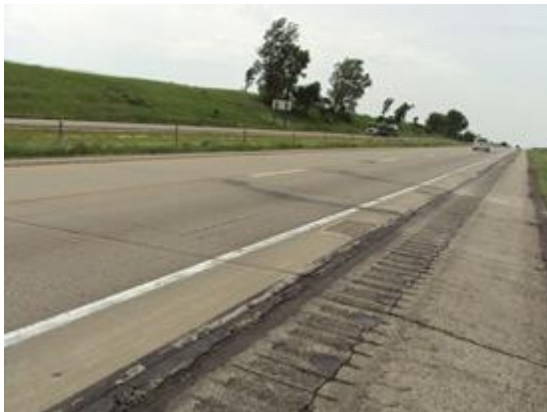
- Transverse cracks two slabs away

Transverse cracking

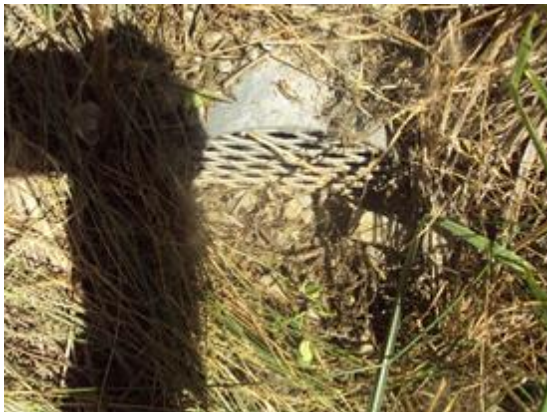
## IA 60/E/MP 48.97

Soil blockage

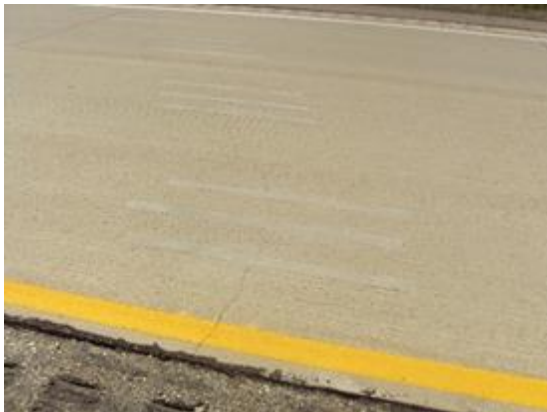
- Dowel bar installation

Dowel bar retrofit

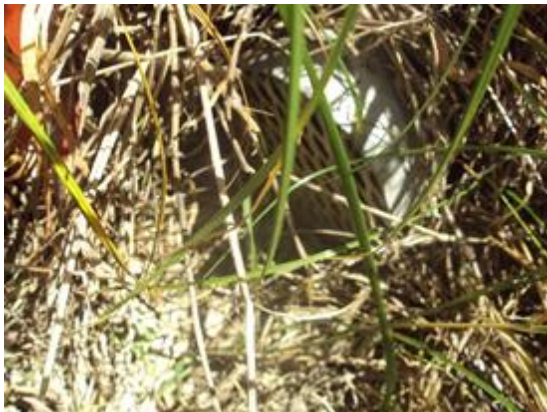
## IA 60/W/MP 47.75

Sediment blockage

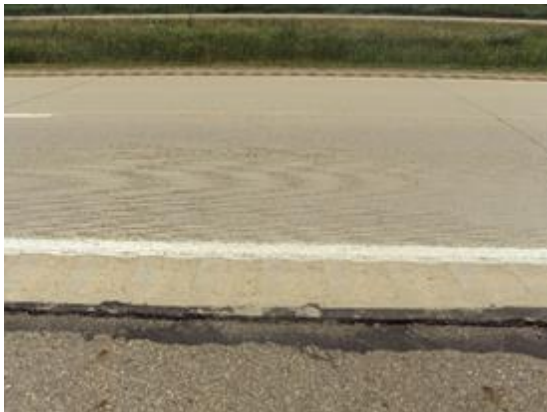
No pavement surface distress

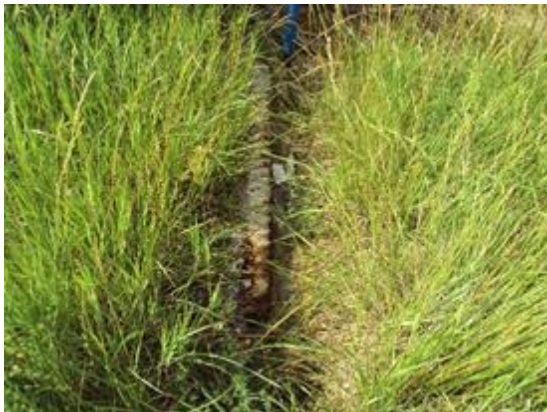
## **I-80/W/MP47.60**

- Broken open 7-ft. up from opening; water is flowing from there

Tufa blockage and damage

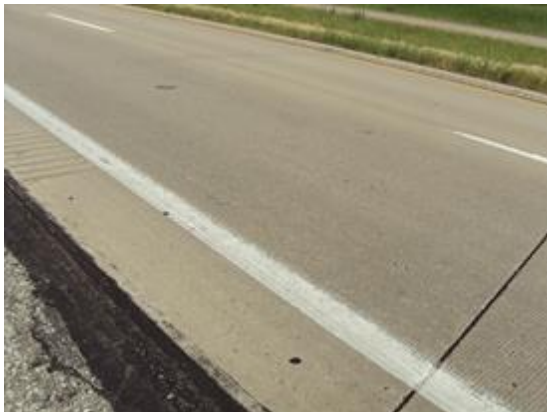
No pavement surface distress

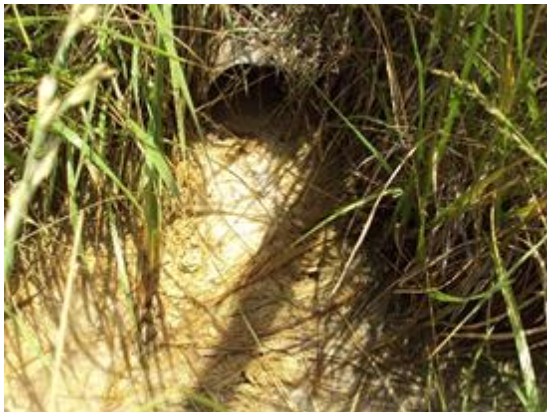
## I-80/W/MP38.20

Tufa blockage

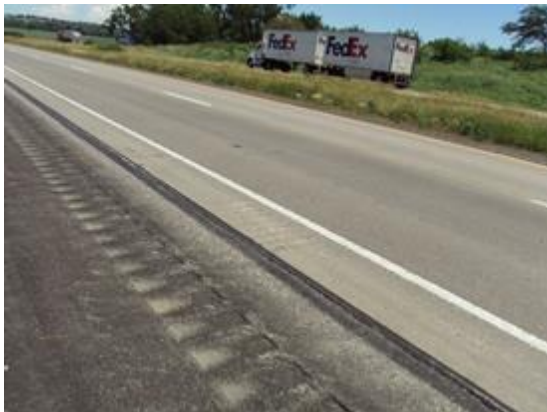
No pavement surface distress

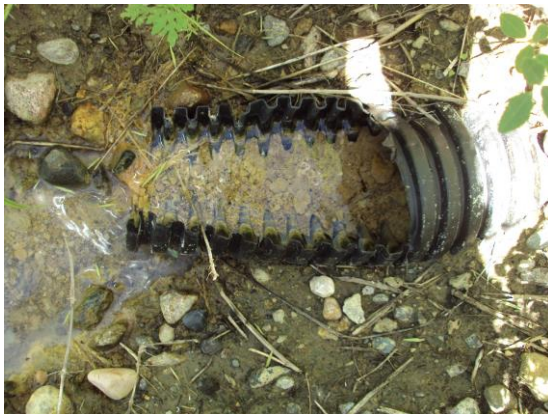
## **I-80/W/MP25.82**

- Tufa in plastic pipe (only one observation in all inspected locations)

Tufa blockage

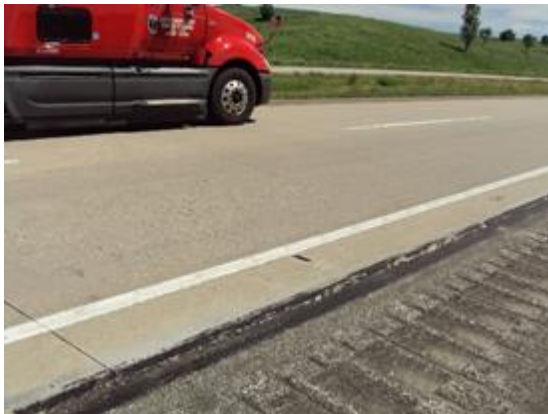
No pavement surface distress

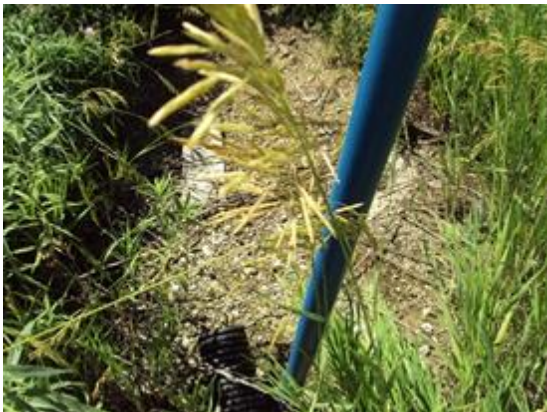
## I-80/W/MP10.40

- New installation

No blockage

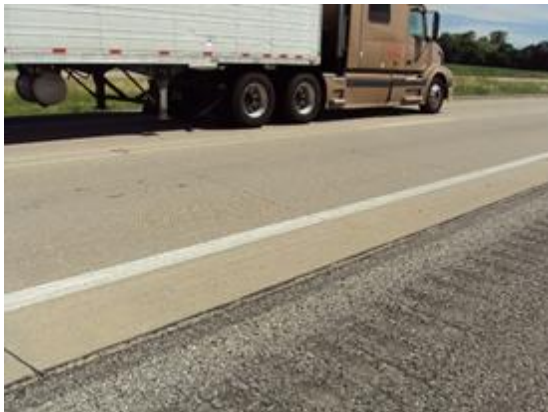
Transverse cracking

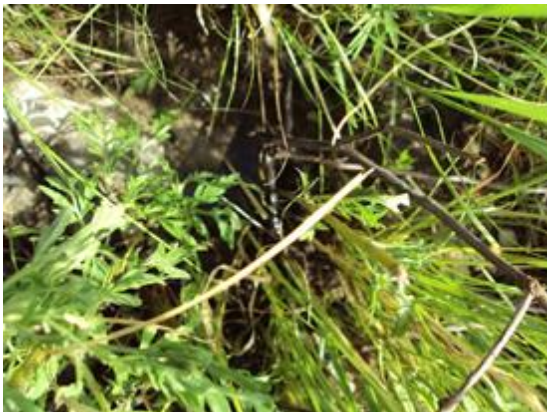
- Number of outlet pipe: 1
- Type of outlet pipe: Corrugated steel
- Size of outlet pipe: 6 inch
- Condition of outlet pipe: 100% blockage (soil blockage)
- Water present inside outlet pipe: Yes (standing)
- Type of rodent guard: Fork
- Tufa/Dead zone (due to tufa) present: No
- Embankment slop condition: Less than 30 degree
- Slope condition at outlet: Uphill

Soil blockage

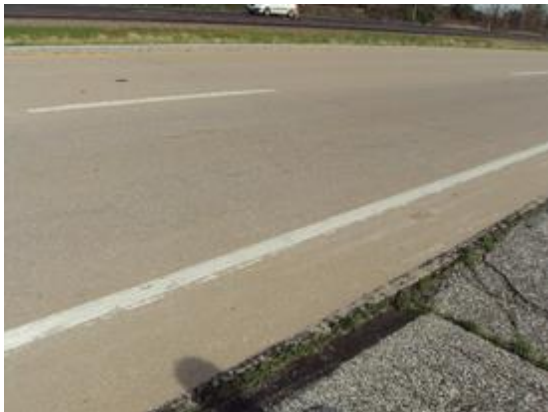
No distress

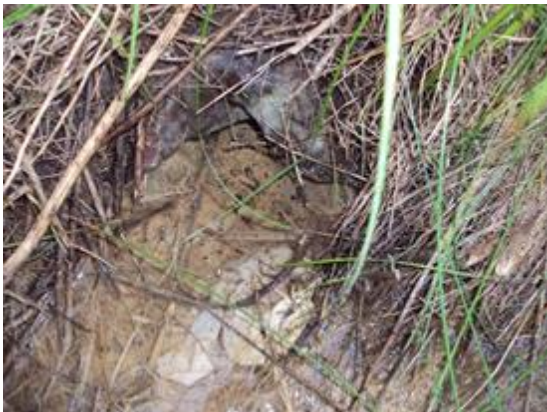
- Number of outlet pipe: 1
- Type of outlet pipe: Corrugated steel
- Size of outlet pipe: 6 inch
- Condition of outlet pipe: 50% blockage (tufa blockage)
- Water present inside outlet pipe: Yes (free flowing)
- Type of rodent guard: Gate
- Tufa/Dead zone (due to tufa) present: Yes
- Embankment slop condition: Less than 30 degree
- Slope condition at outlet: Parallel/Less than 1-ft. downhill

Tufa blockage

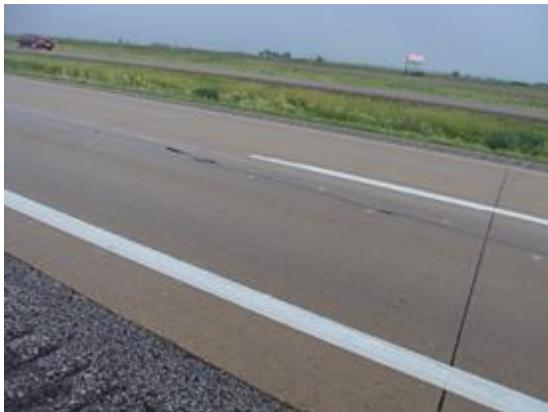
Longitudinal cracking
