# Evaluating Roadway Subsurface Drainage Practices – Phase II

**Final Report**  
**April 2015**

**IOWA STATE UNIVERSITY**  
**Institute for Transportation**

**Sponsored by**  
Iowa Highway Research Board  
(IHRB Project TR-662)  
Iowa Department of Transportation  
(InTrans Project 13-473)

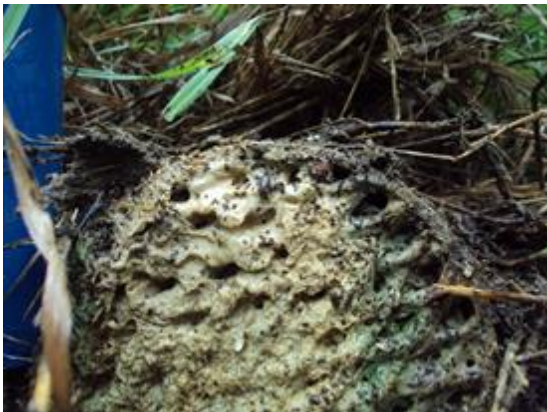
- Number of outlet pipe: 1
- Type of outlet pipe: Corrugated plastic
- Size of outlet pipe: 4 inch
- Condition of outlet pipe: 100% blockage (tufa blockage)
- Water present inside outlet pipe: Yes (standing)
- Type of rodent guard: Gate
- Tufa/Dead zone (due to tufa) present: Yes
- Embankment slop condition: Less than 30 degree
- Slope condition at outlet: Downhill

Tufa blockage

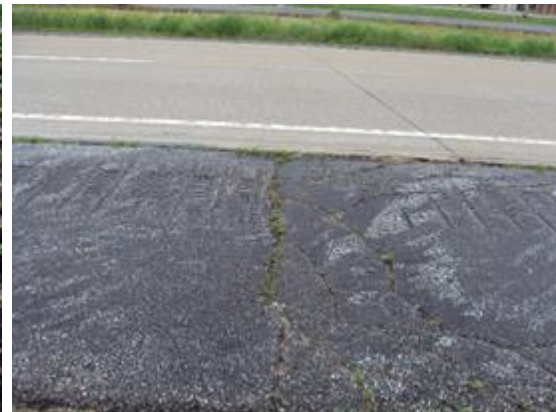
No pavement surface distress

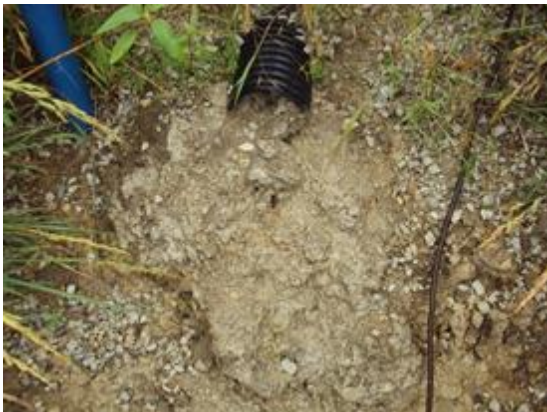
- Number of outlet pipe: 1
- Type of outlet pipe: Corrugated plastic
- Size of outlet pipe: 4 inch
- Condition of outlet pipe: 90% blockage (tufa blockage)
- Water present inside outlet pipe: Yes (standing)
- Type of rodent guard: N/A
- Tufa/Dead zone (due to tufa) present: Yes
- Embankment slop condition: More than 30 degree
- Slope condition at outlet: Downhill

Tufa blockage

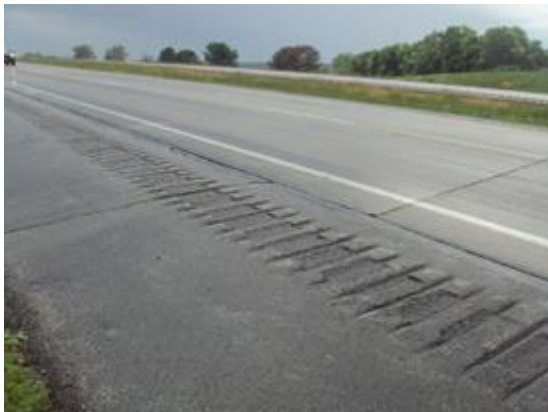
No pavement surface distress

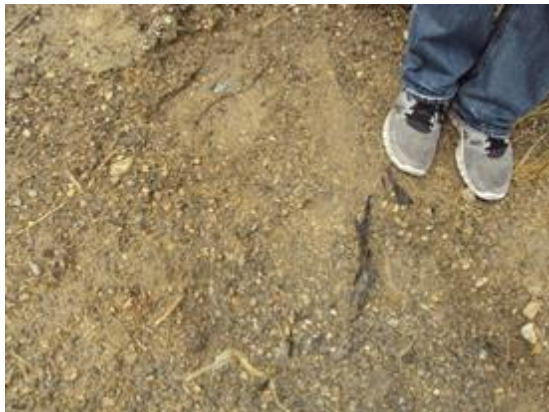
- Potential break higher up in pipe

Water flowing out of ground

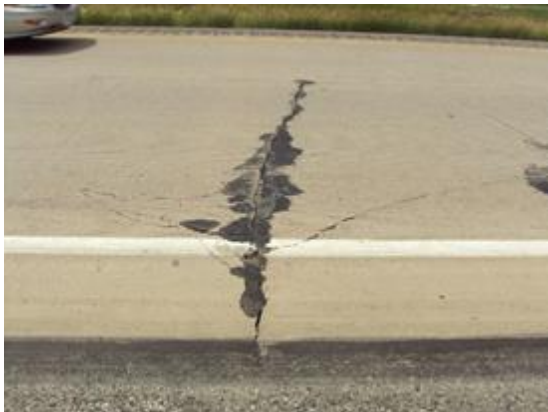
Longitudinal and transverse cracking

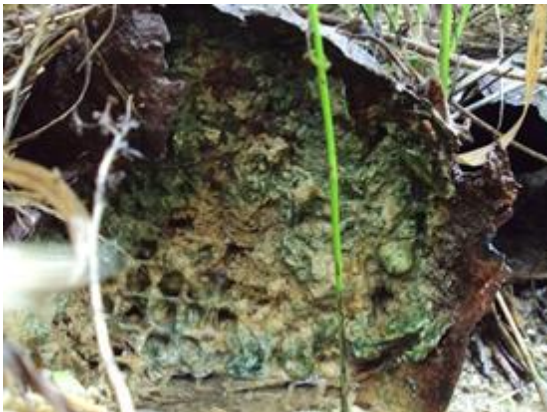
- Number of outlet pipe: 1
- Type of outlet pipe: Corrugated steel
- Size of outlet pipe: 6 inch
- Condition of outlet pipe: 100% blockage (tufa blockage)
- Water present inside outlet pipe: Yes (standing)
- Type of rodent guard: Gate
- Tufa/Dead zone (due to tufa) present: Yes
- Embankment slop condition: Less than 30 degree
- Slope condition at outlet: Parallel/Less than 1-ft. downhill

Tufa blockage

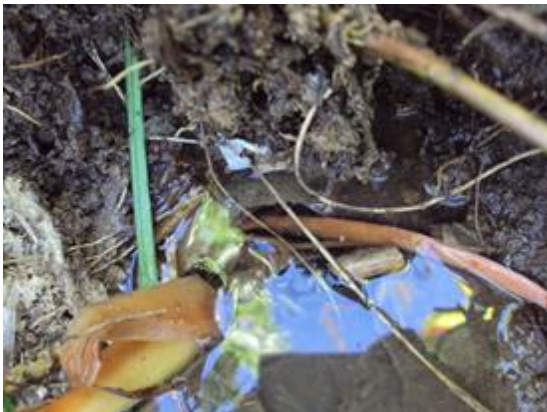
- Number of outlet pipe: 1
- Type of outlet pipe: Corrugated steel
- Size of outlet pipe: 6 inch
- Condition of outlet pipe: 100% blockage (soil blockage)
- Water present inside outlet pipe: Yes (standing)
- Type of rodent guard: Fork
- Tufa/Dead zone (due to tufa) present: Yes
- Embankment slop condition: Less than 30 degree
- Slope condition at outlet: Uphill

Soil blockage

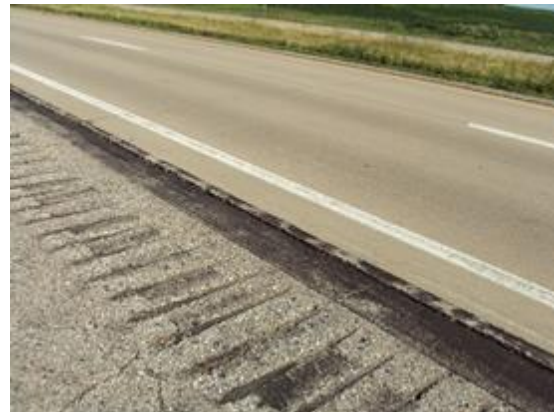
No pavement surface distress

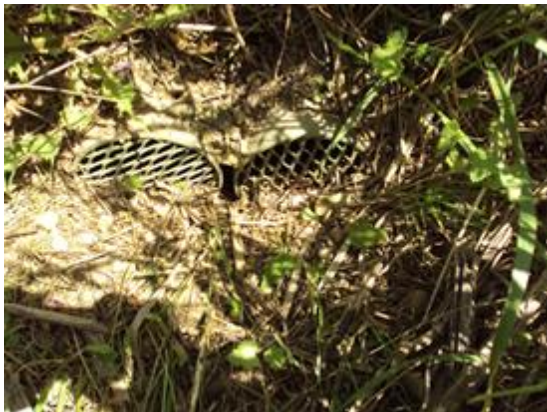
- Number of outlet pipe: 2
- Type of outlet pipe: Corrugated plastic
- Size of outlet pipe: 4 inch
- Condition of outlet pipe: 40% blockage (soil blockage)
- Water present inside outlet pipe: No
- Type of rodent guard: Gate
- Tufa/Dead zone (due to tufa) present: No
- Embankment slop condition: Less than 30 degree
- Slope condition at outlet: Downhill

Soil blockage

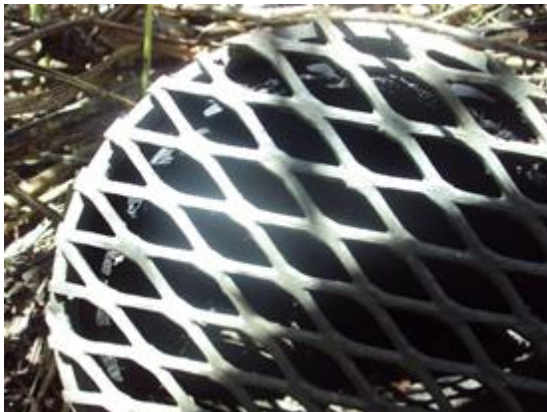
- Number of outlet pipe: 2
- Type of outlet pipe: Corrugated plastic
- Size of outlet pipe: 4 inch
- Condition of outlet pipe: 10% blockage (sediment blockage)
- Water present inside outlet pipe: No
- Type of rodent guard: Gate
- Tufa/Dead zone (due to tufa) present: No
- Embankment slop condition: Less than 30 degree
- Slope condition at outlet: Downhill

Sediment blockage

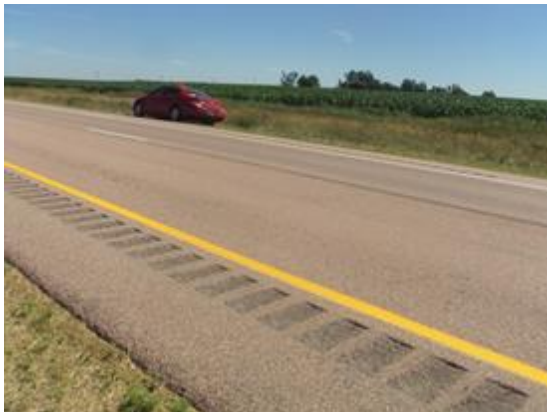
No pavement surface distress

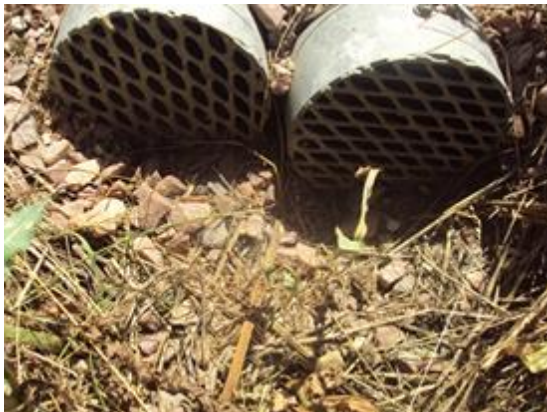
- Number of outlet pipe: 2
- Type of outlet pipe: Corrugated plastic
- Size of outlet pipe: 4 inch
- Condition of outlet pipe: 20% blockage (soil blockage)
- Water present inside outlet pipe: No
- Type of rodent guard: Gate
- Tufa/Dead zone (due to tufa) present: No
- Embankment slop condition: Less than 30 degree
- Slope condition at outlet: Downhill

Soil blockage

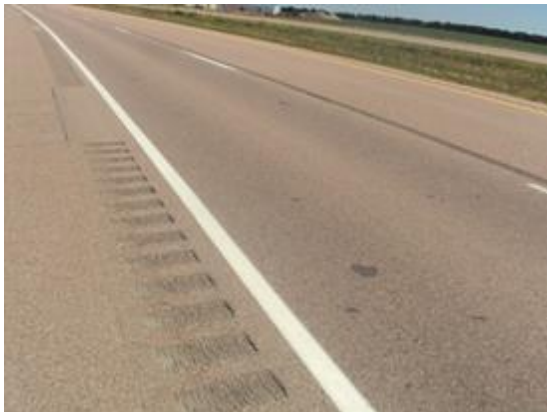
No pavement surface distress

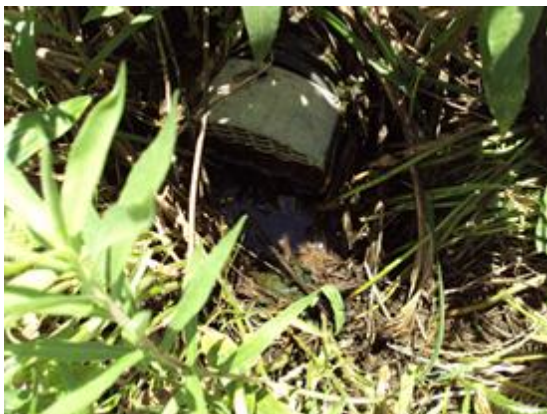
- Number of outlet pipe: 1
- Type of outlet pipe: Corrugated plastic
- Size of outlet pipe: 4 inch
- Condition of outlet pipe: 20% blockage (soil blockage)
- Water present inside outlet pipe: Yes (free flowing)
- Type of rodent guard: Gate
- Tufa/Dead zone (due to tufa) present: No
- Embankment slop condition: More than 30 degree
- Slope condition at outlet: Downhill

Soil blockage

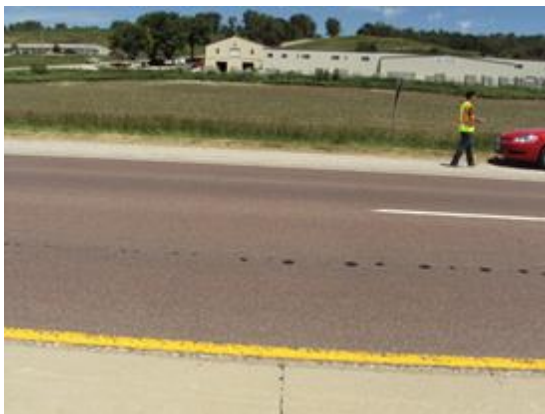
Transverse cracking

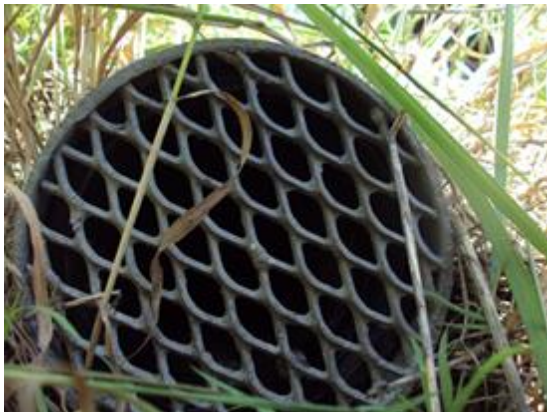
No blockage

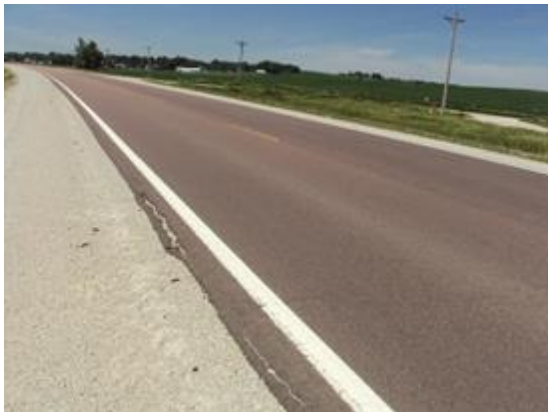
Transverse cracking

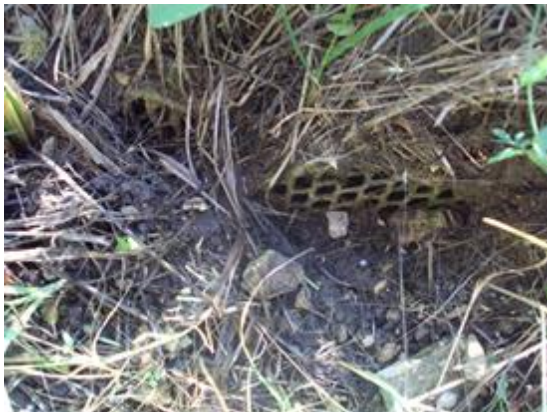
Soil blockage

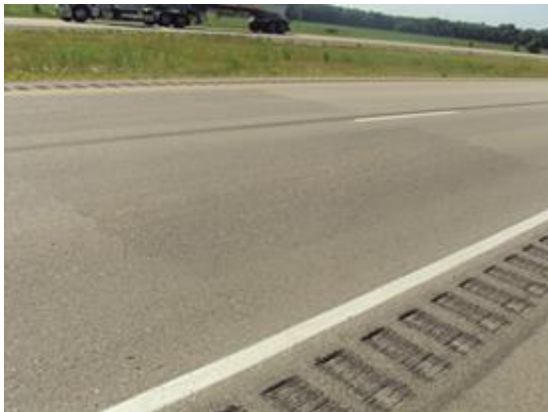
Pavement surface grinding

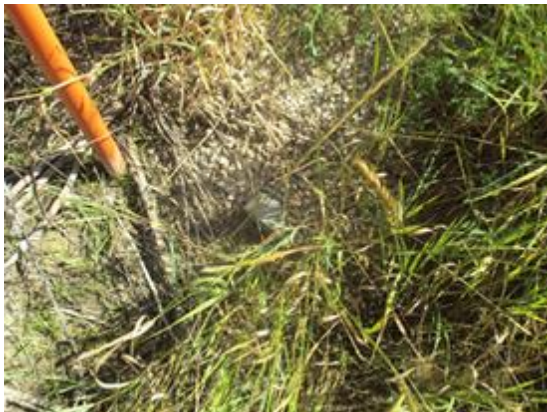
Soil blockage

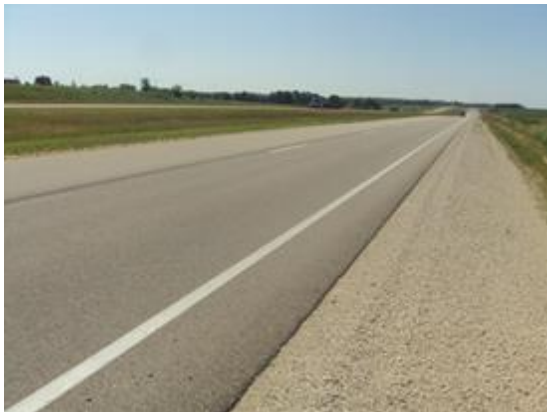
No pavement surface distress

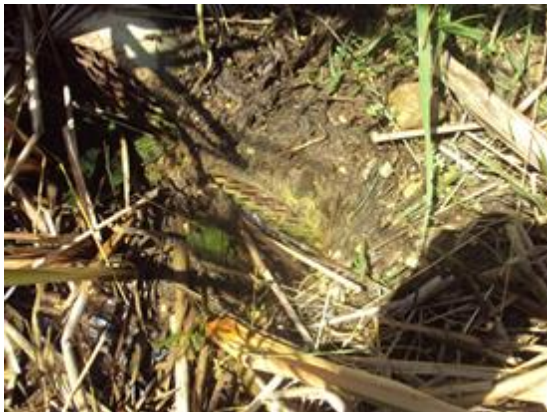
Soil blockage

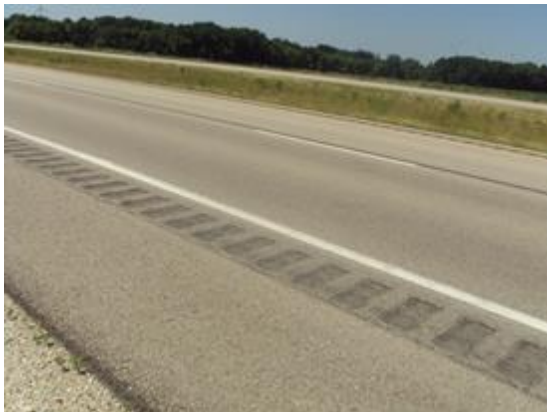
No pavement surface distress

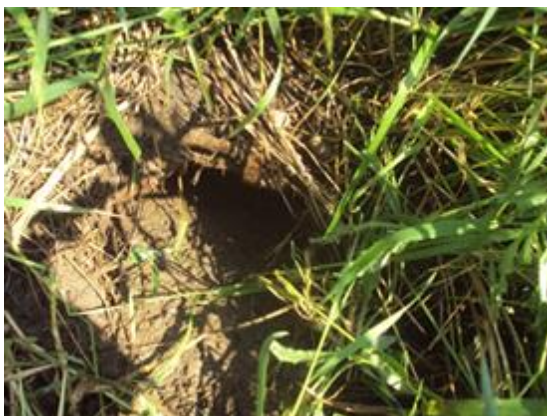
Soil blockage

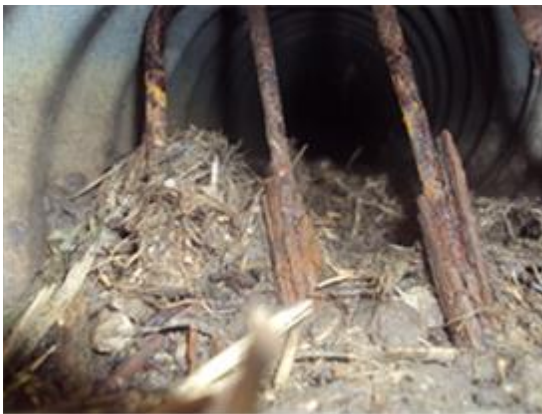
Sediment blockage

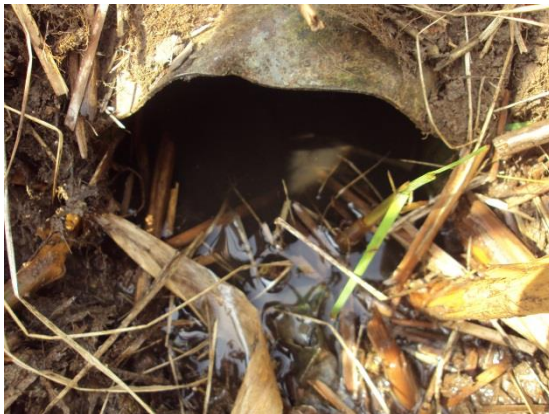
Sediment blockage

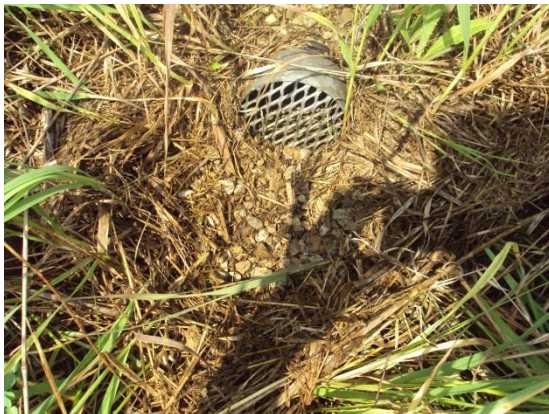
Soil blockage

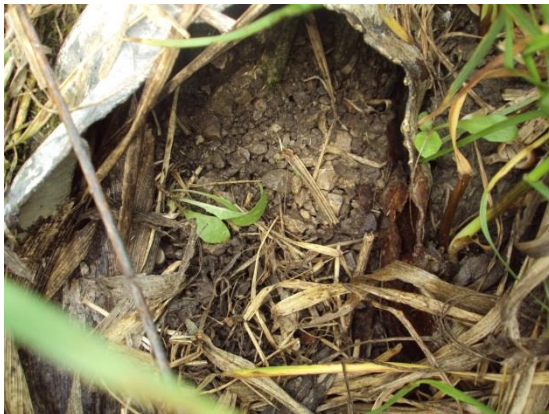
Soil blockage

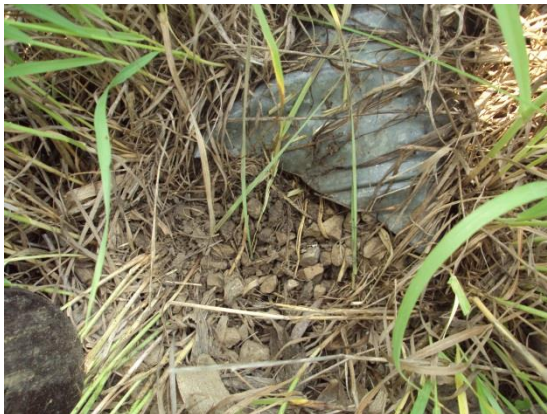
Soil blockage

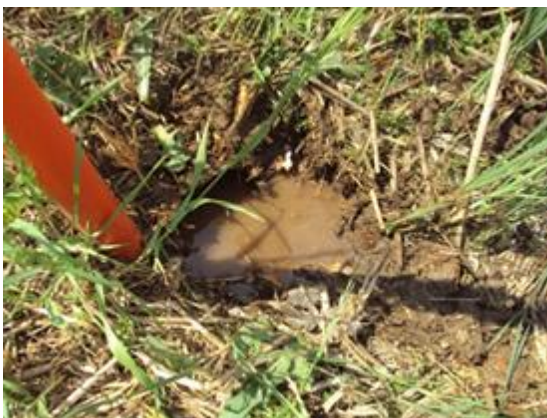
Soil blockage

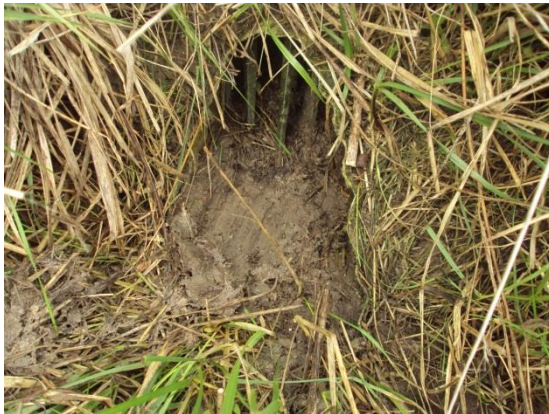
- Suggested by District 5 for investigation
- Skewed joint without load transfer
- Pipe has 90% gravel in.

Sediment blockage

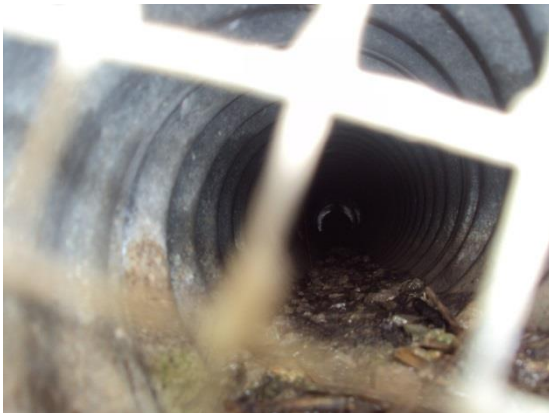
Sediment blockage

- Number of outlet pipe: 2
- Type of outlet pipe: Corrugated steel
- Size of outlet pipe: 6 inch
- Condition of outlet pipe: 30% blockage (soil blockage)
- Water present inside outlet pipe: No
- Type of rodent guard: Gate screen
- Tufa/Dead zone(due to tufa) present: No
- Embankment slop condition: Less than 30 degree
- Slope condition at outlet: Parallel

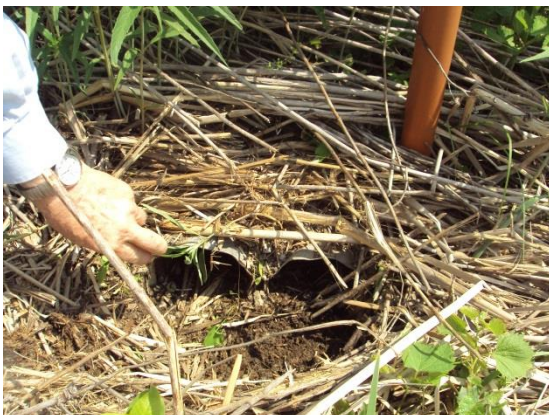
Soil blockage

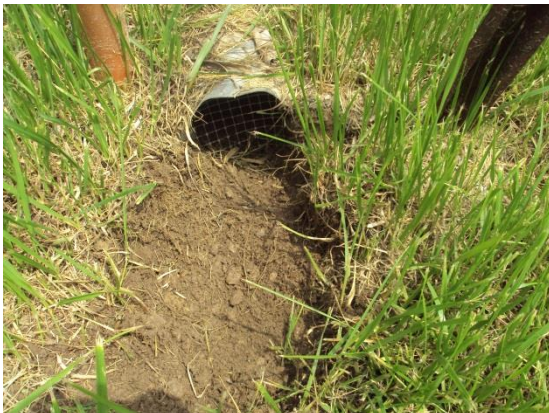
- Number of outlet pipe: 1
- Type of outlet pipe: Corrugated steel
- Size of outlet pipe: 6 inch
- Condition of outlet pipe: 30% blockage (soil blockage)
- Water present inside outlet pipe: No
- Type of rodent guard: Gate screen
- Tufa/Dead zone (due to tufa) present: No
- Embankment slop condition: Less than 30 degree
- Slope condition at outlet: Parallel

Soil blockage

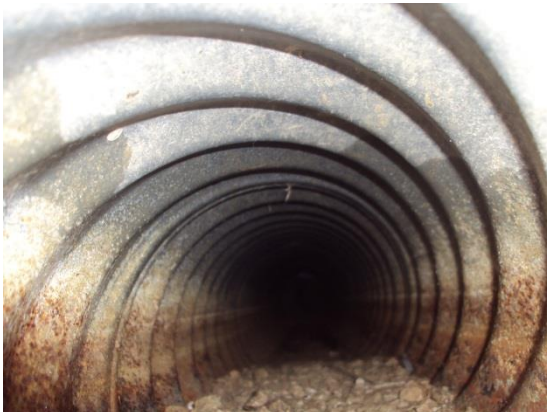
- Number of outlet pipe: 1
- Type of outlet pipe: Corrugated steel
- Size of outlet pipe: 6 inch
- Condition of outlet pipe: 40% blockage (sediment blockage)
- Water present inside outlet pipe: Yes (flowing)
- Type of rodent guard: N/A
- Tufa/Dead zone (due to tufa) present: No
- Embankment slop condition: Less than 30 degree
- Slope condition at outlet: Parallel

Sediment blockage

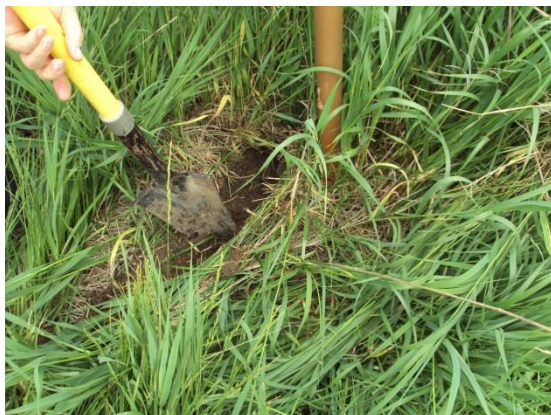
- Number of outlet pipe: 1
- Type of outlet pipe: Corrugated steel
- Size of outlet pipe: 6 inch
- Condition of outlet pipe: 100% blockage (soil blockage and damaged)
- Water present inside outlet pipe: No (wet)
- Type of rodent guard: Fork
- Tufa/Dead zone (due to tufa) present: No
- Embankment slop condition: Less than 30 degree
- Slope condition at outlet: Parallel

Soil blockage

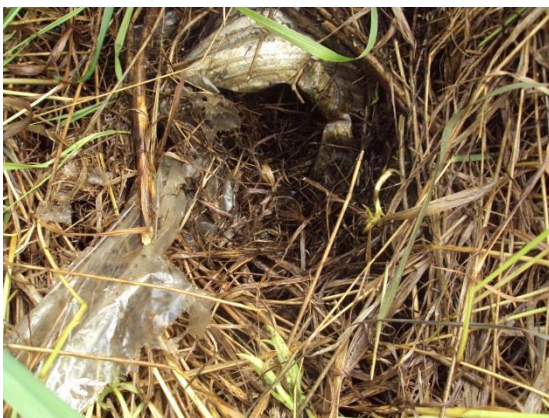
- Number of outlet pipe: 1
- Type of outlet pipe: Corrugated steel
- Size of outlet pipe: 6 inch
- Condition of outlet pipe: 100% blockage (soil blockage)
- Water present inside outlet pipe: Yes (standing)
- Type of rodent guard: Fork
- Tufa/Dead zone (due to tufa) present: No
- Embankment slop condition: Less than 30 degree
- Slope condition at outlet: Parallel

Soil blockage

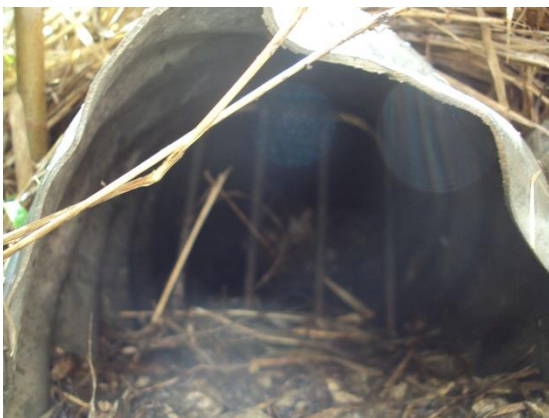
- Number of outlet pipe: 1
- Type of outlet pipe: Corrugated steel
- Size of outlet pipe: 6 inch
- Condition of outlet pipe: 50% blockage (soil blockage)
- Water present inside outlet pipe: Yes (standing)
- Type of rodent guard: Fork
- Tufa/Dead zone (due to tufa) present: No
- Embankment slop condition: Less than 30 degree
- Slope condition at outlet: Parallel

Soil blockage

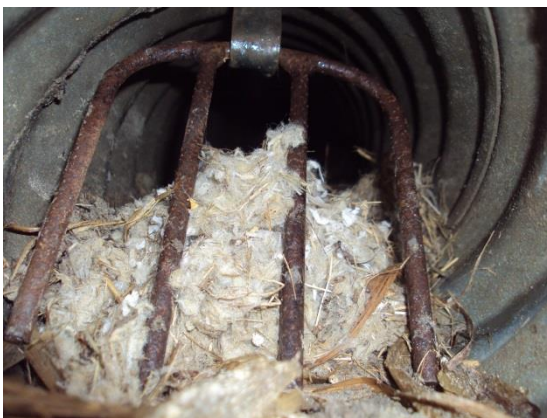
- Number of outlet pipe: 1
- Type of outlet pipe: Corrugated steel
- Size of outlet pipe: 6 inch
- Condition of outlet pipe: 70% blockage (sediment blockage)
- Water present inside outlet pipe: No
- Type of rodent guard: Fork
- Tufa/Dead zone (due to tufa) present: No
- Embankment slop condition: Less than 30 degree
- Slope condition at outlet: Parallel

Sediment blockage

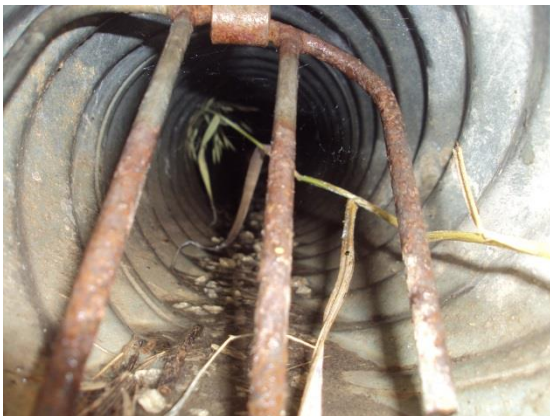
No blockage

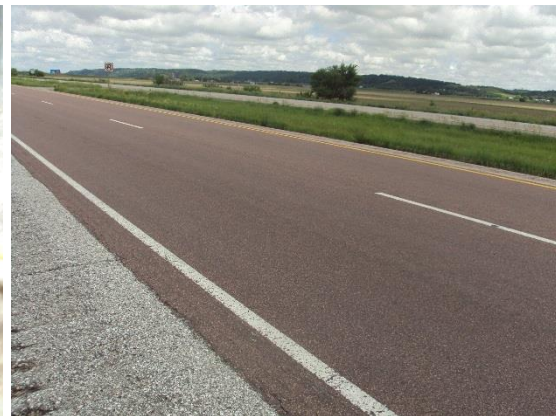
No pavement surface distress

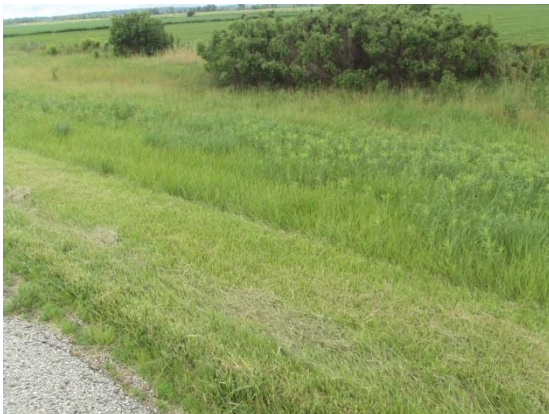
- Flooded by Missouri River in 2011
- Quartz aggregates
- This section has no drainage outlet

No drainage outlet

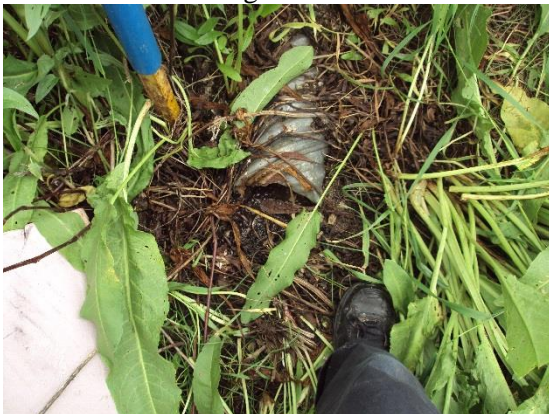
- Number of outlet pipe: 1
- Type of outlet pipe: Corrugated steel
- Size of outlet pipe: 6 inch
- Condition of outlet pipe: 50% blockage (sediment blockage)
- Water present inside outlet pipe: Yes (standing)
- Type of rodent guard: Fork
- Tufa/Dead zone (due to tufa) present: No
- Embankment slop condition: Less than 30 degree
- Slope condition at outlet: Parallel

Soil blockage

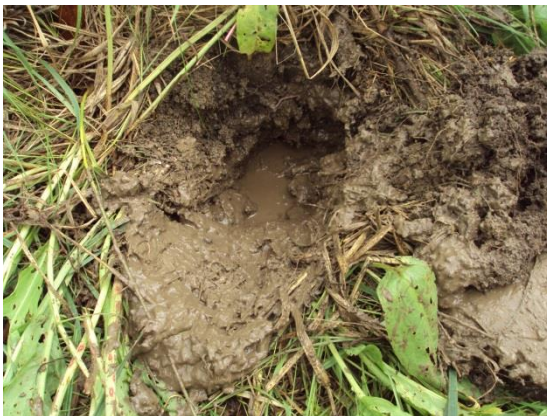
- Number of outlet pipe: 1
- Type of outlet pipe: Corrugated steel
- Size of outlet pipe: 6 inch
- Condition of outlet pipe: 100% blockage (soil blockage)
- Water present inside outlet pipe: Yes (standing)
- Type of rodent guard: N/A
- Tufa/Dead zone (due to tufa) present: No
- Embankment slop condition: Less than 30 degree
- Slope condition at outlet: N/A

Soil blockage

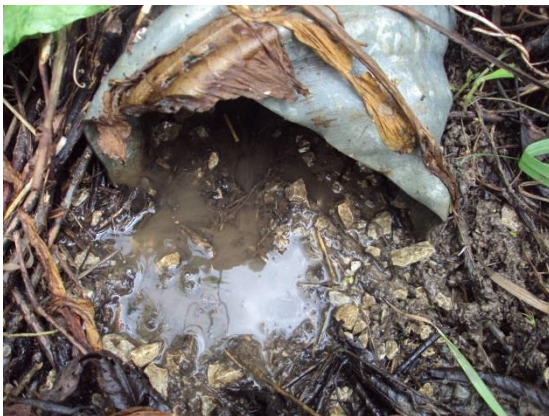
- Number of outlet pipe: 1
- Type of outlet pipe: Corrugated steel
- Size of outlet pipe: 6 inch
- Condition of outlet pipe: 50% blockage (sediment blockage)
- Water present inside outlet pipe: Yes (flowing)
- Type of rodent guard: Fork
- Tufa/Dead zone (due to tufa) present: No
- Embankment slop condition: Less than 30 degree
- Slope condition at outlet: Parallel

Sediment blockage

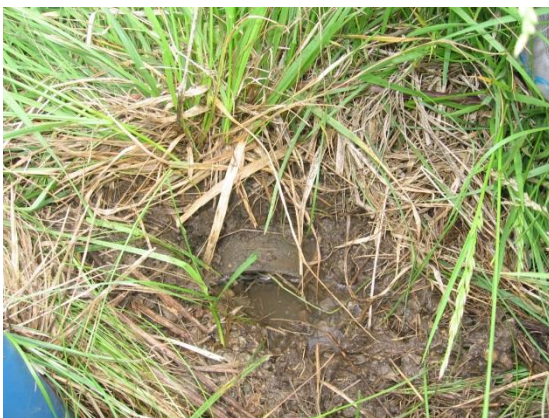
Soil blockage

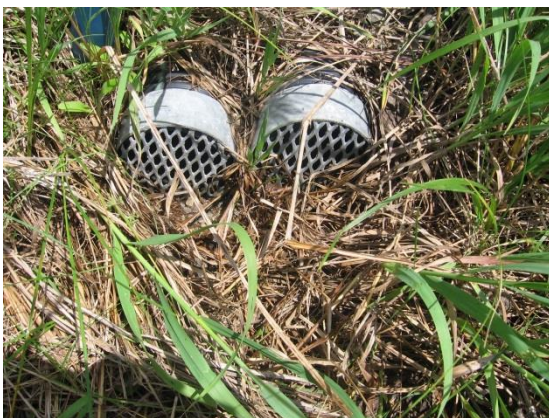
Soil blockage

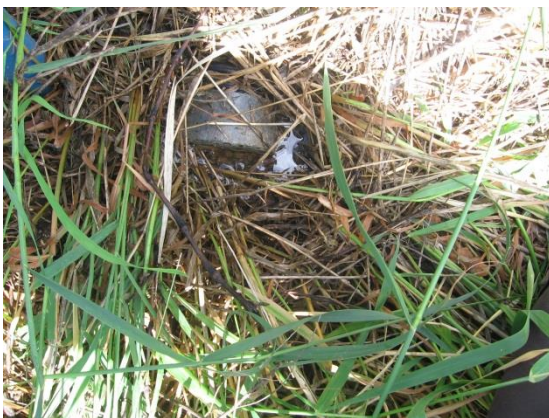
Soil blockage

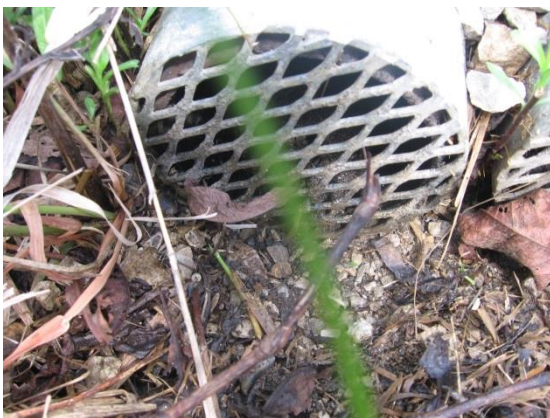
Sediment blockage

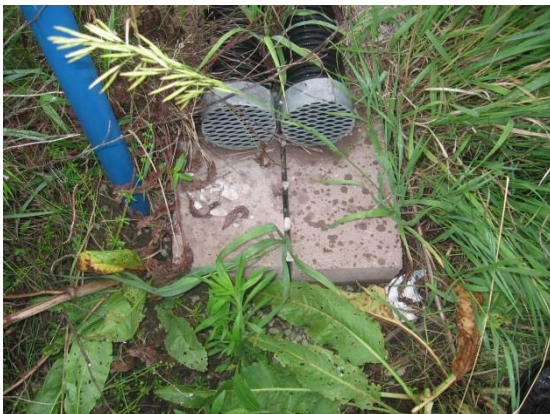
No blockage

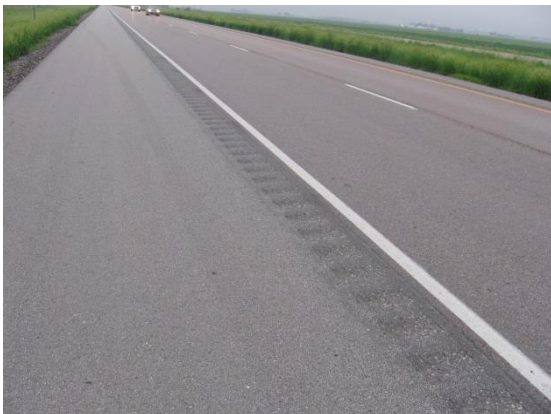
No pavement surface distress

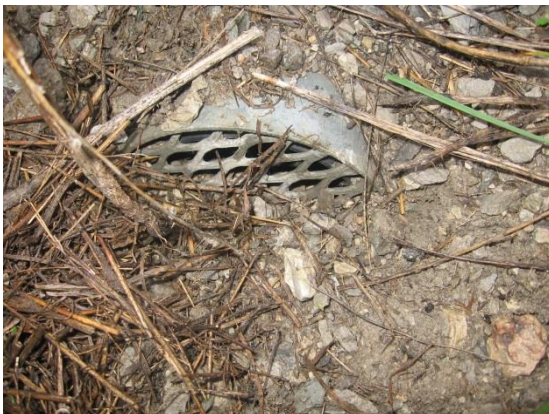
Soil blockage

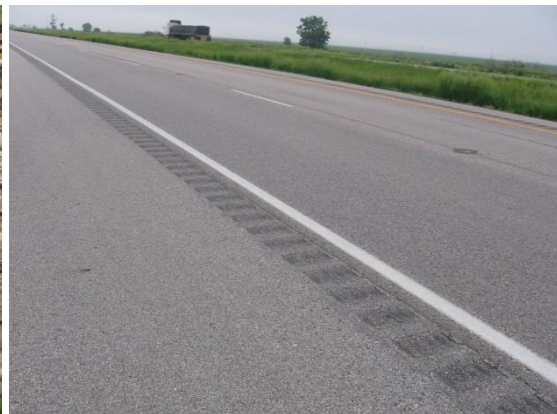
No pavement surface distress

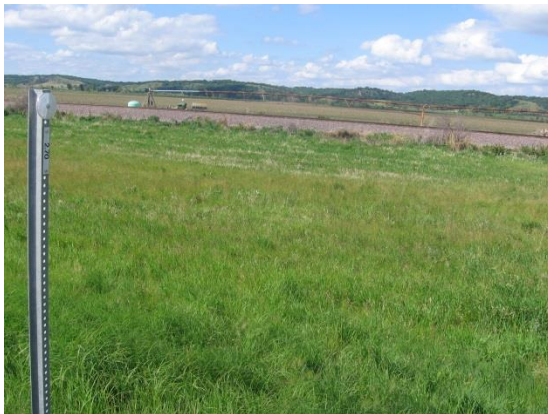
- Flooded by Missouri River in 2011
- This section has no drainage outlet.
- Cracking is related to drainage

No drainage outlet

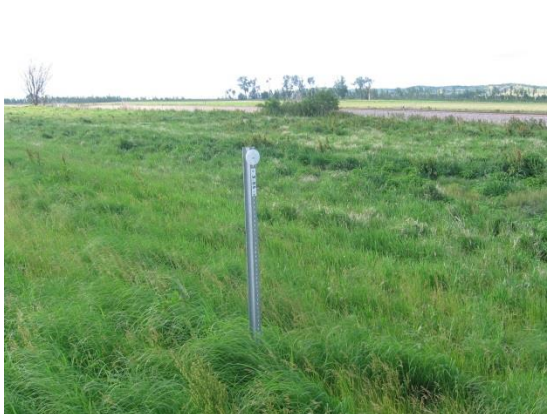
No drainage outlet

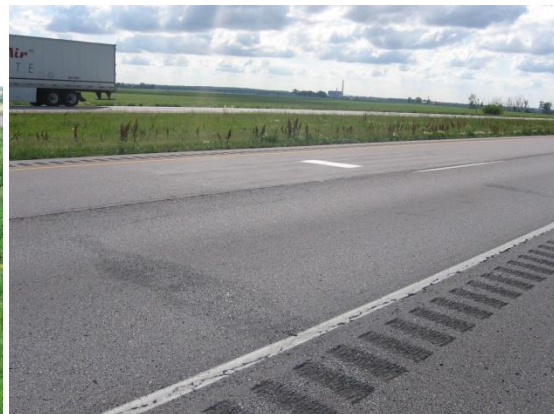
Stripping/patching

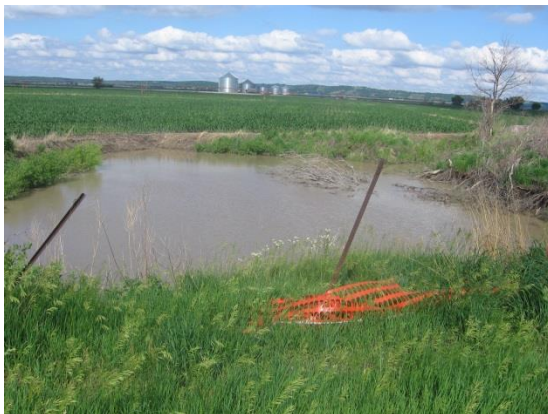
No drainage outlet

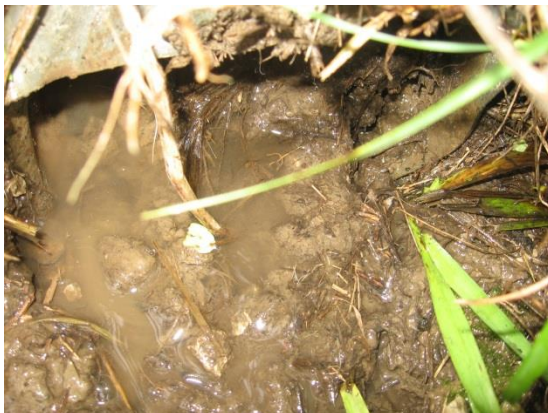
Soil blockage

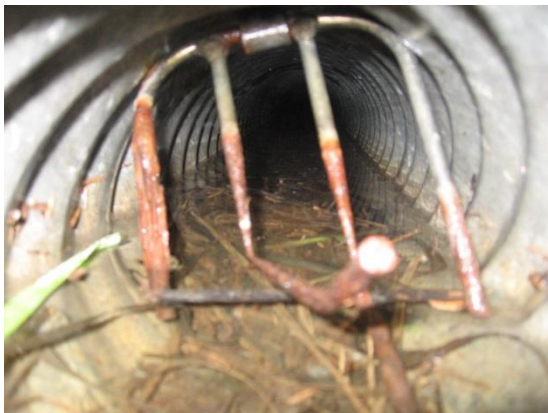
Sediment blockage

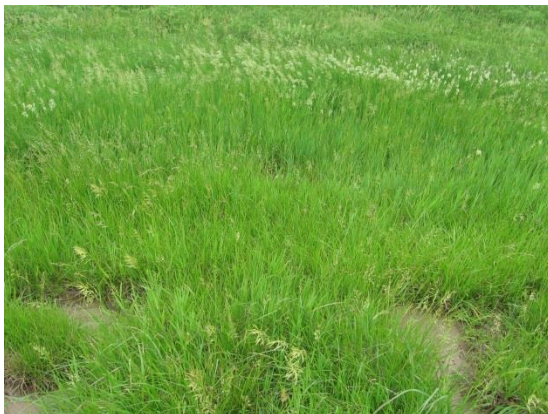
No drainage outlet

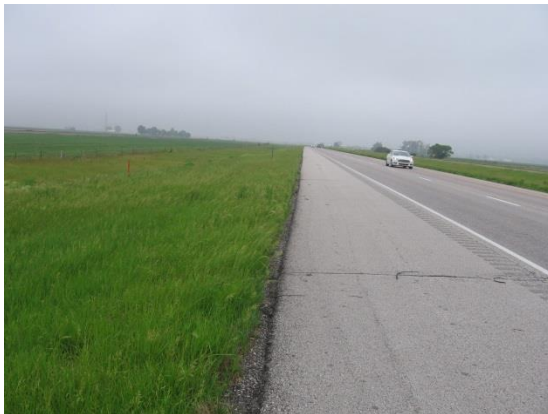
- Flooded by Missouri River in 2011
- This section has no drainage outlet.
- The cracking has a culvert nearby.

No drainage outlet

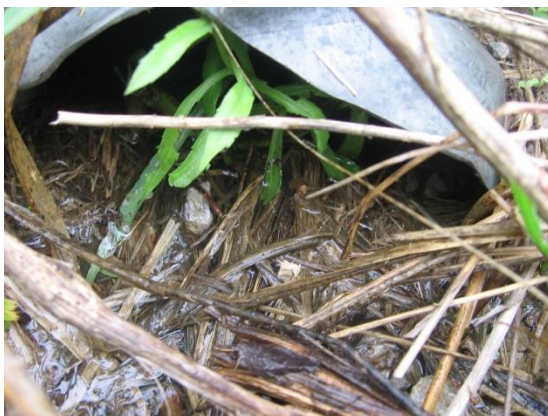
Sediment blockage

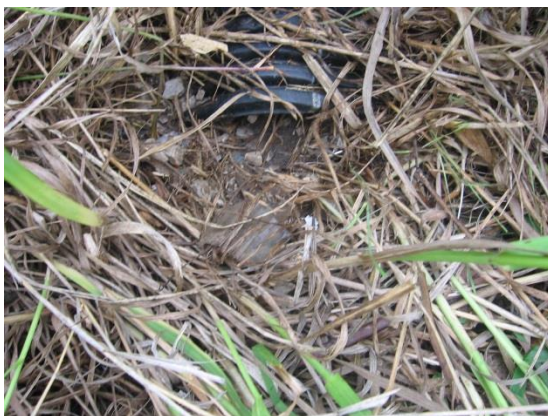
Soil blockage

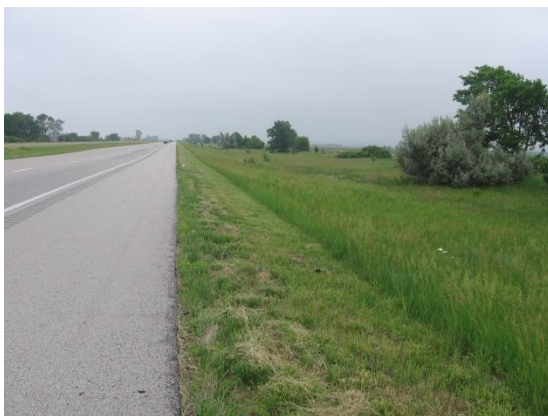
No drainage outlet

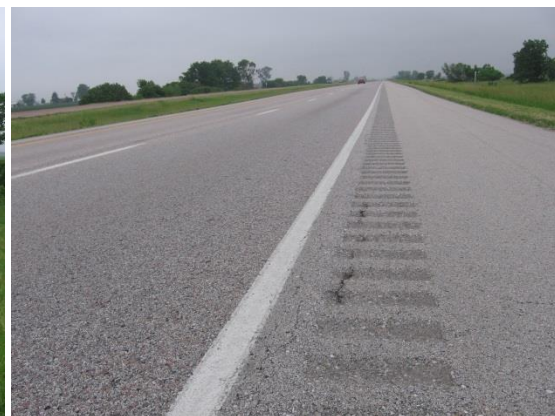
Rutting

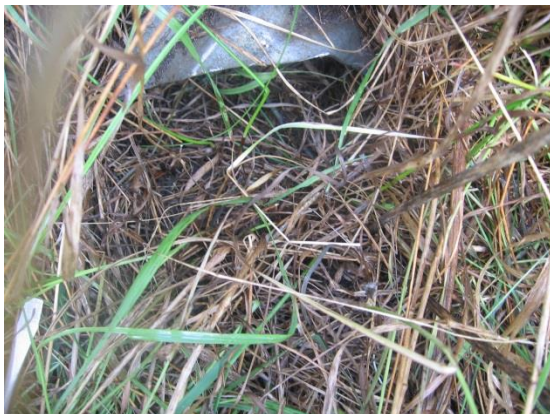
Soil blockage

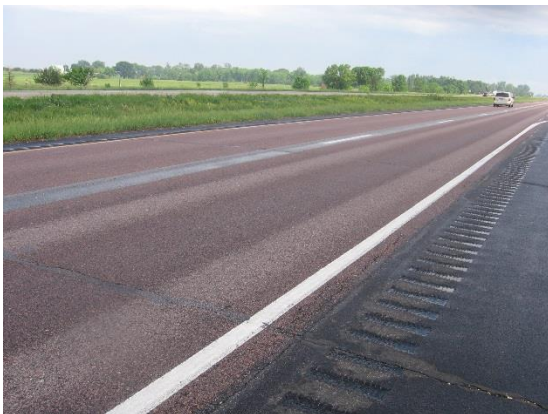
Reflection cracking

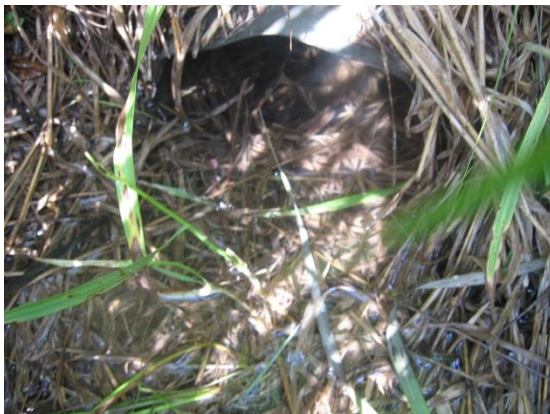
Soil blockage

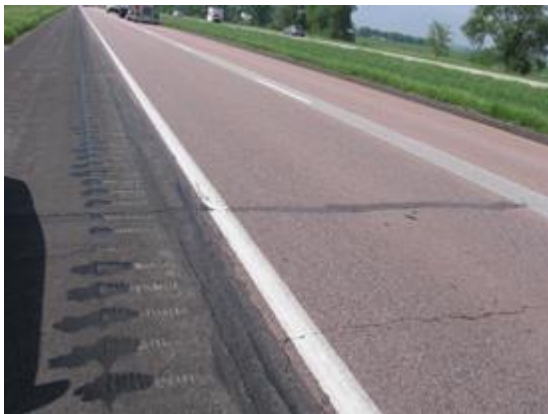
Reflection and transverse cracking

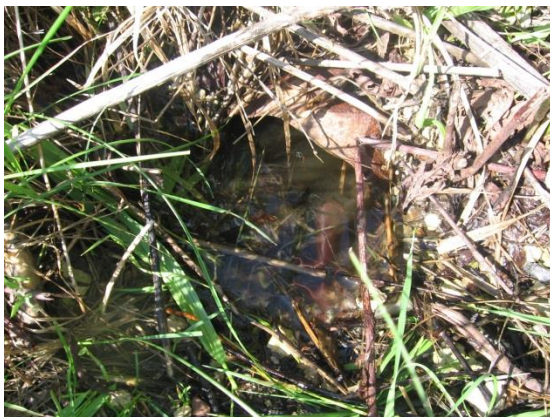
- Suggested by District 3 for investigation
- Quartz aggregates
- This section has concrete patch. The beginning and ending points of patching have no drainage outlet, and the middle point has a drainage outlet

Soil blockage

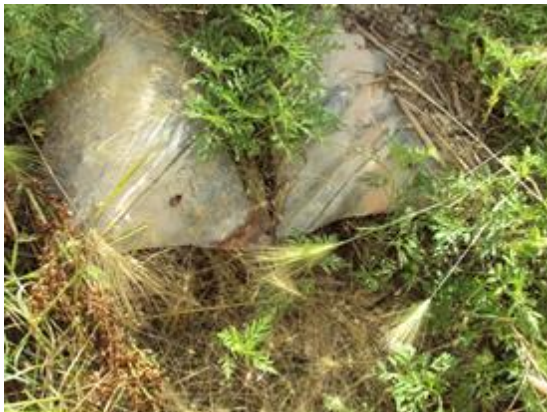
- Number of outlet pipe: 2
- Type of outlet pipe: Corrugated steel
- Size of outlet pipe: 6 inch
- Condition of outlet pipe: 80% blockage (sediment block)
- Water present inside outlet pipe: No
- Type of rodent guard: Gate
- Tufa/Dead zone (due to tufa) present: No
- Embankment slop condition: Less than 30 degree
- Slope condition at outlet: Parallel/Less than 1-ft. downhill

Sediment blockage

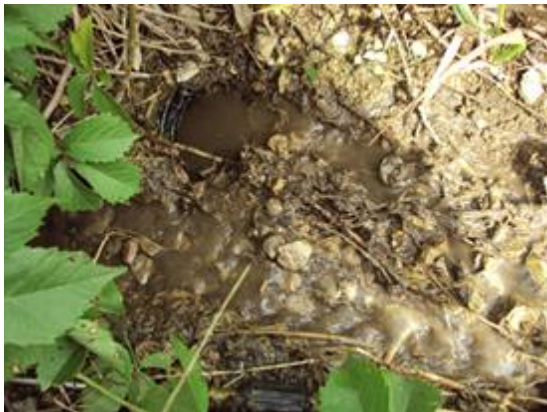
## **I-29/S/MP 60.35**

- Number of outlet pipe: 2
- Type of outlet pipe: Corrugated plastic
- Size of outlet pipe: 4 inch
- Condition of outlet pipe: 90% blockage (soil blockage)
- Water present inside outlet pipe: Yes (free flowing)
- Type of rodent guard: Gate
- Tufa/Dead zone (due to tufa) present: No
- Embankment slop condition: More than 30 degree
- Slope condition at outlet: Downhill

Soil blockage

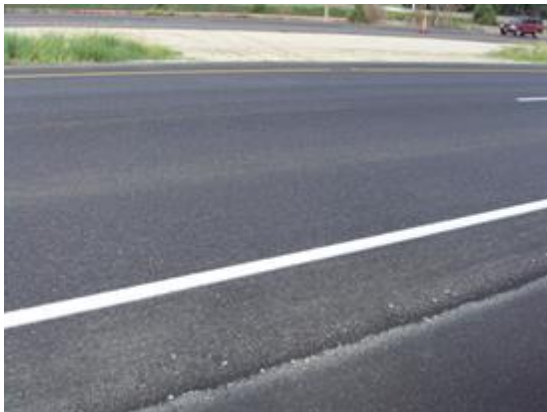
- No distress observed

New HMA overlay

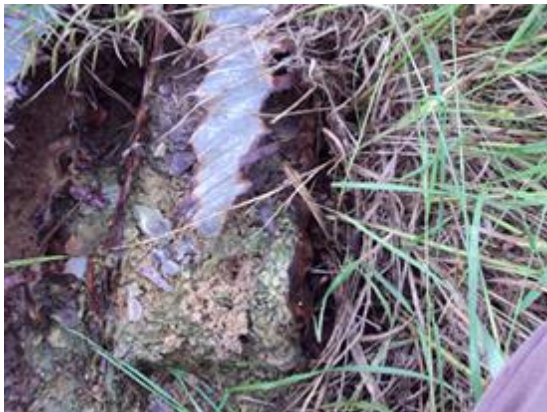
## I-29/N/MP 72.15

- Number of outlet pipe: 2
- Type of outlet pipe: Corrugated steel
- Size of outlet pipe: 6 inch
- Condition of outlet pipe: 80% blockage (tufa blockage and damaged)
- Water present inside outlet pipe: Yes (standing)
- Type of rodent guard: N/A
- Tufa/Dead zone (due to tufa) present: Yes
- Embankment slop condition: Less than 30 degree
- Slope condition at outlet: Parallel/Less than 1-ft. downhill

Tufa blockage/damaged outlet pipe

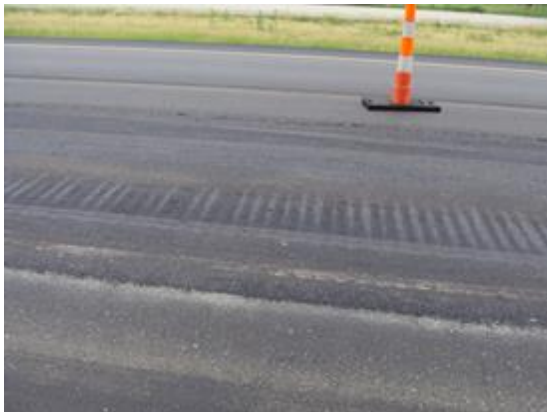
- No distress observed

New HMA overlay

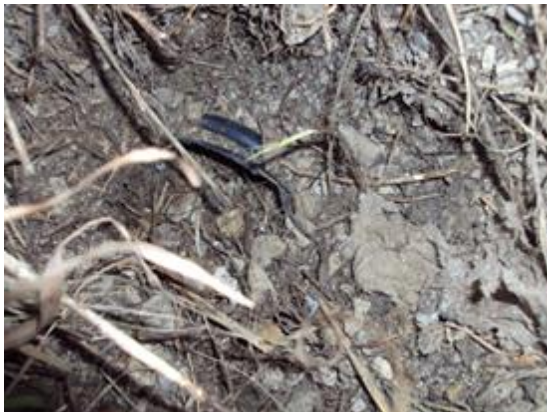
## I-29/N/MP 74.82

- Number of outlet pipe: 1
- Type of outlet pipe: Corrugated plastic
- Size of outlet pipe: 4 inch
- Condition of outlet pipe: 100% blockage (soil blockage and damaged)
- Water present inside outlet pipe: No
- Type of rodent guard: N/A
- Tufa/Dead zone (due to tufa) present: No
- Embankment slop condition: Less than 30 degree
- Slope condition at outlet: Uphill

Soil blockage/damaged outlet pipe

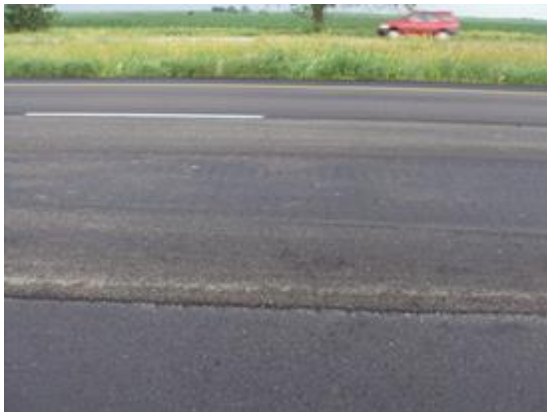
- No distress observed

New HMA overlay
